Re: **STEVESTON INTERURBAN TRAM #1220 - OWNERSHIP**

Re: Steveston Interurban Tram Car #1220 - Condition Report

General Condition Report

Interurban Tram Car #1220

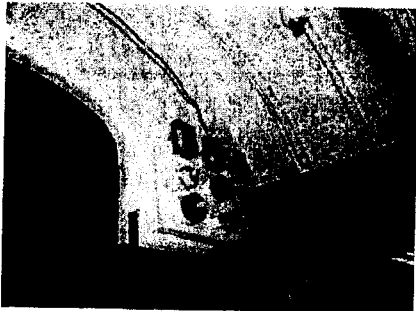
- Snap switches at A end.
- Top three switches and the round black switch not working.
- Bottom round brass switches appear OK.
- Snap switches are difficult to find and are not easily repaired if the porcelain is broken.

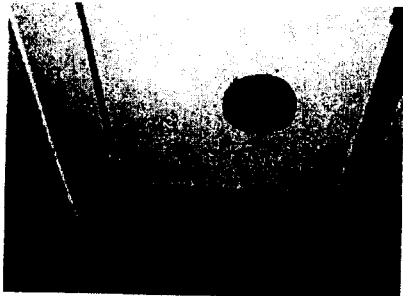
- Brass ventilator covers required.
- Some observed onsite.
- Appears as if approximately 7 are required.

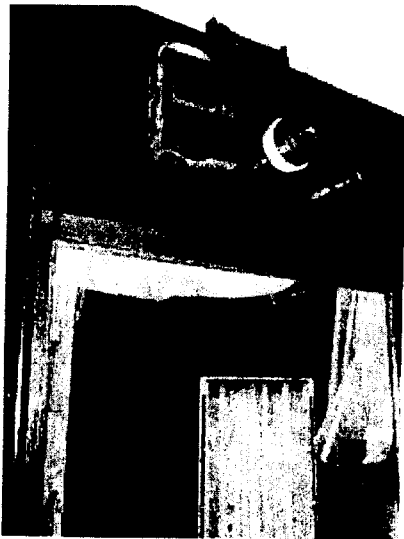
- A end master control switch not moving internal parts are worn but can be repaired.
- Master controller switch is missing and replaced with a snap switch (centre).
- Circuit breaker switch complete.

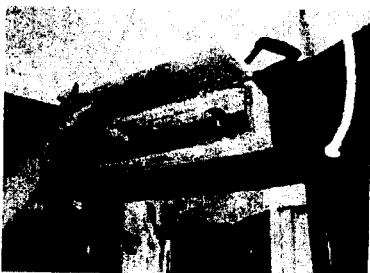
- Knife switch for "Bus Line" operation missing.

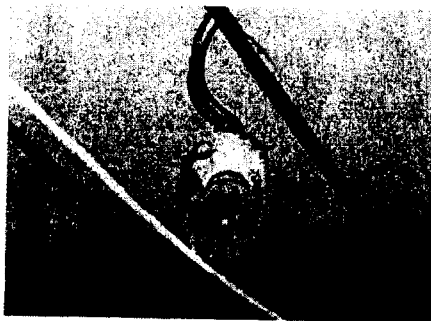
- Light fixtures on Vancouver’s tram 1231 are all porcelain as in this picture.
- The fixtures observed inside the motorman cab at both ends of the car were metal.

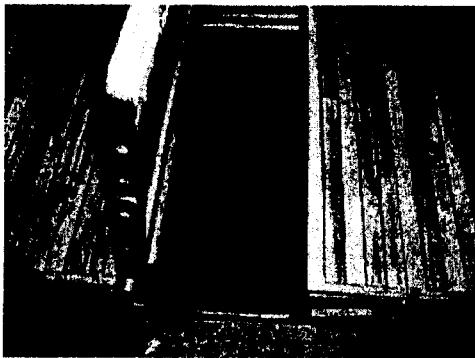
- Original floorboards.
- Nice feature.
- Vancouver had to replace theirs.

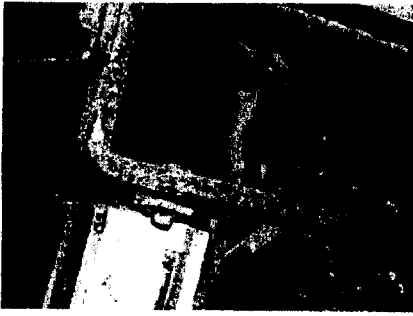
- Kicking coil is original.
- Vancouver had theirs rewound. May be a similar situation here.

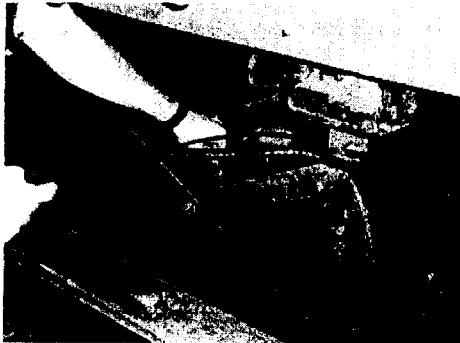
- Compressor pump and motor.
- No brushes in compressor motor.
- Armature original.
- Oil in pump looks to be original although too thick.
- Vancouver required to rebuild compressor motor at an approximate cost of \$2000.
- Intake valve for compressor is present and complete.

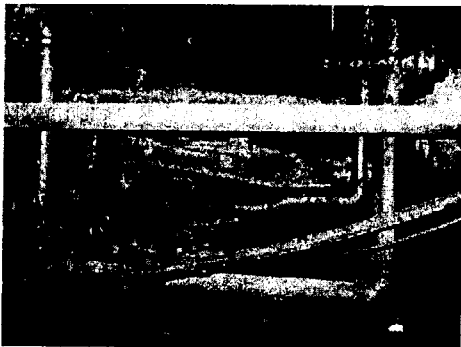
- Triple valve controls flow of air to brake cylinder.
- Questionable whether it is working.
- Only way to determine if it is working is to put air to it.

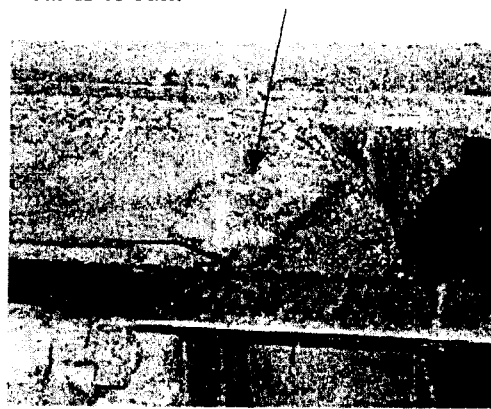
- A end truck on right side similar repairs as to the B end truck.
