City of Richmond

Report to Council

To: Public Works & Transportation Committee *To Public Works + Transp - Sept 21, 2005*
From: Robert Gonzalez, P.Eng.
Director, Engineering **Date:** September 16, 2005
Re: **Emergency Repairs to the Interior and Exterior Piping
for the Geothermal System at Thompson Community Centre** **File:** 2052-20-TCC/Vol 1

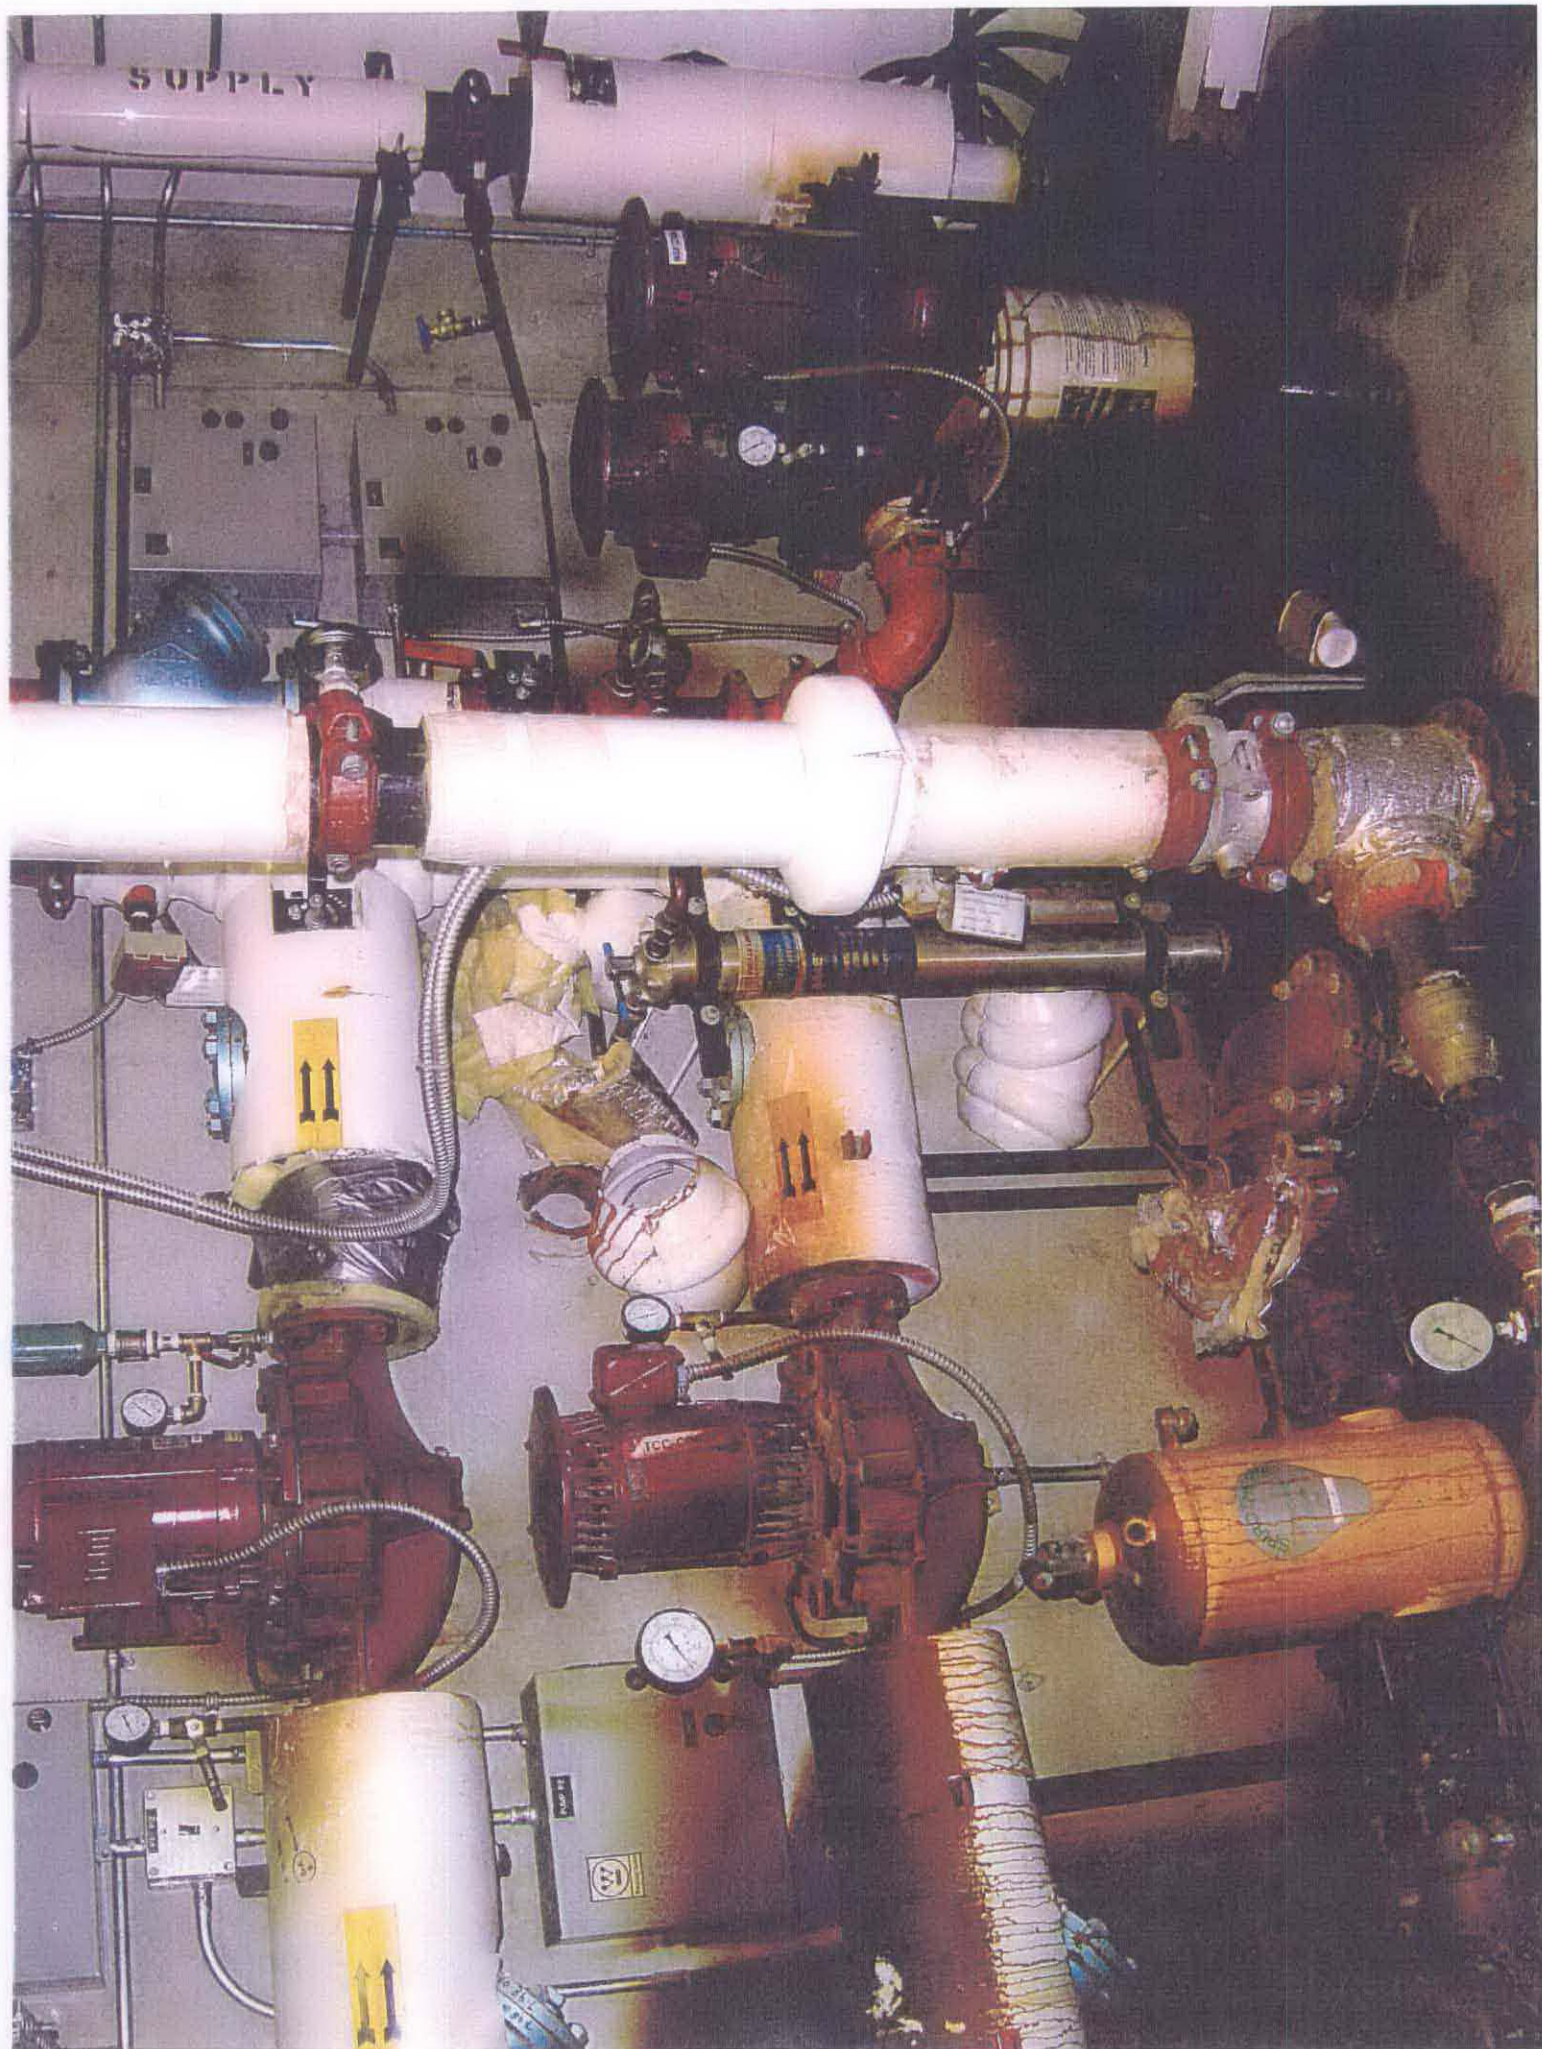
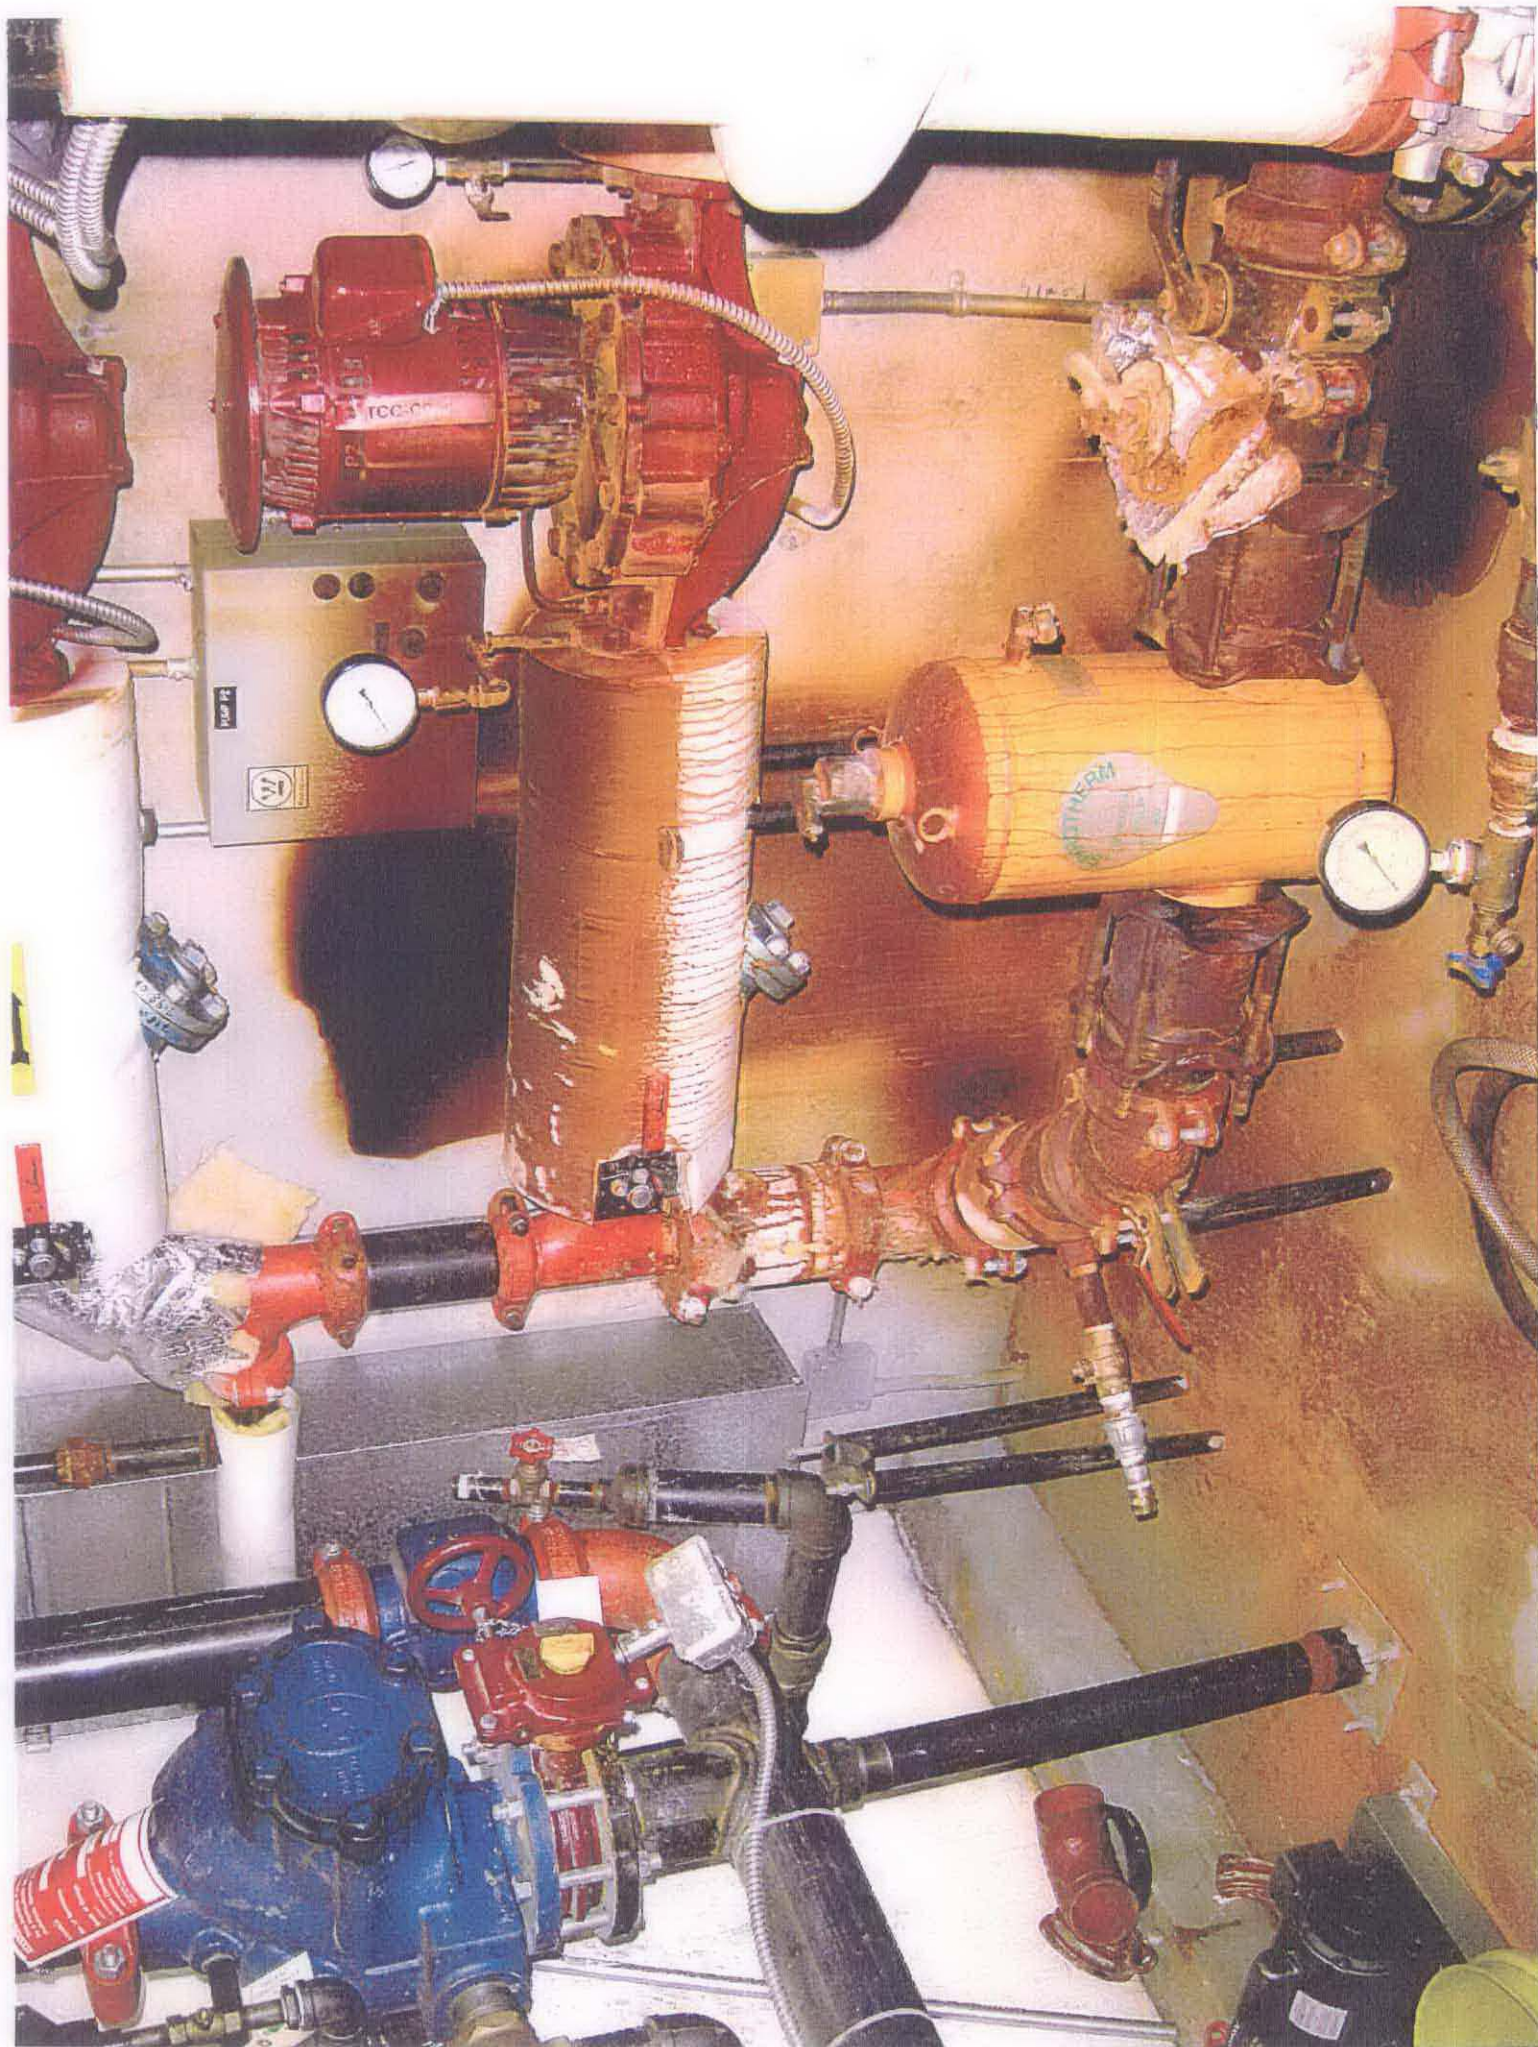
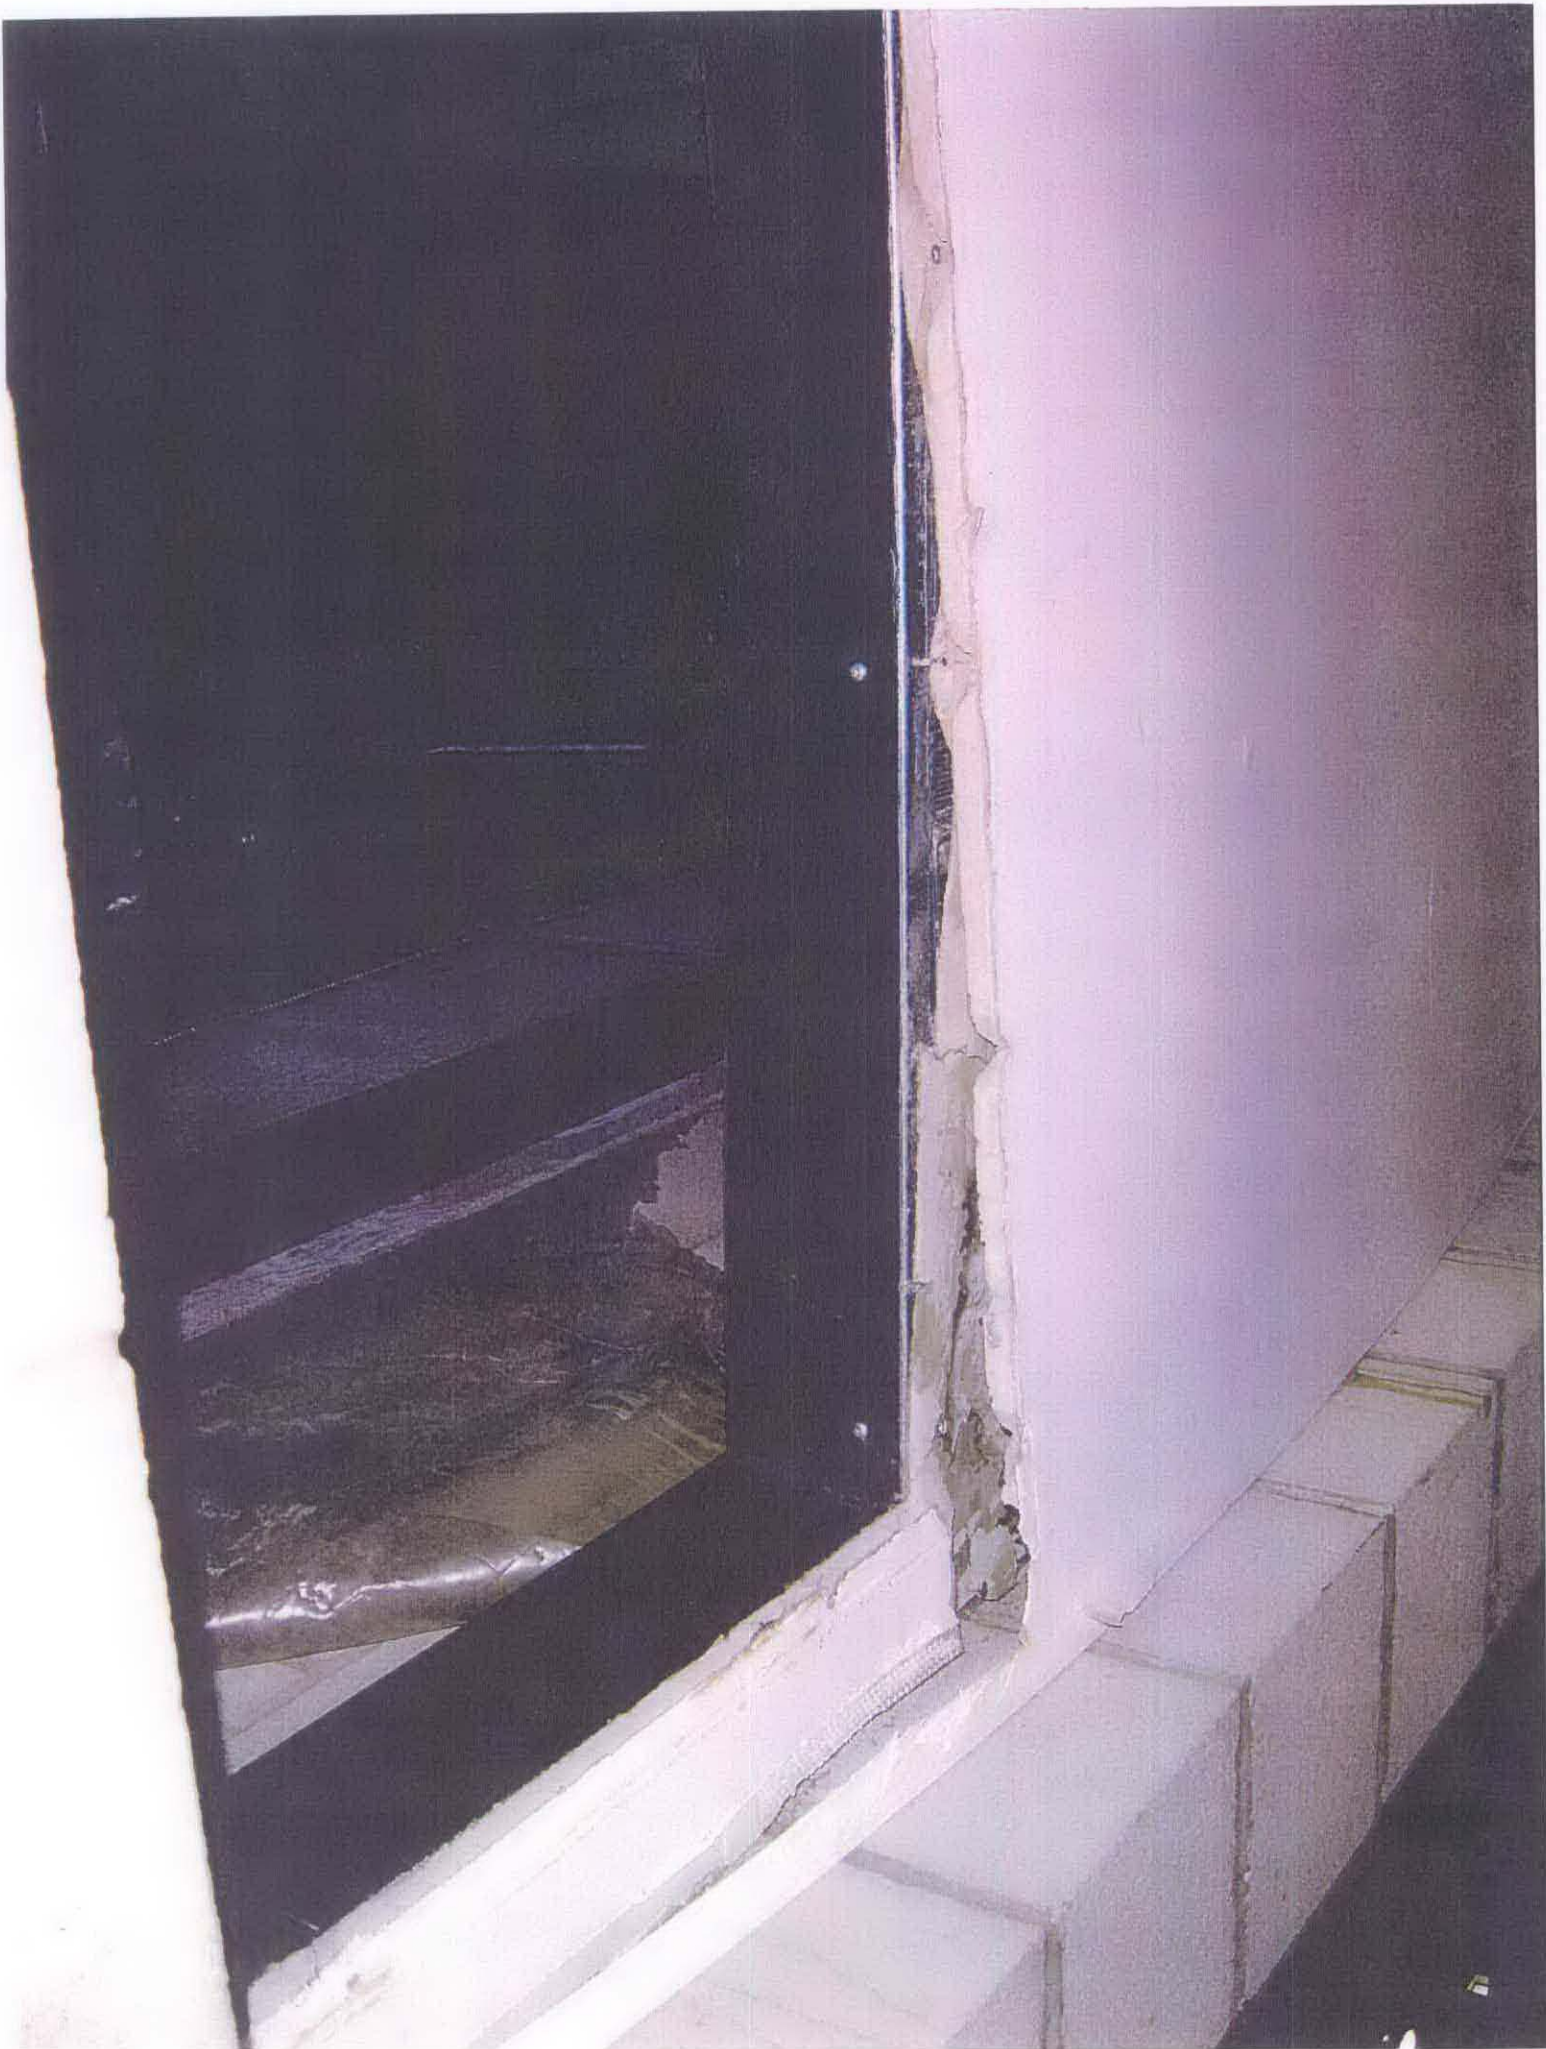
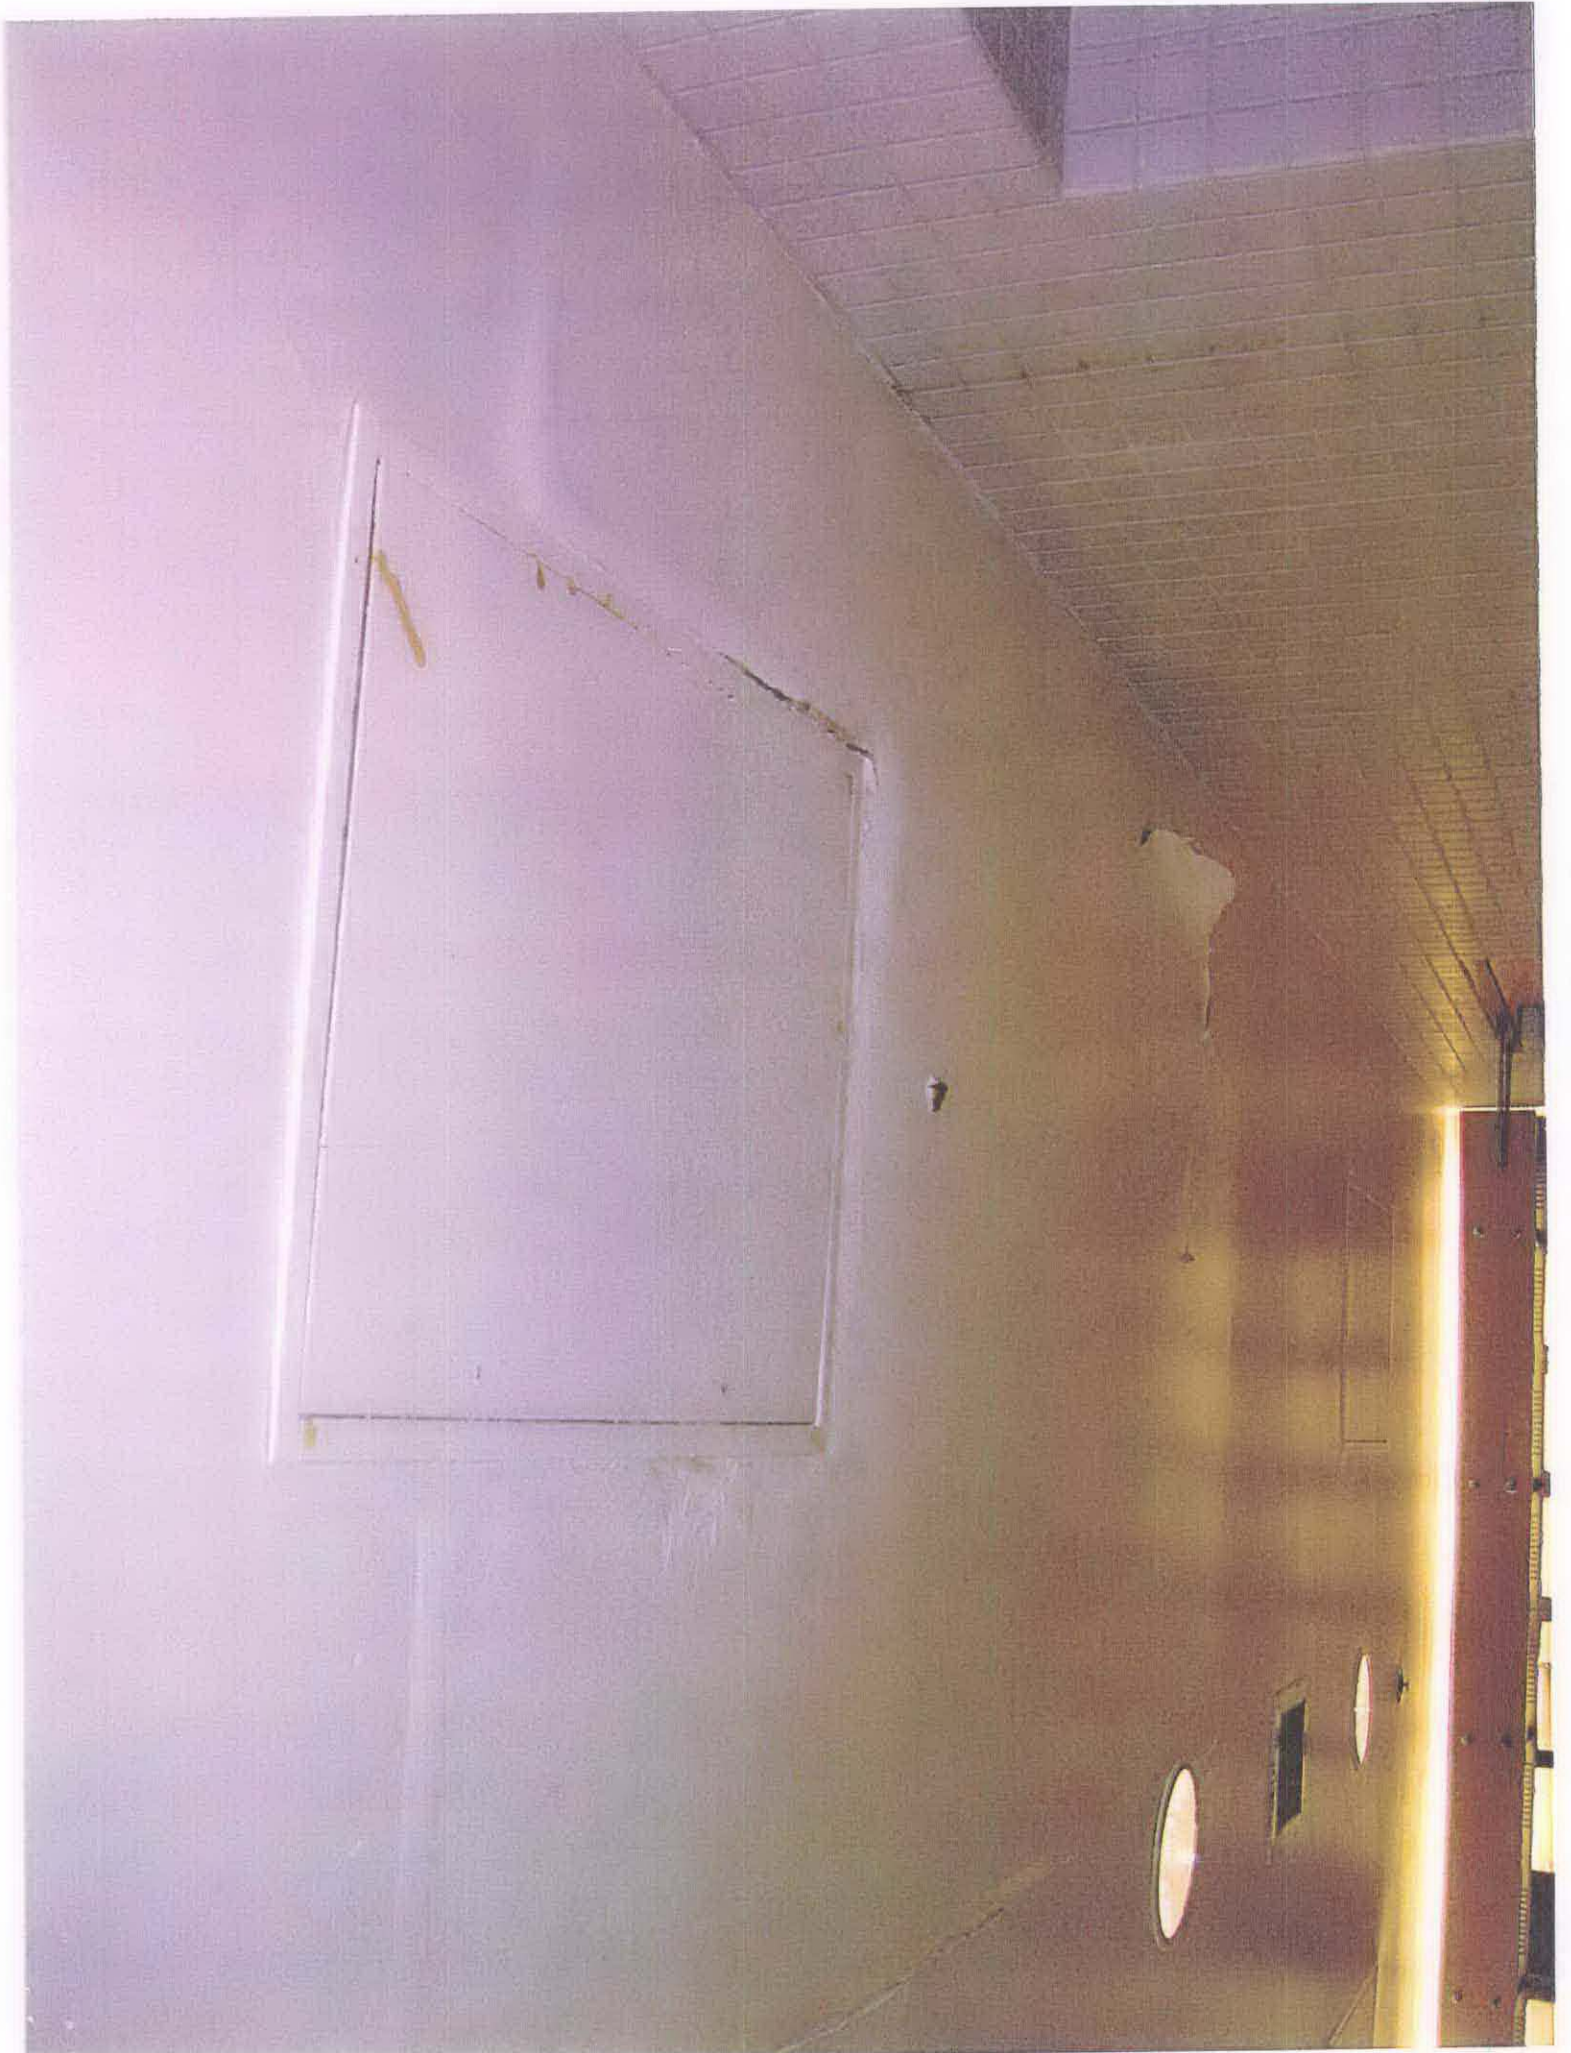
In January 2005 Facility Management staff identified severe corrosion of the inside circulation piping. Work to repair several system failures due to leaks since January has been frustrating, resulting in year to date repair costs in excess of \$54,000. Accessing the failed piping has resulted in damage to the building estimated at \$5,000 and this damage has yet to be repaired.

A recent system audit by our contracted maintenance vendor, Airon Heating and Air Conditioning Ltd. and Earth Source, a geothermal systems consultant, has revealed additional problems with field circulation causing the compressors to operate at a very high head pressure. Failure to correct this problem will eventually result in premature failure of the mechanical system. (Photos attached).

Interior Piping System Facility Management staff have been experiencing on-going problems with the interior geothermal piping system since the beginning of this year. Year to date there have been eleven emergency calls to repair leaking pipes. Water leaks in the building have caused drywall damage and in several locations drywall had to be removed to access the failed piping.

In August, Airon and Earth Source facilitated an audit of the geothermal system. Information received from this audit identified the need to replace additional internal piping as well as flow and heat transfer issues with the external geothermal field. This condition is putting additional load and strain on the mechanical equipment not allowing it to function as designed. Failure to take action will result in premature failure of equipment. In addition the plant is not running efficiently resulting in much higher energy costs than should be expected from typical geothermal systems.

Facilitate the repairs immediately as recommended.

The vendor quoted price for the emergency repairs to the internal and external geothermal system is \$83,460.00 plus GST. A quote for internal resources to repair the damaged walls and ceilings in the building is \$5,000.00. We recommend a contingency of \$21,200.00 to allow for identified needs that accurate pricing cannot be provide for at this time.
