To: Public Works and Transportation Committee
From: Siu Tse, P.Eng.
 Manager, Engineering Planning
Re: **Drainage at 10591 Blundell Road**

Date: October 10, 2003
File: 6060-01

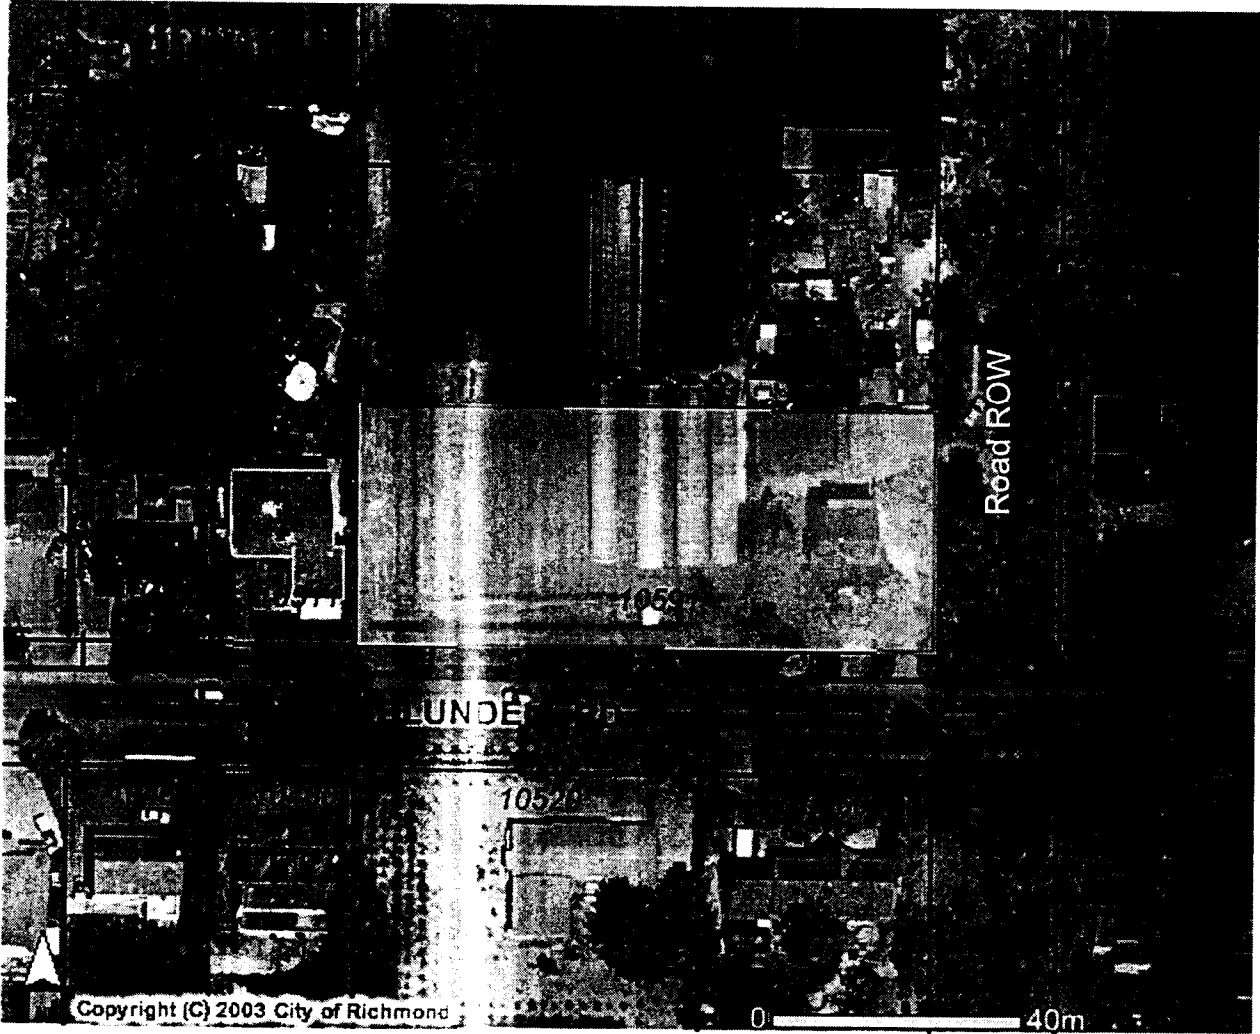
Figure 1. 10591 Blundell Road

The property has eight drainage connections to the fronting city storm main, as identified on the city's GIS (see figure 1). There is also an undeveloped right of way immediately east of the property that is serviced with a 375 mm main stub draining a small section of ditch. Mr. Koop drains a significant portion of his property to this ditch.
