# City of Richmond

## Report to Committee

**To:** General Purposes Committee **Date:** October 31, 2017  
**From:** Serena Lusk **File:** 06-2345-20-MINO1/Vol  
 Interim Director, Parks and Recreation 01  
**Re:** **Minoru Place Activity Centre Reuse Options**

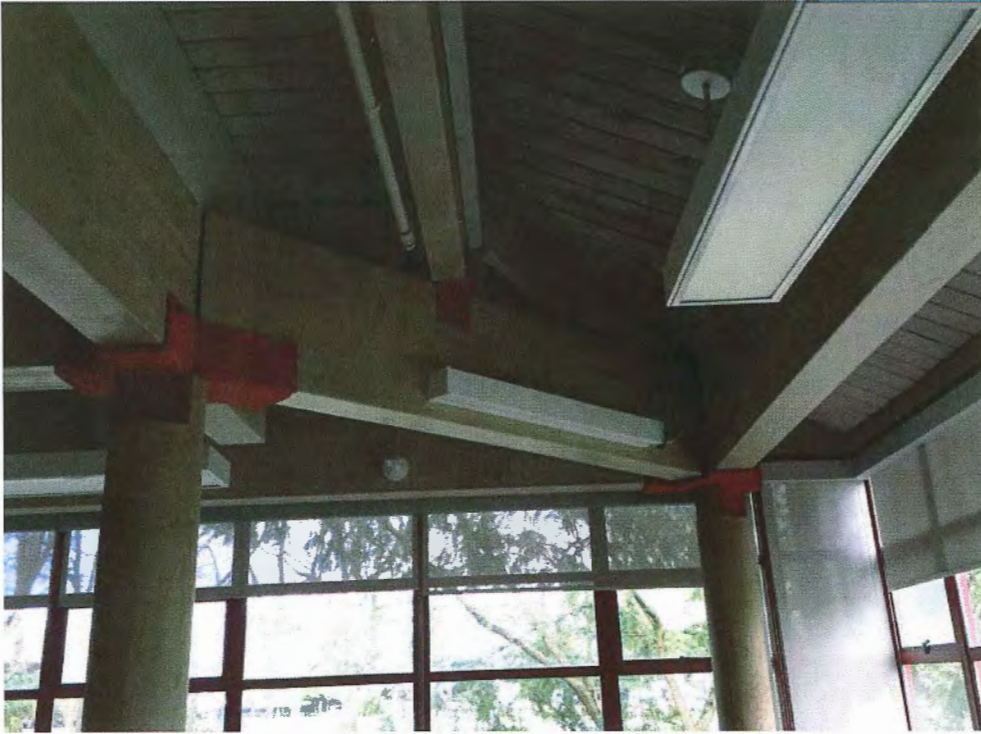
Picture 1 - Exposed Timber Roof Framing

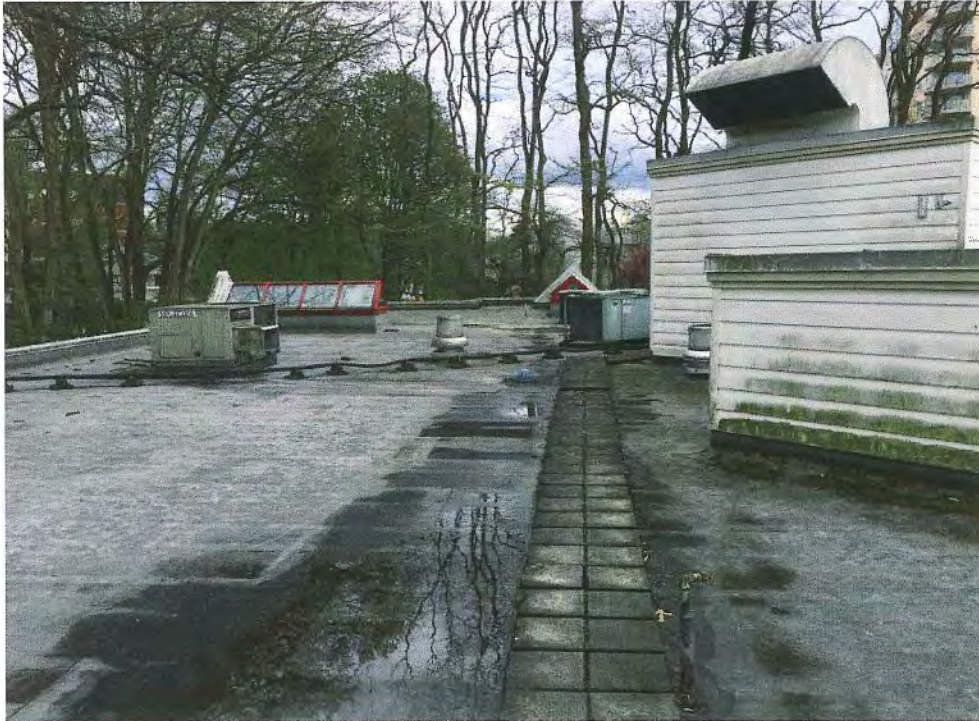
*Picture 3 - Roof in Fair Condition – Drains Well. There are several Rooftop Units.*

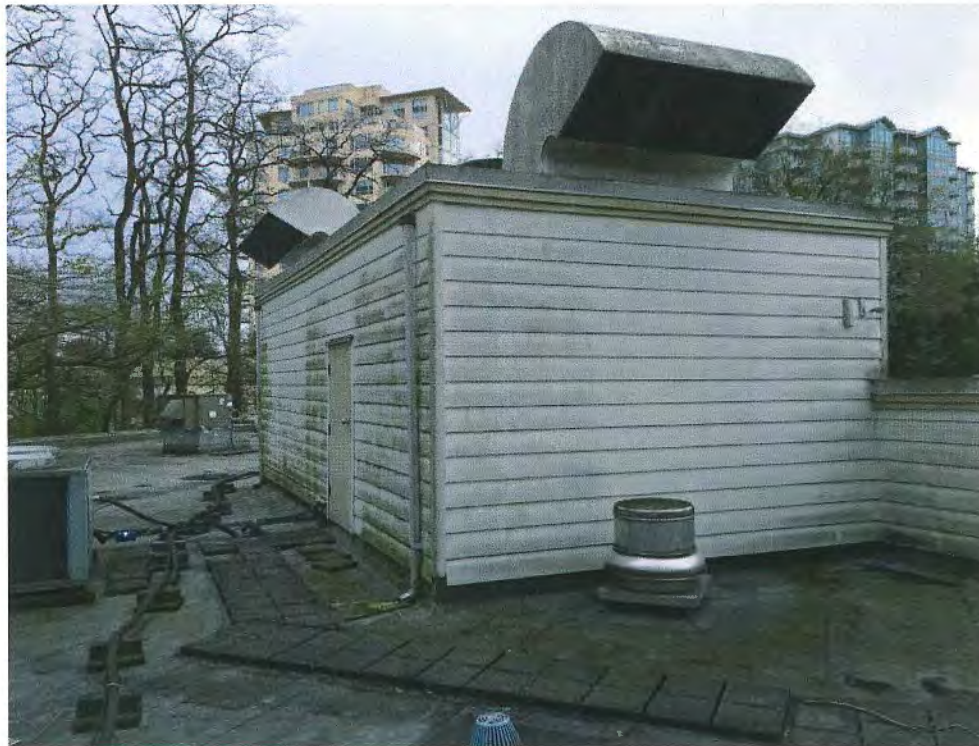
*Picture 3 - Mechanical Penthouse with adjacent roof step over Activity Room*

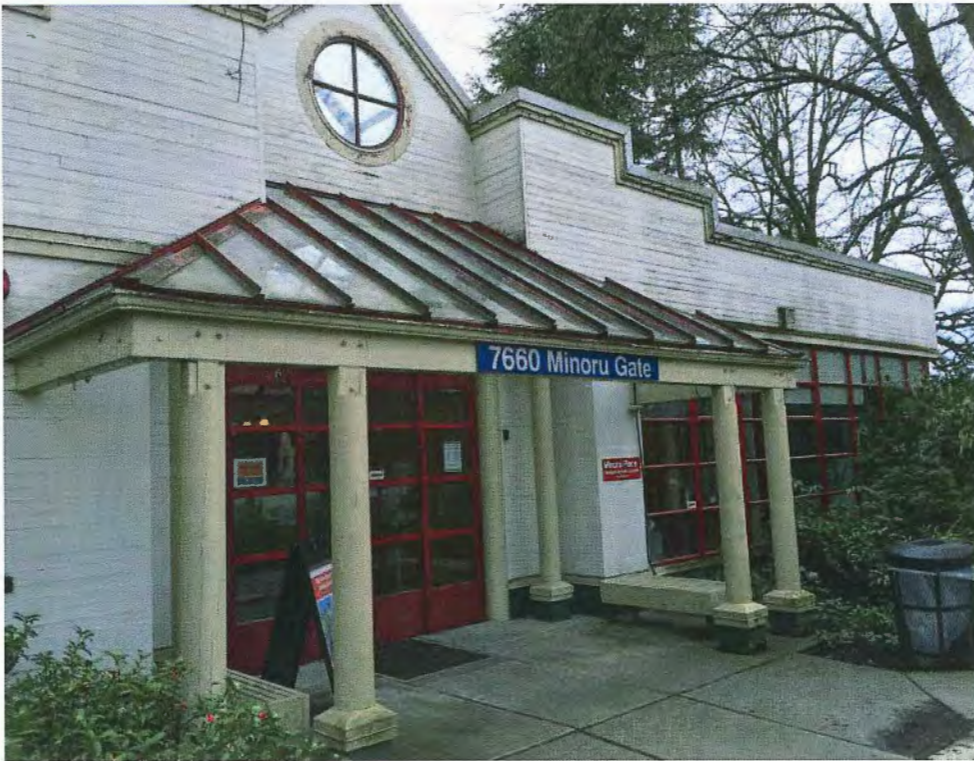
Picture 5 - Building Exterior in Fair Condition – requires cleaning and painting

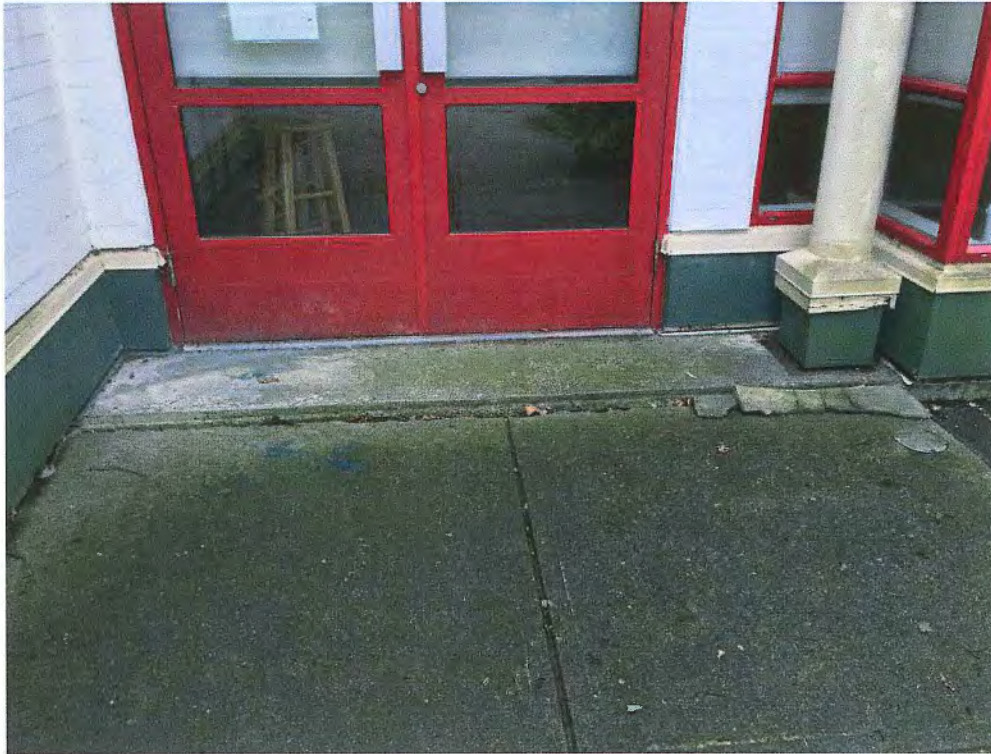
*Picture 5 - Ground settlement at several door thresholds. Edge of raft slab exposed creating a cold bridge.*

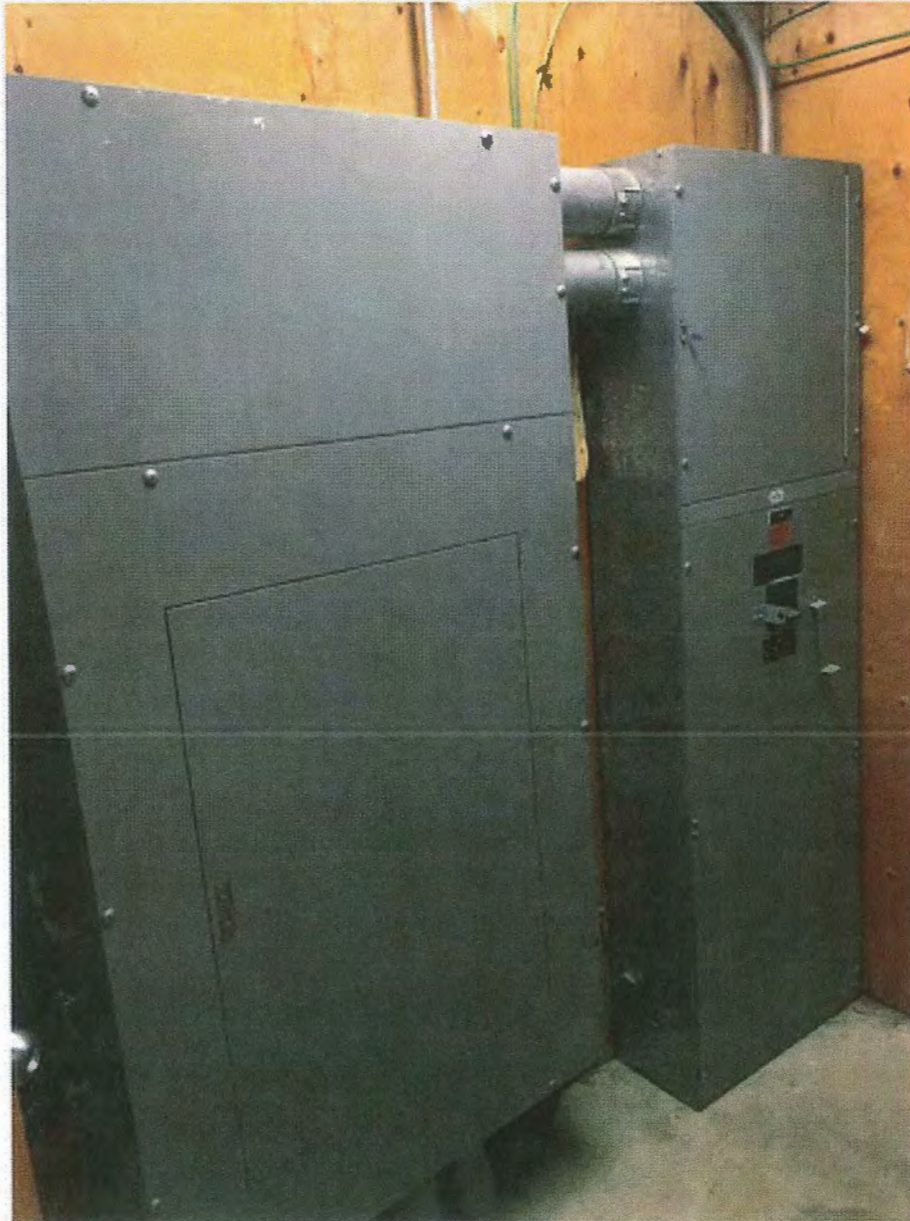
distribution equipment located throughout the building and on the roof (panel boards and disconnect switches) is in good condition.

*Figure 2 – Building Main Switchboard 800A*

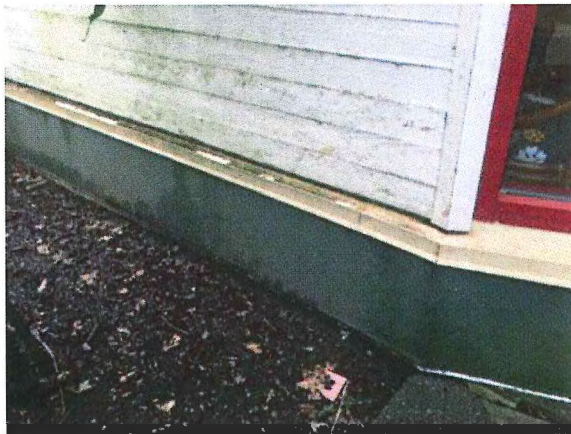
1. The wood framed exterior walls bear on the concrete slab on grade. This is shown on the architectural drawings and was verified on site (Figure 10 and Figure 11). The architectural drawings indicate an elevation difference between the finished grade and top of slab on grade; however, at many locations the finished grade is near the top of the slab. The current building code indicates foundation walls shall be not less than 150mm above the finished grade. We observed that water ingress was occurring at the base of wall at multiple locations (Figure 12).

Figure 10 – Typical base of wall finished grade near the top of the slab on grade.

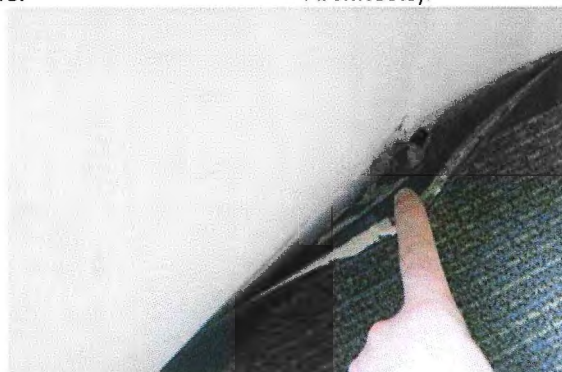
Figure 12 – Typical water ingress at the base of wall.

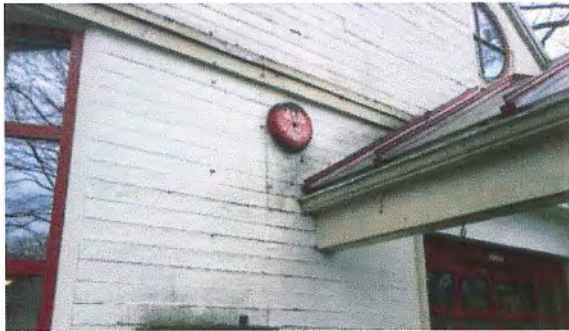
2. We observed microbial growth and other signs of water ingress in the sprinkler room. We suspect the source of the water ingress is poor detailing at the glass canopy to wall interface next to the main entrance on the north-east elevation.

Figure 13 – Suspect detailing at the glass canopy to wall interface next to the main entrance on the north-east elevation.

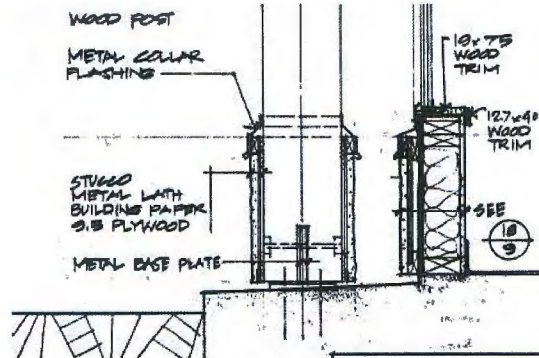
Figure 16 – Typical base of exterior column (from Howard Yano Architects).

- At some locations, such as the exterior columns, the top of the slab on grade is exposed and there is no waterproofing membrane at the wall upturns (Figure 15 and Figure 16).
- The paint finish on the horizontal cedar siding and metal flashing is delaminating and damaged in many areas.

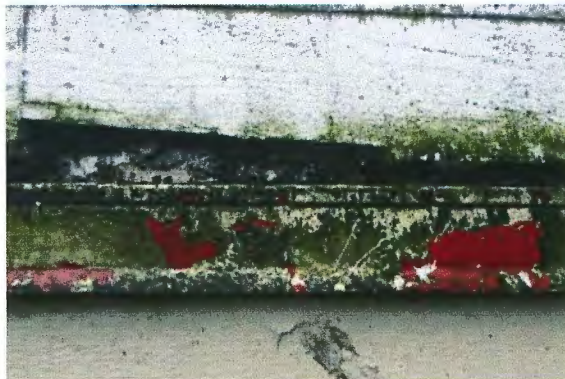
Figure 17 – Delaminating paint on metal flashing.

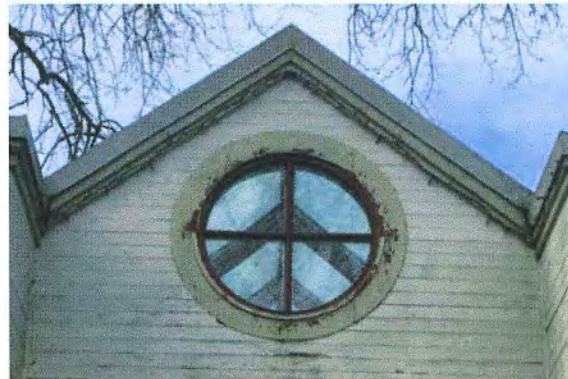
Figure 18 – Delaminating paint finish on the horizontal cedar siding.

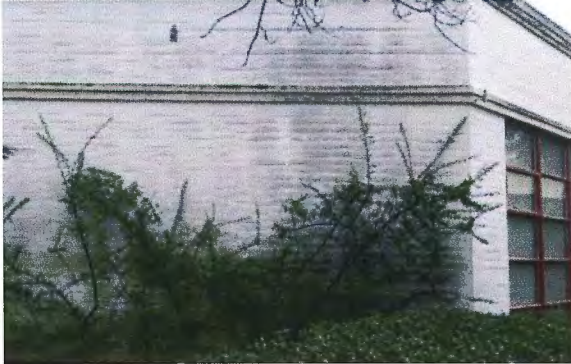
6. The horizontal cedar and cementitious horizontal siding are stained at various locations. In addition, at many locations the horizontal cedar siding is deteriorated and/or has elevated moisture content.

Figure 19 – Stained horizontal cedar siding.

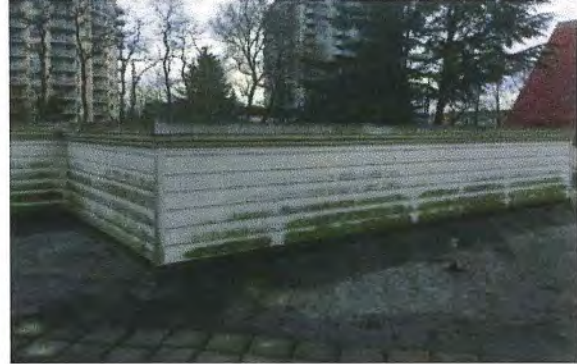
Figure 20 – Stained cementitious horizontal siding at the roof.

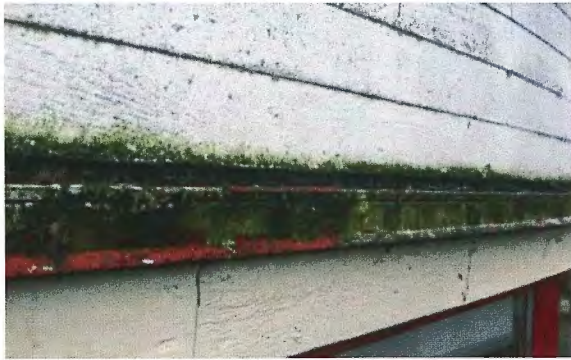
Figure 21 – Deteriorated horizontal cedar siding above window head flashing.

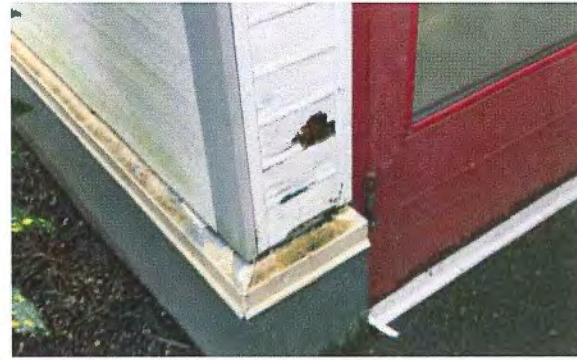
Figure 22 – Deteriorated horizontal cedar siding.

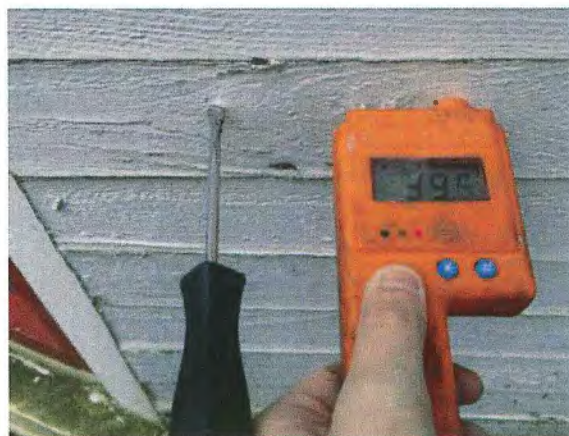
Figure 23 – Elevated moisture content and deterioration of horizontal cedar siding.

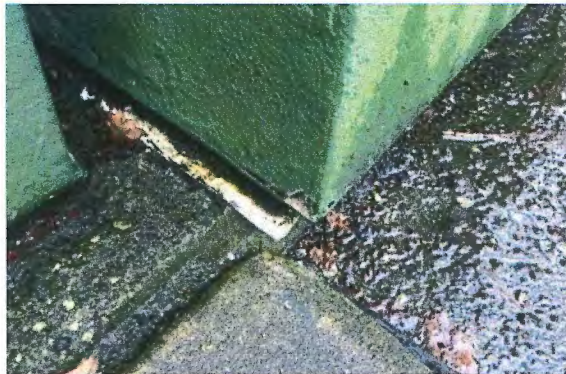
8. At the base of the wall, the stucco stop is corroding at various locations.

Figure 25 – Corroding stucco stop at the base of wall.

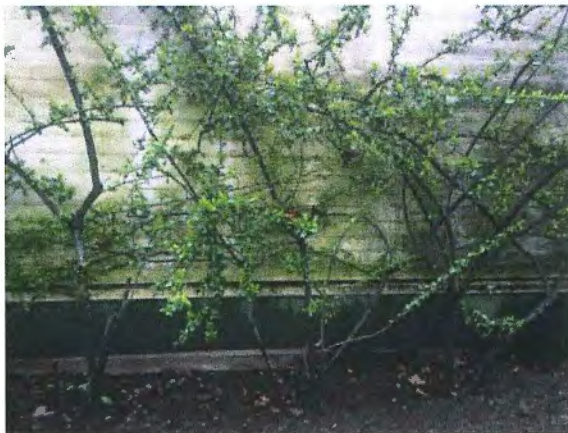
9. The soft landscaping (vegetation) is in close proximity to the building on most elevations. Vegetation holds moisture against the walls and reduces drying capacity, resulting in increased staining and deterioration at these locations.

Figure 26 – Vegetation in close proximity to the exterior wall and staining on the cladding.

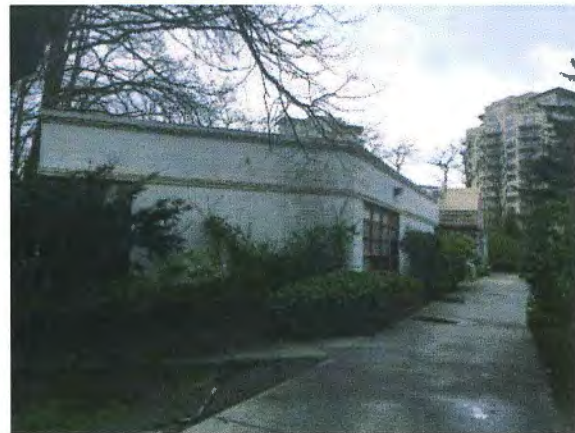
Figure 27 – Vegetation in close proximity to the exterior walls.

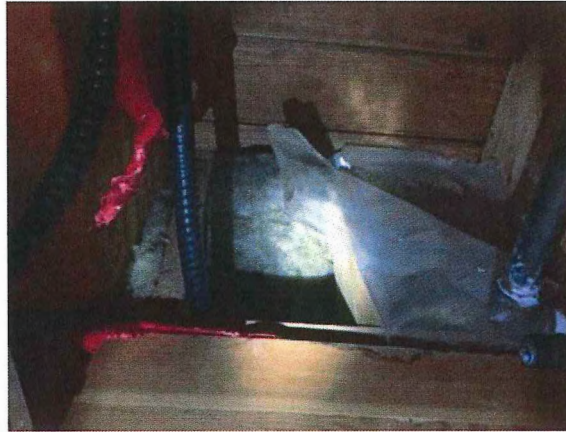
- From the interior, we observed that the vapour barrier is not continuous at various locations, and it is unclear if there is a defined air barrier.

Figure 28 – Discontinuous vapour barrier.

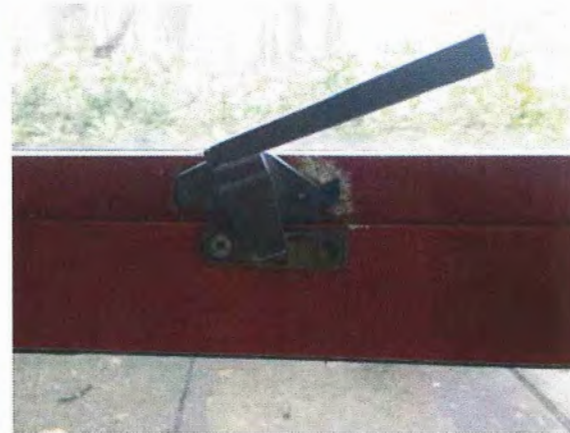
2. The operable vents are a casement style. Many of the operable vents were difficult to open, close, and/or lock, and require adjustments. Some windows were missing or had broken handles or hardware.

Figure 32 – Broken window hardware.

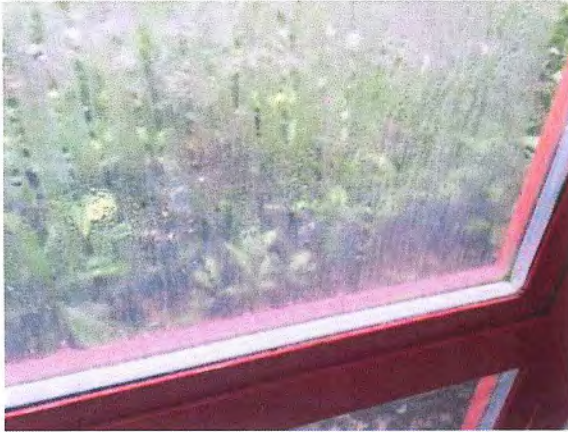
4. Some of the insulating glazing units (IGUs) were found to be failing. Many of the IGUs are original, but we found various units that have been replaced. Both the replaced and original IGUs were found to be failing.

Figure 33 – Failed IGU.

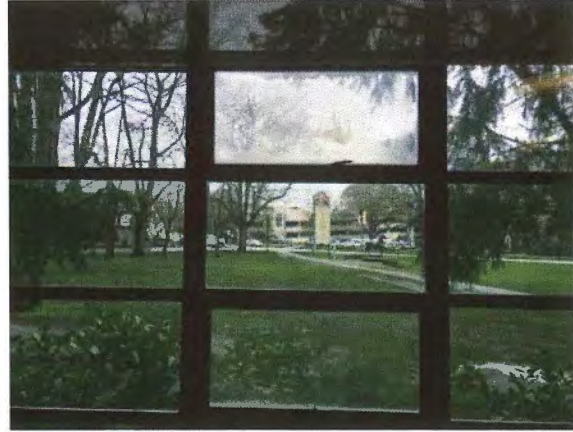
Figure 34 – Failed IGUs

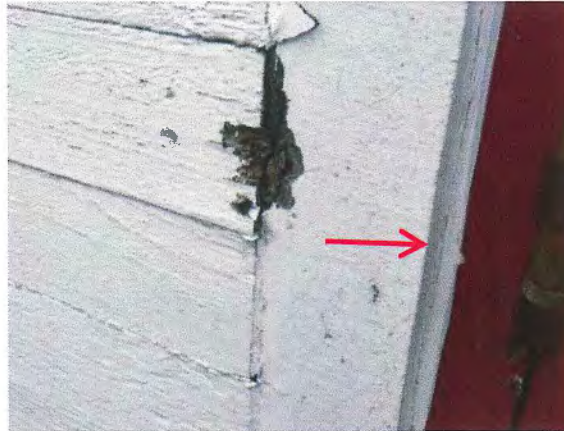
5. The sealant around windows appear to be failing.

Figure 35 – Failed sealant around window.

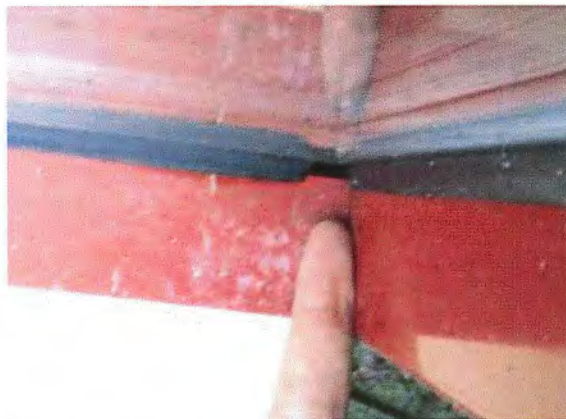
6. Some of the gaskets have shrunk.

Figure 36 – Shrunken gasket at a window.

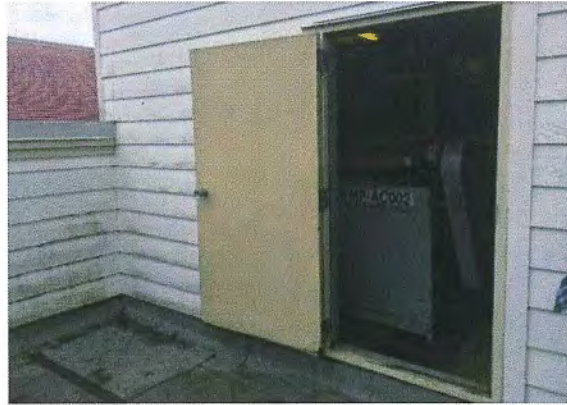
2. One of the doors to the rooftop mechanical room is constructed of wood. These doors are not meant to be fully exposed, and as such the wood door slab is deteriorating.

Figure 40 – Wood door slab at the mechanical room.

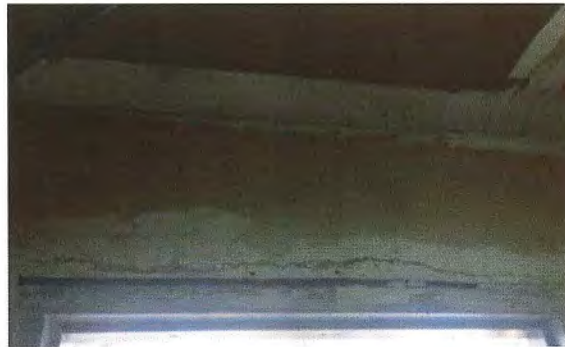
3. Poor detailing at the interface between door and cladding at some locations resulted in water ingress. We observed water ingress at the mechanical room door head.

Figure 41 – Water ingress at mechanical room door head.

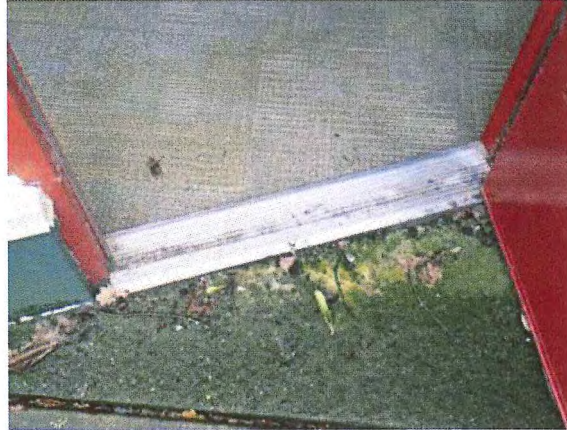
5. Some doors do not have a metal threshold, and some metal threshold fasteners are corroding.

Figure 44 – Corroding fasteners at door threshold (typical).

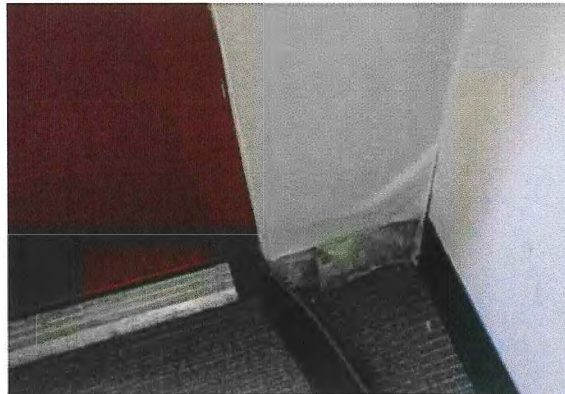
6. The detailing at the sill of the doors is suspect, and water at some of the doors was noted.

Figure 45 – Water ingress at door sill.

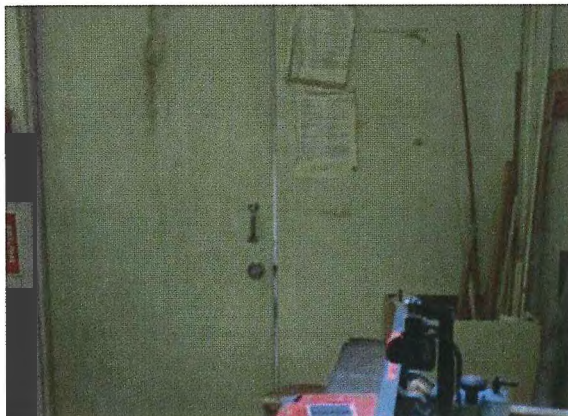
7. Many of the doors do not incorporate gasketing, or the gasketing is damaged.

Figure 46 – No gasket around the door and daylight is visible through the door slabs.

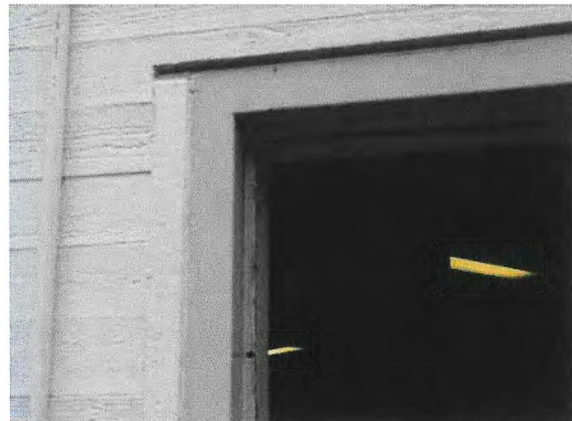
Figure 47 – No gasket around the door.

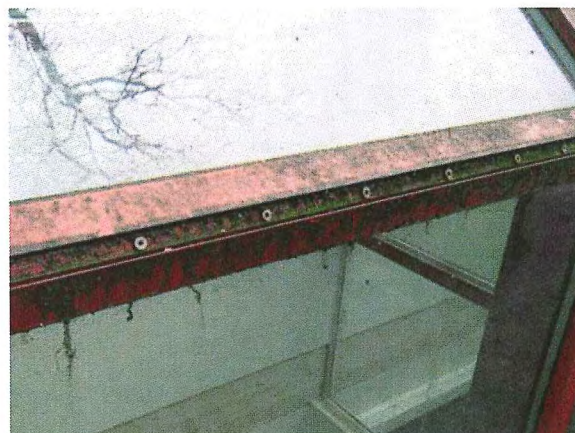
2. Some of the fasteners at skylights appear to be corroding.

Figure 50 – Corroding fasteners at skylight (typical).

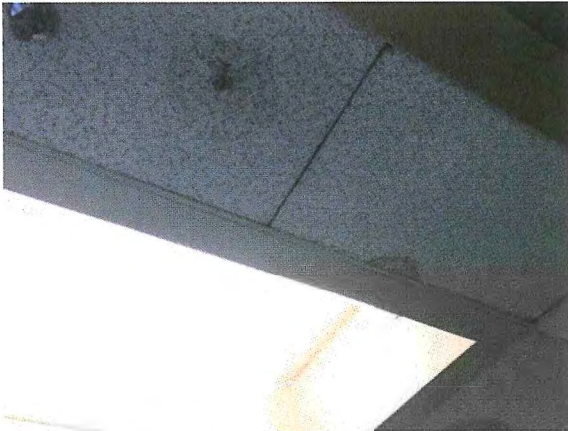
3. There is moisture staining adjacent to and below the skylight at the multipurpose room at north-east side of the building.

Figure 51 – Signs of water ingress at skylight.

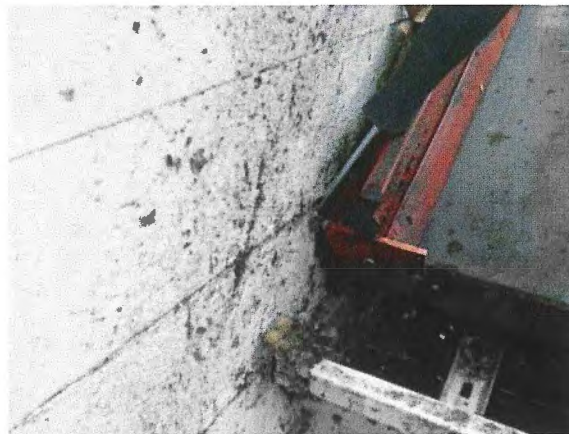
4. The detailing is a suspect at the interface between the glass canopy to wall interface, at all locations.

Figure 53 – Poor detailing at glass canopy to wall interface and deterioration of horizontal cedar siding.

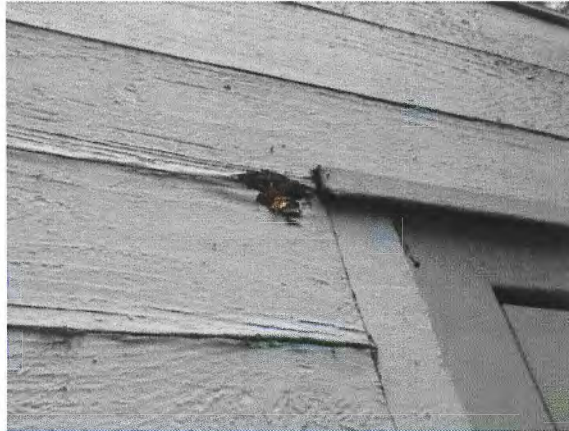
2. Metal flashings do not incorporate end dams.

Figure 57 – Metal flashing at the door head does not incorporate an end dam. Water runoff can cause deterioration of the siding.

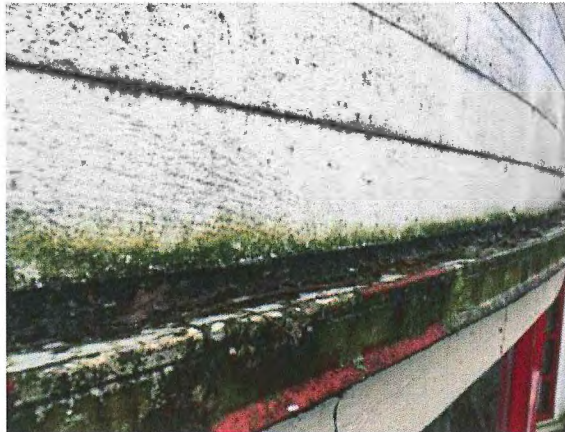
3. At many locations, the metal flashing is back sloped towards the building.

Figure 58 – Back sloped metal flashing at a window head.

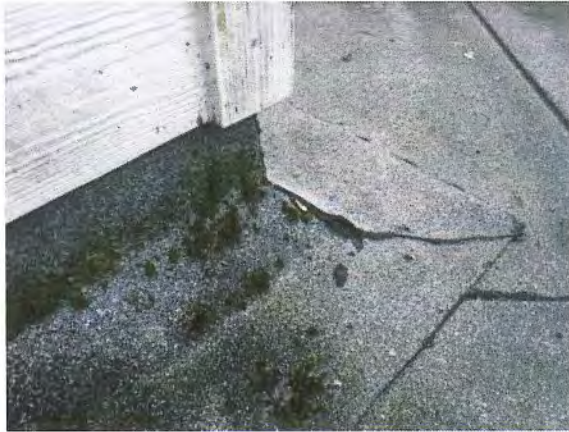
2. We could not confirm the age of the roofs. It appears that the roof is not all the same age, and there are possible two dates of installation. Based on our review, it is likely the remaining service of the roofs is between 5 and 10 years. We recommend the roofing should be reviewed again within the next 5 years.
3. We observed fish mouths and excessive bleed out in the torch-applied roofing membrane. At some locations, the roofing membrane is not well adhered, has failed seams, being cut/damaged by the metal flashing, or has exposed edges (Figure 63 to Figure 69).

Figure 63 – Fish mouth in the roofing membrane.

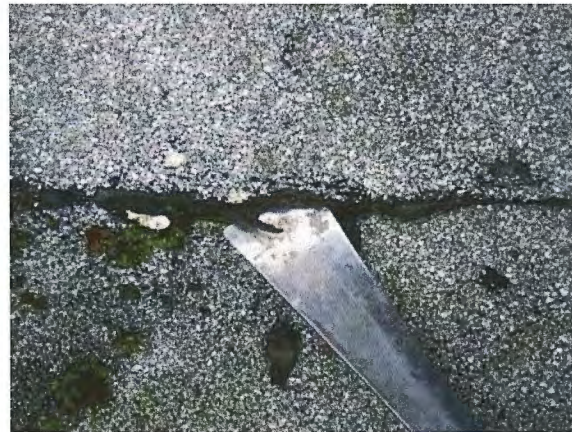
Figure 66 – Failed roofing membrane seams.

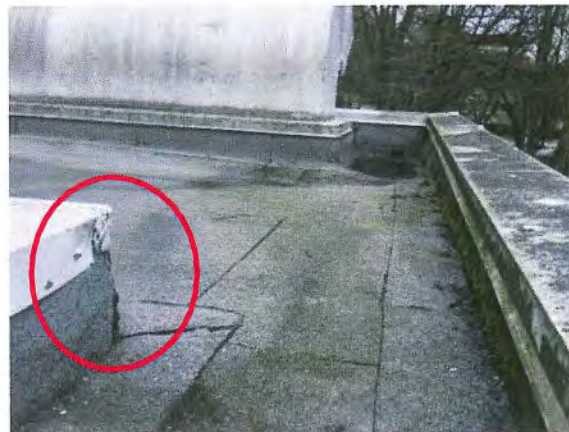
Figure 67 – Metal flashing cutting into the roofing membrane.

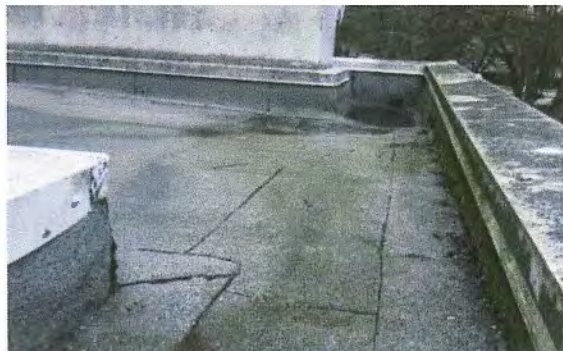
Figure 71 – Ponding water adjacent to scupper drain.

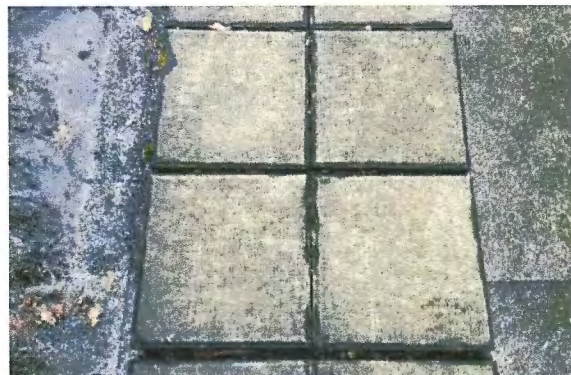
5. We observed debris and/or moss growth. At some locations, the debris and/or moss growth is restricting drainage.

Figure 72 –Debris between roof pavers and obstructed drainage.

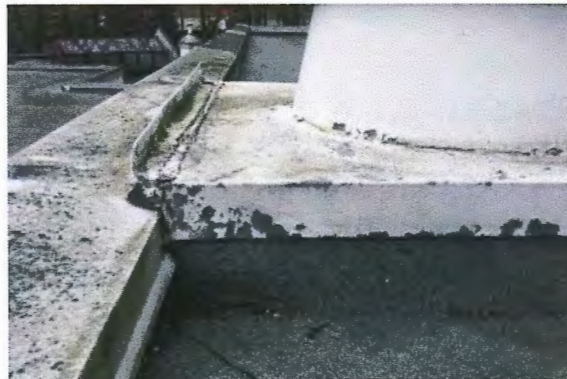
7. At various locations, the paint on the metal flashing is delaminating.

Figure 75 – Delaminating paint at metal flashing.

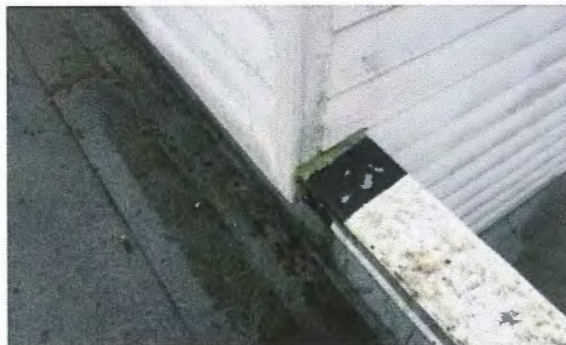
8. At various saddle interfaces, there is exposed self-adhered membrane which is deteriorating due to UV degradation. Detailing at saddle interfaces are suspect.

Figure 76 – Suspect saddle interface and exposed self-adhered membrane.

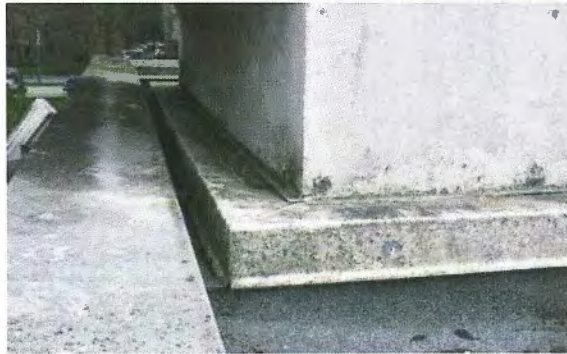
10. On top of the mechanical room, roof vents are in close proximity to roof edge. This makes effective roofing membrane detailing more difficult.

Figure 79 – Roof vent in close proximity to the roof parapet.

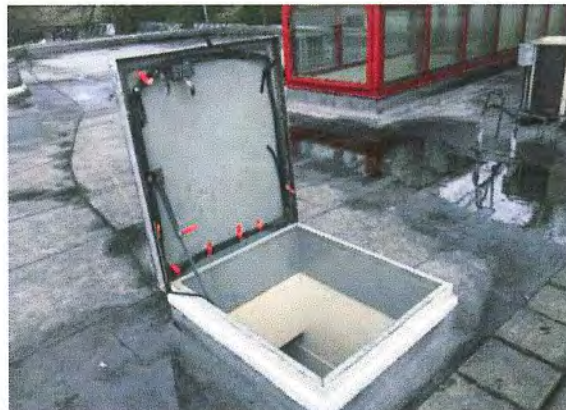
11. The roof access hatch has corroded hinges and hardware, and seal is damaged and is no longer effectively secured in place.

Figure 80 – Roof access hatch.

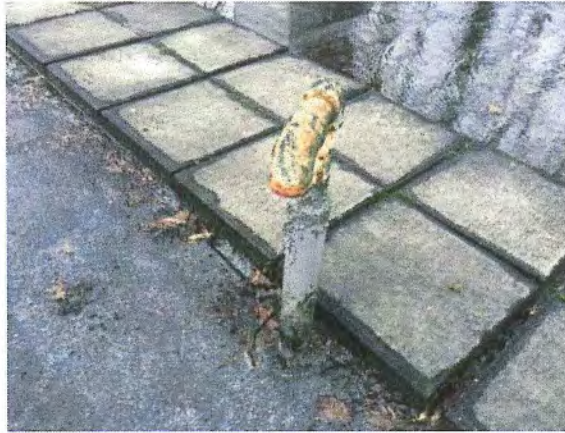
Figure 81 – Roof access vent relies on single sealant.

12. The roof penetrations rely on a single line of defence (i.e. sealant or a storm collar). Where possible, it is recommended to incorporate two lines of defence.

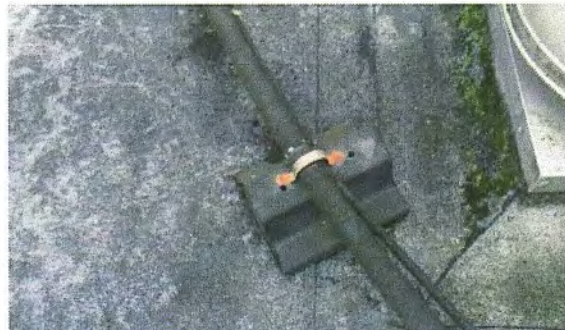
13. The fasteners securing electrical cables are corroding.

Figure 82 – Corroded fasteners at electrical cables.

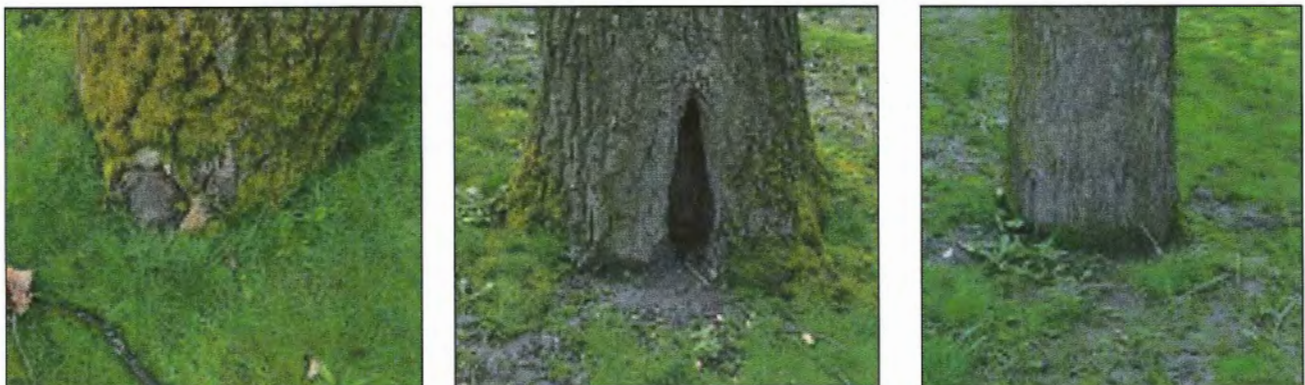
Figure 3: Tree defects (L-R): mechanical injury from mowing equipment, basal cavity, and buried root flare.

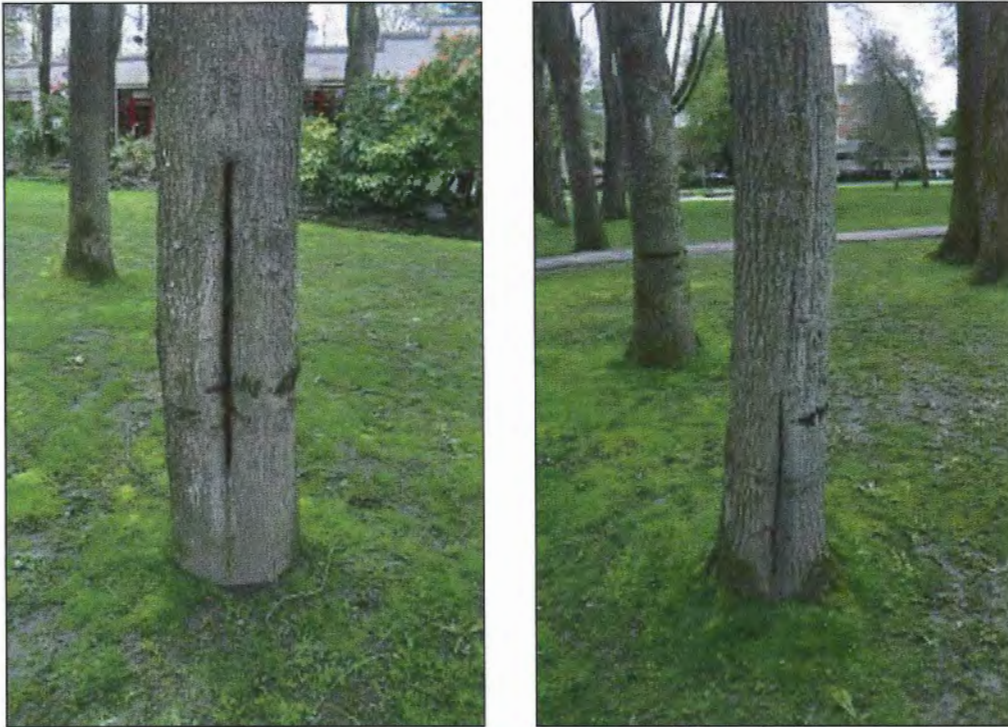
Figure 4: Vertical scarring and pronounced wound wood formation could indicate possible internal decay.

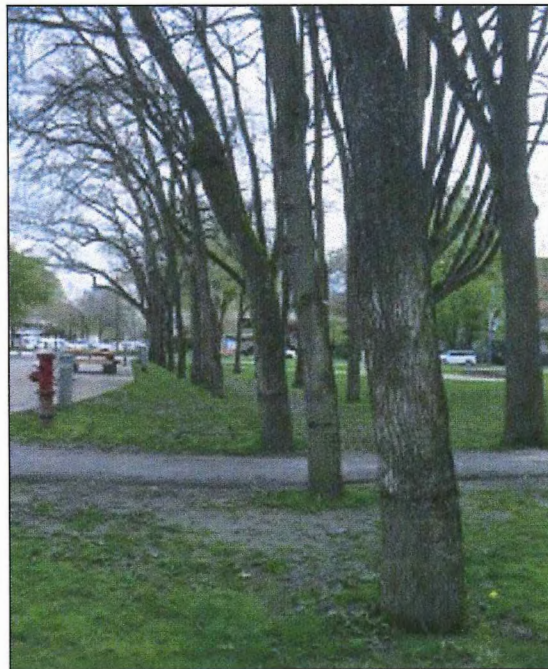
Figure 6: The phototropic lean exhibited by trees at the stand edge.
