**To:** Parks, Recreation and Cultural Services Committee      **Date:** November 15, 2011  
**From:** Jane Fernyhough      **File:**  
Director, Arts, Culture & Heritage Services  
**Re:** **Maintenance and Management of the fleet at Britannia**

**Restoration Possibilities and Preservation Plan  
BRITANNIA HISTORICAL SHIPYARD VESSELS:  
Fleetwood, Shuchona IV, Starliner, Iona and Merrilee II**

August/November 2011

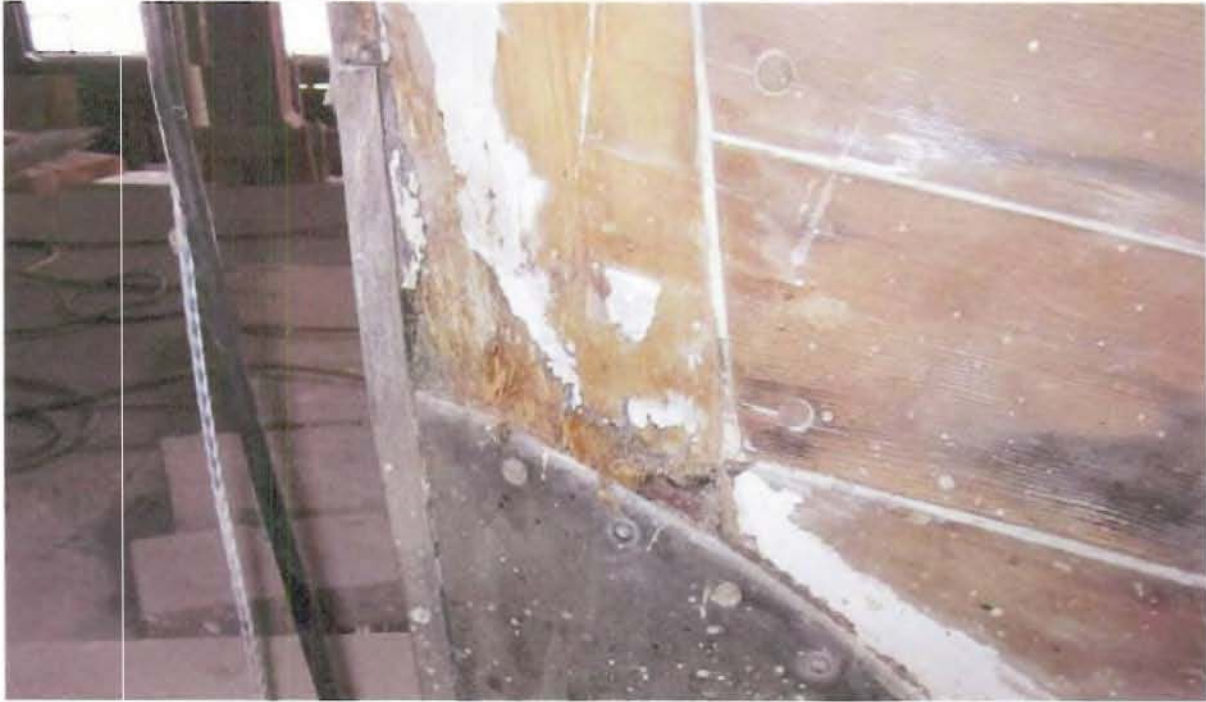
<b>Structure</b>	<b>Condition &amp; steps to repair</b>
<b>Centreline</b>	
Stem & band	Decay of the stem above the metal guard. Photo #1 Repair; Remove the guard to reveal the stem structure; depending of the extent of deterioration it might be possible to scarp in a section. If decay is extensive it would not be practical to repair.
Keel & shoe	Keel generally appeared to be sound
Shaft log & deadwood	Appeared to be sound
Horn timber	Appeared to be sound
Transom frame/built-up transom & knee	Decay was noted in the port side of the transom planking and frame. Photo #2 Repair; Remove all deteriorated structure and replace with new.
<b>Lower hull &amp; bulkheads</b>	
Floor timbers	Many pulled away from the hull with decay noted. Photo #3 Repair; Refasten in place in conjunction with other hull repair.
Bilge stringers (longitudinal members at turn of bilge)	None
Bulkheads	Various decayed particularly below the cabin sole. Photo #4 Repair; Remove deteriorated structure and replace with new. Work will have to be completed in conjunction with hull repair.

Photo #1 Damage of exterior stem structure

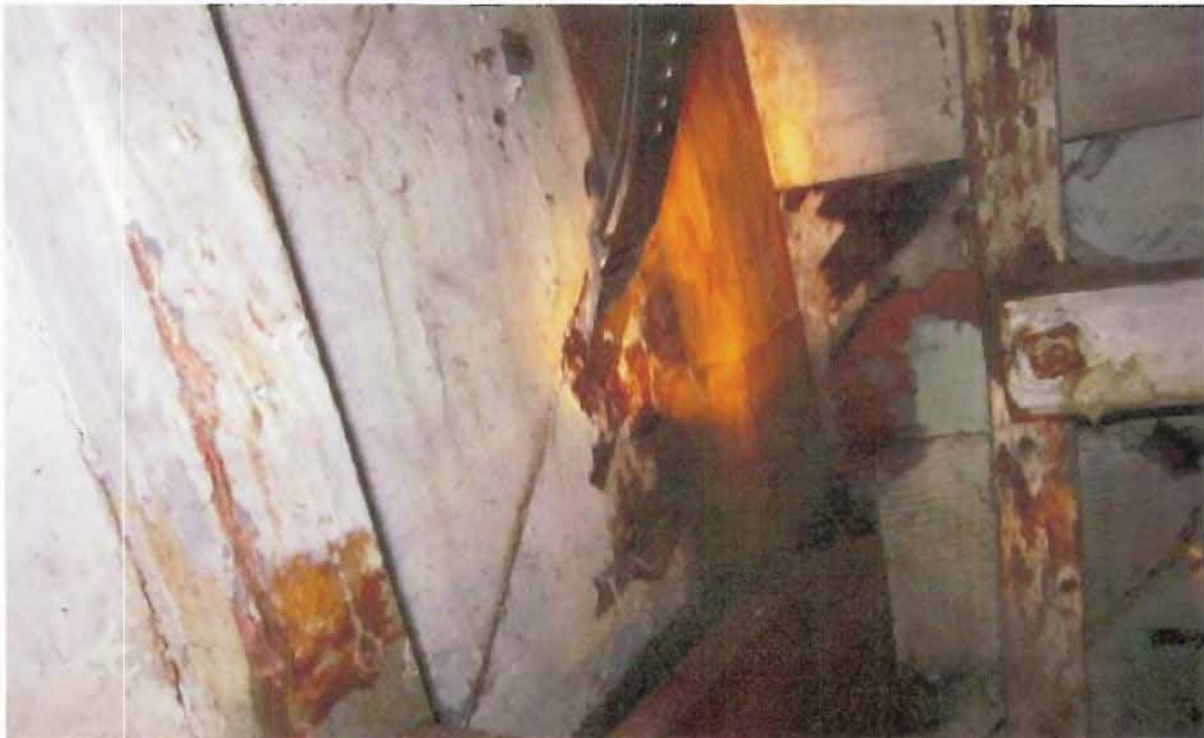
Photo #2 Deterioration of inner transom structure

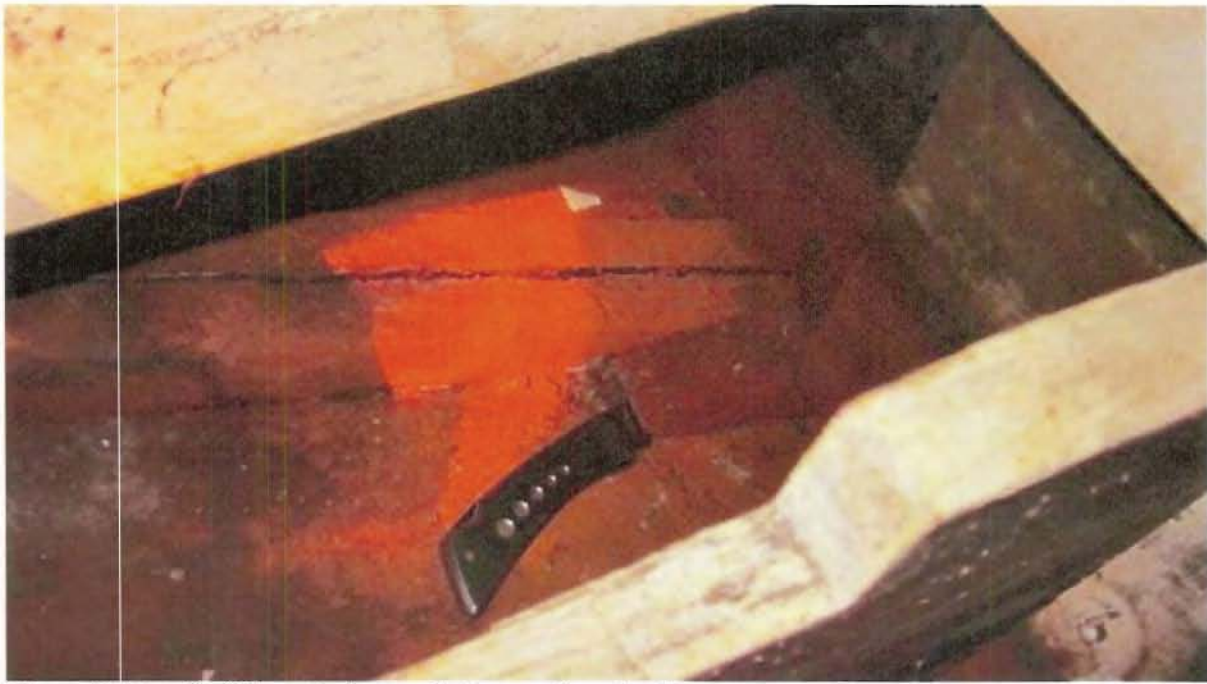
Photo #3 Detail of floor timber pulled away from hull

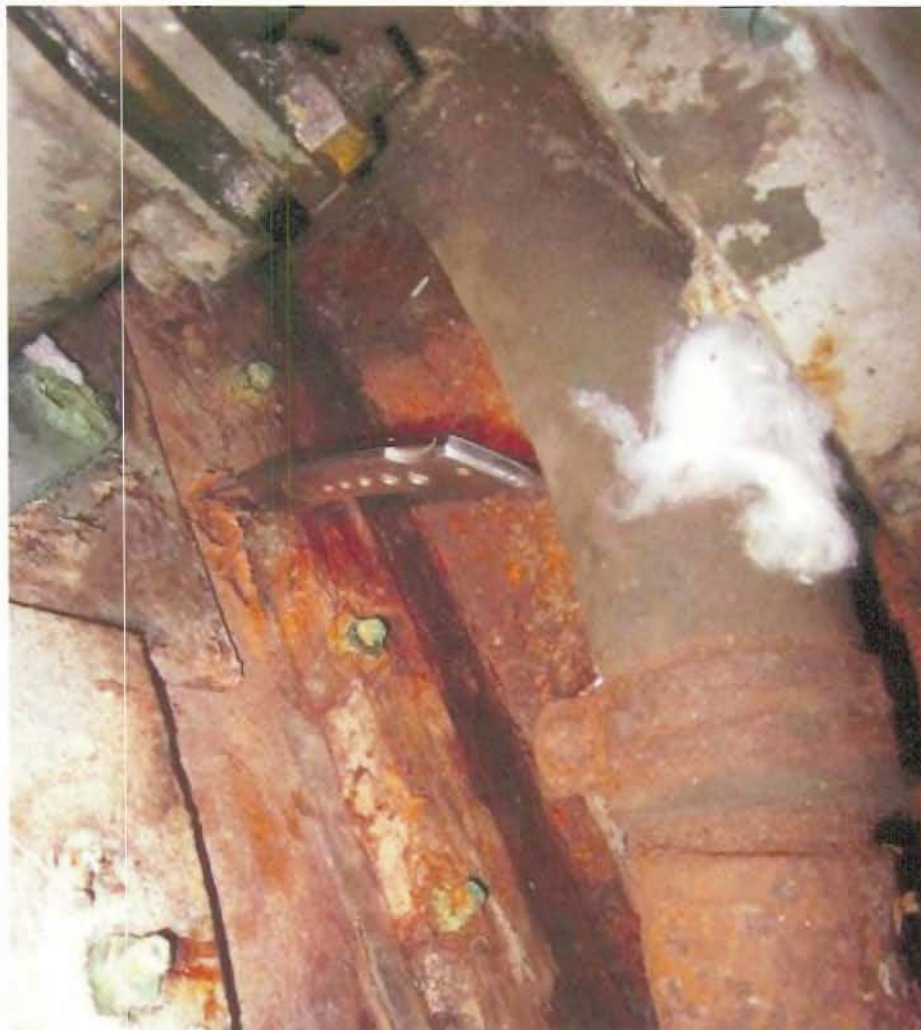
Photo #4 Deterioration of bulkhead under engine stern tube

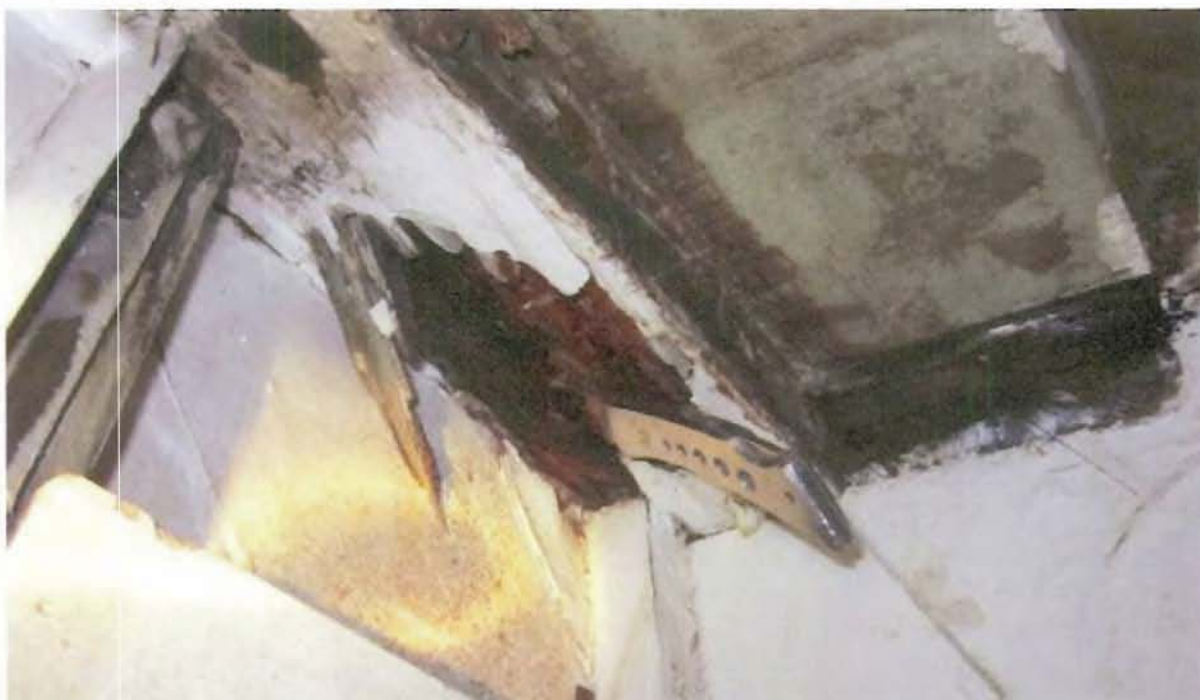
<b>Hull to deck</b>	
Deck/sheer clamp (longitudinal members supporting deck and upper hull shape)	Deteriorated over much of its length. Some sections have been replaced but do not provide designed structural integrity. Photo #5 Repair; Very difficult to repair, the best procedure would be to remove the covering boards to access the sections in conjunction with hull repair, and insert new via upper transom corners.

Photo #5 Deterioration of sheer clamp forward cabin

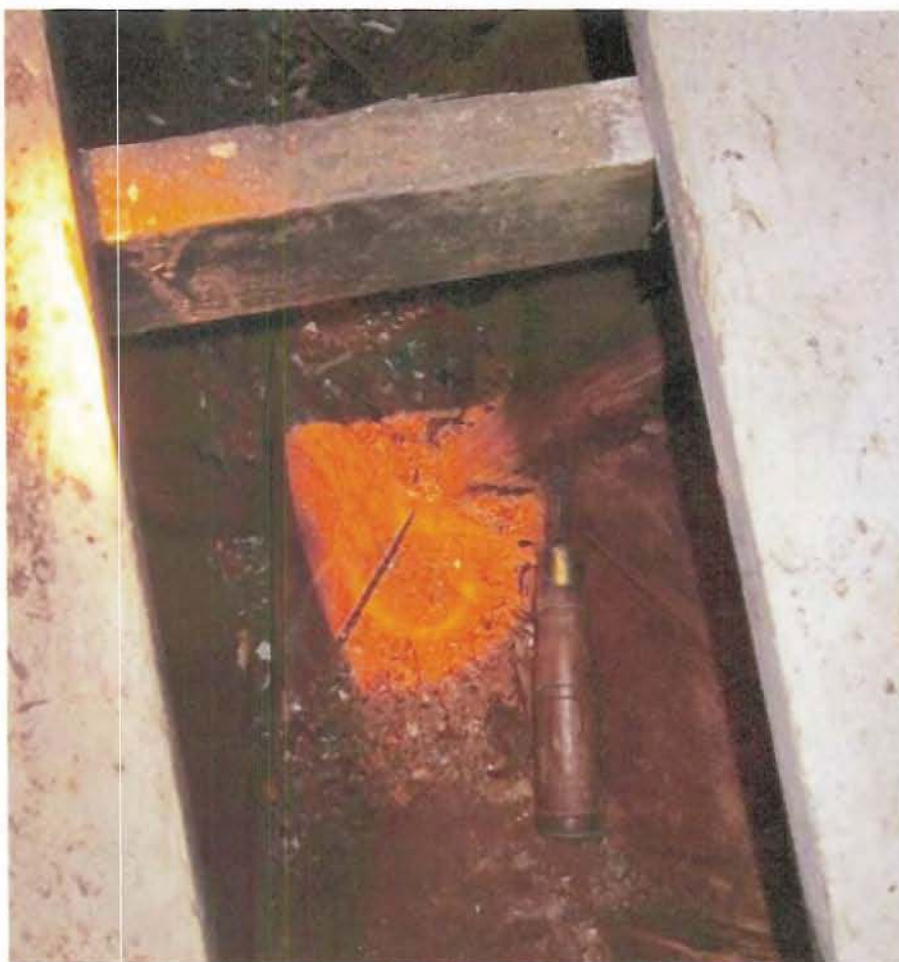
Photo #6 Detail of rib pulled away from hull

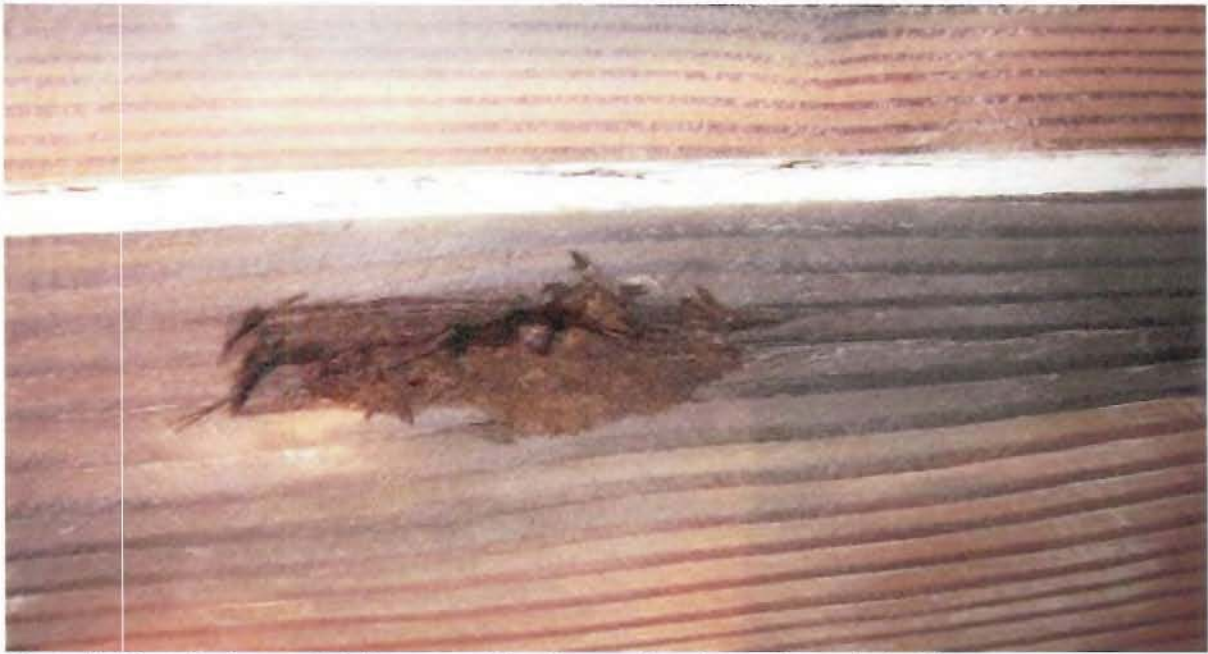
Galvanized hull fasteners generally are corroded and provide no security between the planking. External planking is damaged; much if it from "nail sickness" (the steel composition of the fastener has oxidized, decaying the surrounding wood).

Photo #7 Detail of corroded fastener with adjacent deteriorated wood planking

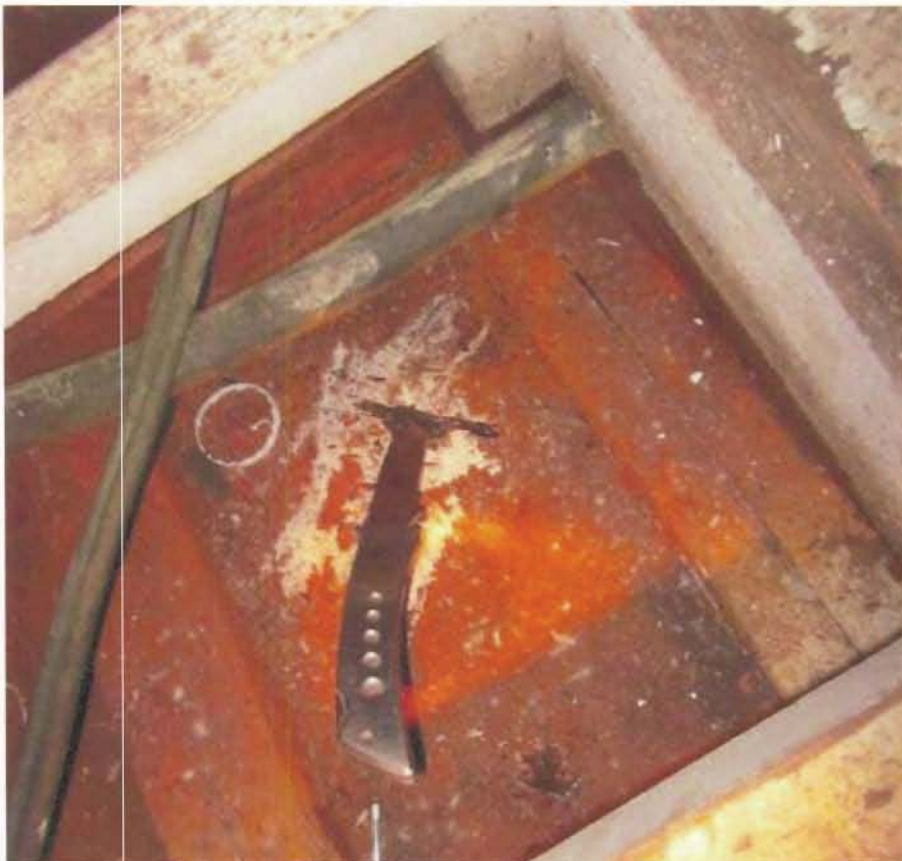
Photo #8 Deterioration of inner planking

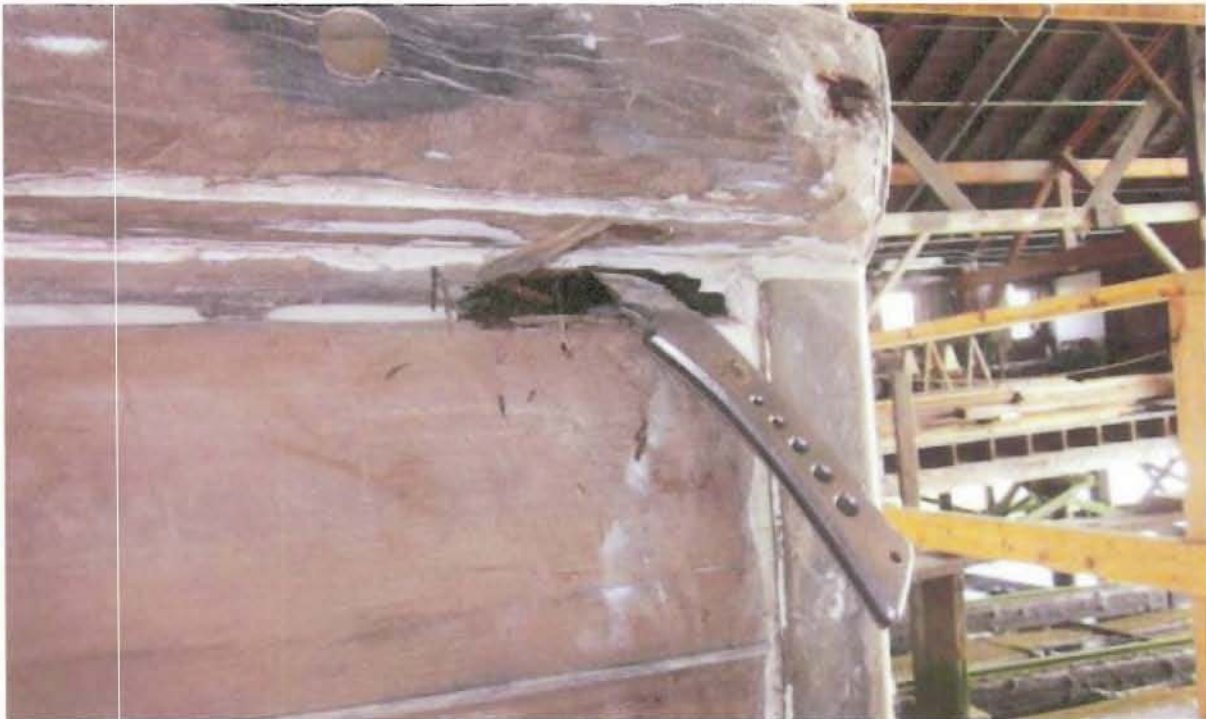
Transom planks	Decay noted in various. Photo #9 Repair; Remove and replace damaged sections
Fasteners	Heavily rusted both inner and exterior. Photo #10 Repair; Replace fasteners in conjunction with replanking
Caulking	Will need to be recaulked after planking
Rub rail	Appeared to be sound
<b>Hull fittings</b>	
Shaft & rudder stuffing boxes	Appeared to be sound. Original (port & starboard) are still in place & should be removed.
Through-hulls/valves, hoses & hose clamps	All to be replaced.
Engine mount through-fastenings	Appear to be sound
Portholes	Appear to be sound
<b>Deck</b>	
Deck beams	Some decay noted in conjunction with deck. Repair; Remove decayed structure and replace in conjunction with deck sections
Carlins (longitudinal members under cabin sides)	Appeared to be sound
Deck & covering boards	We are advised the decks were replaced during this drydocking. Some decay was noted in the inner planking.

Photo #9 Deterioration of transom exterior planking starboard corner

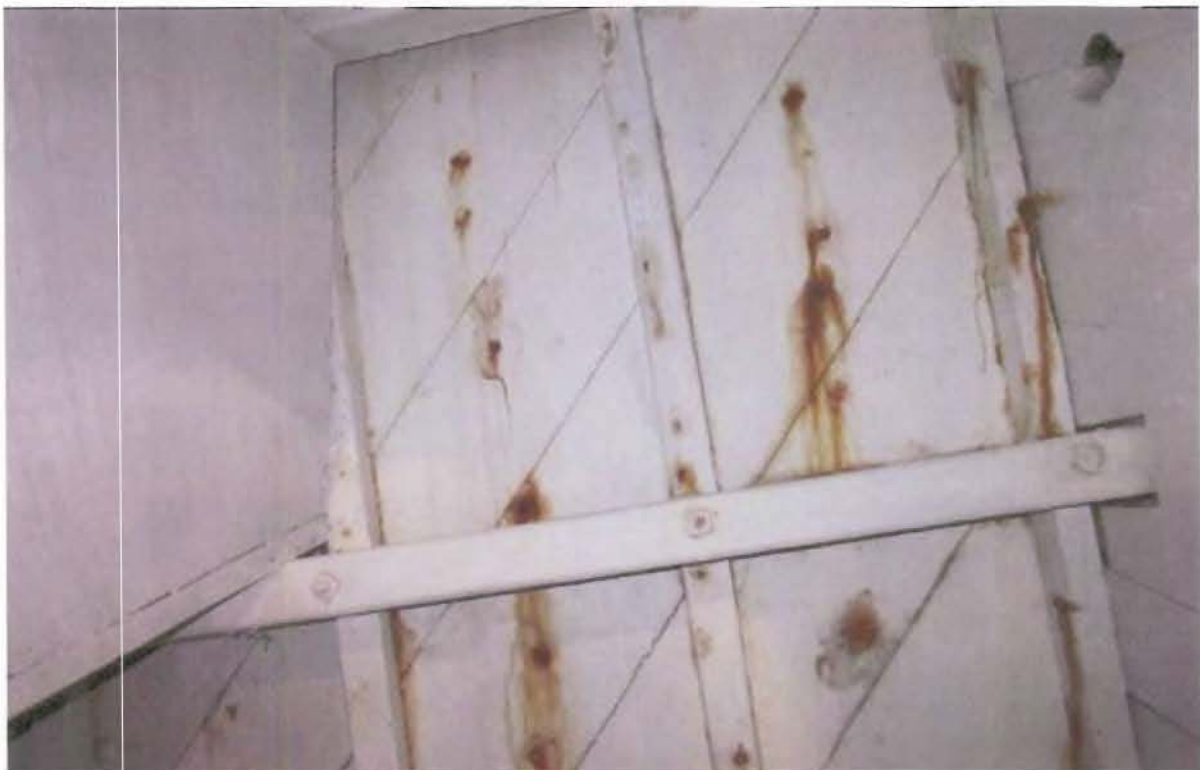
Photo #10 Detail of corroded fasteners inner planking

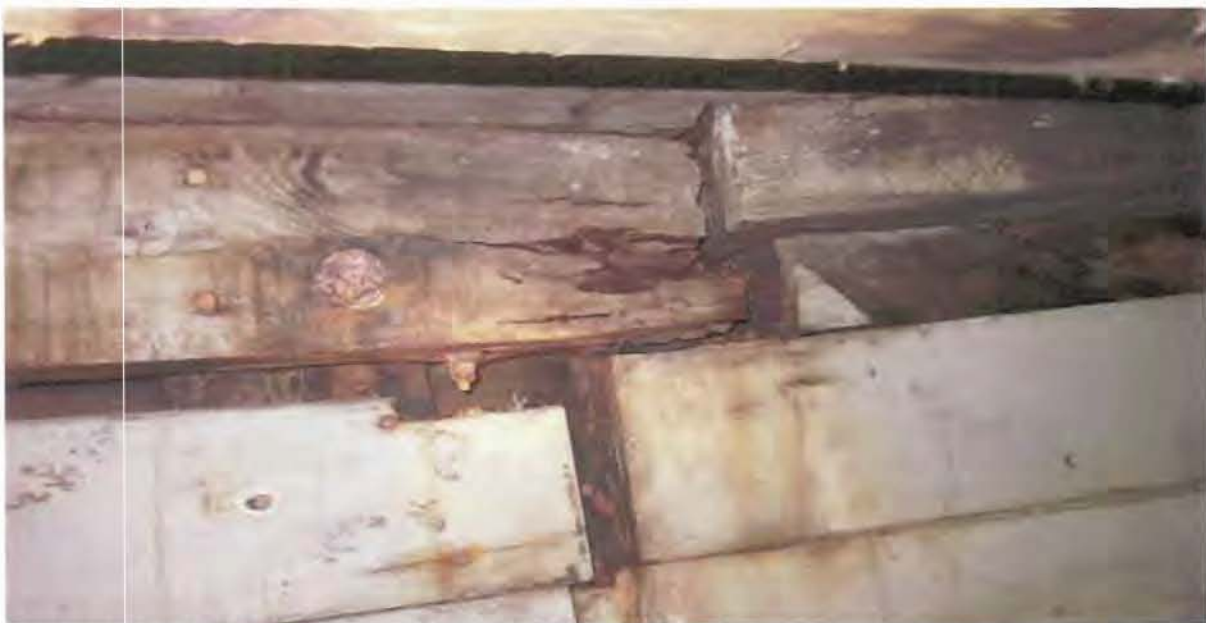
Photo #1 Detail of deterioration in hull framing stern section

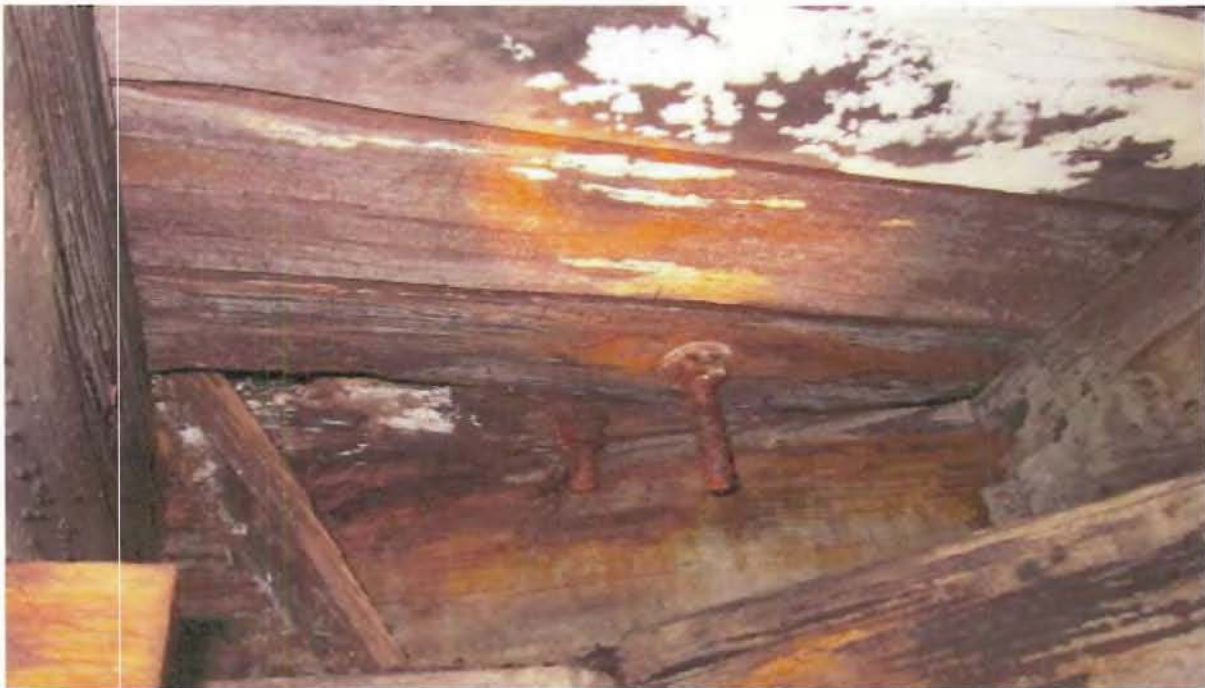
Photo #2 Detail of deterioration under aft deck and transom/hull connection

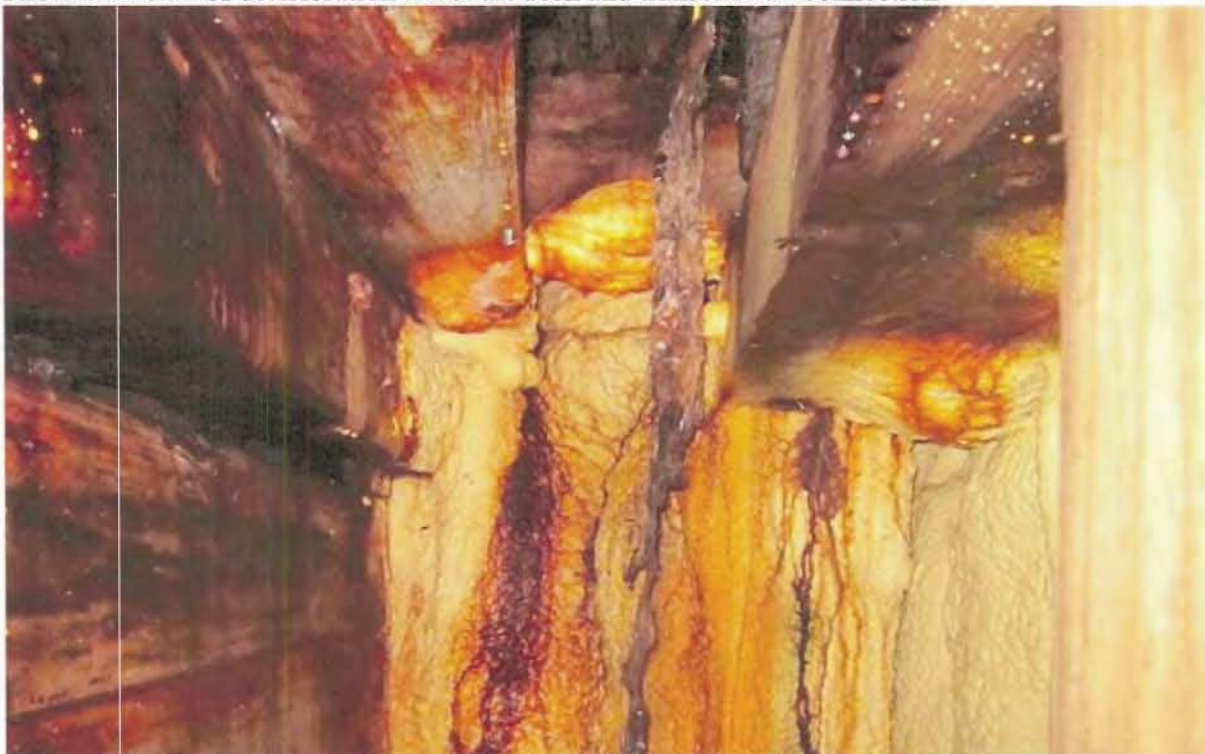
The fish hold has been created with sprayed-in-place foam against the hull; this method of creating an insulated fish hold usually results in deterioration of the hull framing and planking behind the foam.

Photo #3 Detail of deterioration at fish hold foam/hull connection

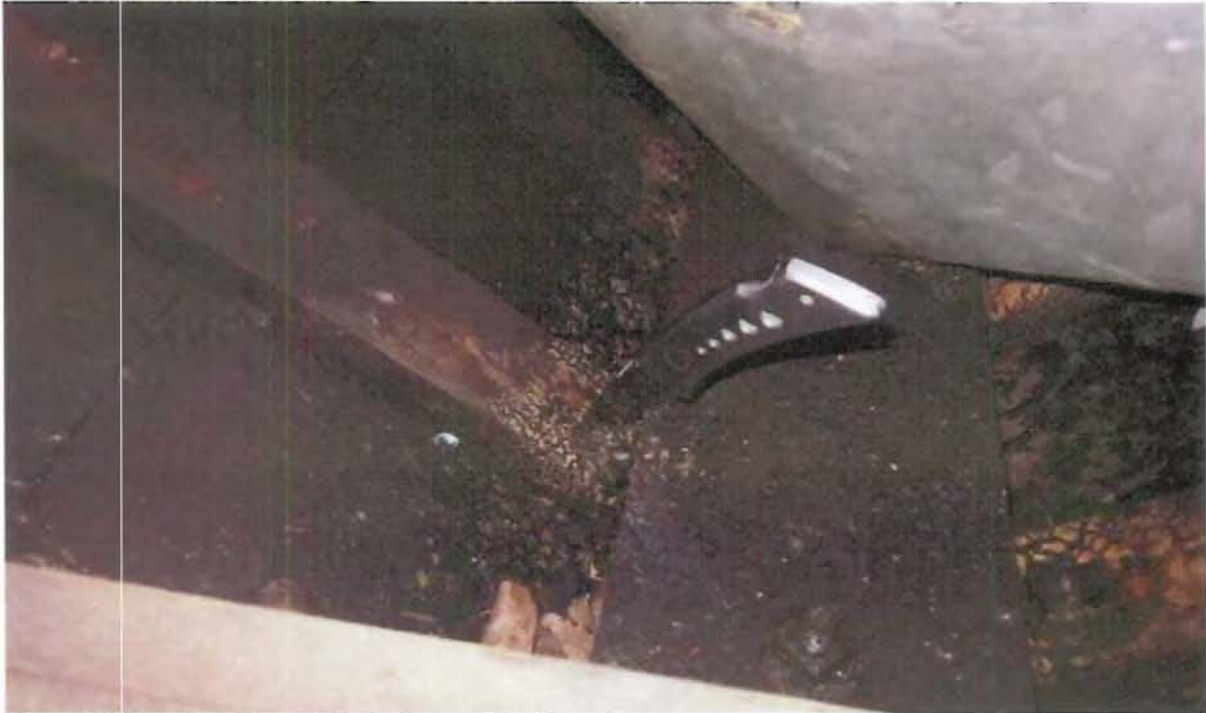
Photo #1 deterioration of rib in forward hull section

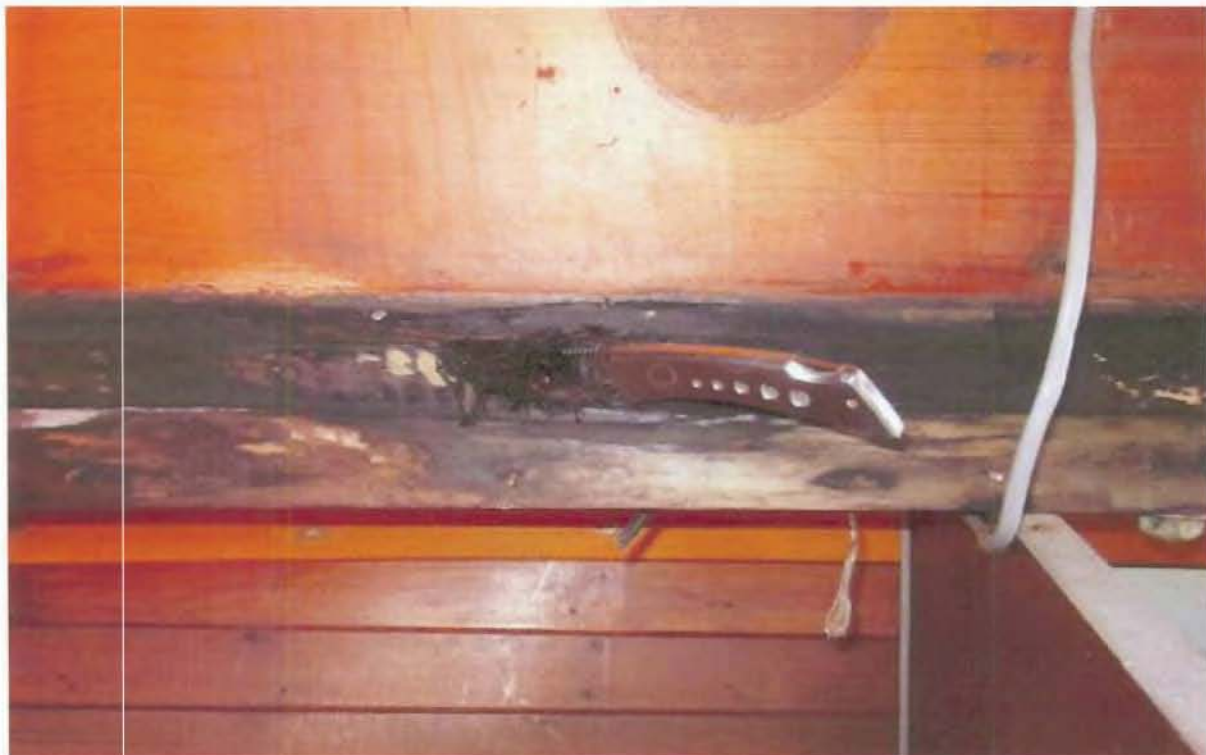
Photo #2 deterioration of side deck over carlin plank

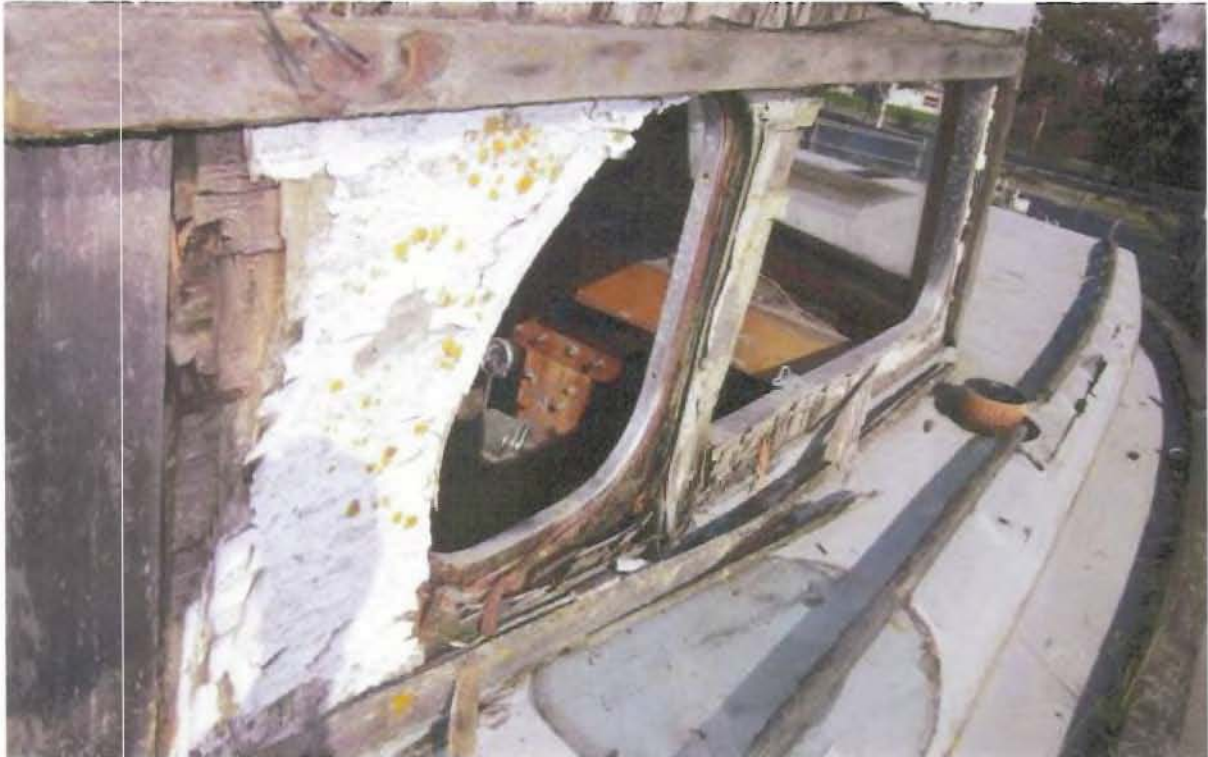
<b>Hull fittings</b>	
Shaft & rudder stuffing boxes	To be replaced with replacement engine installation
Through-hulls/valves, hoses & hose clamps	All to be replaced in conjunction with plumbing system upgrade
Engine mount through-fastenings	To be replaced with engine replacement
Depth sounder, keel cooler, zincs, topside vents	To be replaced with engine replacement
Portholes	None
Swim grid	None
<b>Deck</b>	
Deck beams	Some may be reused forward; will likely all need replacing aft
Carlins (longitudinal members under cabin sides)	Solid yellow cedar under side decks. To be assessed during deck and superstructure replacement.
Deck & covering boards	To be replaced with deck replacement Photo # 2
Bulwarks & caps/toe rail	To be replaced with deck replacement
Hatches & covers	To be replaced with deck replacement
<b>Deck fittings</b>	None
<b>Cabin</b>	Heavy deterioration Photo #3 All to be replaced
<b>Interior</b>

Photo # 3 Heavily deteriorated superstructure

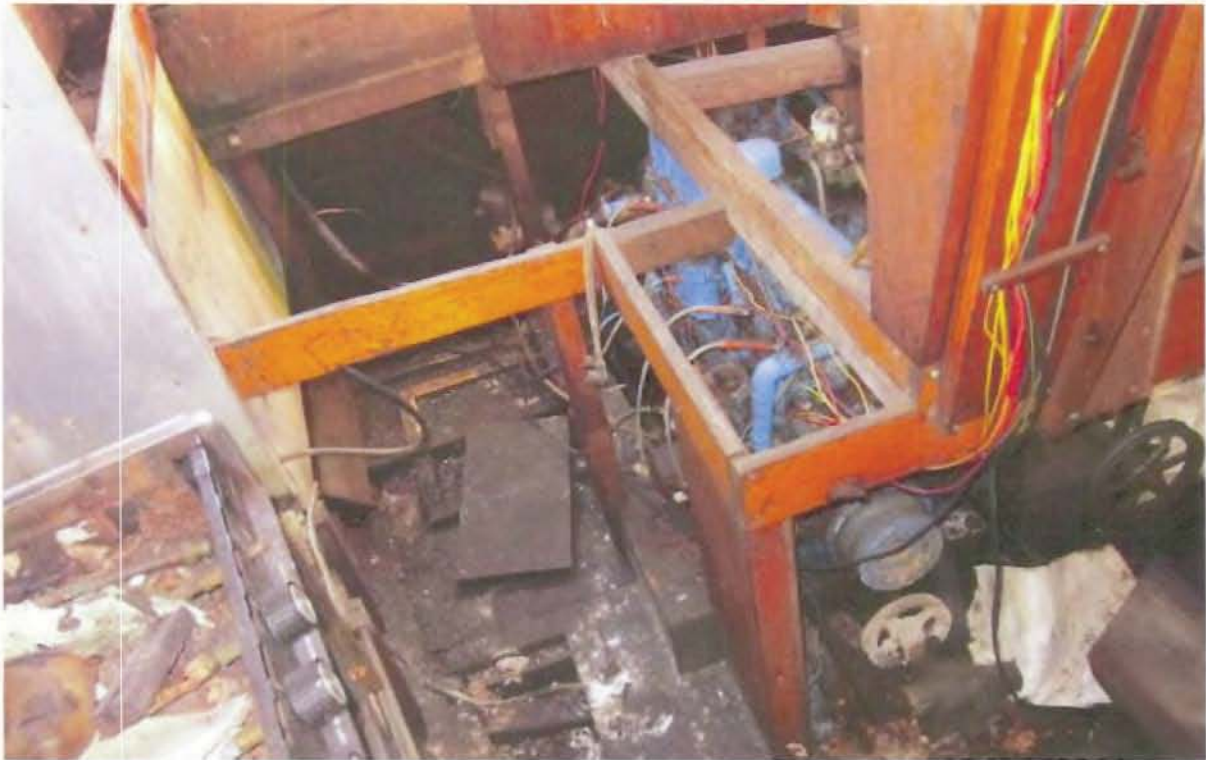
Sole (cabin floor)	To be replaced Photo #4
Cabinetry	In poor condition but may be usable depending on the restored configuration
Overhead liner	None fitted
Hull ceiling	Appeared to be sound but would have to be removed for access to hull framing.
<b>Machinery supports</b>	
Engine log bearers & engine logs	To be replaced with engine replacement
Tank supports	To be replaced in conjunction with cabinetry rebuild
<b>Bilge pumps</b>	To be replaced in conjunction with rewiring electrical systems
Hoses and discharge through-hull	All in poor condition To be replaced in conjunction with hull repair

Photo #4 cabin sole broken up note also gasoline engine installation
