Date: September 26, 2006

From: Victor Wei, P. Eng.  
Director, Transportation

Re: TRAFFIC SAFETY REVIEW OF CAMBIE ROAD / NO. 7 ROAD INTERSECTION

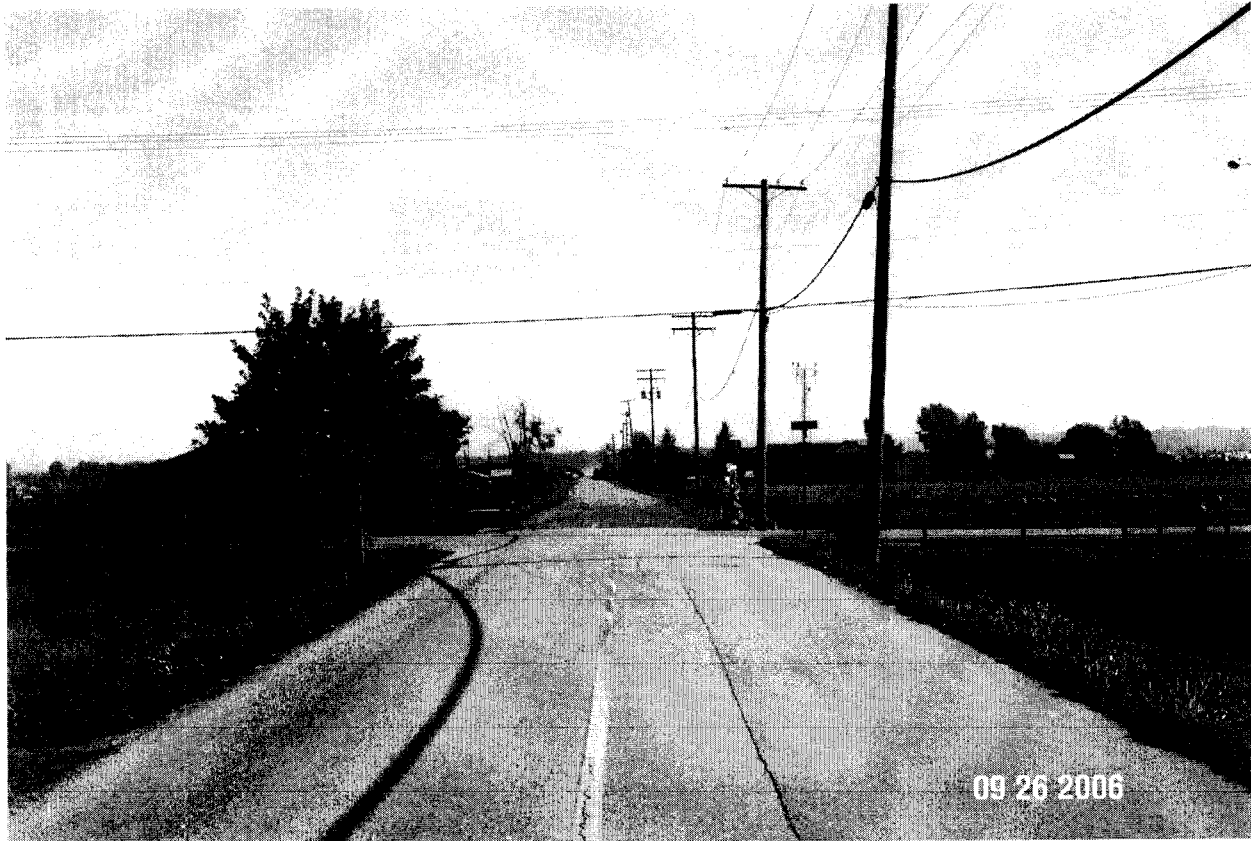
**Cambie Road looking eastbound to No. 7 Road intersection**

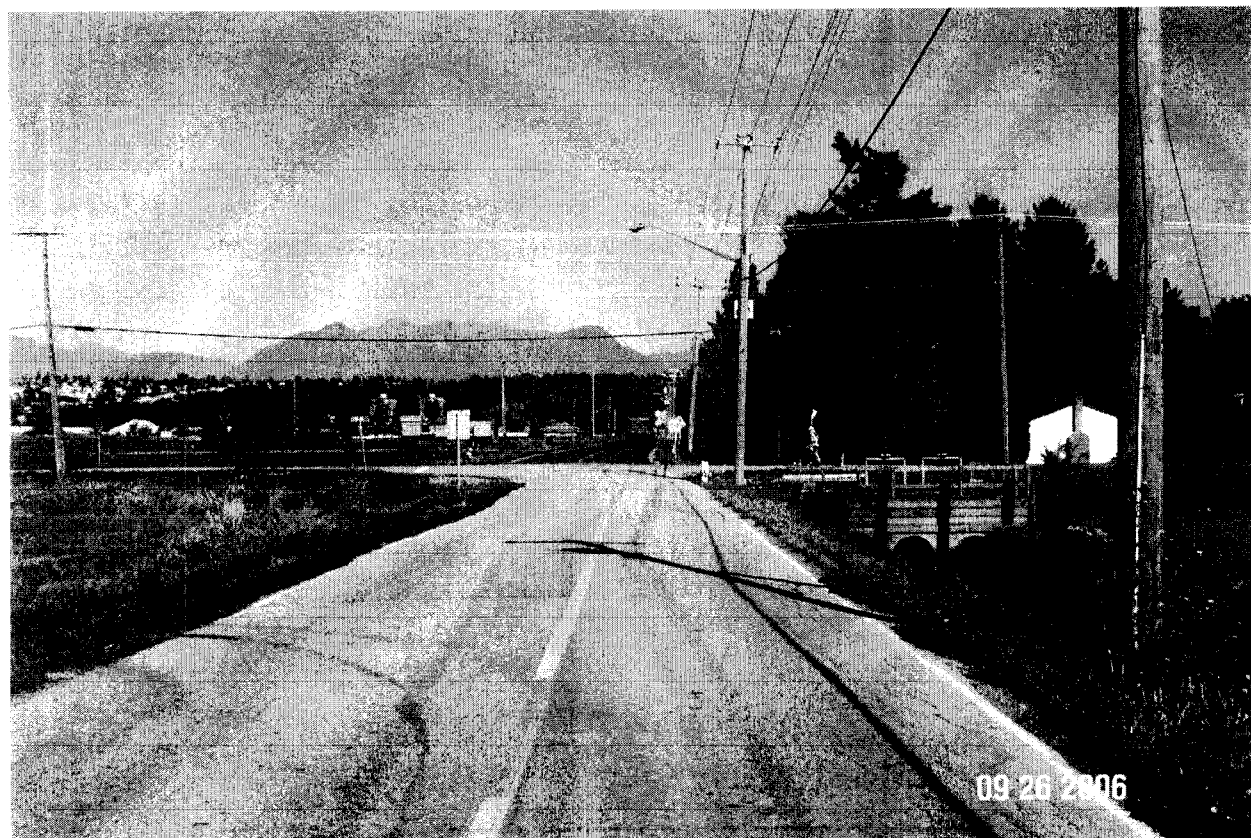
**No. 7 Road looking northbound to Cambie Road intersection**
