**Schedule 1 to the Minutes of the Development Permit Panel Meeting of Wednesday, September 26, 2012.**

**Re: Damage On Our Property Due To Adjacent Site Construction  
BCS 4241 – Newbury  
7771 Bridge Street, Richmond, BC**

September 20, 2012  
File: 10792

**Re: Damage Assessment Report- Newbury Townhouse Development  
7771 Bridge Street, Richmond, BC**

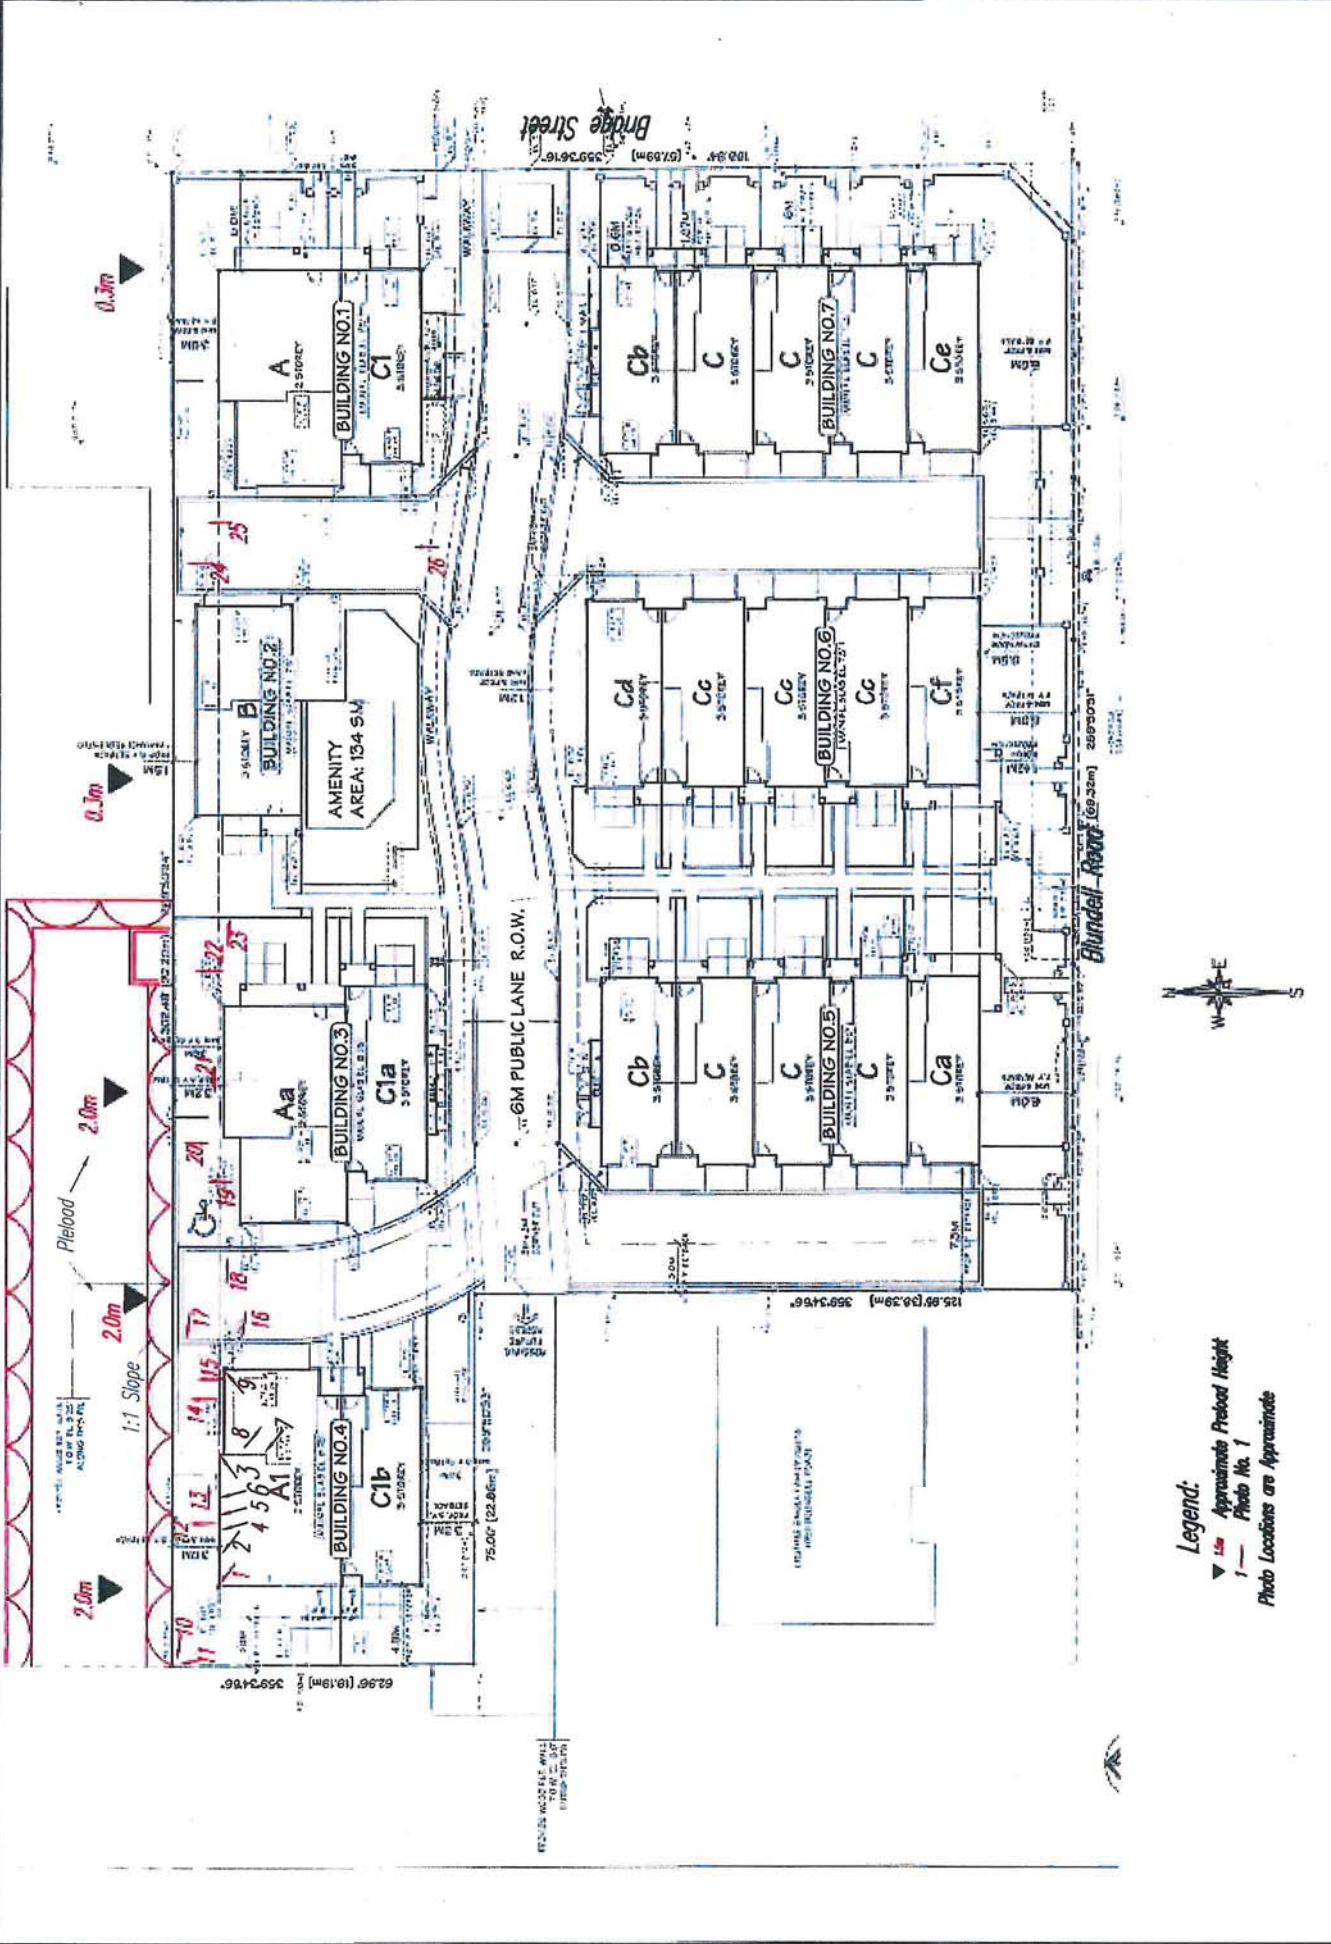
PREPARED BY: DATE: SCALE:	September 18, 2012 MM	PROJECT NO: 10792-01	DRAWING NO: 10792-01
	NOT TO SCALE		
PROJECT TITLE: <b>Newbury</b> 7771 Bridge Street, Richmond, BC Photo Locations and Approximate Preload Heights		SHEET NO: 10792-01	
PREPARED BY: DATE: SCALE:

Approximate preload location and dimensions at the time of our review is provided on drawing 10792-01, following this report.

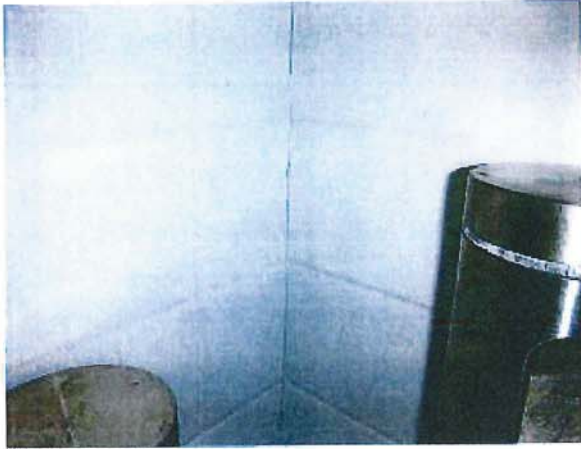
**Photo No.01**

Damage to the interior of unit 6 was noted on the north wall of the first floor. Damage consisted of minor hairline cracks in wall paint (photos 1, 3, & 9), separation of floorboards and cabinets from floors and walls respectively (photos 2, 4, 5, & 6), and propagation of existing shrinkage cracks in the garage floor slab (photos 7 & 8). In general, cracks ranged from less than 1mm to 3mm in aperture.

Photo #	Location of Damage	Comments
1	Unit 6 interior-kitchen	Cracks in wall tile (<1mm)
2	Unit 6 interior-kitchen	Separation of cabinet from wall (<2mm)
3	Unit 6 interior-dining room	Crack in wall paint (<1mm)
4	Unit 6 interior- dining room	Window sill crack (<2mm)
5	Unit 6 interior- dining room	Separation of floor board from floor (<2mm)
6	Unit 6 interior- dining room	Window sill crack (<1mm)
7	Unit 6 interior- garage	Cracks in slab-on-grade (<5mm)
8	Unit 6 interior- garage	Cracks in slab-on-grade (<5mm)

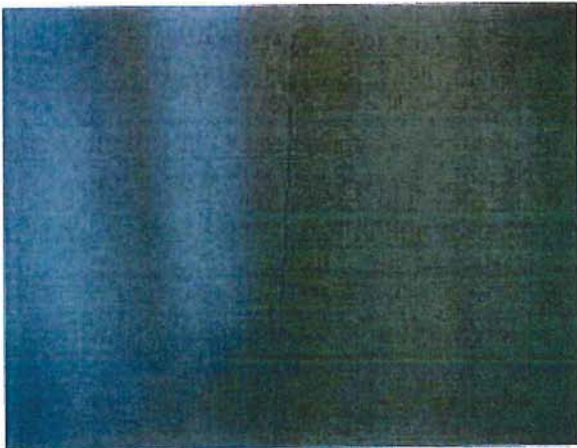
**Photo No.09**

9	Unit 6 interior- garage	Crack in wall paint (<1mm)
10	Unit 6 exterior	Fence section separation (<20mm)
11	Unit 6 exterior	Fence section separation (<20mm)
12	Unit 6 exterior	Soil stress crack (<25mm)
13	Unit 6 exterior	Movement of fence door (<55mm)
14	Unit 6 exterior	Soil crack and paving stone separation (<30mm)
15	Unit 6 exterior	Paving stone separation (<30mm)
16	Unit 6 exterior	Paving stone separation and curb settlement (<30mm)
17	Unit 6 exterior	Curb settlement (<30mm)
18	Unit 4 exterior	Paving stone separation and curb settlement (<30mm)
19	Unit 4 exterior	Paving stone separation (<30mm)
20	Unit 4 exterior	Paving stone separation (<30mm)
21	Unit 4 exterior	Movement of fence door (<30mm)
22	Unit 4 exterior	Soil stress crack (<20mm)
23	Unit 4 exterior	Movement of fence door (<10mm)
24	Unit 1 exterior	Crack in concrete curb (<15mm)
25	Unit 1 exterior	Example of non-damaged paving brick
26	Unit 1 exterior	Paving stone separation (<20mm)

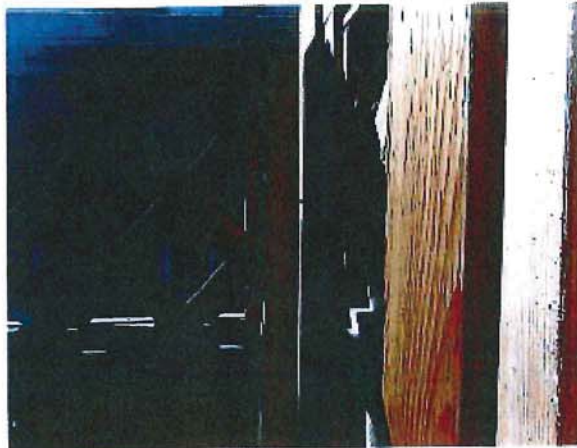
**Photo No.10**

Considerable ground movements and resulting impacts on serviceability of exterior structures were noticed along the north sides of units 1, 4, and 6. These included separations of fence sections up to 20mm wide (photos 10 & 11), movements of fence gates up to 55mm (photos 13, 21, & 23), stress cracks in soil up to 25mm wide running parallel to and at a distance of approximately 1.0m from the preload boundary (photos 12, 14, & 22), separation of paving bricks up to 30mm (photos 14 to 20, & 26), and settlements (<30mm) and cracks (<15mm) in concrete curbs (photos 16, 17, 18, & 25)

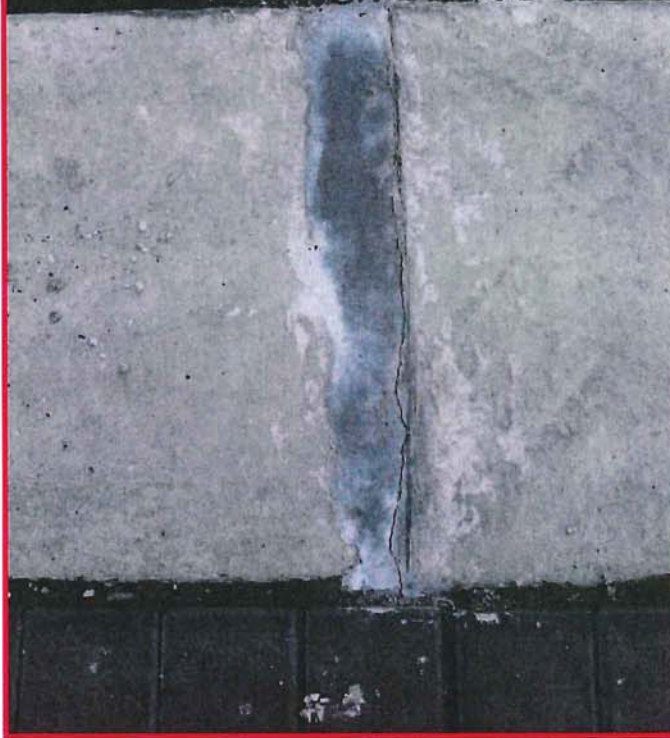
Unit #6 - 9/22/12

Attached are some pictures of the patched work to repair the damages outside Unit # 4 and Unit 6. It is believed that this patched work was done by the related developer.
