Re: Application by 1265028 B.C. Ltd. for Rezoning at 8180 Heather Street from "Single Detached (RS1/E)" Zone to the "Single Detached (RS2/A)" Zone

Reference No. VAN-2339

**Re: Assessment of Existing Neighboring Retaining Walls - Revision 1
8180 Heather Street, Richmond, BC**

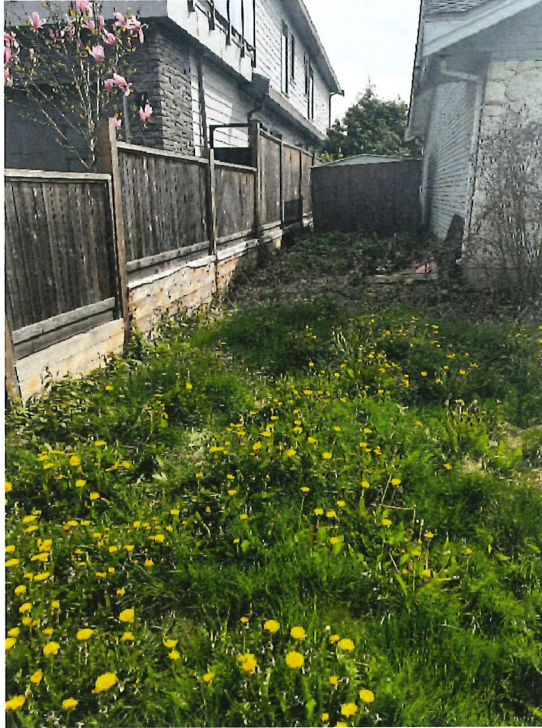
Photo 1 Existing wood retaining wall along north property line

Based on our site observations, the existing wood retaining wall along the north property line appeared to be in good condition. No significant ground movements (particular settlement) observed.

Considering the wood retaining wall located along the north property line is in good condition and the wood wall is supporting the existing wood fences, removing this wall is not recommended. It is recommended to raise the ground near the north property line to match the north neighboring property using free draining materials such as river sand or clear crushed gravel.

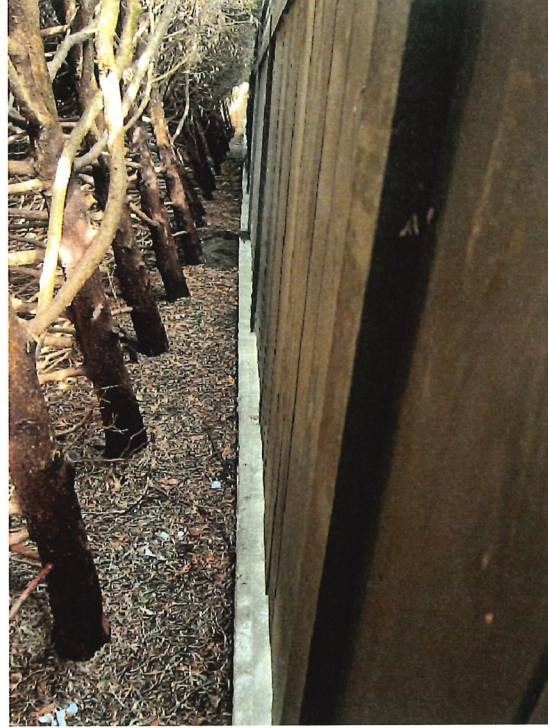
Based on the survey plan, the site is relatively flat with existing ground elevations ranging between +0.83m to +1.41m. The existing ground at the north neighboring property is about 0.3 to 0.4m higher than the ground near the common property line of the subject property. The grade separation is supported by a wood landscaping retaining wall (located on the north neighboring property) as shown in Photo 1 below. The existing ground at the east neighboring property is about 0.15 to 0.2m higher than the ground near the common property line of the subject property. The grade separation is supported by a cast-in-place concrete retaining wall as shown in Photo 2 below.

Photo 2 Existing CIP retaining wall along east property line

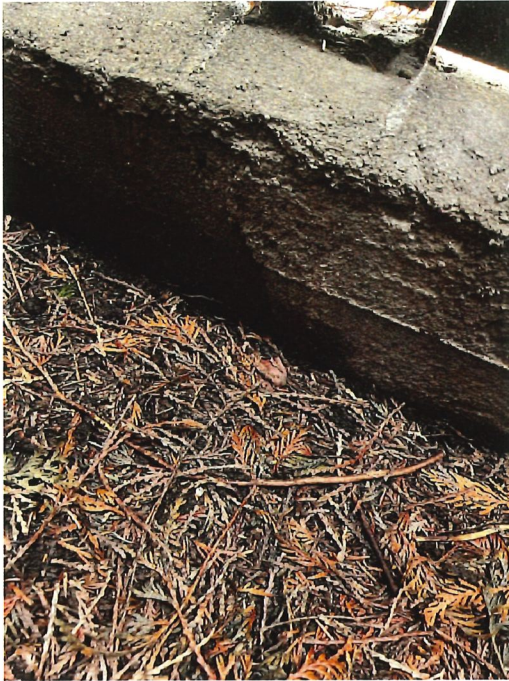
The existing cast-in-place (CIP) concrete retaining wall located along the east property line is in very poor condition. Numbers of cracks (spaced at 2 to 2.5m) were observed at the top and exposed front face of the wall and extended below ground (shown in in Photo 3-6). The observed cracks indicated that the concrete wall has no or inadequate reinforcement. In addition, a section of this wall (about 3m long) close to the southwest corner of the east neighboring building has tilted outward towards the subject property indicated significant ground movements had occurred and the wall could fail in the future.

Phot 3 Cracks on CIP Concrete Retaining Wall

Totally removing the existing CIP concrete retaining wall is not recommended. However, considering the poor condition of the existing CIP concrete wall and the location of the wall (crosses properties), partially remove the visible broken CIP concrete wall may be considered. The existing CIP concrete retaining wall may be sawcut to 0.3m below the finished grade and backfilled using topsoil. Please note that should any portion of the retaining wall be removed, written approval from the owner of the east neighbor shall be obtained. Reinstallation of the fence and that all work would be done at the cost of the developer of 8180 Heather Street, Richmond. If no agreement can be reached the retaining wall should be left in place.

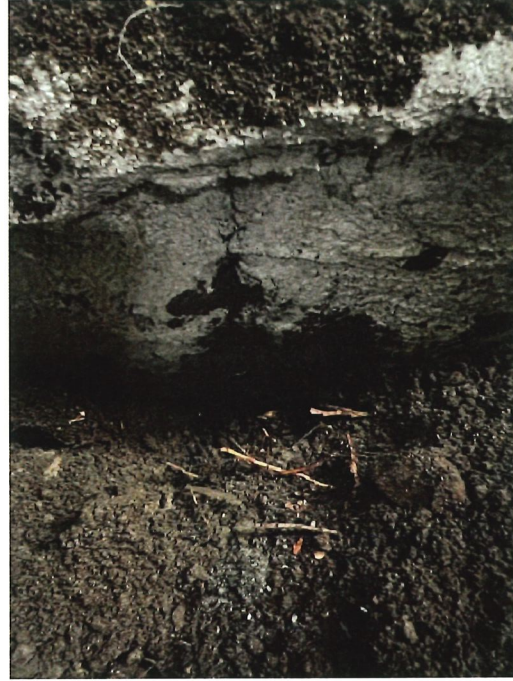
Phot 4 Cracks on CIP Concrete Retaining Wall

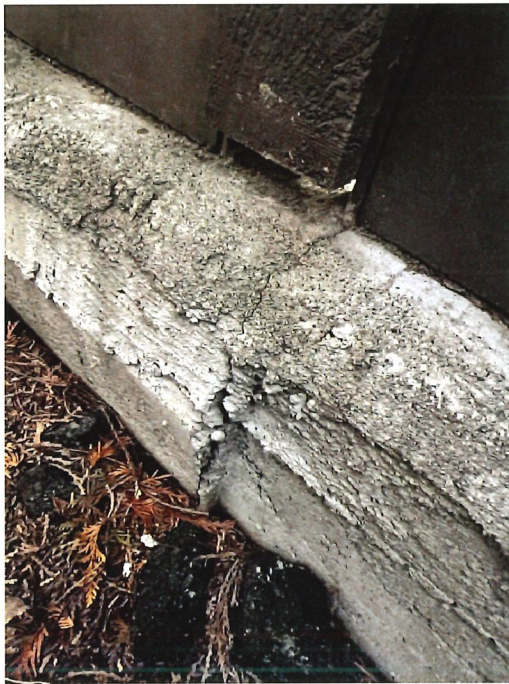
Photo 5 Cracks on CIP Concrete Retaining Wall

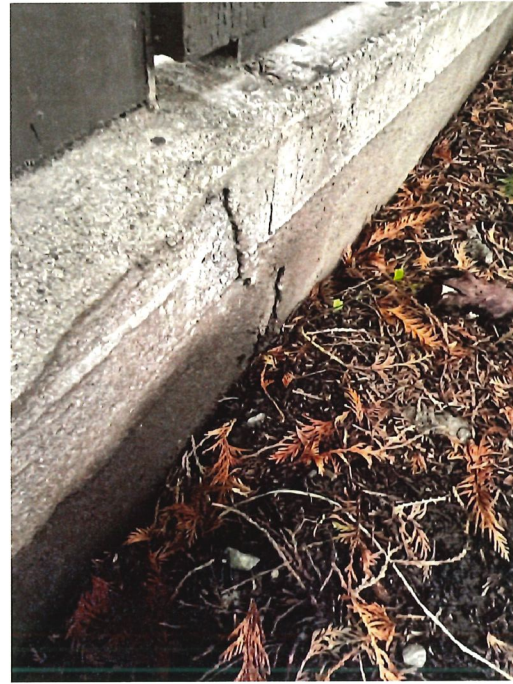
Photo 6 Cracks on CIP Concrete Retaining Wall

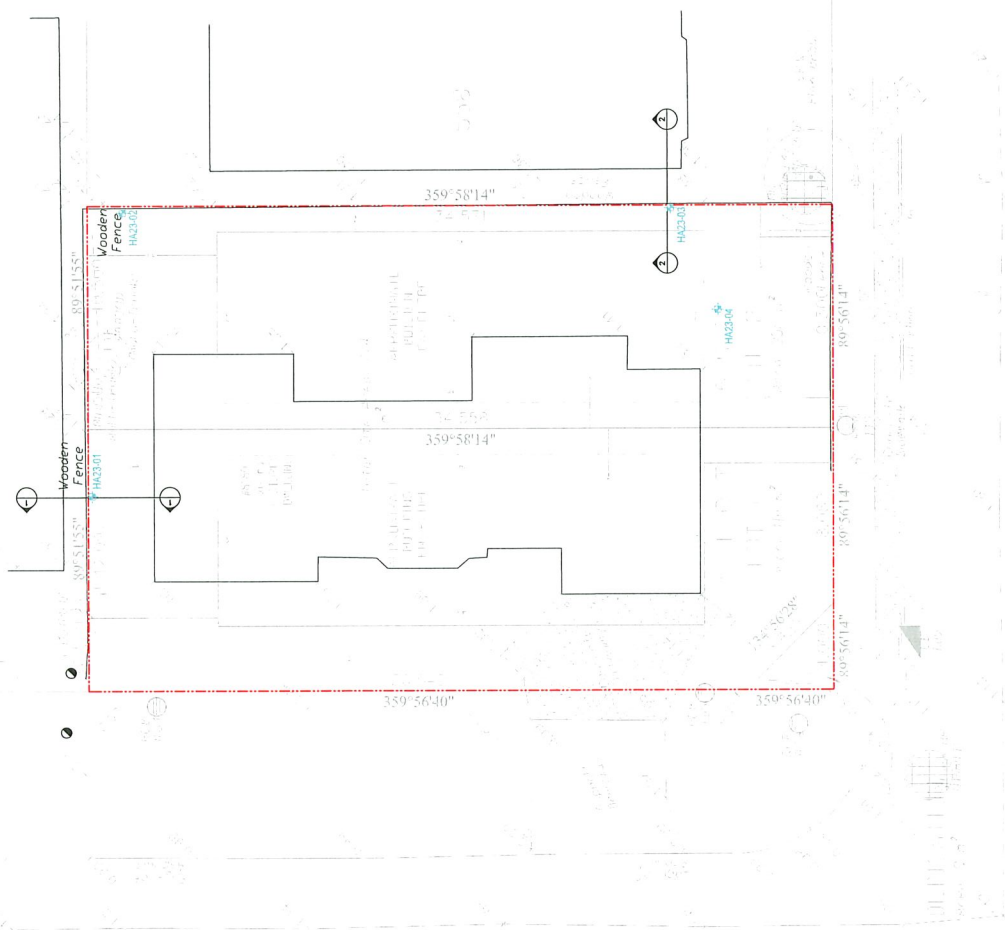
A senior geotechnical engineer from **Summit** attended the site on April 25, 2023. During our site reconnaissance, four (4) hand dug test holes were attempted at locations shown on the attached Figure 1 Site Plan. Hand dug test holes were advanced to up to 1.22m below the existing ground surface to assess near surface subsoil condition. The encountered subsoil are generally complied with that described in the geological map. Detail description of subsoil encountered in hand dug test holes are presented I Table 1 below

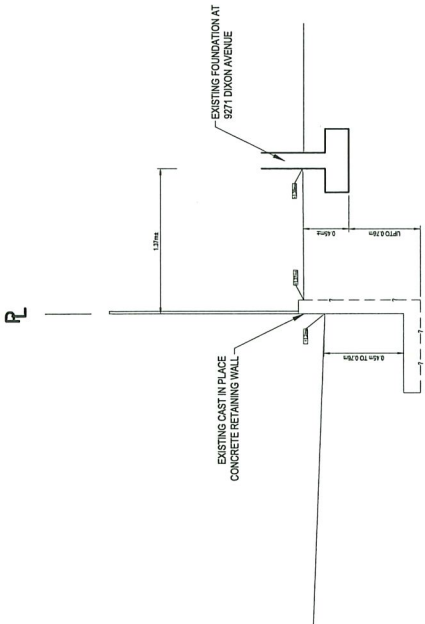
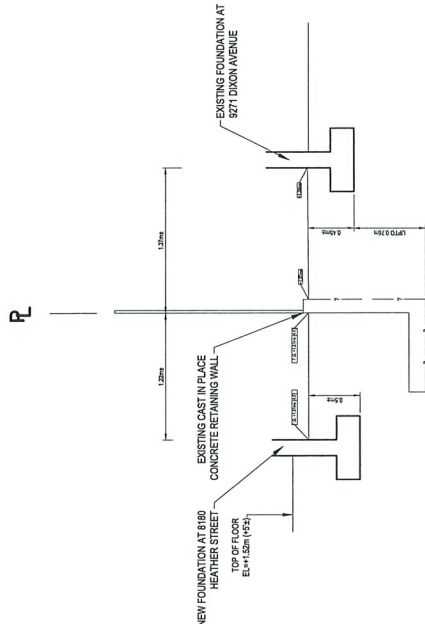
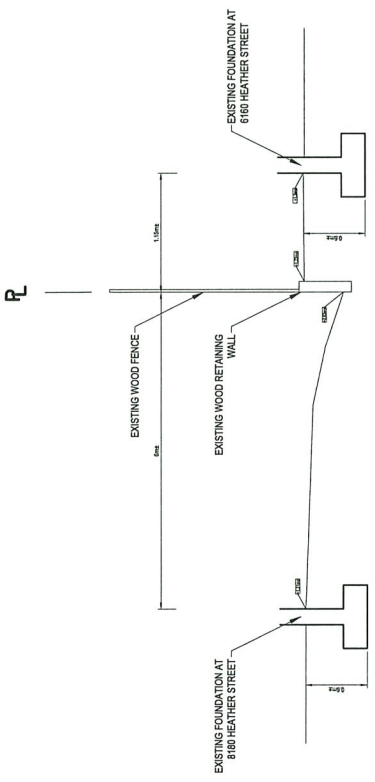
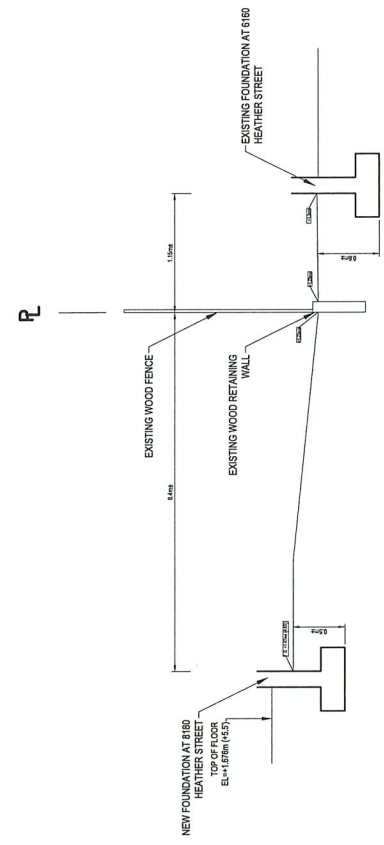
TITLE: CROSS SECTIONS
DATE: 2023-04-26
SCALE: AS SHOWN
DWG. NO.: FIGURE 2

Hand dug test hole 2 and 3 are excavated adjacent to the existing CIP concrete retaining wall to the bottom of the wall. It was noted that the existing CIP concrete retaining wall has an enlarged footing that likely extended about 0.76m (2.5') into the subject property as shown in the attached Figure 2 Cross Sections. The top of the retaining wall footing is likely located at about 0.5m to 0.76m below the existing ground surface.

The existing CIP concrete retaining wall is in very poor condition. Considering the existing wall is a shared wall (the exposed portion of the wall crosses properties and the footing of the wall extends into the subject property by about 2.5') and the condition of the wall is very poor, it is recommended that the ground at the west side of the existing CIP concrete retaining wall should be raised to match the east neighboring ground to ensure no lateral soil pressure apply to the wall from the east neighboring property as illustrated in Figure 2 Cross Section. The fill is expected to be up to 0.3m and extended to maximum 1.22m (4 ft.) to the edge of the proposed new building.
