Memorandum

Community Safety Division Community Bylaws

Results of Inspection of 12620 No. 3 Road

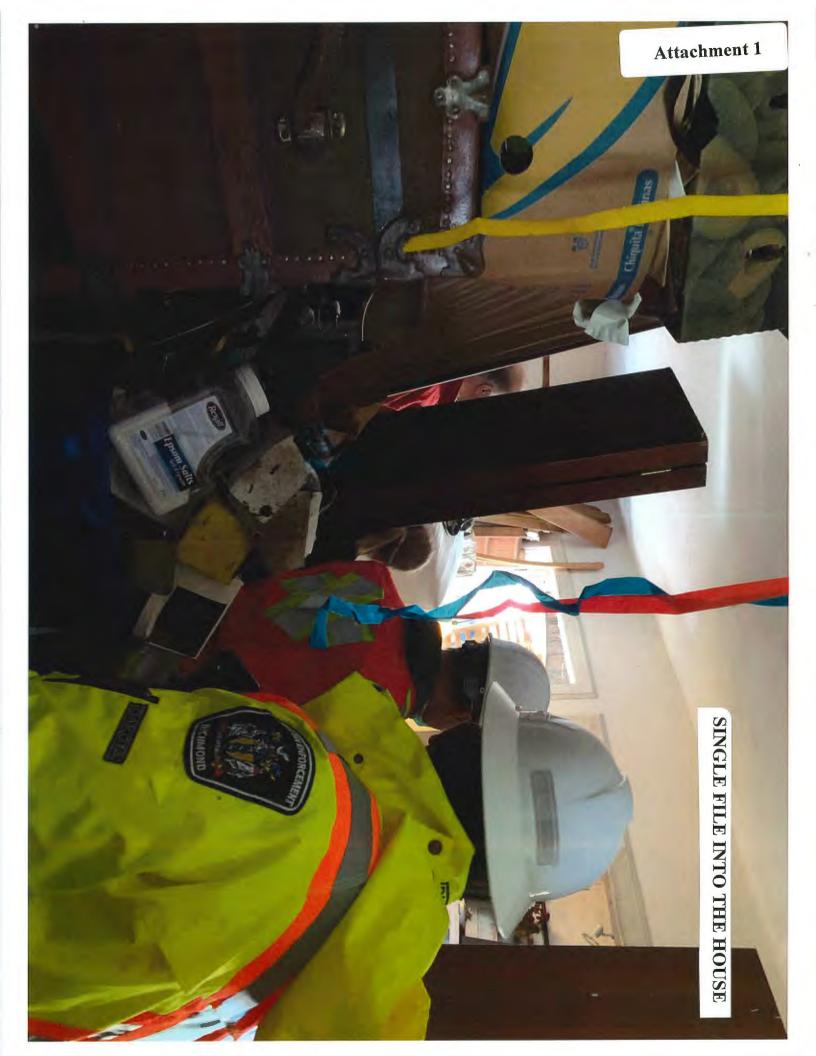
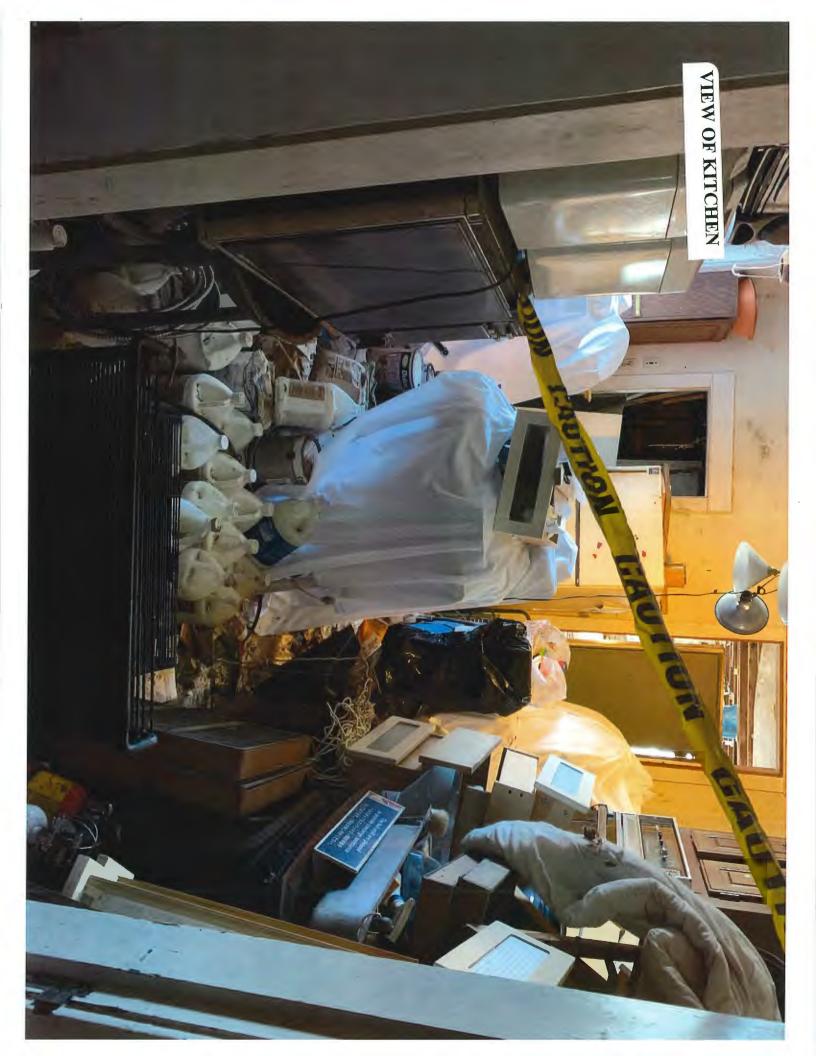
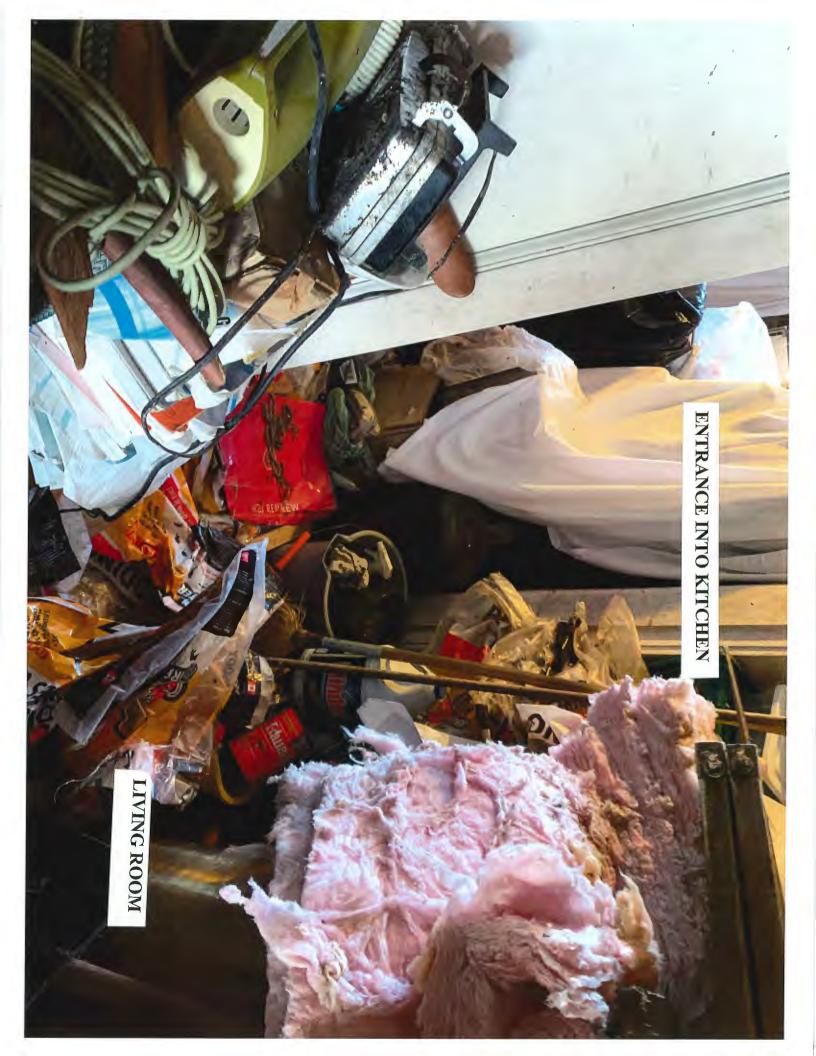
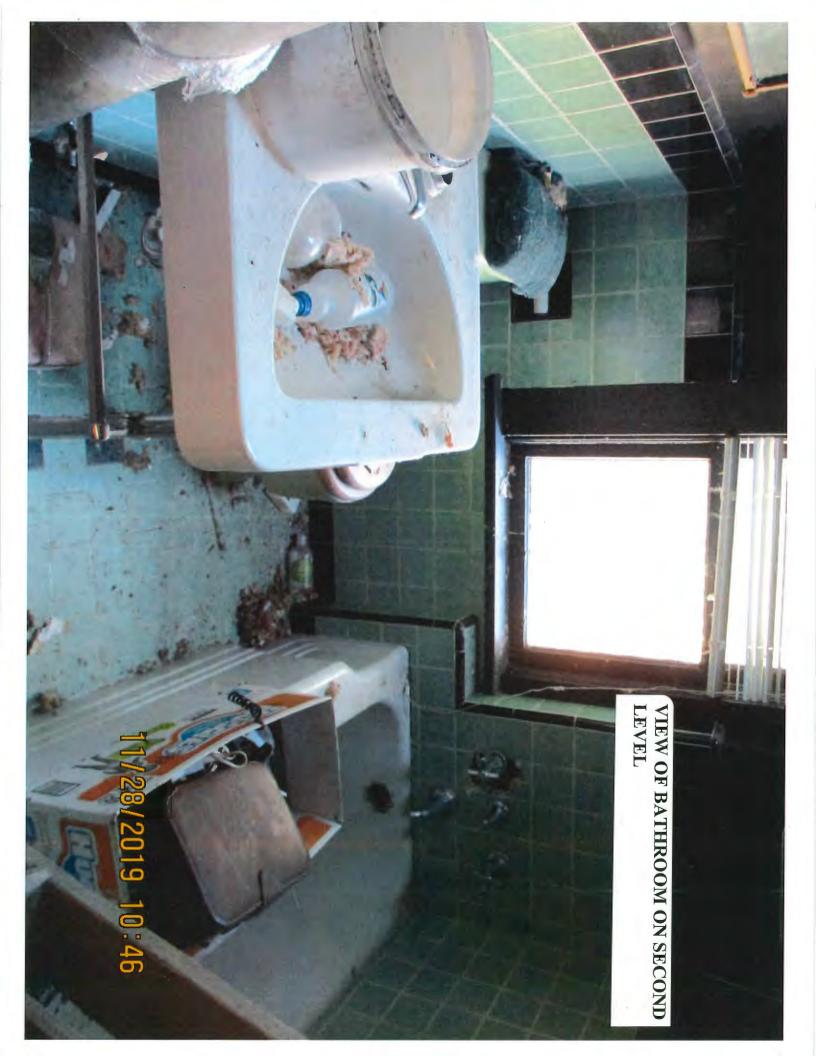
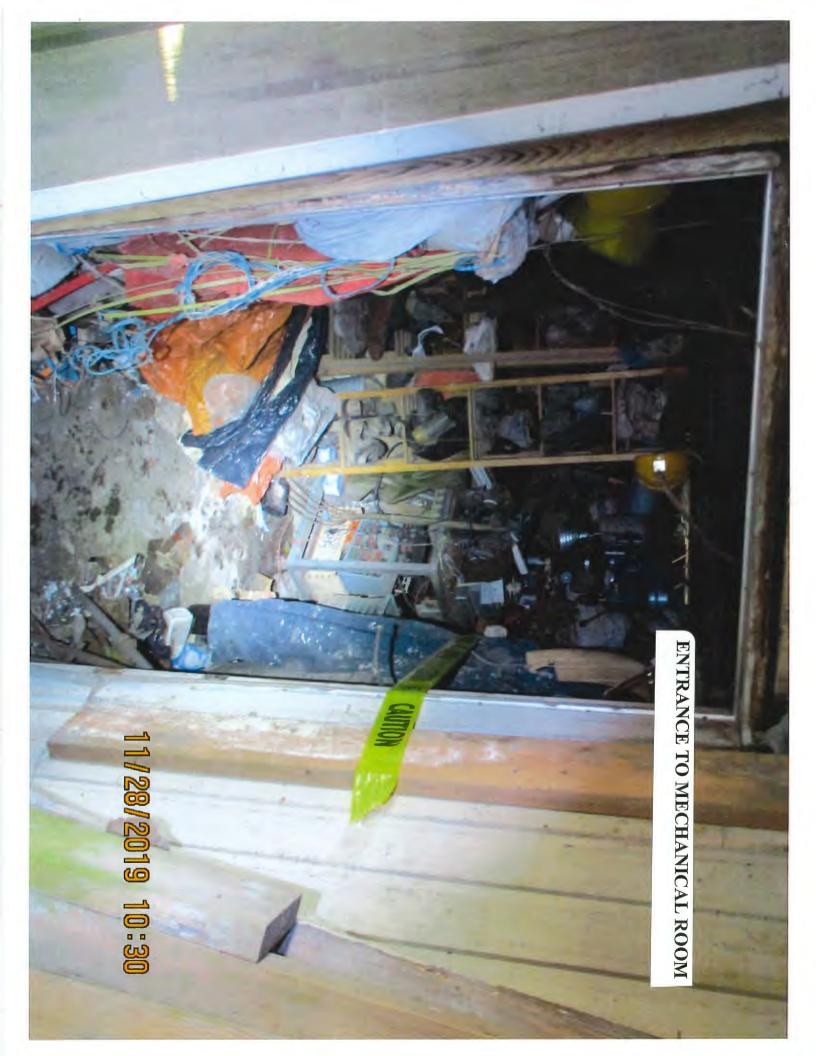
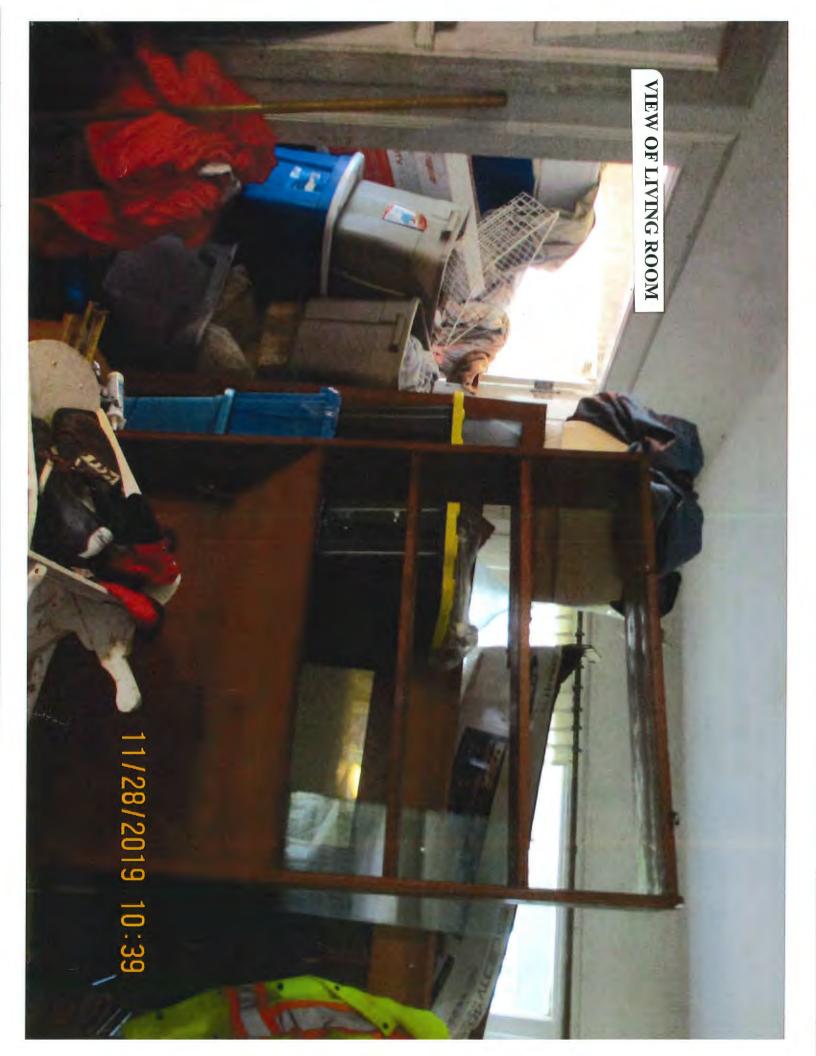
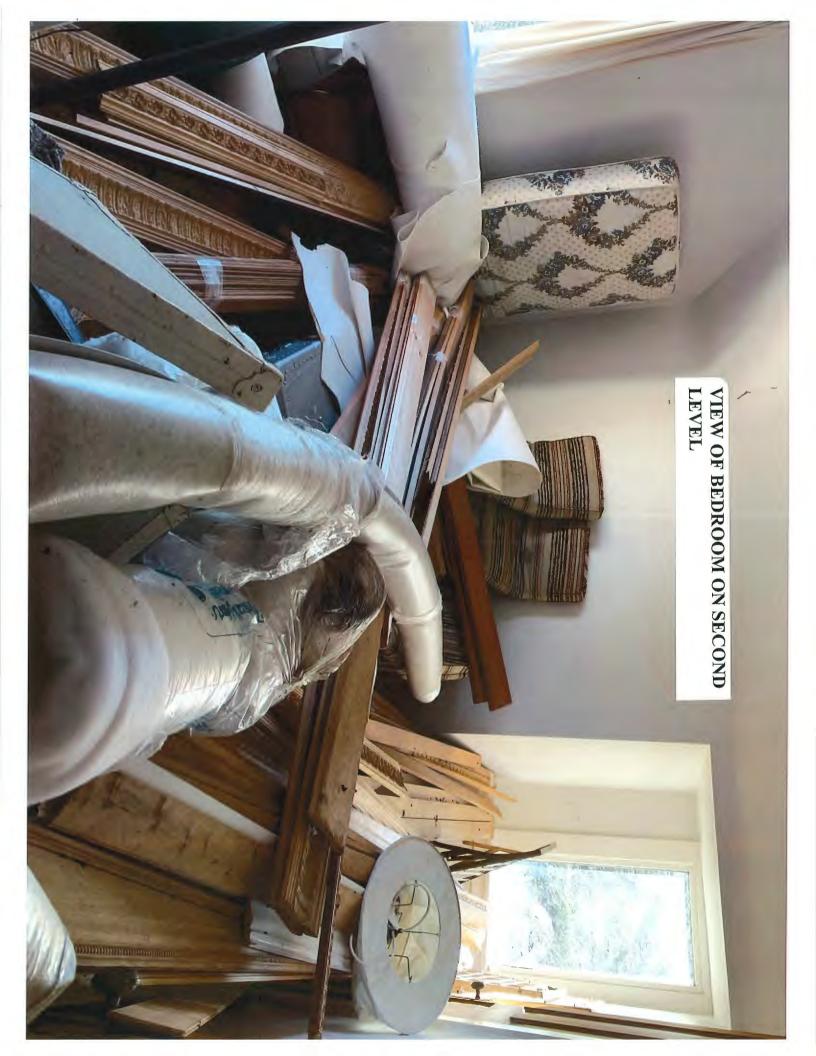
In addition to the lack of services in the house, the house is being used for storage and several of the rooms are inaccessible due to a large accumulation of materials. Some of the rooms, including the kitchen and the bathroom, have been marked off with caution tape to prevent entry. Rooms that are accessible have only a pathway wide enough for one person at a time and many of the rooms have items stacked to the ceiling. While there are some construction materials inside the house which would have value, most of the material in the house is discarded, damaged or aged beyond repair. Attachment 1 contains pictures taken from inside the house.

The main portion of the house was built over 100 years ago and may be structurally sound. However, there was an addition to the back of the house 30-40 years ago which is deteriorating and falling away from main part of the house. The roof is leaking and there are large gaps that are allowing racoons, squirrels and other rodents to freely access the interior of the house. This portion of the house is unsafe and cannot be accessed. In addition, a tree has fallen on the front part of the house and damaged a second floor balcony.

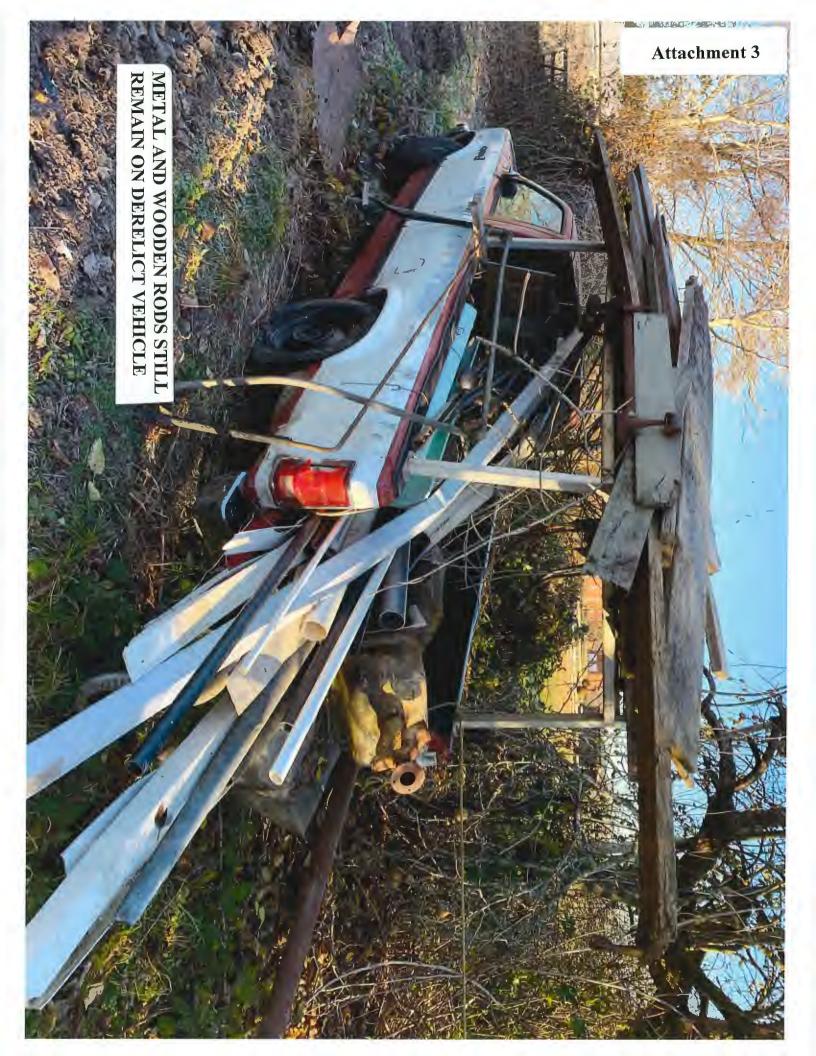
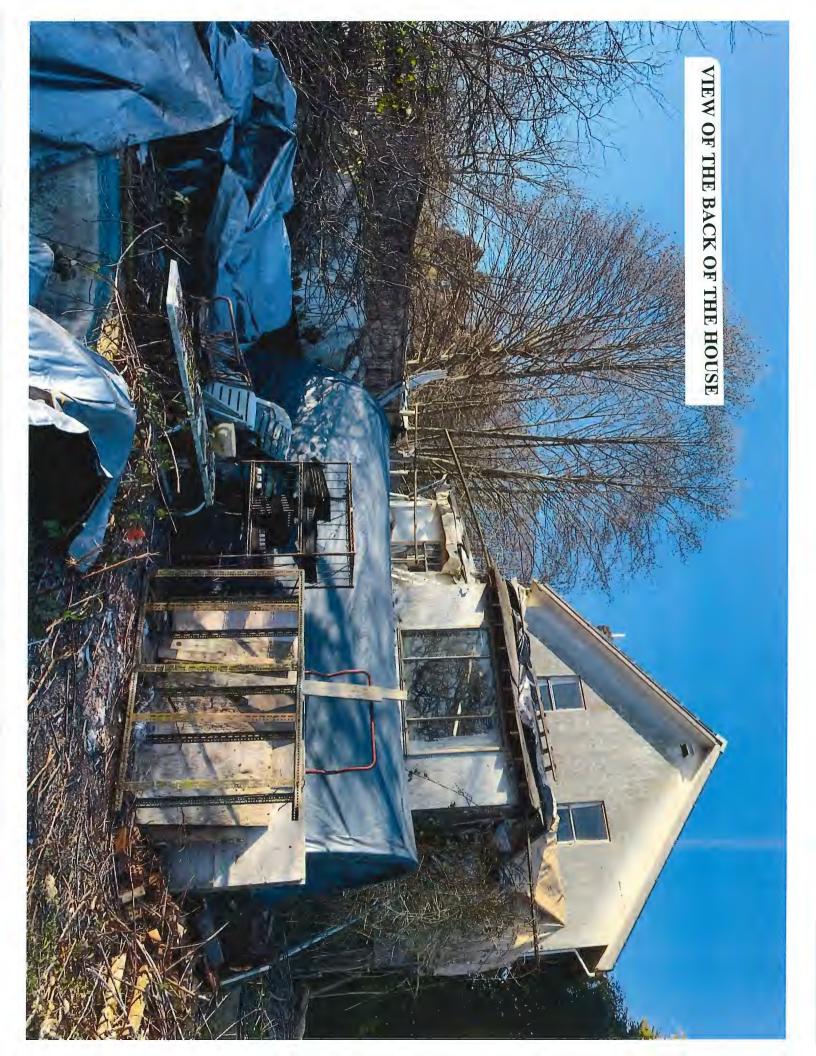
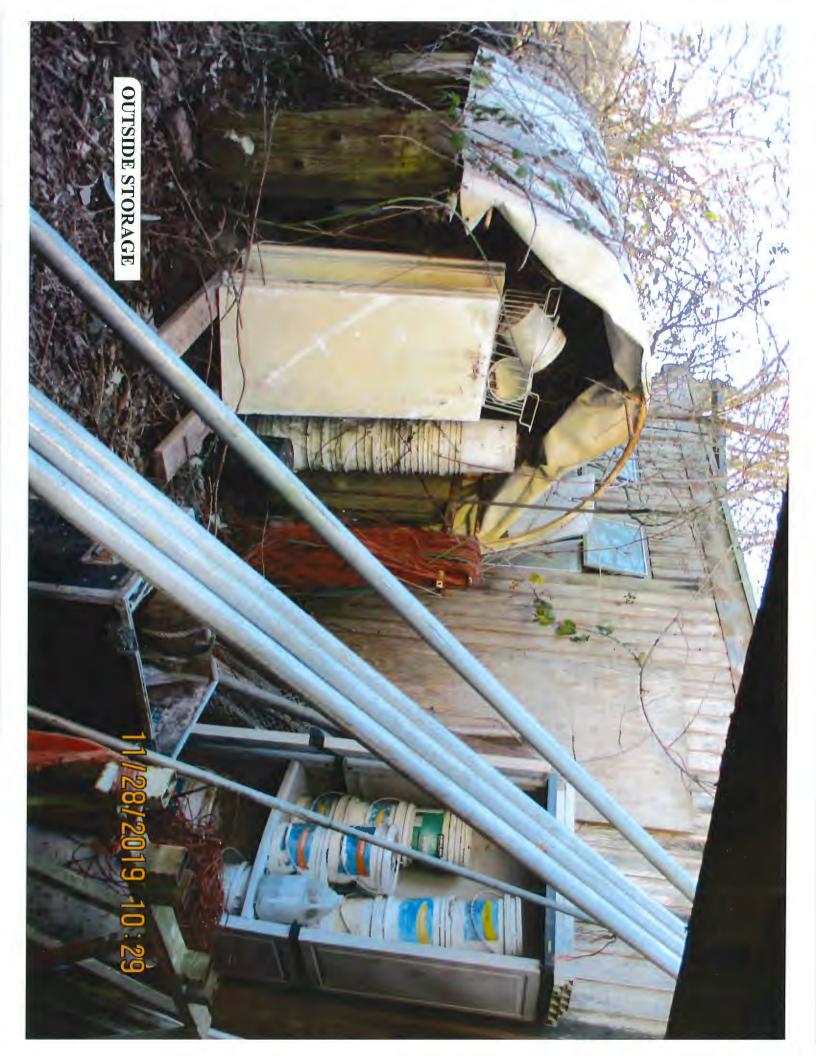
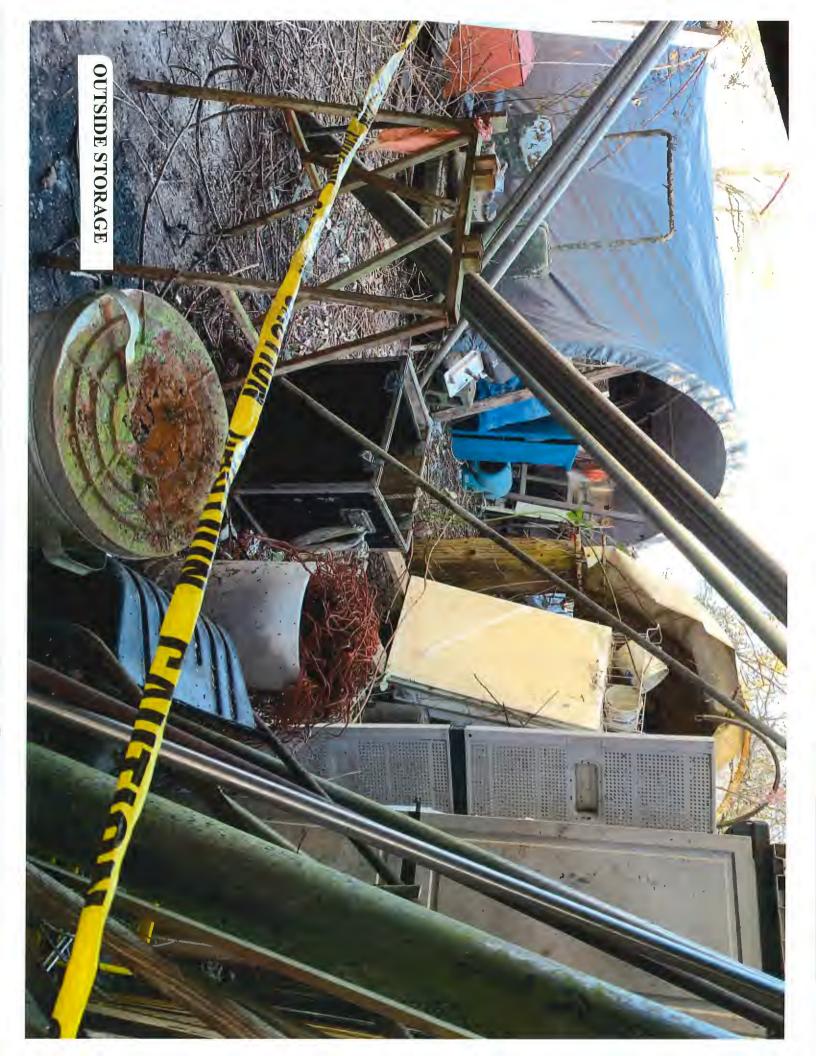
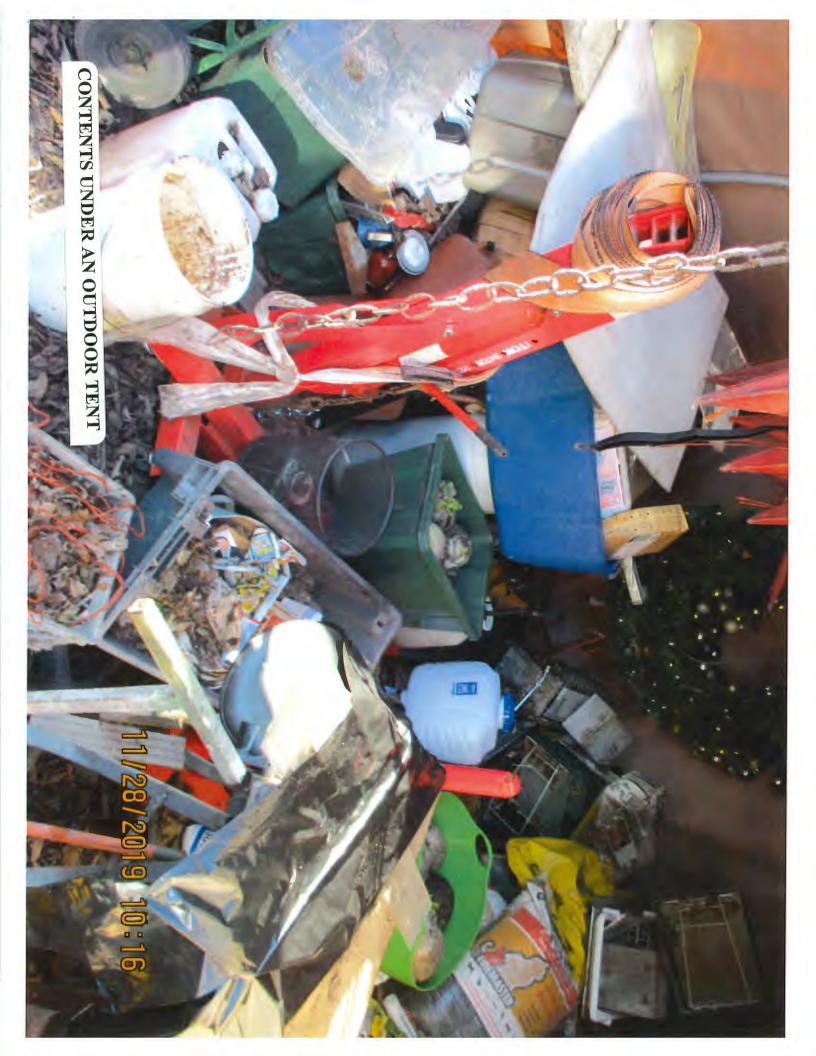
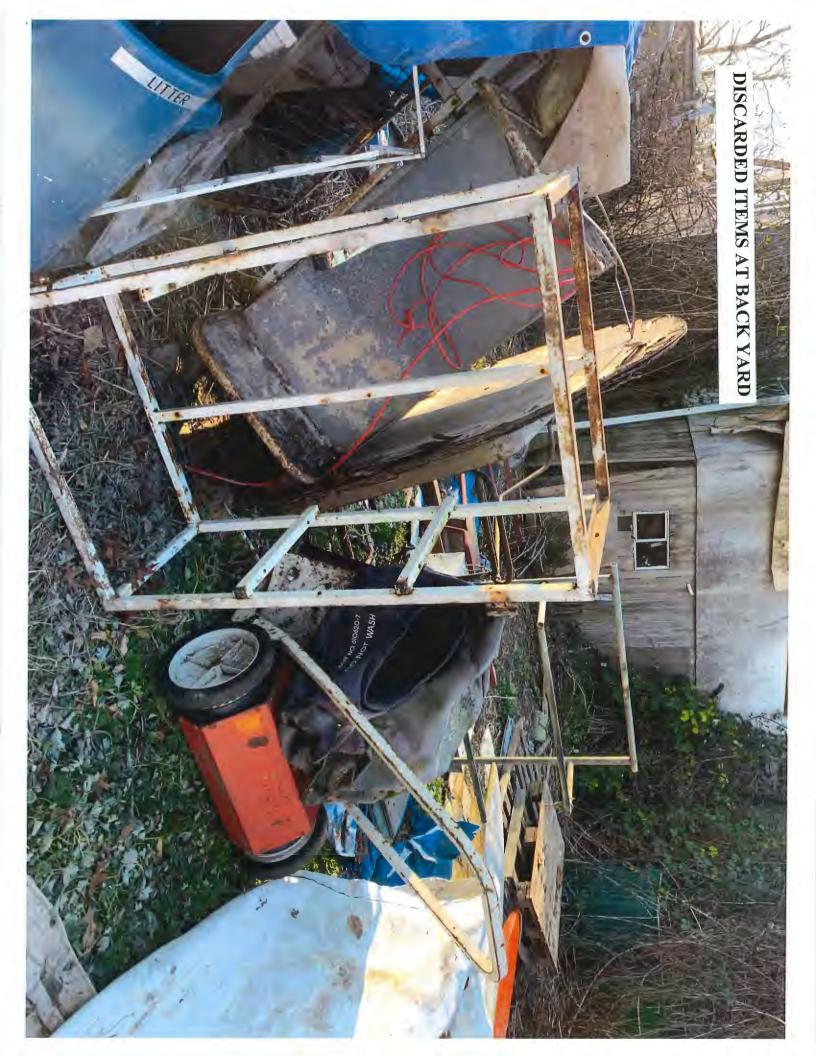
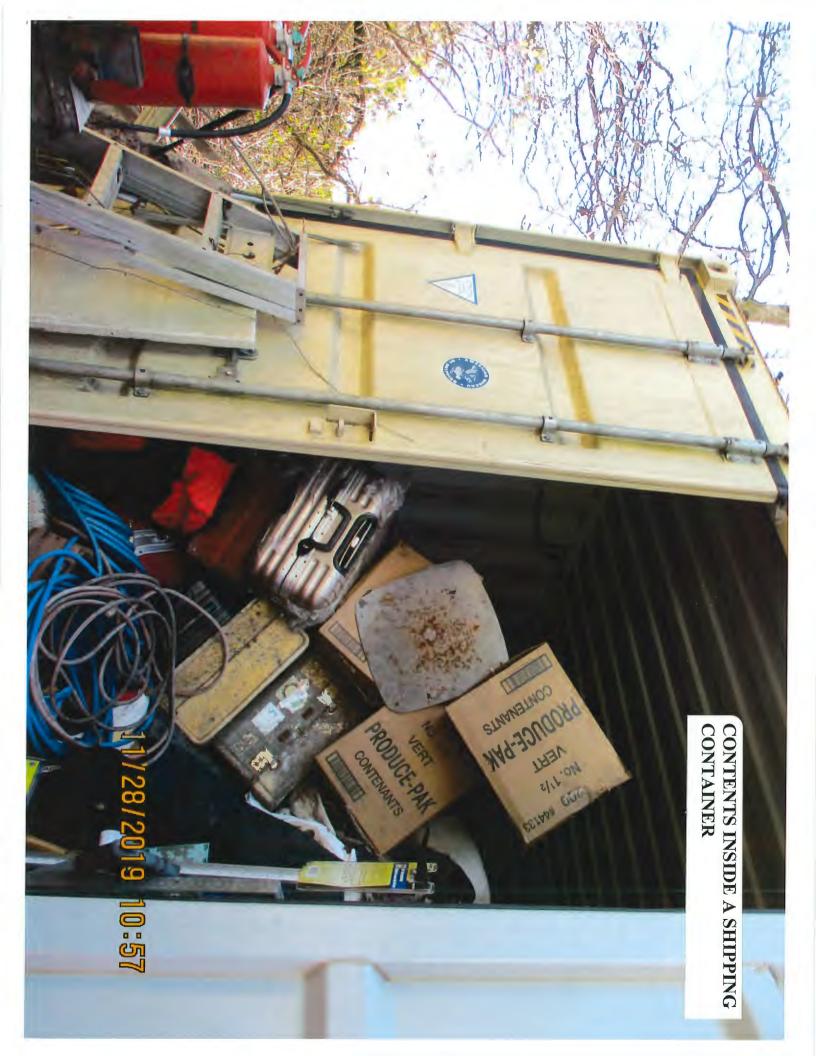
Moving to the outside of the house, staff noted that there is still much progress to be made to remove the unsightly accumulation of rubbish and discarded materials as required by Unsightly Premises Regulation Bylaw No. 7162. Acknowledging that there are some items being stored that would have value, most of the items have deteriorated beyond their useful life and are not salvageable. In addition to storing items around the yard, there is also a considerable amount of items being stored in a variety of structures in the yard including a garage, three shipping containers and several portable tents. Pictures of the items in the yard and outdoor structures are provided in Attachment 3.
