Report to Committee

RZ 07-377838

Application by Malhi Construction Ltd. and Ajit Thaliwal for Rezoning at

8571 Ash Street from Single-Family Housing District, Subdivision Area B

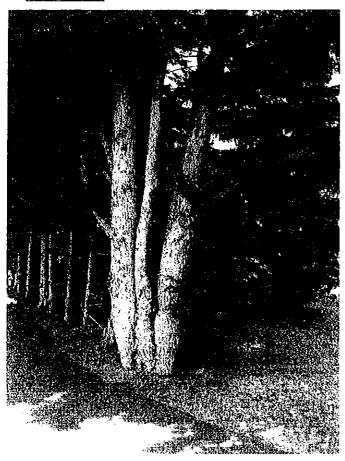
Recommended Treatment	Tree #	Dbh¹	Species	Condition	Comments
Remove	899	36+16+40	Leyland Cypress	Hazard	This is a large twin stemmed tree with a smaller subdominant stem growing between the two leaders. The twin leader union has a visible crack and inclusion made worst by the subdominant stem growing through the union. The leaders have been previously topped resulting in large upsweeping scaffold limbs. This tree is high risk for failure as result of the weak stem unions, and it should be removed to mitigate the safety risk to the site. This tree is growing on the property line and there for is considered a shared tree. In addition to city approvals, approval from the neighbour will be needed before the tree is removed.
Remove (off site tree)	900	68	Leyland Cypress	Hazard (once 899 is removed)	This tree has been historically topped resulting in large upsweeping scaffold limbs. The tree shares crown space with tree #899 giving the appearance of one large crown. This tree is not at a high risk for main trunk failure all though it is a high risk for scaffold limb failure due to the large relative size of the upswept multiple leaders and their weak attachments to the main stem. The risk of failure will increase after tree

Tree # 899	Tree # 899	Tree # 904
Probability of Failure (1 to 4 pts):	3	3	4
Size of Defective Part (1 to 3 pts²):	2	2	2
Target Rating (1 to 3 pts):	3	3	3
Other Risk Factors (0 to 2 pts³):	0	0	1 (active failure)
Total Rating (3 to 12 pts):	8	8	10

Photo showing the very weak stem union of the leaders on tree #899.

#899 is removed, and the foliage will be asymmetrical and bare if it were left after that adjacent tree is removed. Removal of this tree is recommended to miligate safety risk from branch failure toward the active land uses. This tree is an off site tree and the owner of the adjacent property will need to authorize its removal before action is taken.
Remove (Shared ownership)	901 - 903	20 - 22	Arborvitae Cedar Hedge	Poor	The 3 tagged trees are the largest of the row within a 10m (approximate) long hedge. The hedge is comprised of shared and off site ownership trees, and has been affected by neglect. This hedge has not been maintained with proper pruning to maintain its formal appearance or to control its vertical growth. The lower foliage has been removed from the south side. The result is a top heavy hedge that cannot be restored. Restoration of this hedge is not viable and it will always be atheistically unpleasing. The hedge no longer serves its purpose for privacy. Since the hedge cannot be restored, it should be removed and replaced (if desired). These trees are shared by the two properties and therefore approval from the adjacent property owner will be needed before they are removed.

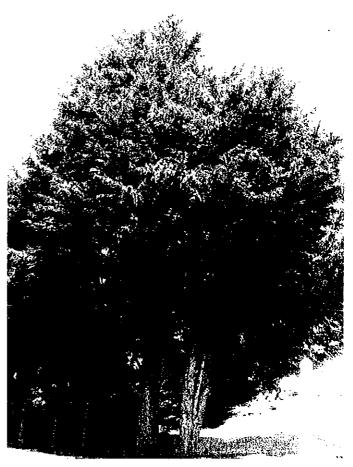
All 5 on-site or shared ownership bylaw trees as well as one offsite tree are deemed to be in very poor health and/or have significant structural defect. Tree # 904 is rated as an extreme risk tree and tree #'s 899 and offsite tree # 900 are both rated high risk for failure. Years of improper tree care has resulted in a specification for removal as the only option for the on site trees in relation to the proposed development.

Photo showing the tree #'s 899 and 900 growing as one crown, fully merged and essentially being one tree.

- Hazard tree #'s 899 and 900, plus the hedge #'s 901 to 903 are consented to be removed by the neighbour
 who co-owns them (they straddle the property line). A copy of their consent letter is already on file with the
 city.

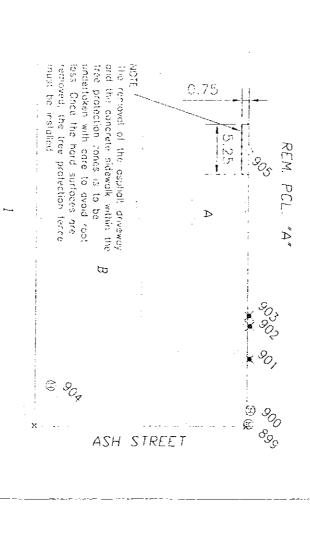
TREE RETENTION PLAN

- Tree # 905: A small holly tree located offsite, within the north adjacent property, that was previously not surveyed is to be retained. This tree has now been surveyed and is reported to be a 36 cm diameter holly. Our measurements find it to be a twin stemmed trunk with 16 and 15 cm dbh, for a size rating by bylaw criteria of 25 cm. This tree is in good health condition, however it has been harshly pruned, affecting its structural form. There is currently a garage foundation within 1.5m of the trunk, and a concrete sidewalk covers the soil in the dripline, right up to the property line. It is likely than very minimal rooting is found beneath the sidewalk. This is a viable tree, and can be retained without impacts to its health if a small protection zone of 0.75m offset from the property line is provided for its roots. The concrete sidewalk will need to be removed with care to avoid digging and excavaling the roots.
