City of Richmond

Report to Committee

To: Public Works and Transportation Committee **Date:** May 27, 2005
From: Victor Wei, P. Eng. **File:** 10-6450-09-01/2005-Vol
Acting Director, Transportation 01
Re: **TRAFFIC SAFETY CONCERNS - 22000 BLOCK RIVER ROAD**

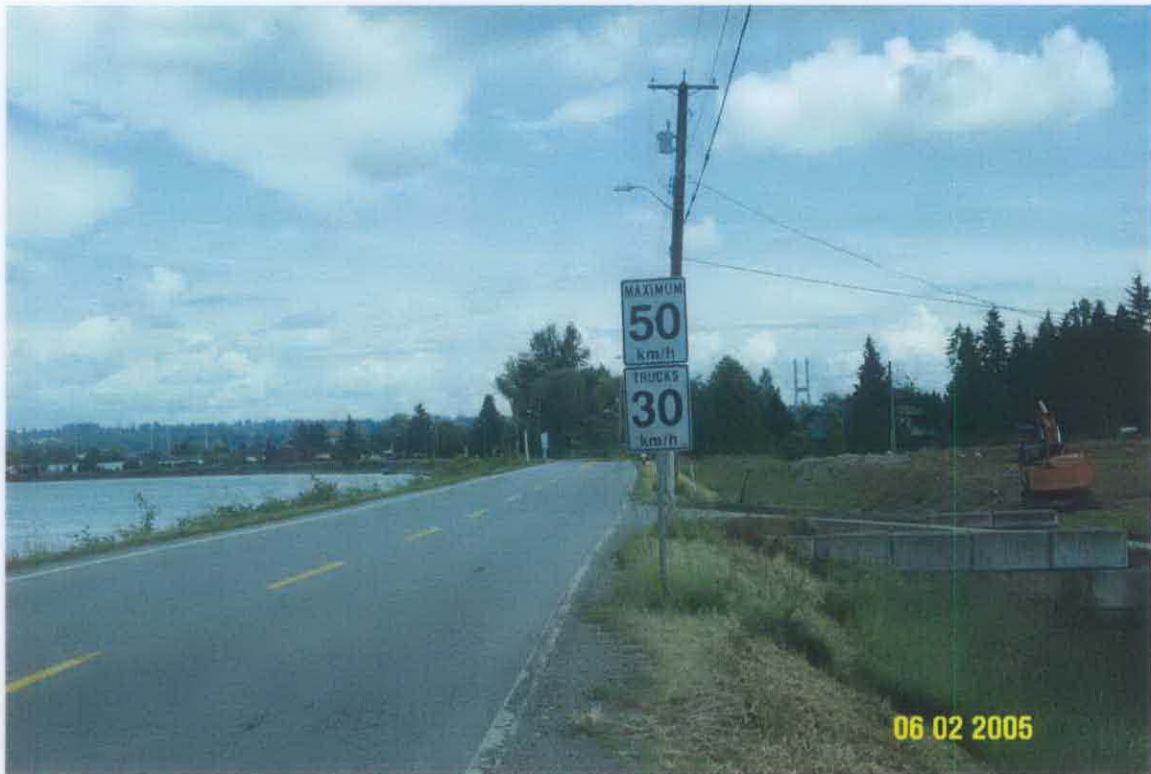
21000 Block River Road looking east, shows car and truck speed limit signs

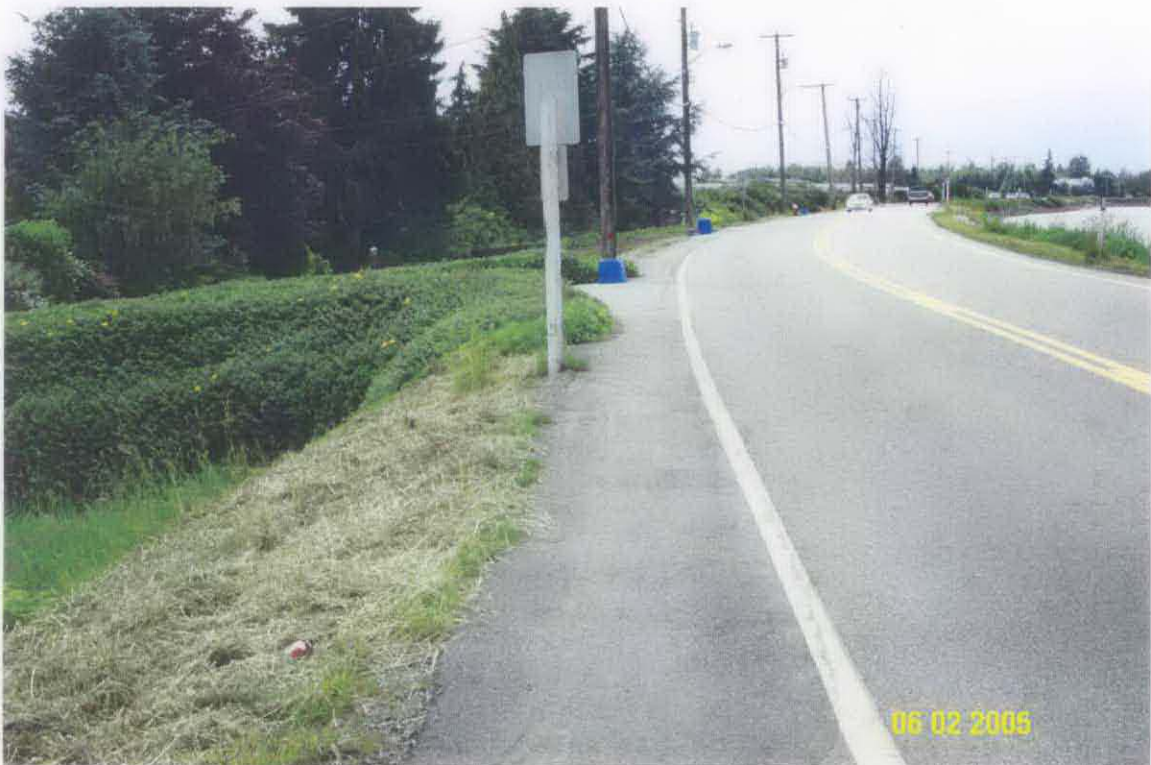
River Road at Queens Road walkway looking west
