Report to Committee

Re: **Application by Watson and Barnard, BC Land Surveyors for Rezoning at
12751 Rice Mill Road from Agricultural District (AG1) to Light Industrial District
(I2)**

RZ 06-330060

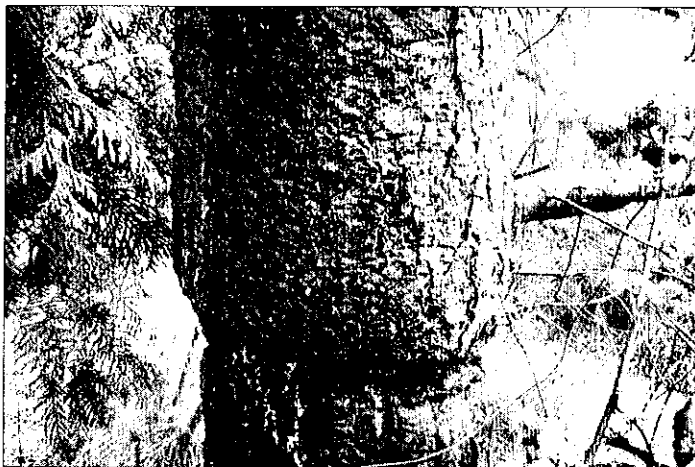
Photograph 2:

A dead, topped Douglas-fir (Tree #185) was located in the southwest corner of the property. The tree is located in between the main entrance of the existing golf facility and the neighbouring single-family dwelling. Given the surrounding land use, this tree is a hazard and should be removed immediately.

Additional example of girdling by staking equipment (Tree #185).

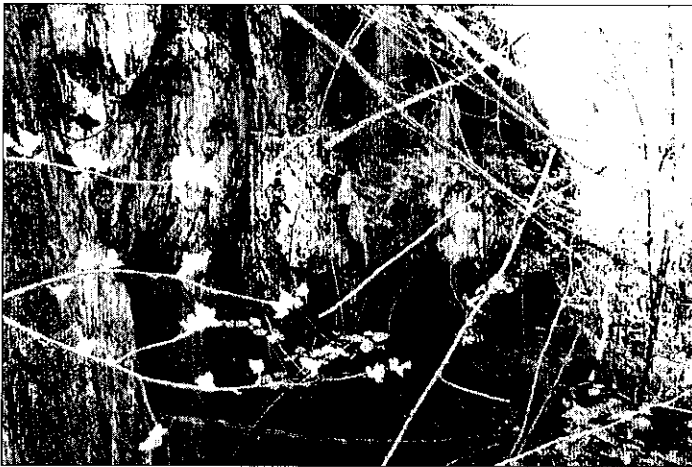
Photograph 5:

Tag #	Species Name		dbh (cm)	Height (m)	Condition	Comments/Recommendations
	Scientific	Common				
130	<i>Populus balsamifera</i> ssp. <i>trichocarpa</i>	black cottonwood	230	30	Poor (Hazard)	- significant decay at base from failed stem; may have been historically attached to 129 - 2 main stems; union above dbh - may represent a significant hazard, pending development designs - remove or wildlife tree, or increase no-development buffer zone to remove targets and reduce hazards
131	<i>Populus balsamifera</i> ssp. <i>trichocarpa</i>	black cottonwood	20	7	Moderate	- lesser stem growing from old stump
132	<i>Populus balsamifera</i> ssp. <i>trichocarpa</i>	black cottonwood	68	18	Good	- leaning over slough
133	<i>Populus balsamifera</i> ssp. <i>trichocarpa</i>	black cottonwood	158	30	Good	- 2 main stems; union above dbh
134	<i>Populus balsamifera</i> ssp. <i>trichocarpa</i>	black cottonwood	143	32	Good

Wound and subsequent decay at base of Tree #130.

- Complete removal of both Trees #129 and #130;
- *Wildlife* both Trees #129 and #130 to a height that will remove targets from striking distance (e.g., a distance equal to or greater than one and a half tree height) under stem failure; or
- Modify the proposed environmental setback in this area to create an acceptable buffer between Trees #129 and #130 and their potential targets (e.g., distance between trees and buildings and/or heavily used areas such as parking lots and/or walkways greater than or equal to one and a half the existing tree height).

Tree #129 and #130 are located in the proposed setback area along the northern property boundary and should be retained to maintain the integrity and continuity of the riparian habitat. However, the development of buildings or other potential targets in and around these trees, outside of the setback area, may render both trees a hazard requiring removal. An adequate buffer zone (e.g., $\geq 1.5 \times$ tree height) should be established around each tree to avoid the need for removal. Alternatively, these trees may be *wildlifed* to a height that will provide an adequate buffer between the trees and proposed development, while maintaining a portion of their habitat value.
