To: Parks, Recreation and Cultural Services Committee **Date:** June 7, 2011
From: Dave Semple
General Manager, Parks and Recreation **File:** 11-7141-01/2011-Vol
01
Re: Phoenix Net Loft

RE: Phoenix Net Loft Assessment

WorleyParsons Canada Services Ltd. (WorleyParsons) is pleased to provide the following condition assessment of the City of Richmond's (CoR) Phoenix Net Loft located in Steveston, BC and presentation of remedial options.

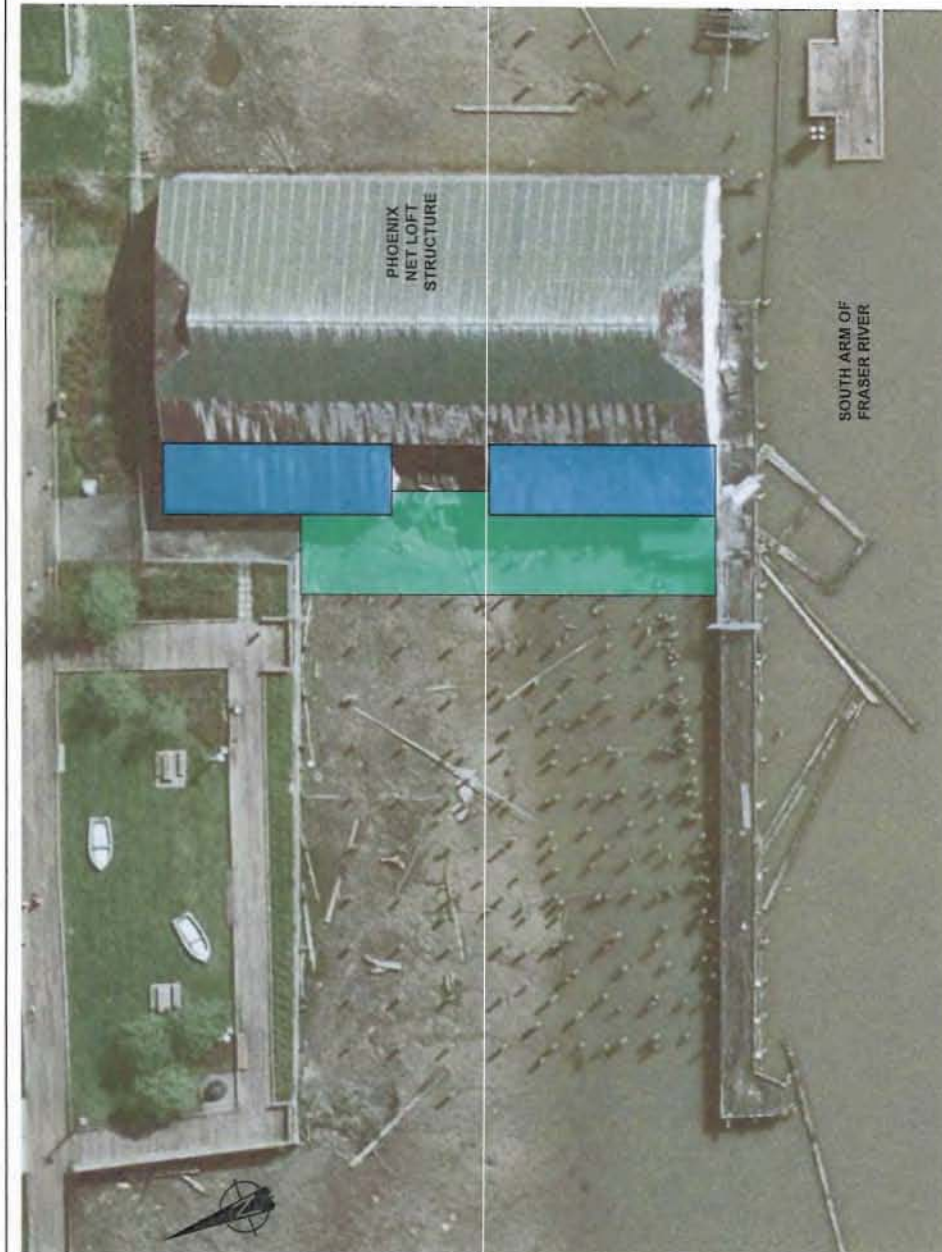
- [Blue Box] THREE WING ARRANGEMENTS TO PRIMARY NET LOFT STRUCTURE TO BE REMOVED
- [Green Box] ZONE OF PROPOSED WIND BREAKING WALLS TO BE CONSIDERED WITH LIGHT-POINT SHADING ELEMENTS

- Demolish portions that are susceptible to collapse, such as the shed appendages and remaining portions of exposed wharf deck (estimated cost \$140,000). See **Attachment C**.
- Install lightweight shading elements (required to prevent the creation of new marine habitat, as this could inhibit future clean-up operations of a collapsed structure) (estimated cost \$95,000).
- Undertake an updated condition assessment (estimated cost \$15,000).
