Schedule 1 to the Minutes of the
Development Permit Panel
meeting held on Thursday
October 20, 2022.

ESA TREES ASSESSMENT SUMMARY

2022 ESA COMPENSATION PROPOSAL - WITHIN ORIGINAL ESA ZONE

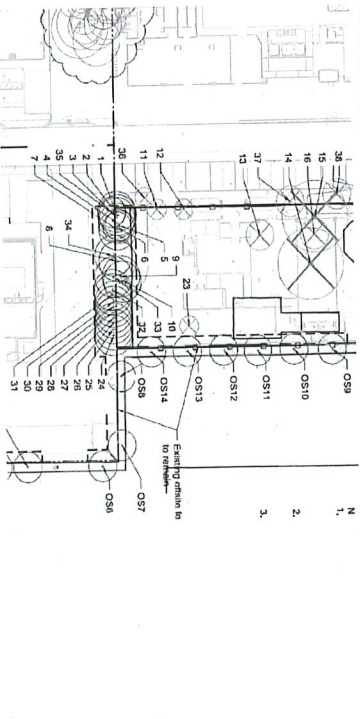
Figure 2 - Excerpt from tree management plan indicating tree numbers and locations.

The following trees are located at 9520 Beckwith Road			
Tree #	Common Name Botanical Name	DBH (cm)	Condition
1	Western redcedar Thuja plicata	47	DEAD
2	Western hemlock Tsuga heterophylla	37	DEAD
3	Western redcedar Thuja plicata	20	DEAD
4	Western redcedar Thuja plicata	27	DEAD
5	Douglas-fir Pseudotsuga menziesii	27	DEAD
6	Western redcedar Thuja plicata	24	DEAD
7	Western hemlock Tsuga heterophylla	51	DEAD
8	European mountain-ash Sorbus sp.	22, 20, 11	DEAD
9	Lawson cypress Chamaecyparis lawsoniana	33	DEAD
10	Lawson cypress Chamaecyparis lawsoniana	37	DEAD

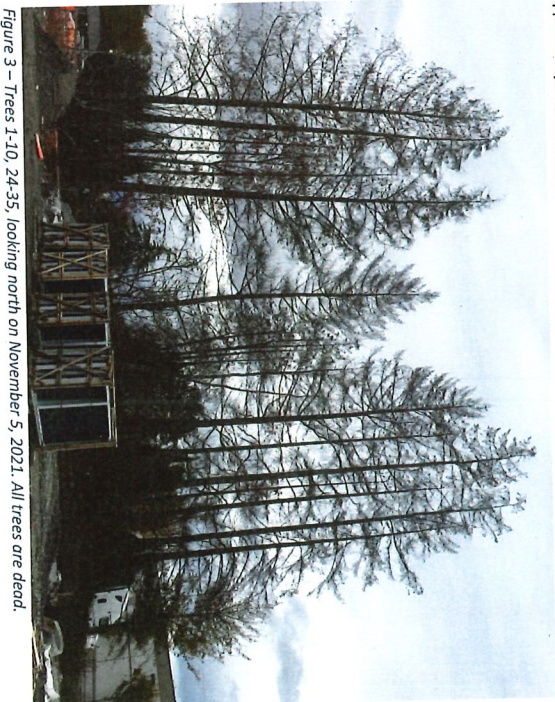
A total of 22 trees were identified for retention within the ESA that overlaps 9520 Beckwith Road and 2899 Jow Street. All of the trees are now dead. The city of Richmond requires a 2:1 tree replacement ratio for all trees removed for new development. If these trees had been removed with an approved permit for development, 44 replacement trees would be required for this site.

Figure 3 – Trees 1-10, 24-35, looking north on November 5, 2021. All trees are dead.

All the trees are dead, and removal is recommended, except for trees 1, 24, 25, 28, 31, which should be considered for retention as wildlife trees.

If these trees are removed and replaced, the standing water must be addressed, or trees suitable for saturated conditions should be selected for replanting.

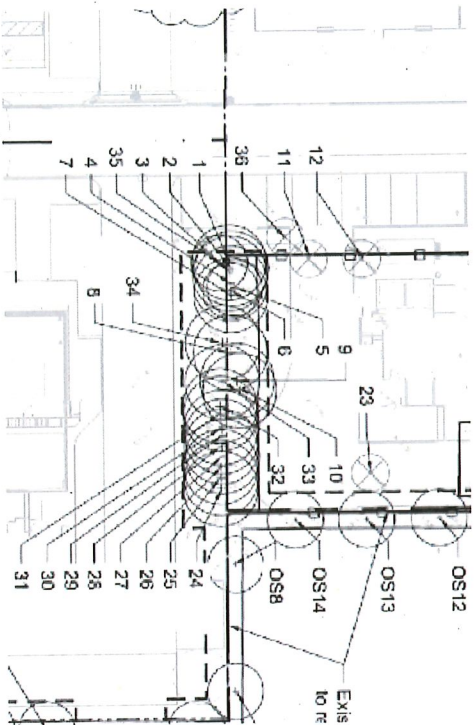
FIG. 2 - Site map indicating location of subject trees

Tree #	Common name <i>Botanical name</i>	DBH (cm)	Risk Condition	Risk Analysis	Health Analysis
1	Western redcedar <i>Thuja plicata</i>	47	Dead scaffolds and trunk.	Probability of Failure: Possible Probability of Impact: Medium Likely consequences: Severe Overall Risk: Low	Dead - Class 3
24	Douglas fir <i>Pseudotsuga menziesii</i>	49	Dead scaffolds and trunk.	Probability of Failure: Possible Probability of Impact: Medium Likely consequences: Severe Overall Risk: Low	Dead - Class 3
25	Douglas fir <i>Pseudotsuga menziesii</i>	44	Dead scaffolds and trunk.	Probability of Failure: Possible Probability of Impact: Medium Likely consequences: Significant Overall Risk: Low	Dead - Class 3
28	Douglas fir <i>Pseudotsuga menziesii</i>	55	Dead scaffolds and trunk.	Probability of Failure: Possible Probability of Impact: Medium Likely consequences: Severe Overall Risk: Low	Dead - Class 3
31	Douglas fir <i>Pseudotsuga menziesii</i>	48	Dead scaffolds and trunk.	Probability of Failure: Possible Probability of Impact: Medium Likely consequences: Severe Overall Risk: Low	Dead - Class 3
