**Schedule 3 to the Minutes of
the Development Permit
Panel Meeting of Wednesday,
September 26, 2012.**

FENCE ASSESSMENT REPORT

**BCS 4241 Newbury
7771 Bridge Street
Richmond, BC**

**Re: Damage Assessment Report- Newbury Townhouse Development
7771 Bridge Street, Richmond, BC**

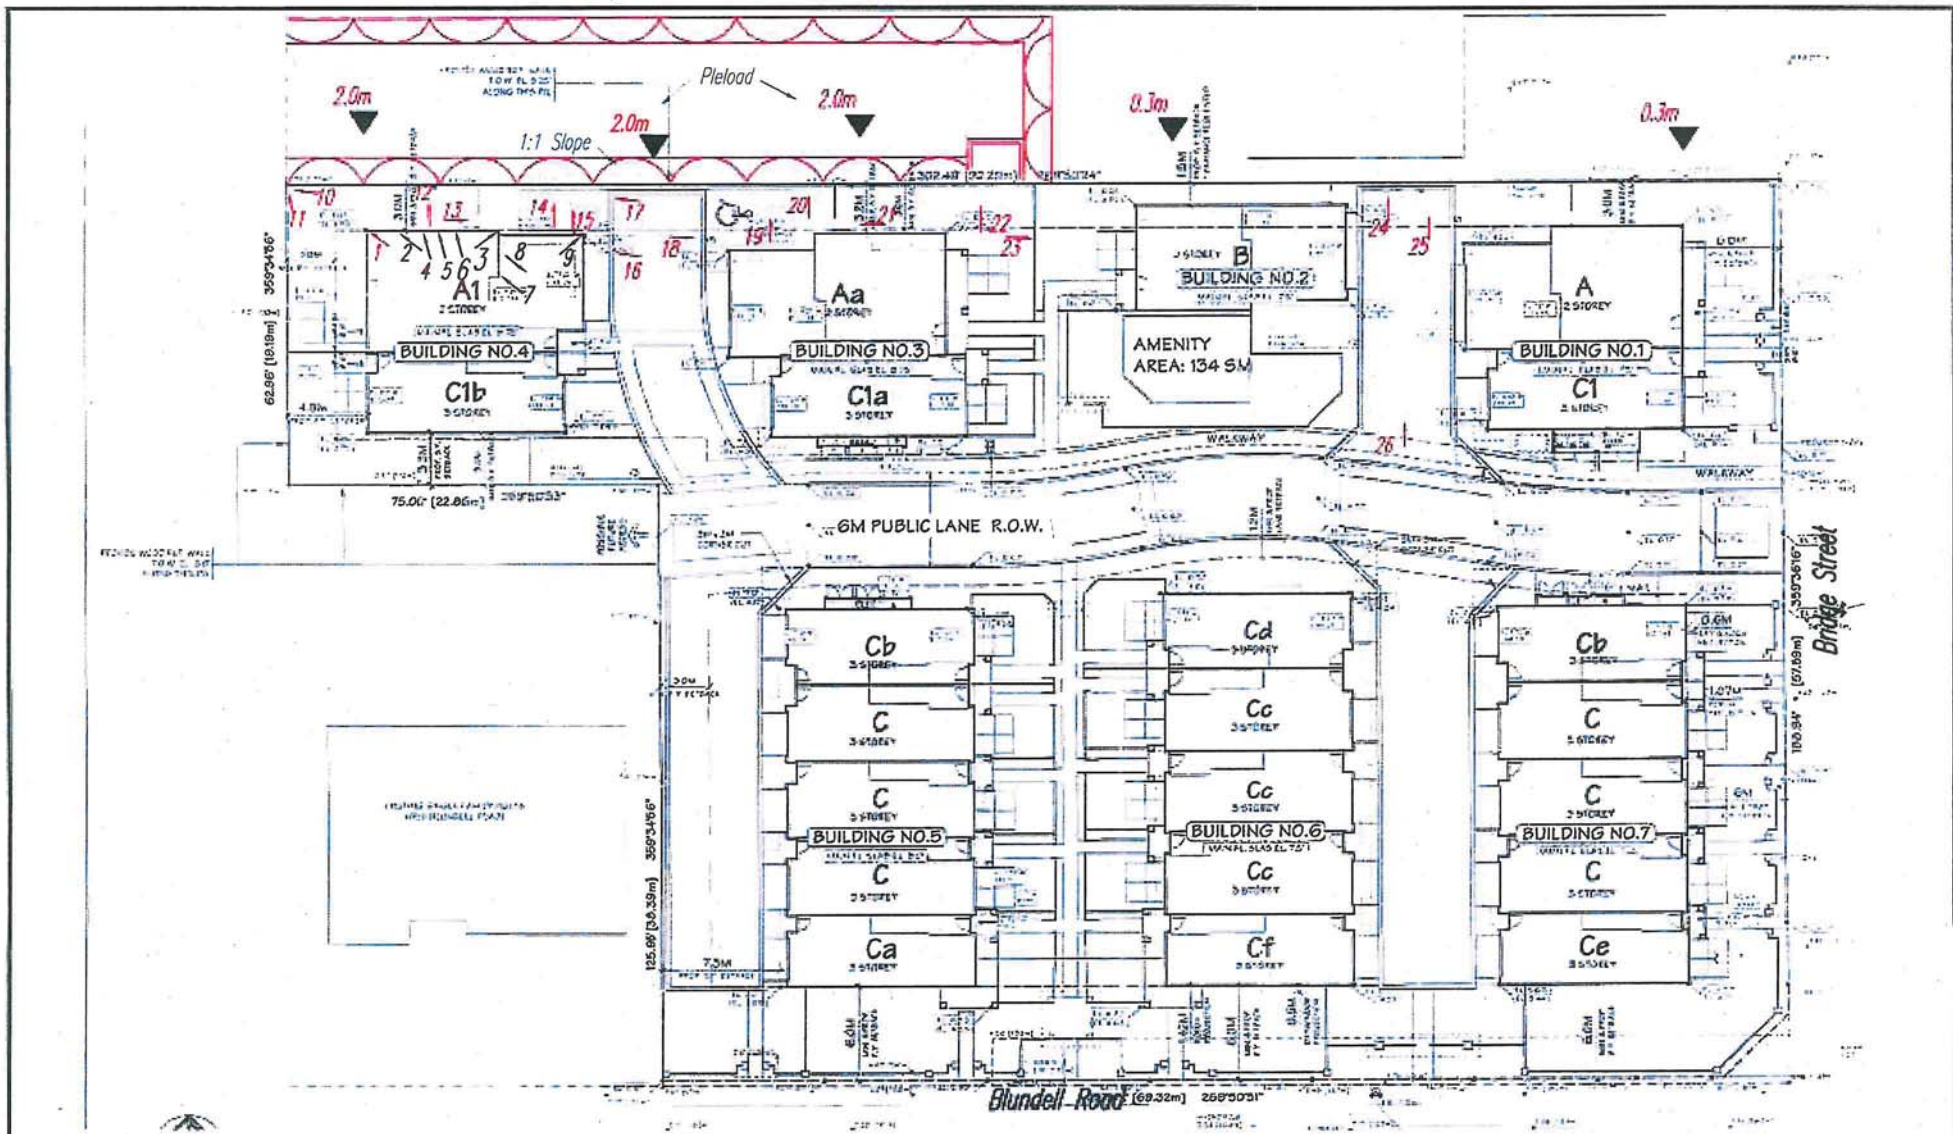
At the time of our site review, the preload consisted of a combination of sloped and lock block retained sand fill placed to heights ranging from 0.3m to 2.5m above grade, based on visual observation. The sloped boundaries of the preload fill extended directly against the Newbury Complex's northern property line. In May of 2012, residents of the Newbury Complex noticed ground settlements and resulting damage to both interior and exterior structures, and roads within approximately 6.0m of the northern property line. The most significant of which were located within 1.0m to 3.0m of the preload boundary. Furthermore, settlements were most prevalent around units 4 and 6, where the adjacent preload was the highest.

Approximate preload location and dimensions at the time of our review is provided on drawing 10792-01, following this report.

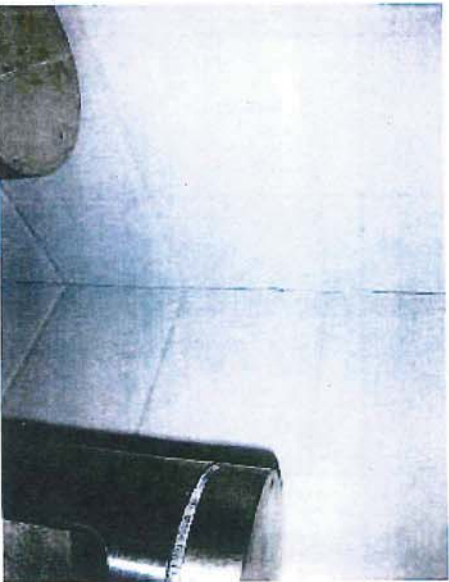
Photo No.01

Damage to the interior of unit 6 was noted on the north wall of the first floor. Damage consisted of minor hairline cracks in wall paint (photos 1, 3, & 9), separation of floorboards and cabinets from floors and walls respectively (photos 2, 4, 5, & 6), and propagation of existing shrinkage cracks in the garage floor slab (photos 7 & 8). In general, cracks ranged from less than 1mm to 3mm in aperture.

| Number | Location | Description of Damage |
|---|---|---|
| 1 | Unit 6 interior-kitchen | Cracks in wall tile (<1mm) |

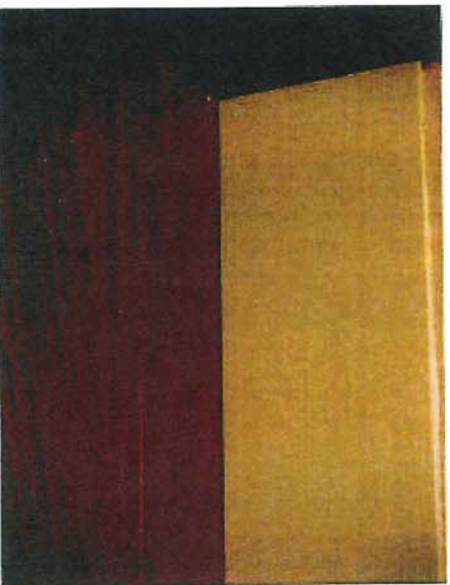
Photo No.05

| Number | Location | Description of Damage |
|---|---|---|
| 5 | Unit 6 interior- dining room | Separation of floor board from floor (<2mm) |

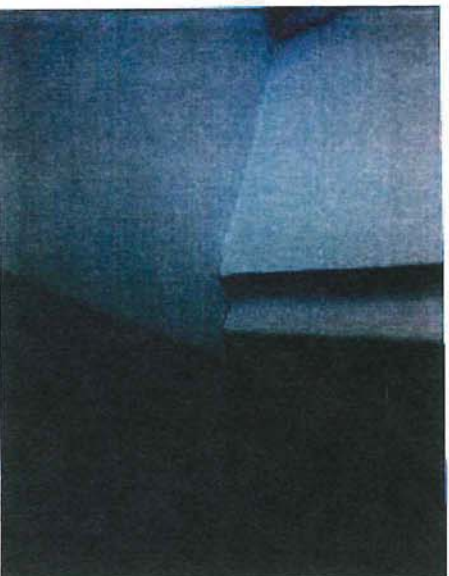
Photo No.06

| Number | Location | Description of Damage |
|---|---|---|
| 6 | Unit 6 interior- dining room | Window sill crack (<1mm) |

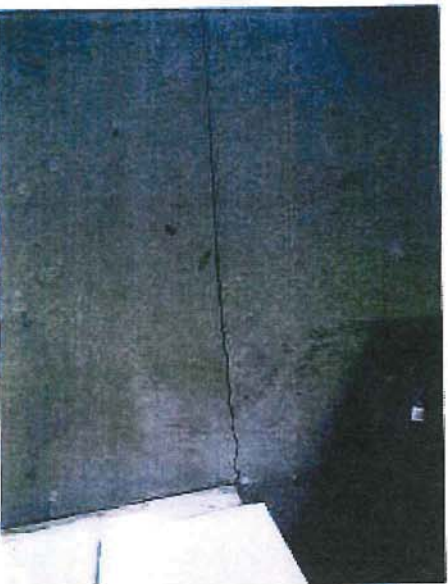
Photo No.07

| Number | Location | Description of Damage |
|---|---|---|
| 7 | Unit 6 interior- garage | Cracks in slab-on-grade (<5mm) |

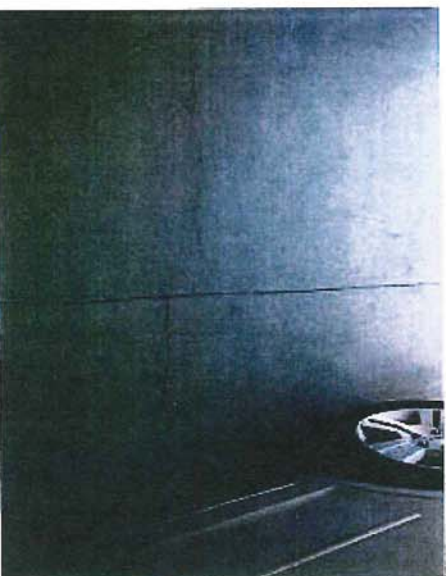
Photo No.08

| Number | Location | Description of Damage |
|---|---|---|
| 8 | Unit 6 interior- garage | Cracks in slab-on-grade (<5mm) |

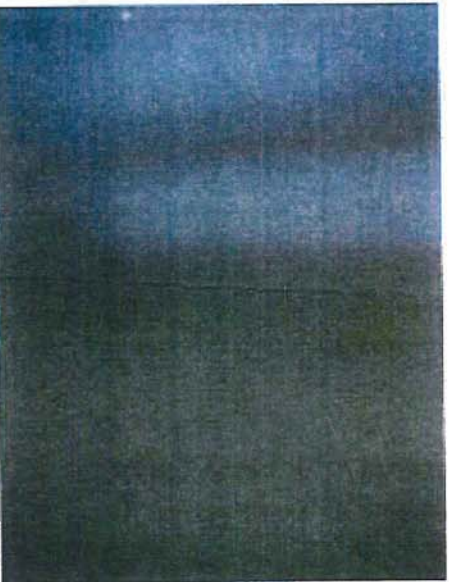
Photo No.09

| 9 | Unit 6 interior- garage | Crack in wall paint (<1mm) |

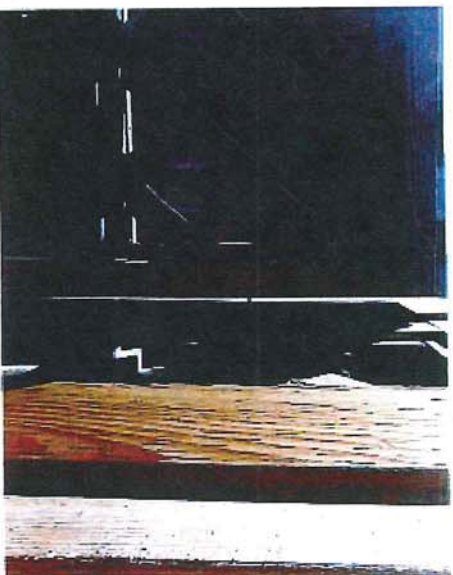
Photo No.10

Considerable ground movements and resulting impacts on serviceability of exterior structures were noticed along the north sides of units 1, 4, and 6. These included separations of fence sections up to 20mm wide (photos 10 & 11), movements of fence gates up to 55mm (photos 13, 21, & 23), stress cracks in soil up to 25mm wide running parallel to and at a distance of approximately 1.0m from the preload boundary (photos 12, 14, & 22), separation of paving bricks up to 30mm (photos 14 to 20, & 26), and settlements (<30mm) and cracks (<15mm) in concrete curbs (photos 16, 17, 18, & 25)

| 10 | Unit 6 exterior | Fence section separation (<20mm) |

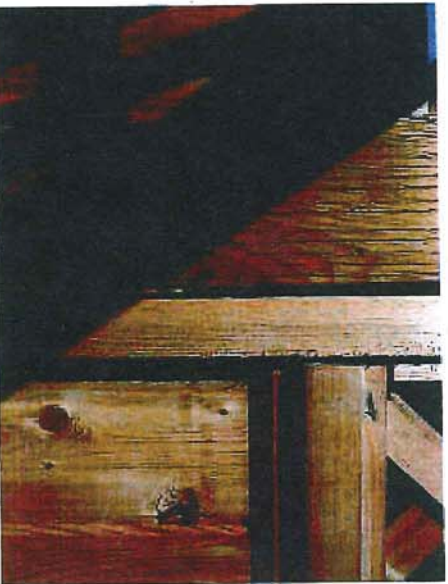
Photo No.11

| 11 | Unit 6 exterior | Fence section separation (<20mm) |

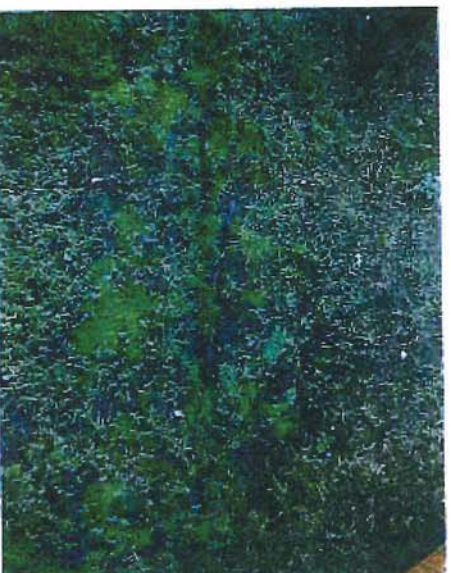
Photo No.12

| 12 | Unit 6 exterior | Soil stress crack (<25mm) |

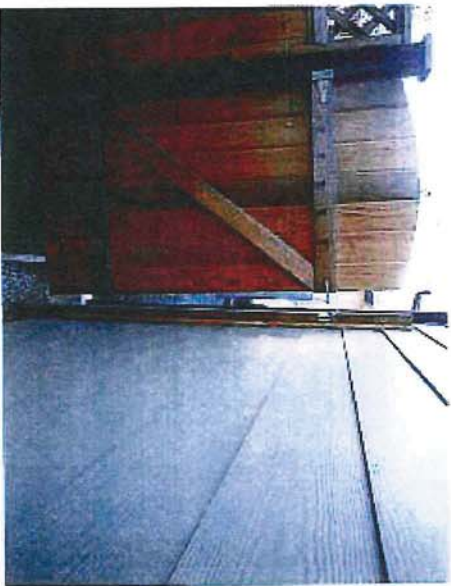
Photo No.13

| 13 | Unit 6 exterior | Movement of fence door (<55mm) |

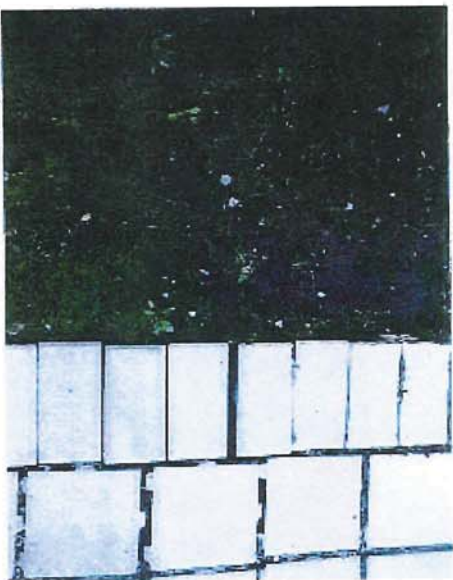
Photo No.14

| 14 | Unit 6 exterior | Soil crack and paving stone separation (<30mm) |

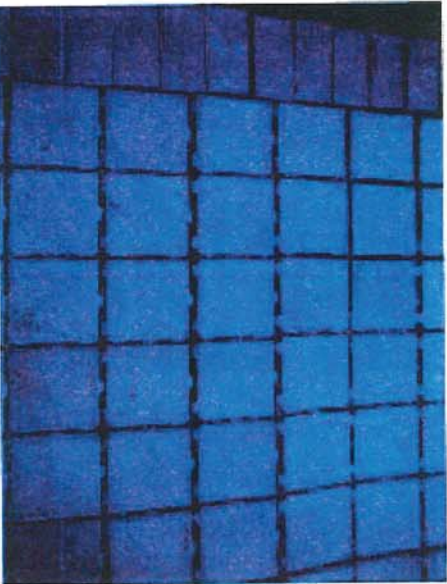
Photo No.15

| 15 | Unit 6 exterior | Paving stone separation (<30mm) |

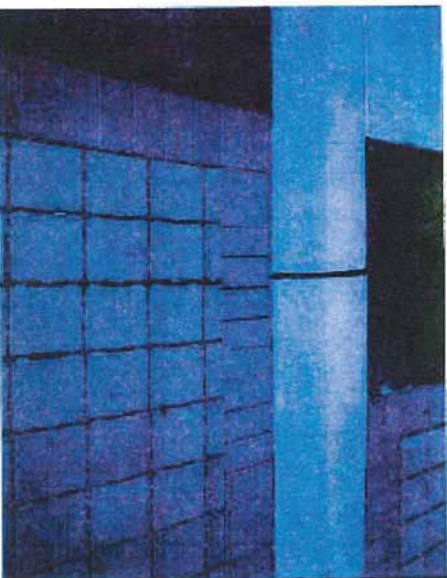
Photo No.16

| 16 | Unit 6 exterior | Paving stone separation and curb settlement (<30mm) |

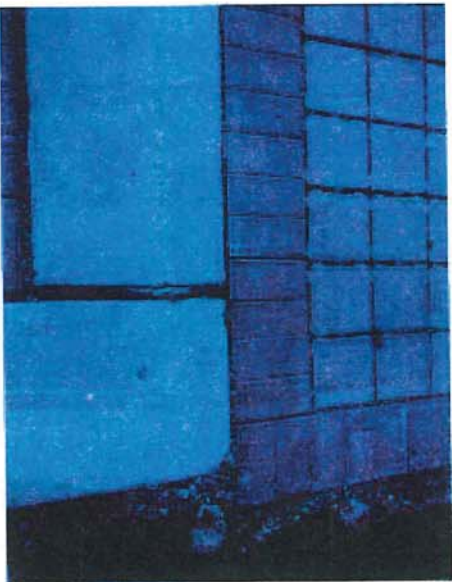
Photo No.17

| 17 | Unit 6 exterior | Curb settlement (<30mm) |

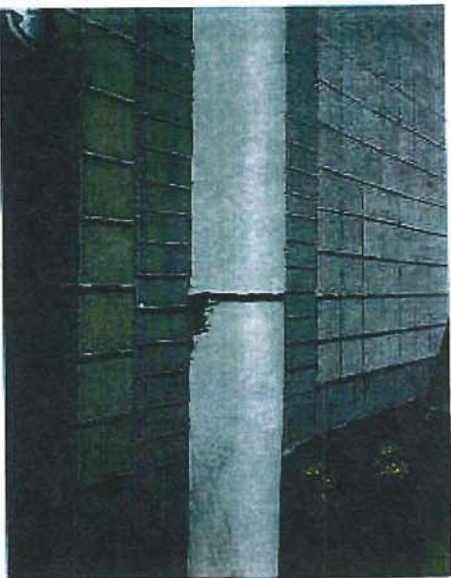
Photo No.18

| 18 | Unit 4 exterior | Paving stone separation and curb settlement (<30mm) |

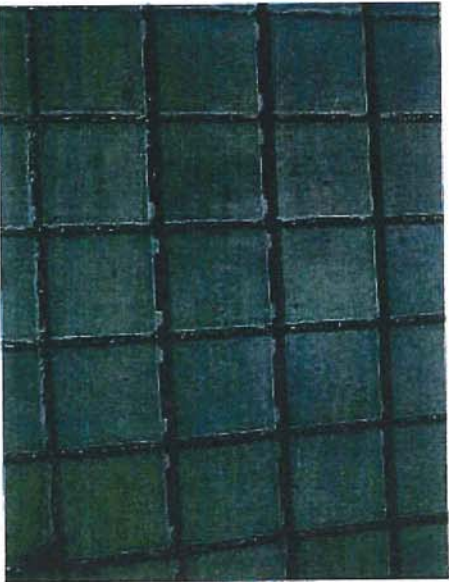
Photo No.19

| 19 | Unit 4 exterior | Paving stone separation (<30mm) |

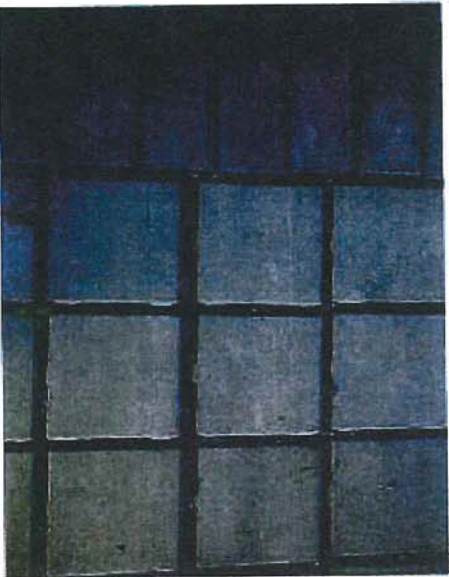
Photo No.20

| 20 | Unit 4 exterior | Paving stone separation (<30mm) |

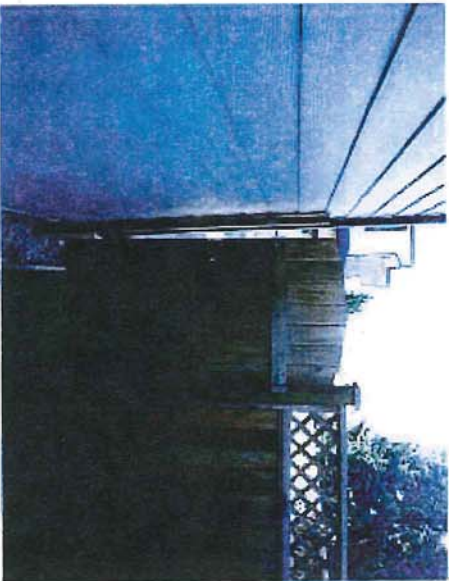
Photo No.21

| 21 | Unit 4 exterior | Movement of fence door (<30mm) |

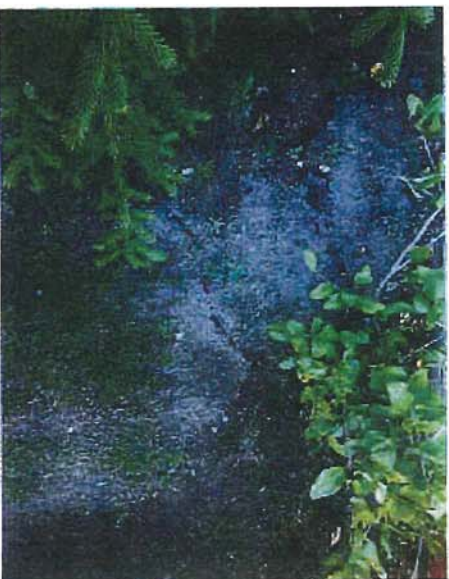
Photo No.22

| 22 | Unit 4 exterior | Soil stress crack (<20mm) |

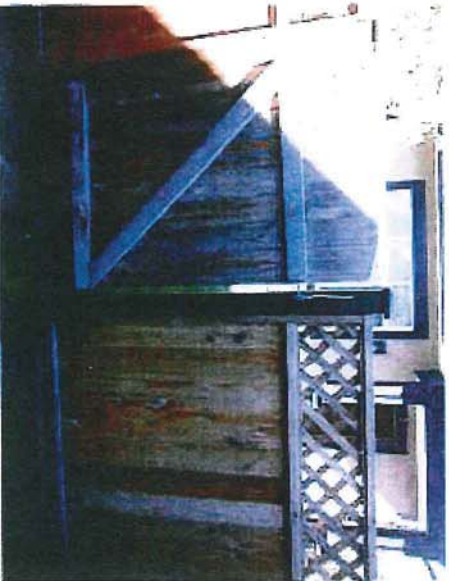
Photo No.23

| 23 | Unit 4 exterior | Movement of fence door (<10mm) |

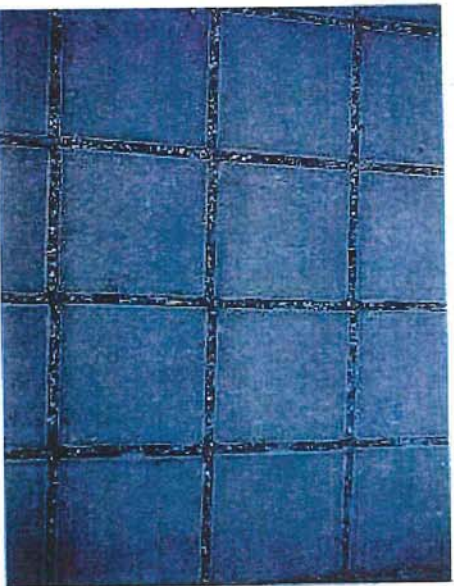
Photo No.25

| 25 | Unit 1 exterior | Example of non-damaged paving brick |

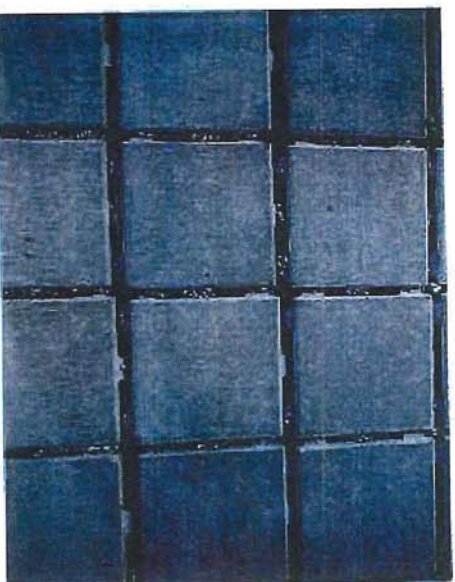
Photo No.26

| 26 | Unit 1 exterior | Paving stone separation (<20mm) |
