To: General Purposes Committee
From: Carli Williams, P.Eng.
Manager, Business Licence and Bylaws
Jason Ho, P.Eng.
Manager, Engineering Planning
Date: January 13, 2020
File: 12-8080-12-01/Vol 01
Re: **Non-Farm Use Soil Deposit Proposal for the Property Located at 21700 River Road**

The owners of the property located at 21700 River Rd, Richmond, BC have requested permission to import soil to improve their land for crop production.

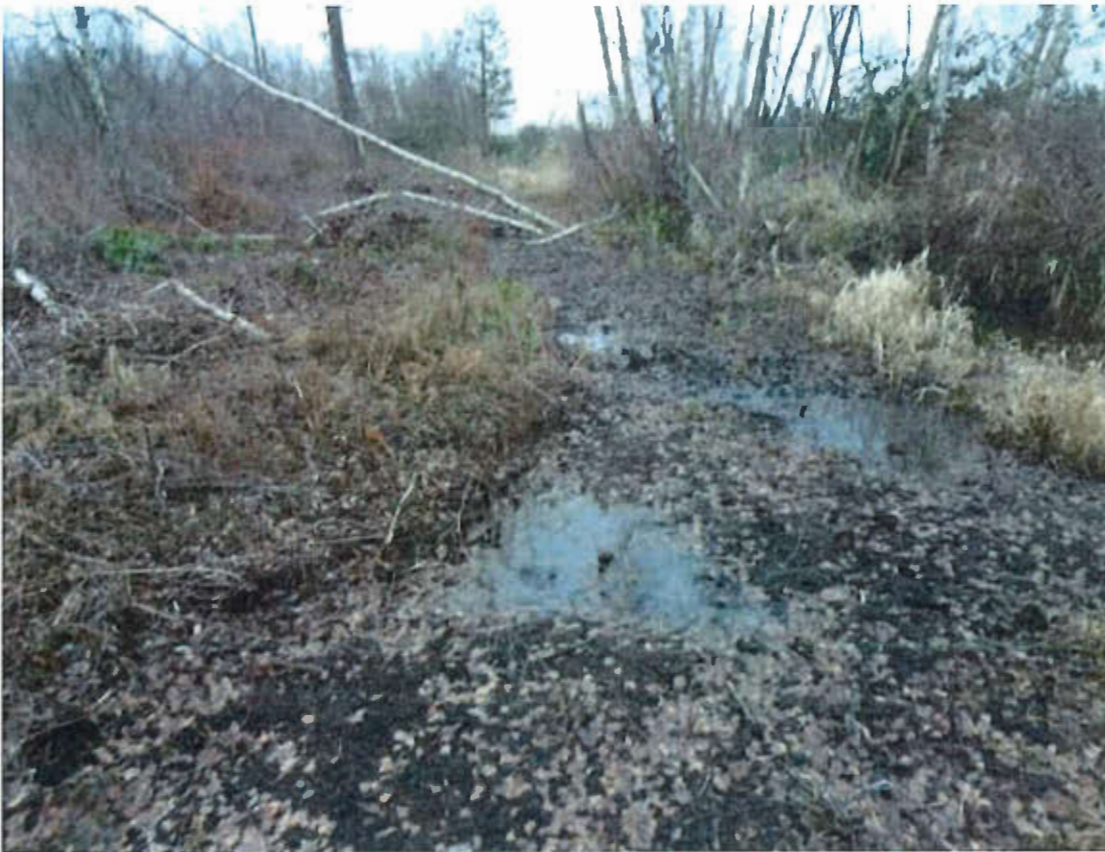
Figure 1. Photo of the southern portion of the property (Jan 8, 2019)

After failed attempts to establish a berry crop, the soil is populated with grasses, shrubs and some deciduous trees common to poorly drained soils.

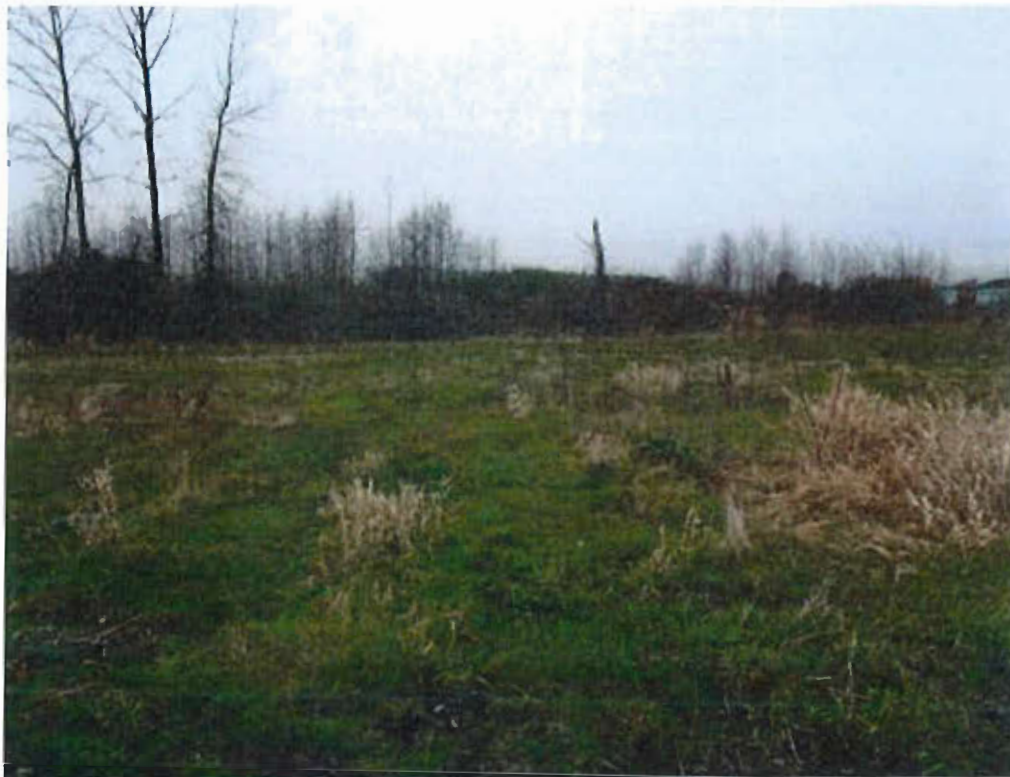
Figure 15. Area in the northwest quadrant where some soil had already been deposited.

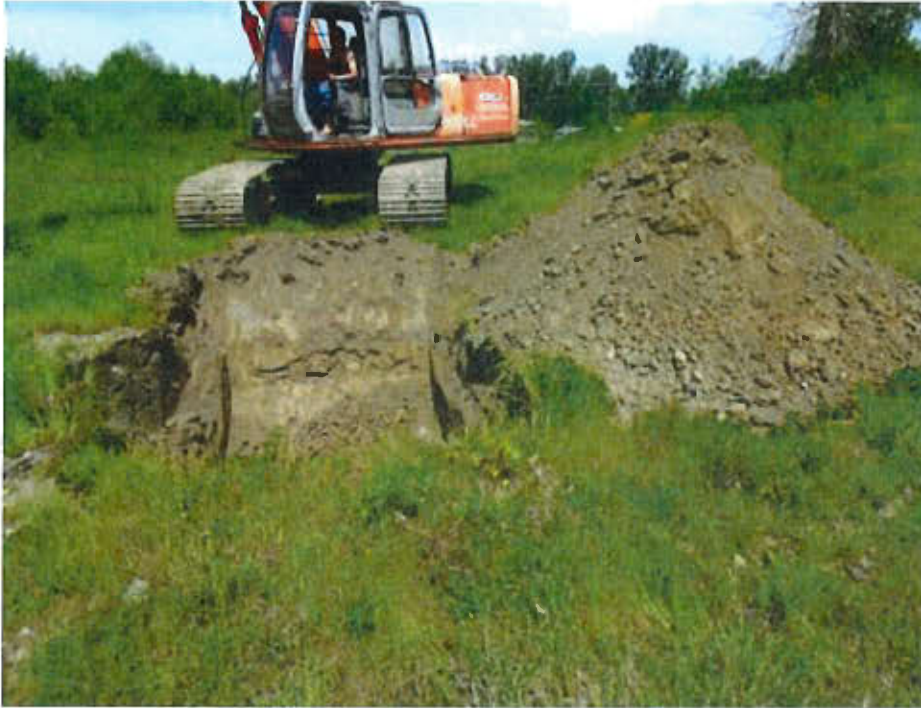
Figure 20. Inspection of the imported soil in Hole # 3 did not reveal any contamination.

The fill that had already been imported as observed in Pit # 3 was clean and free of debris.

We recommend ongoing inspection of the fill that was already imported to ensure that it is all clean and free of debris.
