**CITY OF RICHMOND**

**REPORT TO COMMITTEE**

**RE:** Approval for Additional Ageing Sewer Pipe Assessment Work

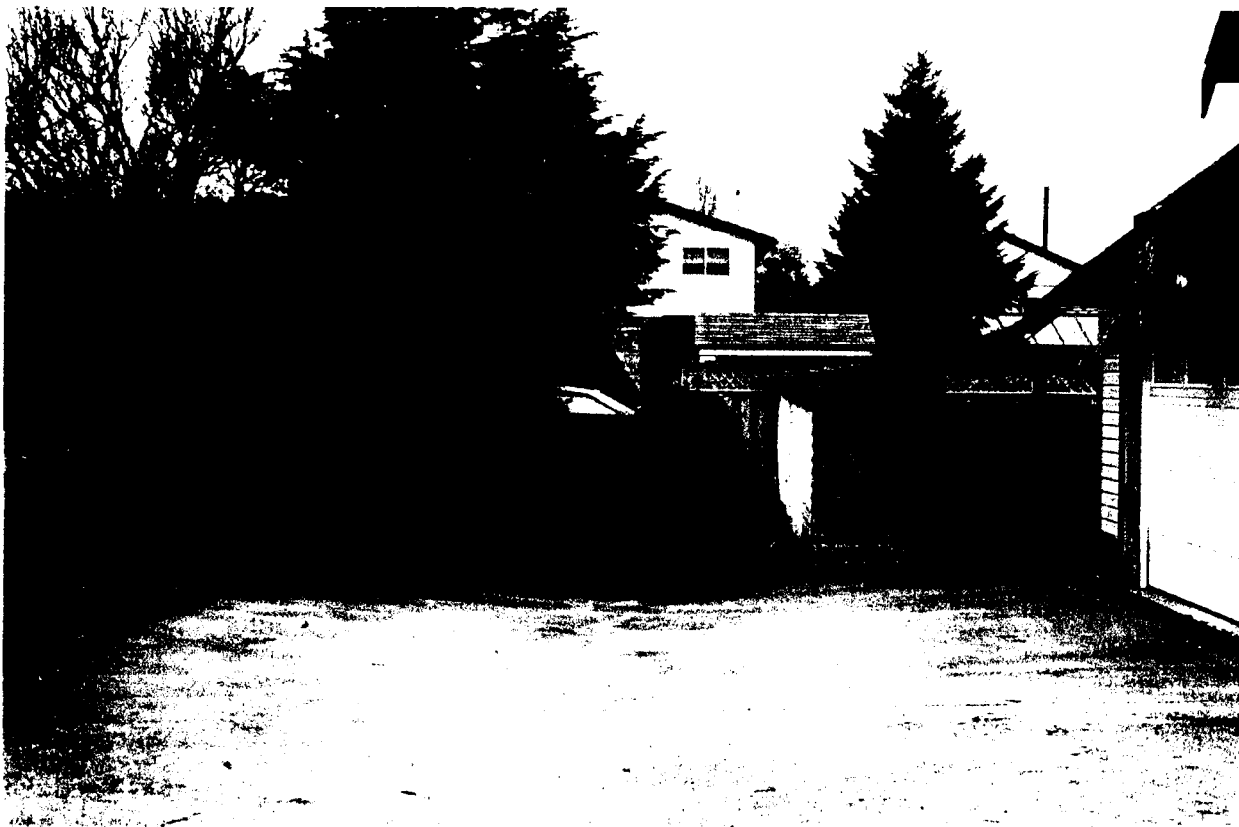
Existing structures built along right-of-way above sewer which was repaired using liner pipe installed by trenchless technology.

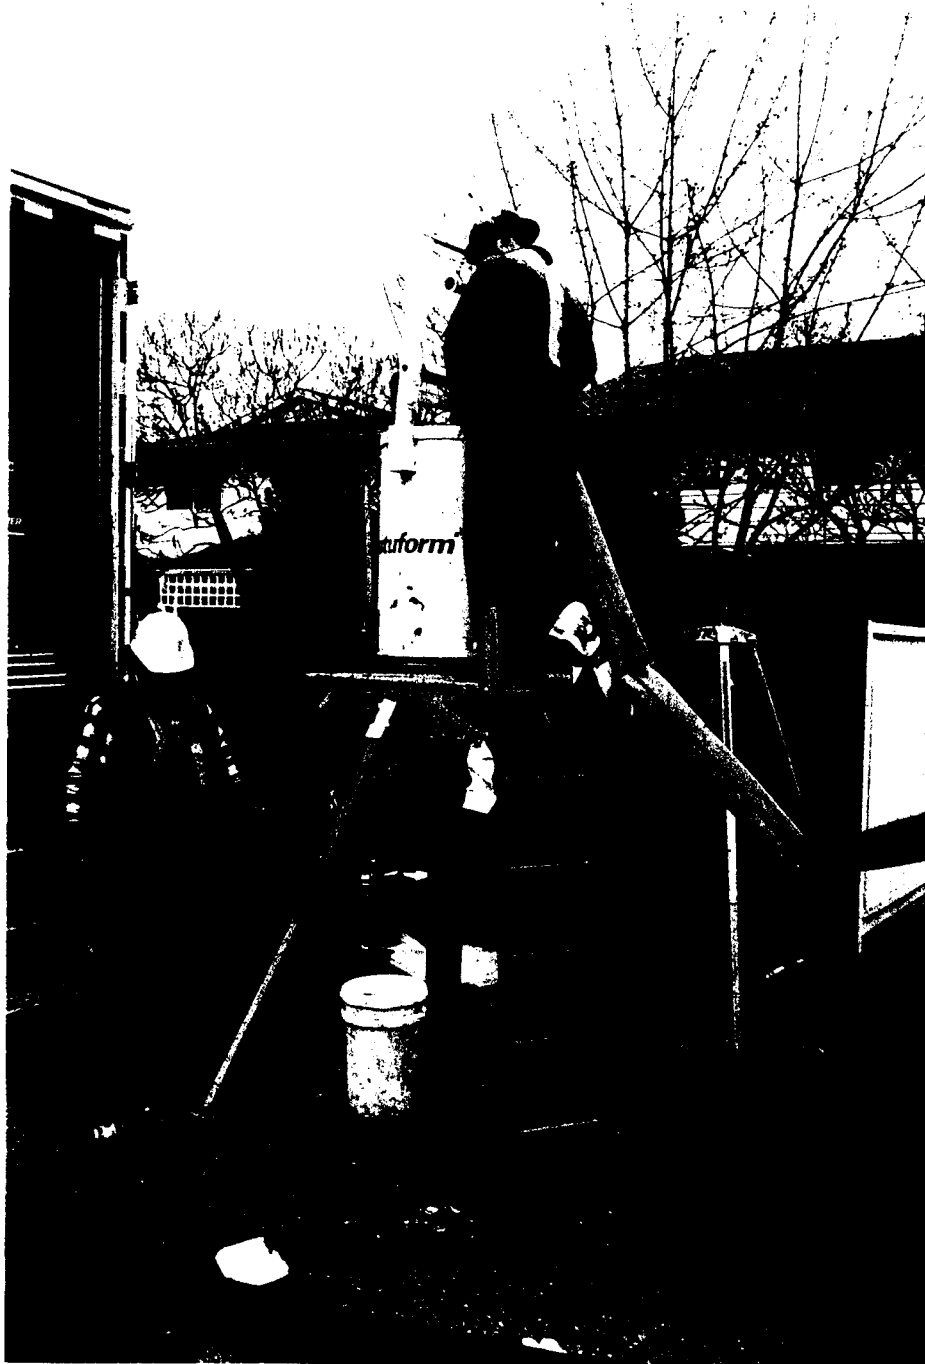
Installation of new sewer pipe lining via manhole.

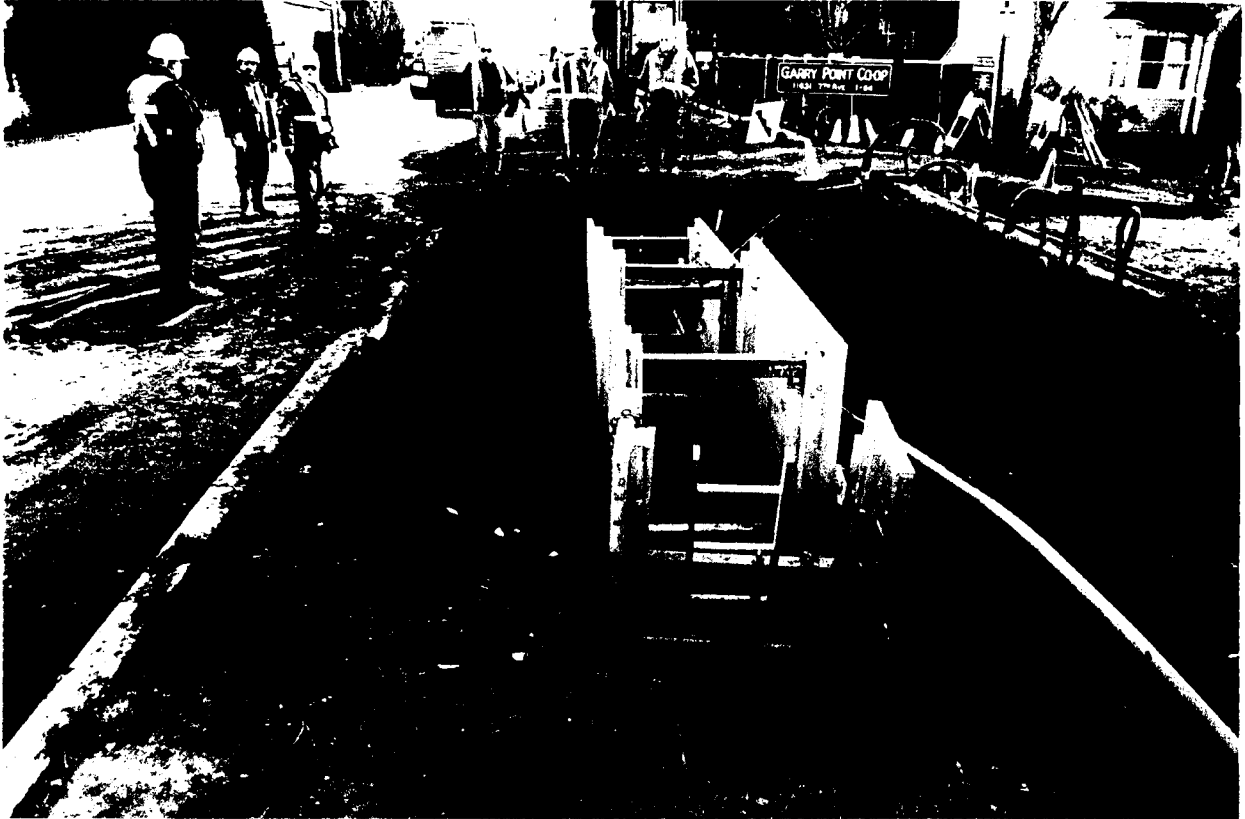
Conventional open cut sewer point repair.
