# City of Richmond

## Report to Committee

**To:** General Purposes Committee **Date:** October 5, 2021  
**From:** Mark Corrado **File:** 12-8080-12-01/Vol 01  
 Manager, Community Safety Policy and Programs  
**Re:** **Soil Use for the Placement of Fill Application for the Property PID: 005-480-663 (17260 Block of River Road - Sahota)**

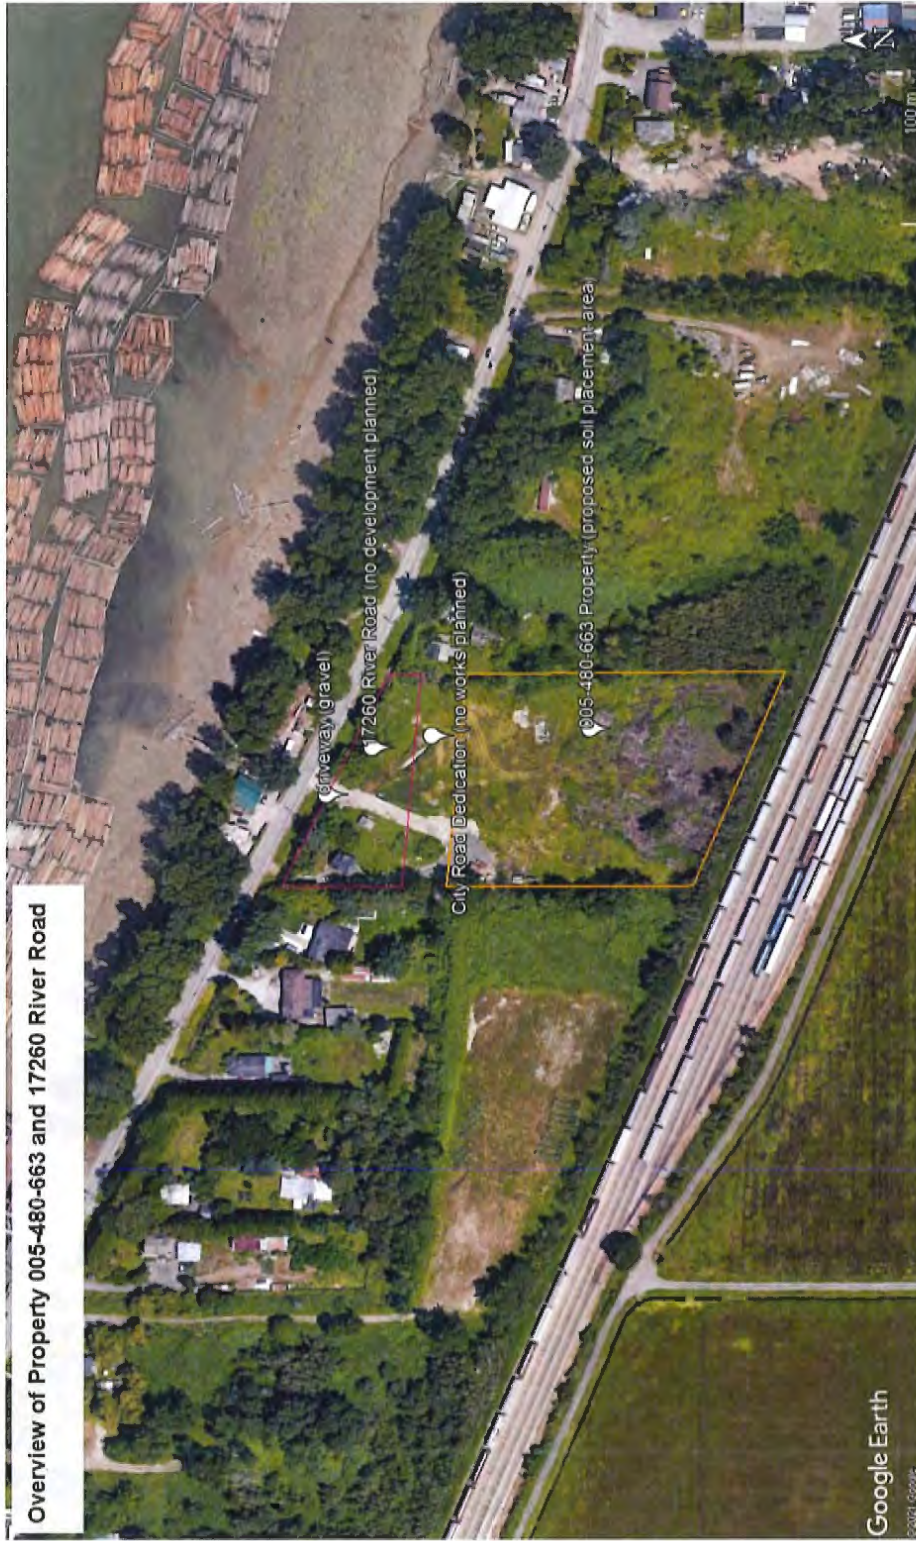
FIGURE 1: OVERVIEW OF THE PROPERTY (ORANGE OUTLINE) AND 17260 RIVER ROAD (PINK OUTLINE). THE RIGHT-OF-WAY FEATURE SEPARATING THE LOTS IS INDICATED (NOT PART OF EITHER PROPERTY). THE PARCEL BOUNDARIES ARE FROM IMAPBC, WHICH IS A PROVINCIAL GEODATABASE.

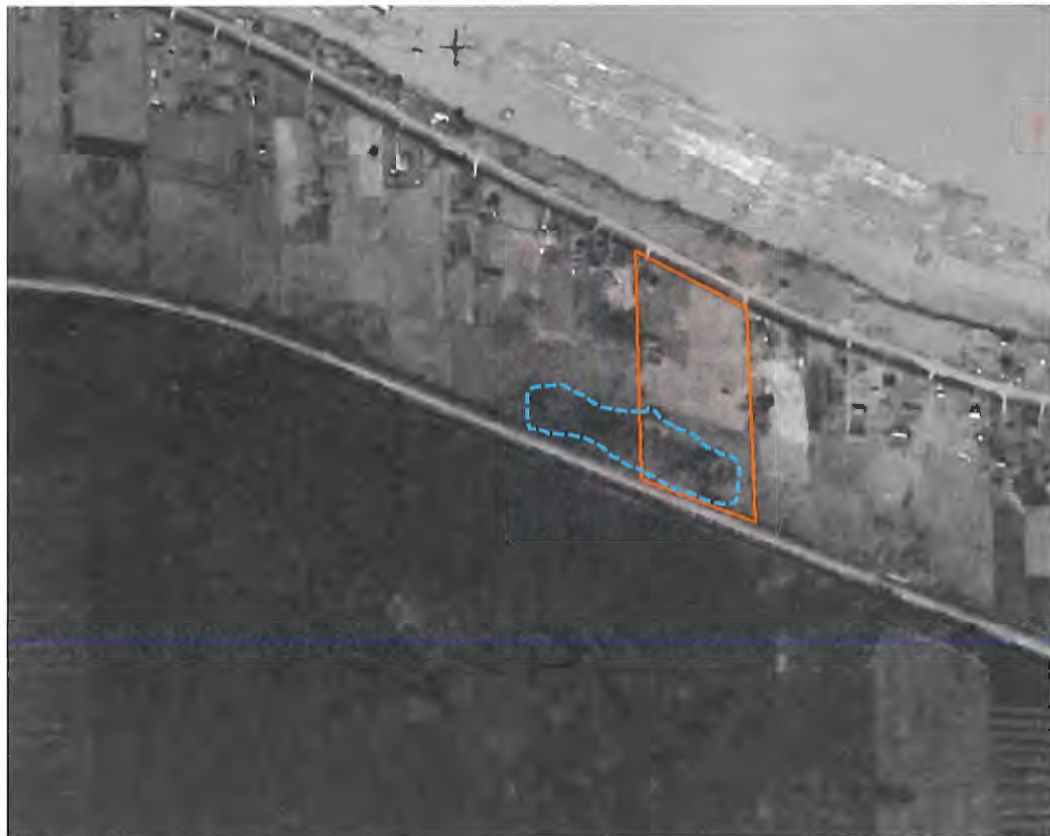
**PHOTO 1: AIRPHOTO FROM 1951 OF THE SUBJECT PROPERTY (INCLUDING 17260 RIVER ROAD).**

There is a body of standing water along the southern property line of the proposed placement area. This merges with water to the west. This is a peat bog that formerly merged with the peat bog to the south. The peat bog to the south of the railway is undeveloped (there are farms on the perimeter of No. 7 (west) and No. 8 (east) Roads. The 17260 river road property and the right-of-way appears to be a pasture (forage, hay crop).

In the 1951 airphotos, I observed what observed to be a connected waterbody (ponded water) between the Property and the neighbouring property to the west. This connectivity no longer exists – the west property was filled with soil sometime after 1991 and by 1997. Essentially, the property was cut off from the larger bog to the south by the construction of the CN railway.

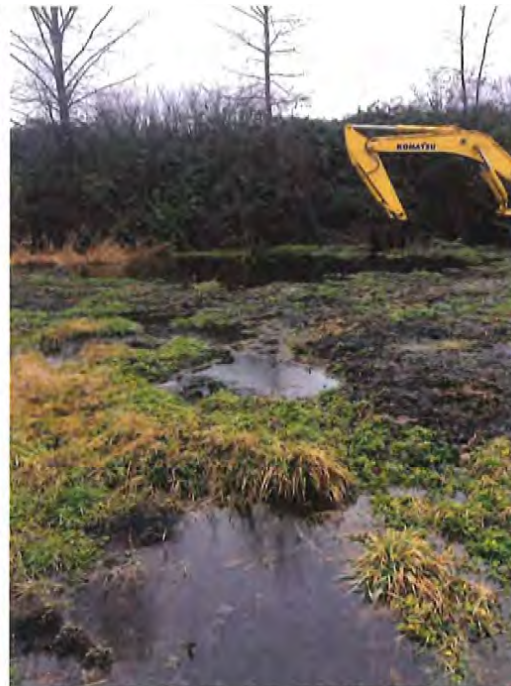
**PHOTO 5: FACING DUE WEST ON THE PROPERTY. THIS STANDING WATER IS OVER 0.3 M DEEP.**

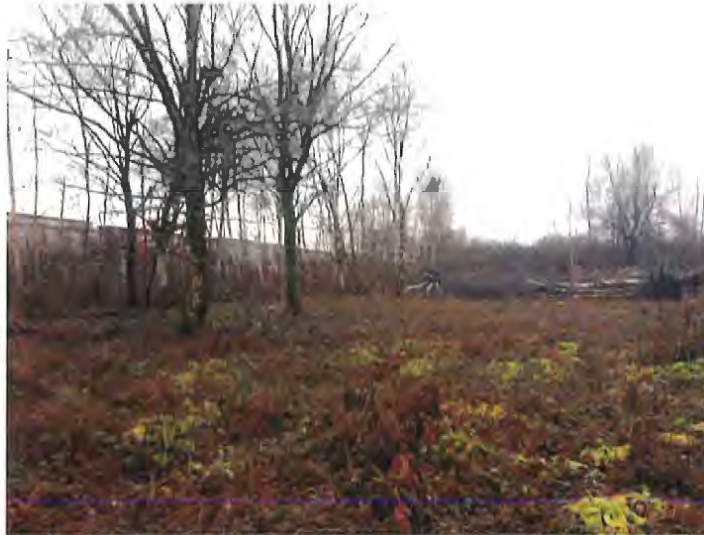
**PHOTO 6: LOOKING ACROSS THE SOUTHERN END OF THE PROPERTY, FACING WEST. THE TREES ON THE LEFT SIDE OF THE PHOTO REMAIN ON SITE (PAPER BIRCH). THE TRAINS ON THE LEFT ARE ON THE CN RAILWAY.**

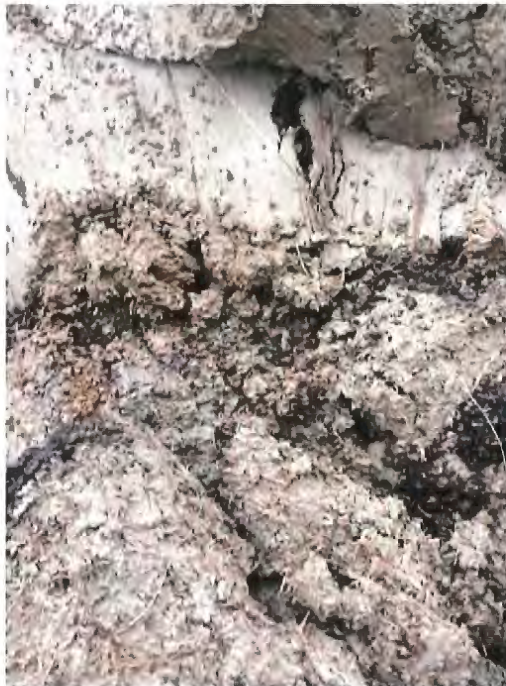
**PHOTO 7: SILT LOAM (LESS COMMONLY, SILTY CLAY LOAM) FOUND IN THE Cg HORIZON. NOTE DECOMPOSED PLANT MATERIAL PRESENT IN THIS SAMPLE.**

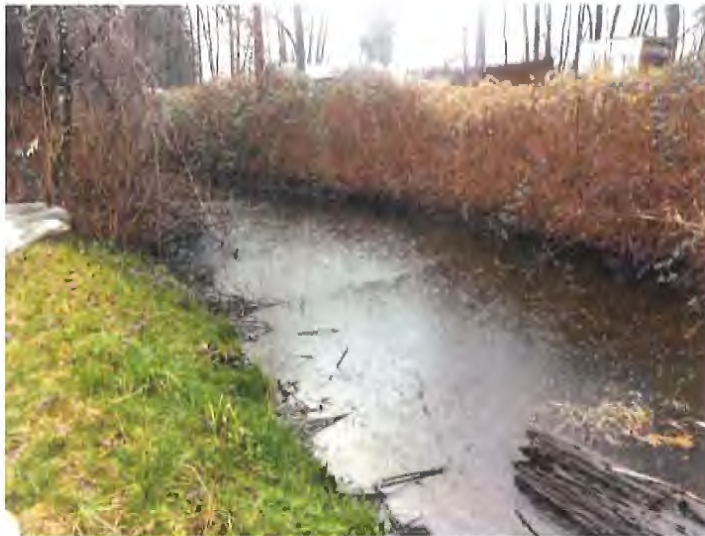
**PHOTO 11: DITCH LOCATED AT 17260 RIVER ROAD - NOTE WATER LEVELS ARE QUITE HIGH. THIS PHOTO WAS TAKEN JANUARY 7, 2020**

There is a ditch along the northern property line of 17260 River Road. The water levels in this ditch were observed to be quite high. Connecting perforated pipes to this ditch from the Property would require piping the water between 40 (from northeast corner to River Road ditch) and 180 m (southeast corner to River Road ditch).

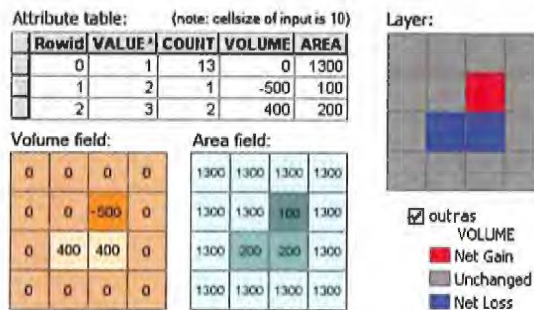
**DRAWING 1: THIS IS AN ILLUSTRATION OF WHAT THE CUT FILL TOOL LOOKS LIKE IN ARCGIS. IN THIS METHOD, ALL AREAS IMPORTED AS THE SURFACE AREA GAINING SOIL TO REACH A FINAL ELEVATION. THE FINAL VOLUME CAN BE CALCULATED FROM THE ATTRIBUTE TABLE FROM:**

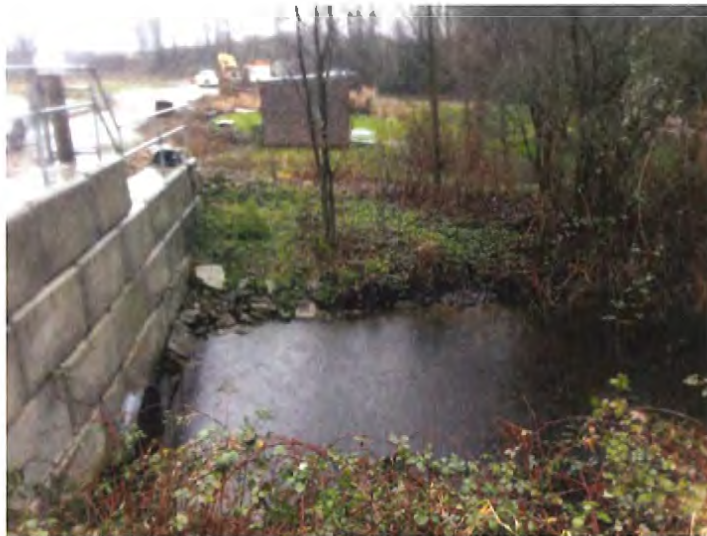
**PHOTO 12: LOOKING DUE SOUTH ACROSS THE ENTRANCE OF 17260 RIVER ROAD. THE SOIL PLACEMENT AREA IS LOCATED IN THE TOP LEFT CORNER OF THE PHOTO. THIS CROSSING WAS UPGRADED IN 2019 - THE OLD CROSSING WAS SITUATED TO THE RIGHT OF THIS PHOTO.**

There is a ditch situated on the south side of River Road (therefore, along the northern property line of the 17260 River Road property). This ditch is treated as a watercourse and riparian management area (RMA) by the City of Richmond. There is a 15 m riparian area regulation (RAR) setback established by the CoR. **As the 17260 River Road lot will not be developed, the setback will not be infringed by the proposed soil placement.** The crossing over this ditch has been upgraded by Mr. Sahota, as seen in the photo below.

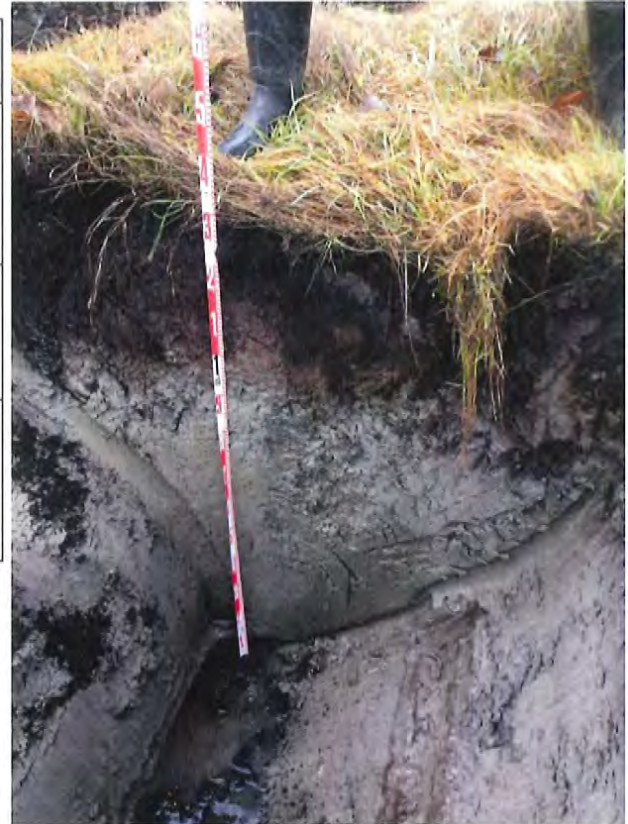
Horizon	Depth (cm)	Description
Op	0 - 35	Dark, reddish brown to black, humic (von Post class 7), plentiful fine roots. Cultivated (p) in the past. Wavy, uneven contact with Cg1 horizon (as seen in photo)
Cg1	35 - 70	Light blue-grey, silt loam, firm, moist, no roots, no coarse fragments. Common, medium prominent orange mottles.
Cg2	70 - 130+	Light blue-grey, silty clay loam, firm, no roots, no coarse fragments. Many, prominent, medium orange mottles. Increased mottling with depth.

- Located in the centre-north property boundary.
- Water encountered at bottom and sides of pit (seeping in quickly) - 1.3 m deep.
- Soil classification: Rego Gleysol

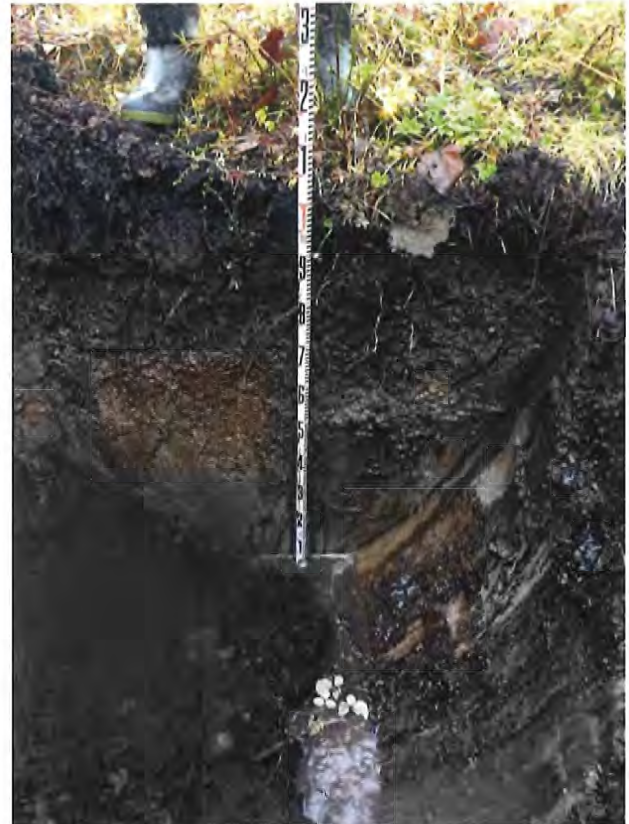
Horizon	Depth (cm)	Description
Oh	0 - 40	Dark brown to black, humic (von Post class 7 to 8), plentiful fine roots. Does not appear to have been cultivated – formerly an upland forest bog area. Very wet.
Cg	40 - 110+	Grey, silt loam, firm, no roots, no coarse fragments. Many, prominent, medium orange mottles. Decomposed plant material (woody plant, sedges etc). Wet.

- Located in the southwest corner of the property – this area was forested until 2019. Surrounding land is wet – ponded water over 0.3 m deep throughout.
- Excavated an area without ponded water but encountered water table at 1.1 m deep. Filled with water during assessment but did not completely fill.
- Soil classification: Rego Gleysol

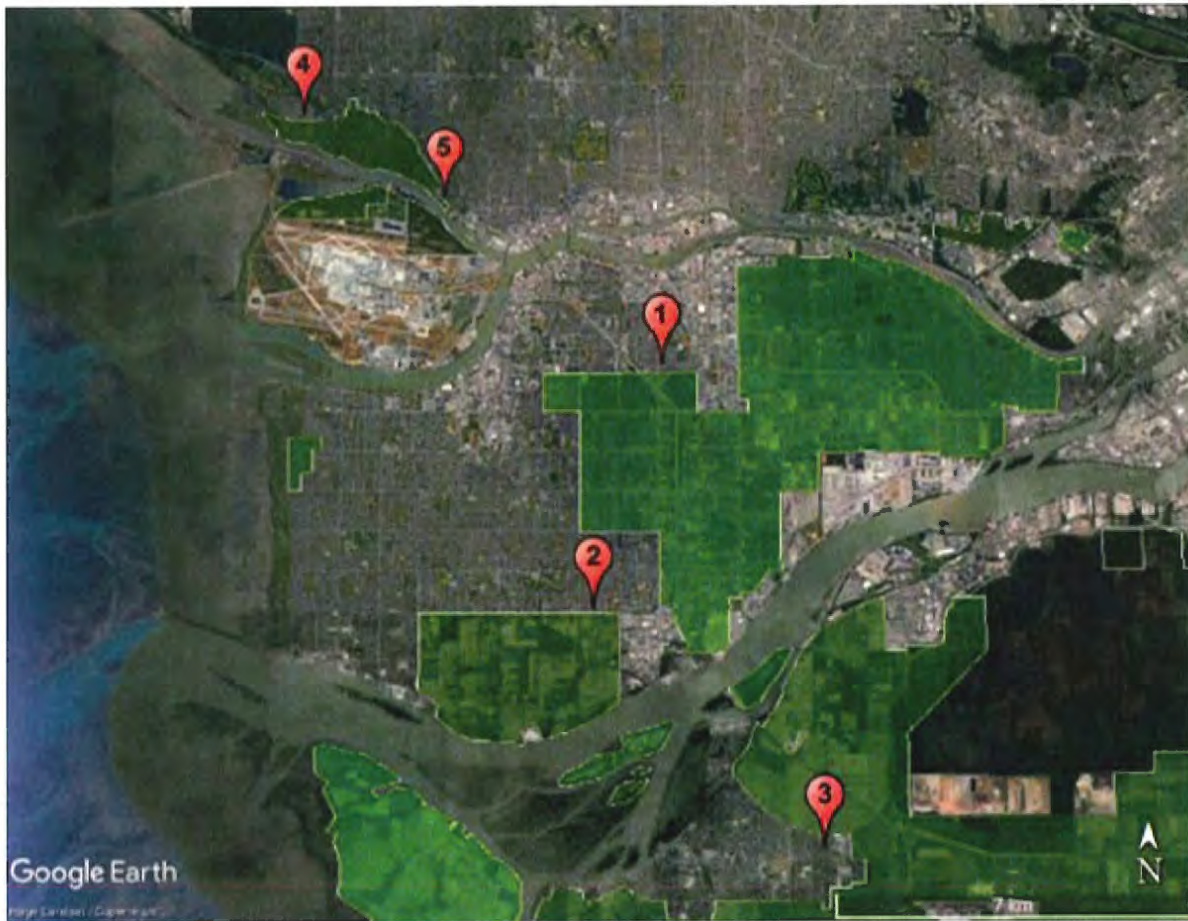
**FIGURE 1. RECOMMENDED LOCATIONS TO SOURCE SOIL FOR IMPORTATION TO PID 005-480-663, RICHMOND, BC. SHADED POLYGONS SHOWS THE LOCATIONS OF THE PROVINCIAL AGRICULTURAL LAND RESERVE (ALR). IMAGERY PROVIDED BY GOOGLE EARTH; DATED 2021.**

In addition to the aforesaid reports, the Agrologists have provided a memorandum (Attachment 3) identifying areas within the Lower Mainland in which the agriculturally-suitable soil may be sourced. As per the memorandum, the Agrologists have identified that agriculturally-suitable soil required to complete the proposal may be sourced from Richmond (first priority of the Applicant), Delta, South Vancouver, South Burnaby, and the UBC Endowment Lands. Analysis to determine suitable source locations was undertaken by the Agrologists utilizing the BC Soil Information Tool which provides access to soil survey data, reports and maps and is hosted by the provincial government.
