City of Richmond

Report to Committee

Re: **Heritage Alteration Permit Application (HA 24-012449) by the City of Richmond - 5180 Westwater Drive (Britannia Shipyard and Seine Net Loft buildings)**

The City of Richmond is applying for a HAP (HA 24-012449) for structural and envelope renewals to the Britannia Shipyard and Seine Net Loft buildings. This HAP application includes roof replacement, siding replacement and repairs, window renewals and structural upgrades. These repairs are needed to preserve the buildings and maintain structural integrity.

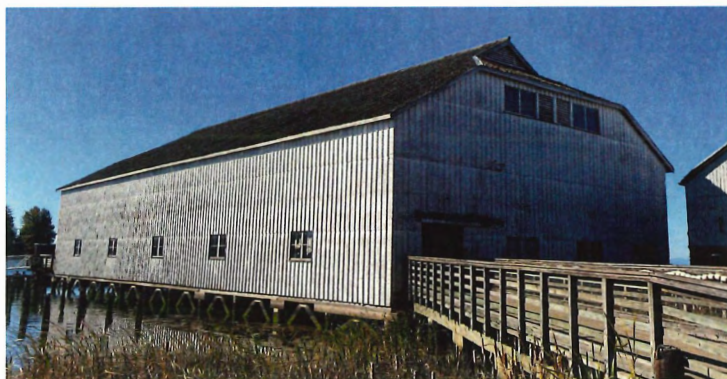
Current view of front and east sides of the Seine Net Loft building. The east perimeter wood piles (and their 2017 added supports) are the only truly visible section of piles on the entire building.

The April 30, 2024 CWMM Consulting Engineers structural assessment of the Seine Net Loft wood piles system under the building, concluded that the majority of the piles will need replacement or major reinforcement.

The visibility of the majority of these piles is very low. The piles below the centre of the building are not visible at all, nor are the perimeter piles on the south and west elevations. Some partial views of piles can be obtained from the front (northern) elevation but the piles at this elevation are also poorly visible. For this reason, hefty reinforcement that alters the look or shape of the original/early cylinder- shaped piles is acceptable in all locations except for the furthest east row of piles which are most visible to the public. These have already been reinforced in 2017 so perhaps less intervention is needed here. Or perhaps this single row of piles could be replaced with new wood cylindrical piles, which replicate the original.

In any case, the proposed reinforcement strategy as illustrated in section x of the preliminary structural plan is acceptable anywhere but at this single eastern row of piles. At the eastern elevation, such significant alteration to the pile form would obscure the original 1954 structural design which we are aiming to conserve.

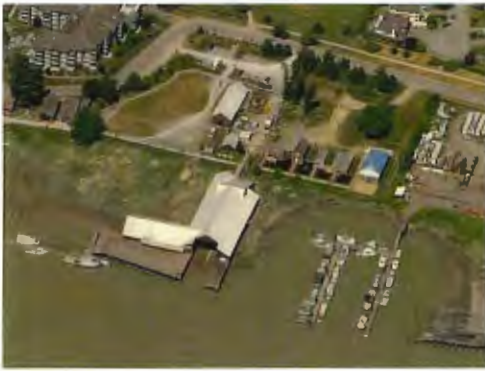
1. Character-Defining Elements	2. Images	3. Heritage Value
<p>Site and setting:</p> <ul style="list-style-type: none"> • Location on pilings extending into the Fraser River • Landmark on the Steveston waterfront • Surrounding Fraser River foreshore environment • Relationship and bridge connection to boardwalk and bulkhead • Still-existing wooden pilings adjacent to the cannery building • Wharves, docks and walkways associated to the cannery building • Views of the Fraser River and foreshore

<p>Retains the connection to the early maritime history of the area.</p>
<p>Building:</p> <ul style="list-style-type: none"> • Part of original cannery/shipyard building cluster pattern • Wood building construction on wooden piling foundation • L-shaped plan and prominent massing • Opening on the south facade to allow the passage of boats • Gable roof including a cross-gable portion at the north side of the building and modified gable roof at the south side

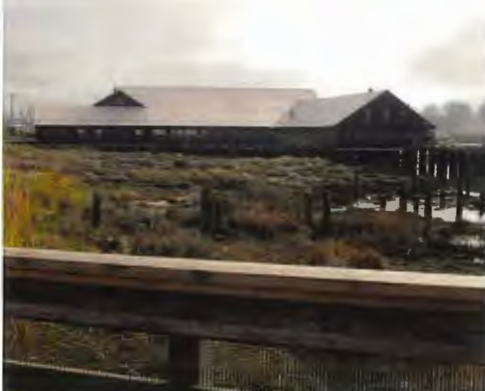
<p>The gabled roof and wooden elements of the Britannia Shipyard reflect the traditional building style and materials utilized in the area in the late nineteenth century.</p>

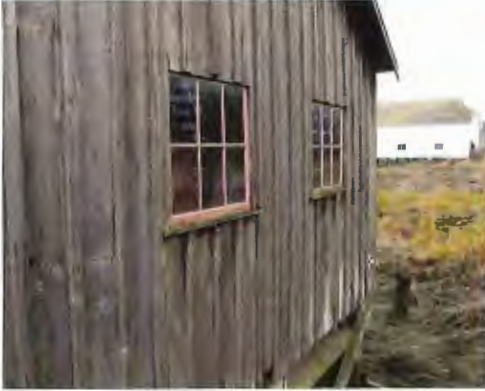
1. Character-Defining Elements	2. Images	3. Heritage Value
<p>Building:</p> <ul style="list-style-type: none"> • Board and batten exterior siding • Multi-paned wood windows • Large wooden entry doors • Winch, cables and ways installed when the building was converted to a shipyard

<p>The building style and materials used in the construction of the Britannia Shipyard connect it to the past traditions of the area and separate it from the contemporary structures of the surrounding neighbourhood.</p>
<p>Interior:</p> <ul style="list-style-type: none"> • Complex floor plan • Complex wood framed roof structure • Heavy square wooden posts with angled roof supports • Wood floors and ceilings • Internal wood doors • Multi-paned wood windows • Horizontal wood planked walls

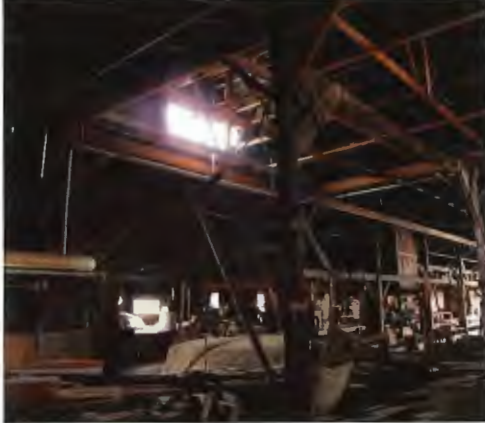
<p>Provides the public with a chance to explore the internal structure of the facility.</p>
<p>Interior:</p> <ul style="list-style-type: none"> • Interior details such as benches, furnishings, brick chimney, hoists, cables and machinery • Tools and marine vessels • Exhibits and demonstrations, such as interpretive panels, tools and boat building displays

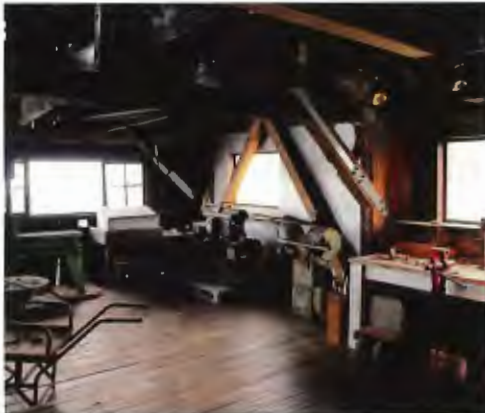
<p>Provides the public with a chance to interact with the components used in the operation of the cannery and later, shipyard.</p>

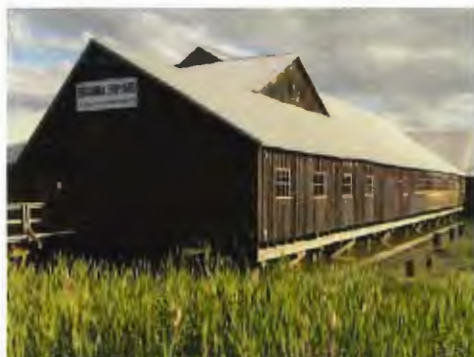
The Britannia Shipyard is a large, L-shaped wooden structure with a gable roof and board and batten siding standing on wood pilings in the tidal foreshore of the Fraser River near Steveston. The building ranges in height from one to one-and-a-half storeys. A wooden bridge connects the cannery to the Britannia boardwalk and a reconstructed wharf extends into the river. Remnants of wood wharf pilings are found adjacent to the building.

The cavernous interior of the building is constructed of wooden posts and beams with wood trusses supporting the gable roof. A large set of marine ways gives boats access from the river into the shipyard. The original internal layout of the building is evident, and along with the remains of the shipyard interior, tools, exhibits, marine vessels and other features reveal the complexity of the building.

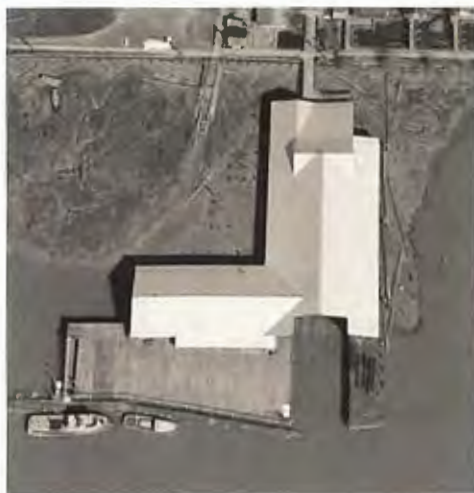
Current images of the Britannia Shipyard.

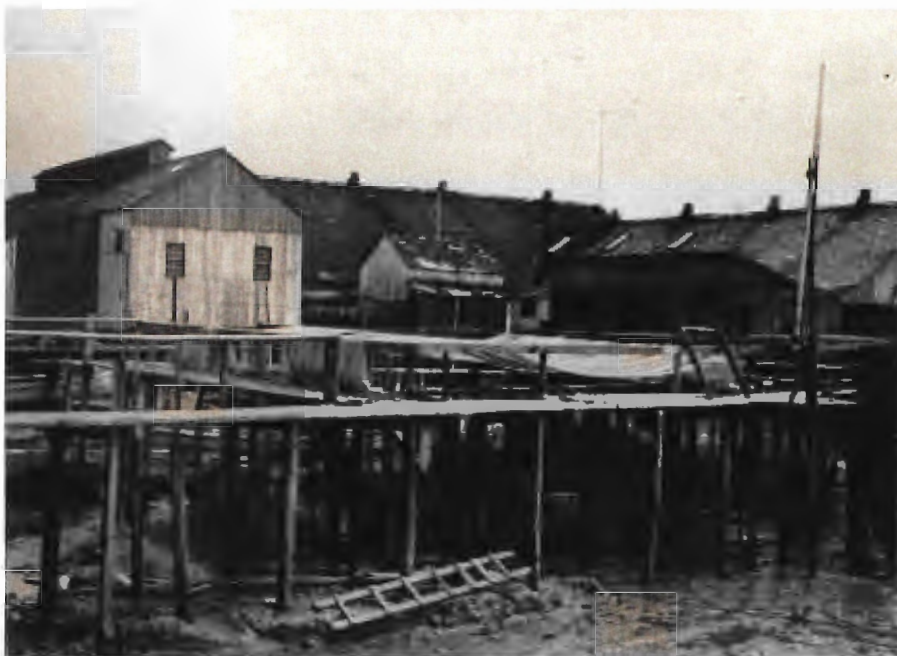
Britannia Cannery / Shipyard complex in the 1930s.
(Richmond Archives 1991-2-26)

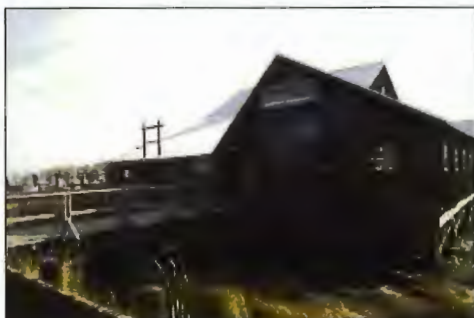
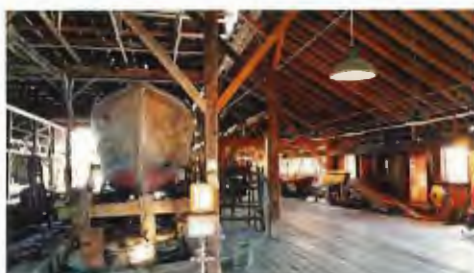
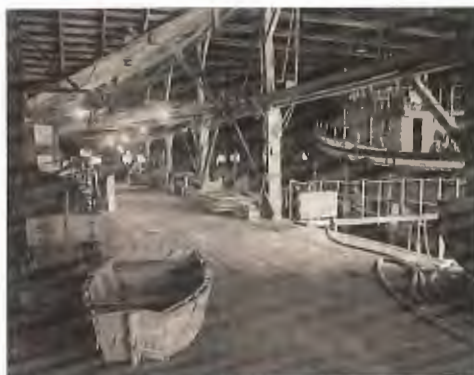
Interior of the Britannia Shipyard, 1990. (BHSS)

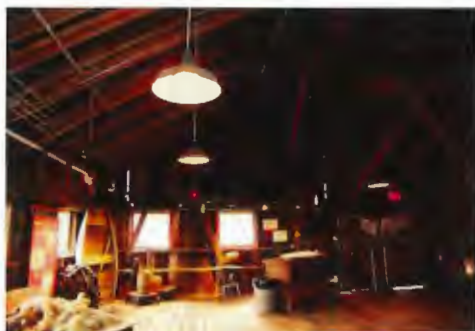
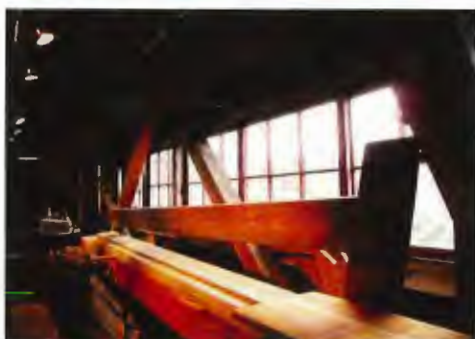
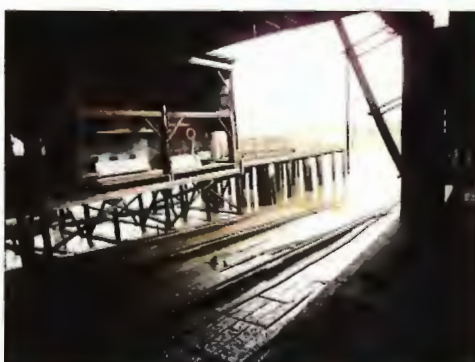
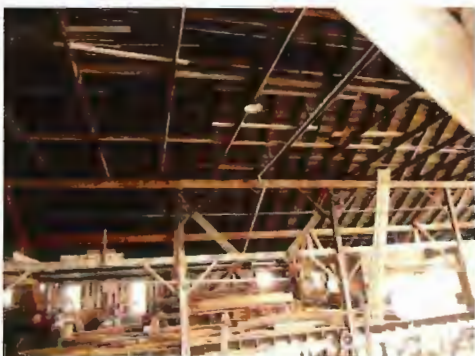
- Wood building construction on wooden piling foundation
- L-shaped plan and prominent massing
- Opening on the south facade to allow the passage of boats

- Gable roof including a cross-gable portion at the north side of the building and modified gable roof at the south side
- Board and batten exterior siding

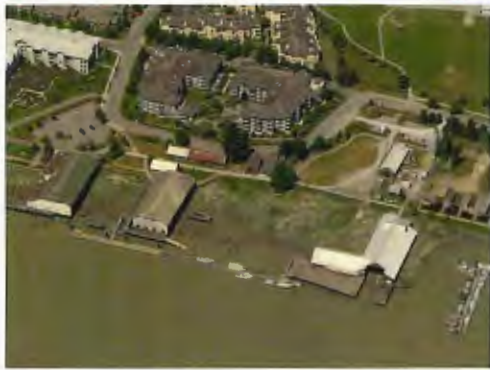
1. Character-Defining Elements	2. Images	3. Heritage Value
<p>Site and setting:</p> <ul style="list-style-type: none"> • Location on pilings extending into the Fraser River • Landmark on the Steveston waterfront • Surrounding Fraser River foreshore • Wooden walkway connection to boardwalk • Remains of wood pilings to the east and west • Wharves on the west and south of the building

<p>Retains the connection to the early maritime history of the area.</p>
<p>Building:</p> <ul style="list-style-type: none"> • Large rectangular massing • Heavy timber construction • Gabled hip roof with asbestos cladding • Regularly spaced, 4-paned square windows • Wooden door • Exterior encapsulated asbestos siding

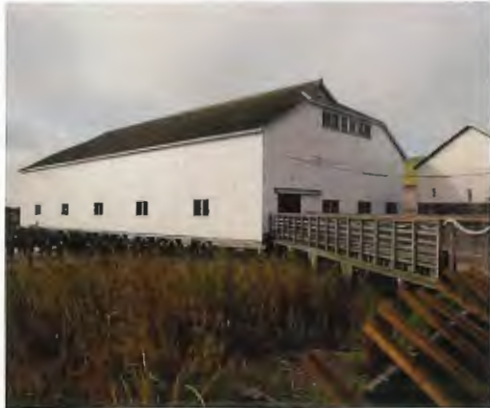
<p>The building style and materials used in the construction of the Seine Net Loft reflect the cannery function of the facility, which dates to 1955, as part of the Phoenix Cannery.</p>

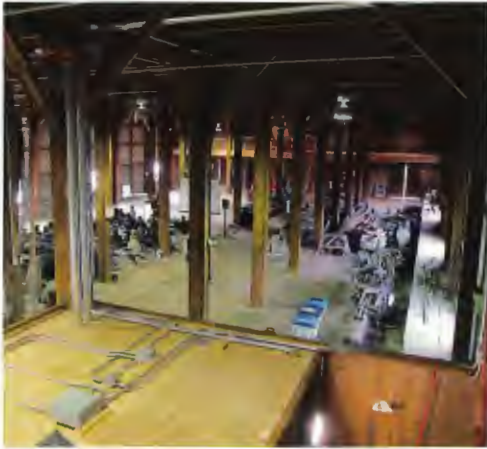
1. Character-Defining Elements	2. Images	3. Heritage Value
<p>Interior:</p> <ul style="list-style-type: none"> • Massive interior volume • Wood floor • Wood posts with angled roof supports • Wood beams, rafters and ceiling • Wood staircase and mezzanine • Artifacts and exhibits

<p>Provides the community with an opportunity to explore the actual stucture of a net loft.</p>
<p>Intangible Features:</p> <ul style="list-style-type: none"> • Community uses such as interpretive tours, festivals, events, programs and exhibits

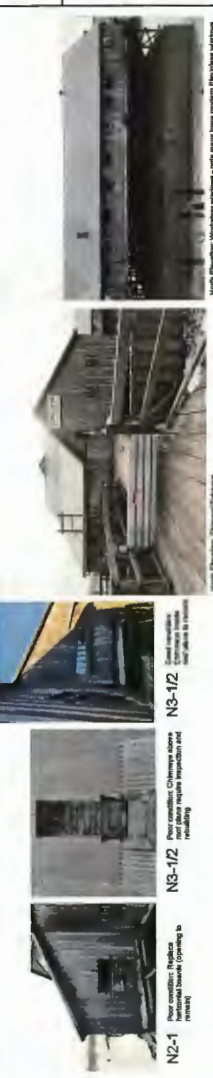
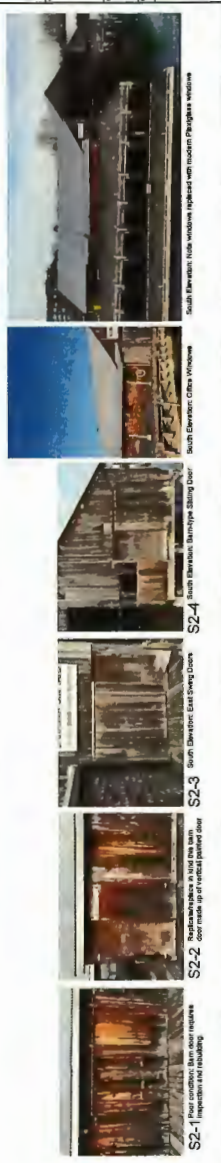
BRITANNIA - SHIPYARD BUILDING
 BRITANNIA NATIONAL HISTORIC SITE
 STEVESTON, RICHMOND, BC
 BRITANNIA SHIPYARD BUILDING ELEVATIONS
 SCALE: 1/8" = 1'-0"
 23059
 3 A201

WOOD DOOR IN POOR CONDITION - RESTORATION IN PLACE:
 1. REPAIR CRACKS, SINK AND TRIMS
 2. REPAIR OR REPLACE DOOR & BOARDS
 3. PAINT TO MATCH BOARD
 4. REPRODUCE DOORS TO MATCH EXISTING DOORS TO MATCH SIZE & FINISH
