City of Richmond

Report to Committee

Re: **Agricultural Land Reserve Exclusion Application by JNA Holdings Inc. at 14540 Burrows Road;**
Agricultural Land Reserve Exclusion Application by Karl, Lydia & Ulrich Wacker at 14680 Burrows Road; and
Agricultural Land Reserve Exclusion Application by Shorewood Developments Ltd. at 14920 Burrows Road

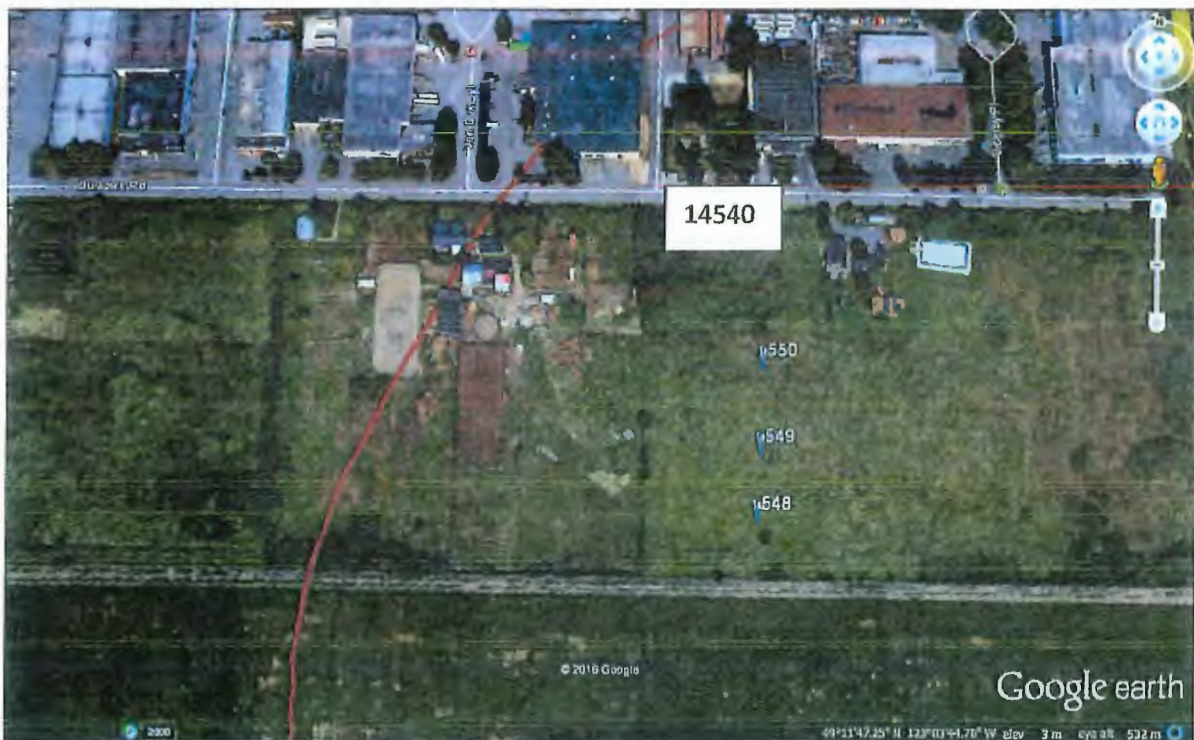
Figure 1 Soil sampling sites

Three field investigations were conducted at GPS locations 548, 549 & 550 as seen in Figure 1. At each site an excavator was used to dig the soil to depths of 120-190 cm. For each site the soils were described in terms of profile morphology including horization, depths, soil textures, coarse fragments, mottles, and depth to water table. The site landscapes were described in terms of landform, surficial materials, surface stoniness, slope, and soil drainage. The soils observed were identified to soil series and were then compared to the existing soil mapping for the subject property (Figure 2).

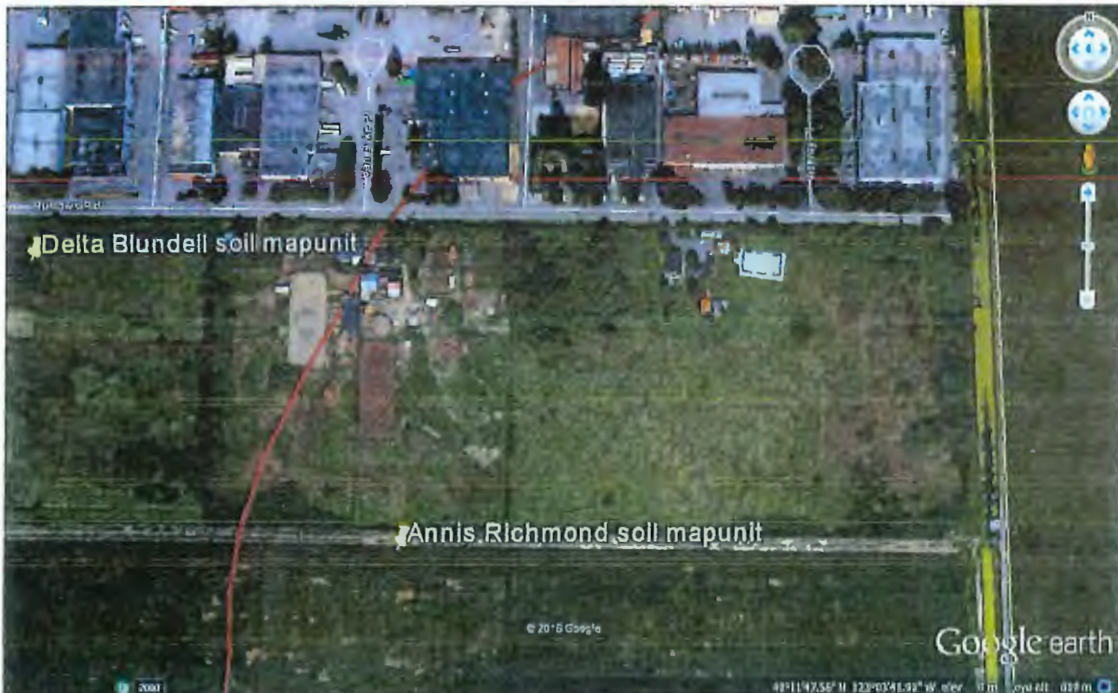
Figure 2 Existing soil map

Luttmarding 1980 Scale 1:25,000

All three sample sites fell within the existing soil mapping polygon AN60% -RC 40%/b, S0 and were classified as belonging to the Annis soil series (Table 1). No obvious Richmond soil was observed on the subject property although GPS Sites 548 and 549 had surface organic layers that were 40 cm thick in places and could be called Richmond soil series.

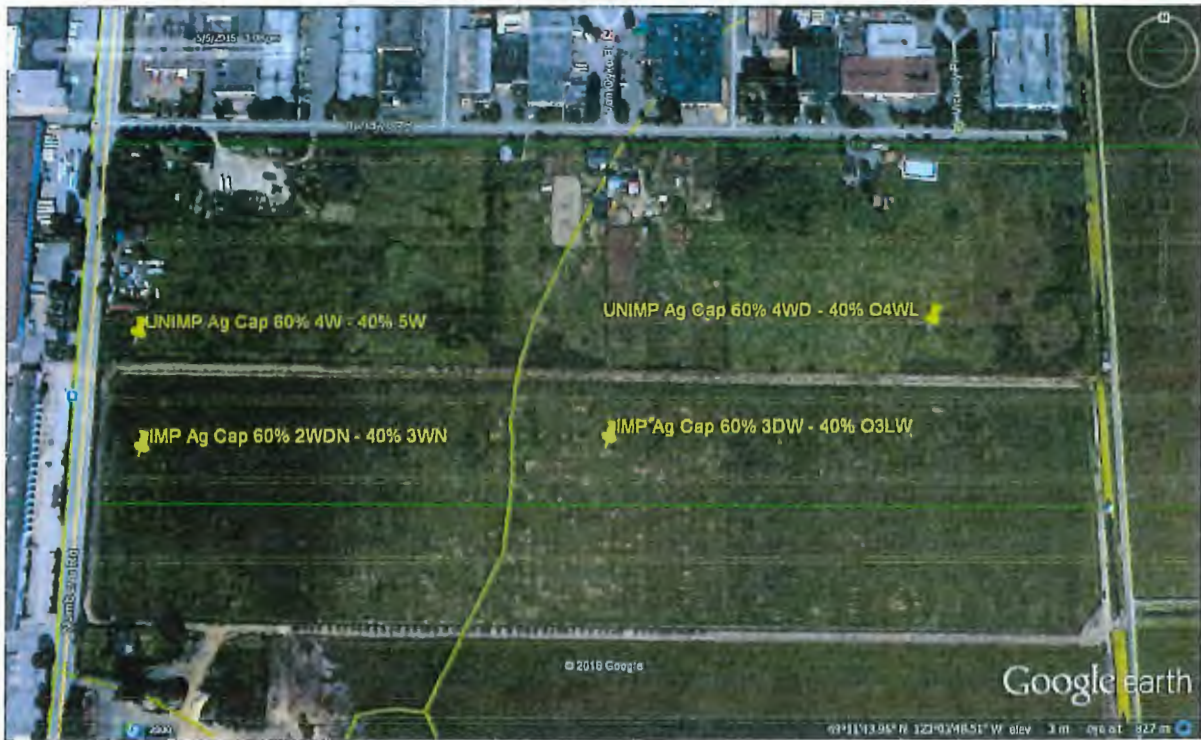
Figure 3 Historical agricultural capability

The soils were also compared to the existing agricultural capability mapping for the subject property (Figure 3). Two soil samples were collected for chemical analysis. The three surface horizons were composited into one sample for analysis to represent the surface Op. The second soil sample consisted of a composite sample from the underlying subsurface B horizons from the three sample points.

Based on interviews with the owner and a review of the Hydrologist’s report it is evident that the property has water at the surface and/or the soil is in a saturated condition for the winter and early spring with at least 4 months of the year that the land is not accessible. This corresponds with the soil observations and confirms the unimproved class 4W capability classification for the majority of the site.

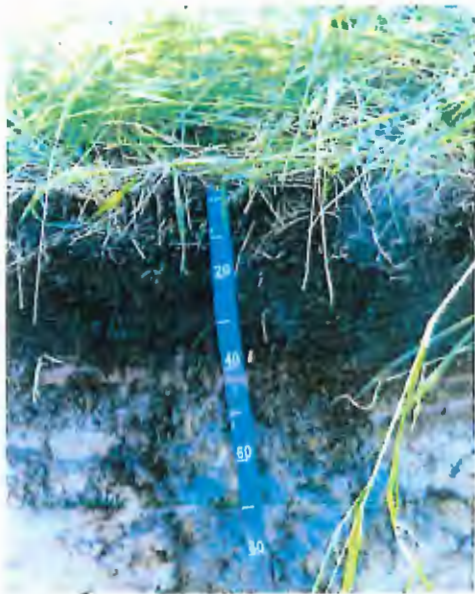
Soil at Site 548

Horizon	Depth (cm)	Coarse Fragments (% by volume)	Texture	Moisture	Comments
Op	0-40	0	Humic	moist	Well decomposed organic matter thickness varies from 34-40 cm Borderline with the Richmond soil series: calling Annis as the thickness varies to less than 40 cm
Bg	40-70	0	SiC	moist	Common, fine mottles, some structure, contains plentiful roots
Cg	70-110	0	SiC-SiCL	wet	Common medium prominent mottles, contains plentiful roots

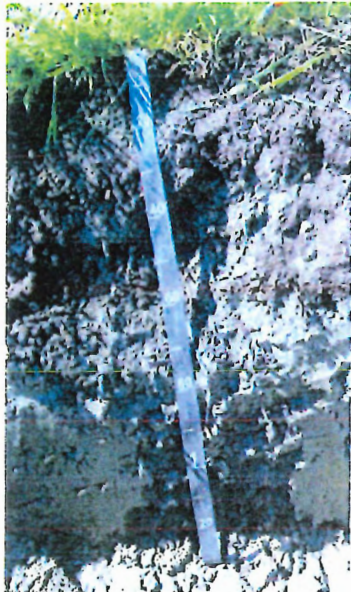
Soil at Site 549

Horizon	Depth (cm)	Coarse Fragments (% by volume)	Texture	Moisture	Comments
Op	0-40	0	Humic	moist	Well decomposed organic matter Borderline with the Richmond soil series: calling this soil Annis as the thickness is 40 cm and in places it is less than 40 cm
Bg	40-93	0	SiC	moist	Common, medium mottles, some structure, contains plentiful roots, contains sand pockets
Cg	93-150	0	SiC	wet	No mottles, contains plentiful roots

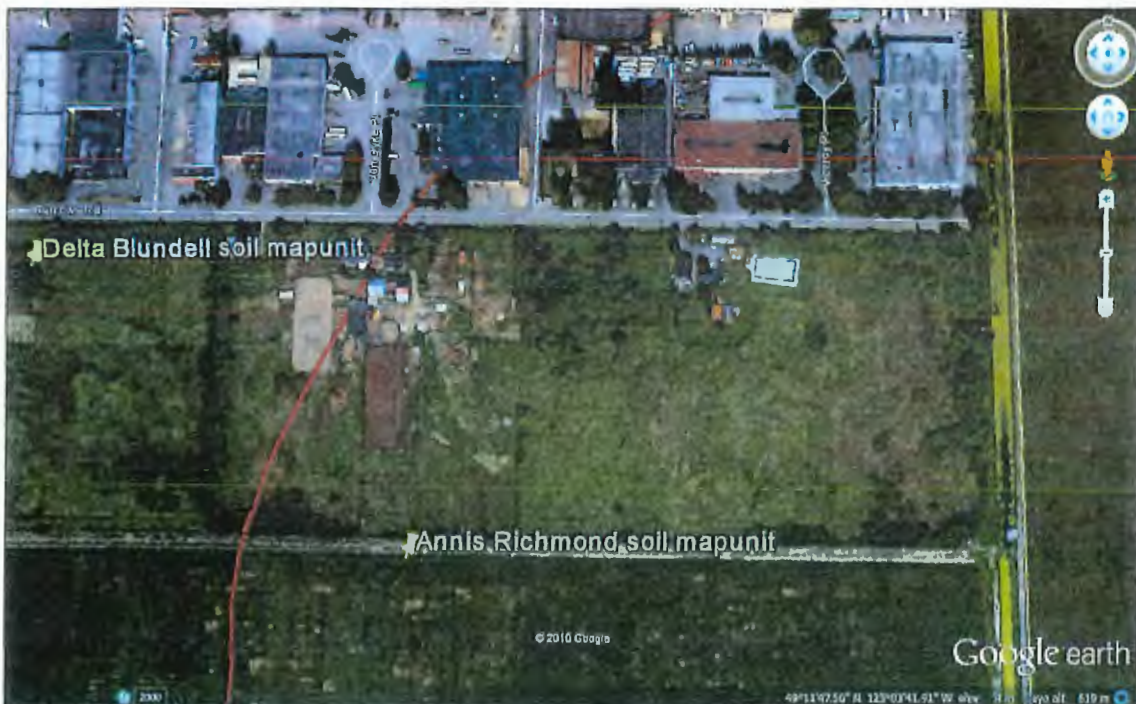
Figure 2 Existing soil mapping (Luttmending 1980 Scale 1:25,000)

The soils observed were identified to soil series and then compared to the existing soil mapping for the subject property (Figure 2). The soils were also compared to the existing agricultural capability mapping for the subject property (Figure 3).

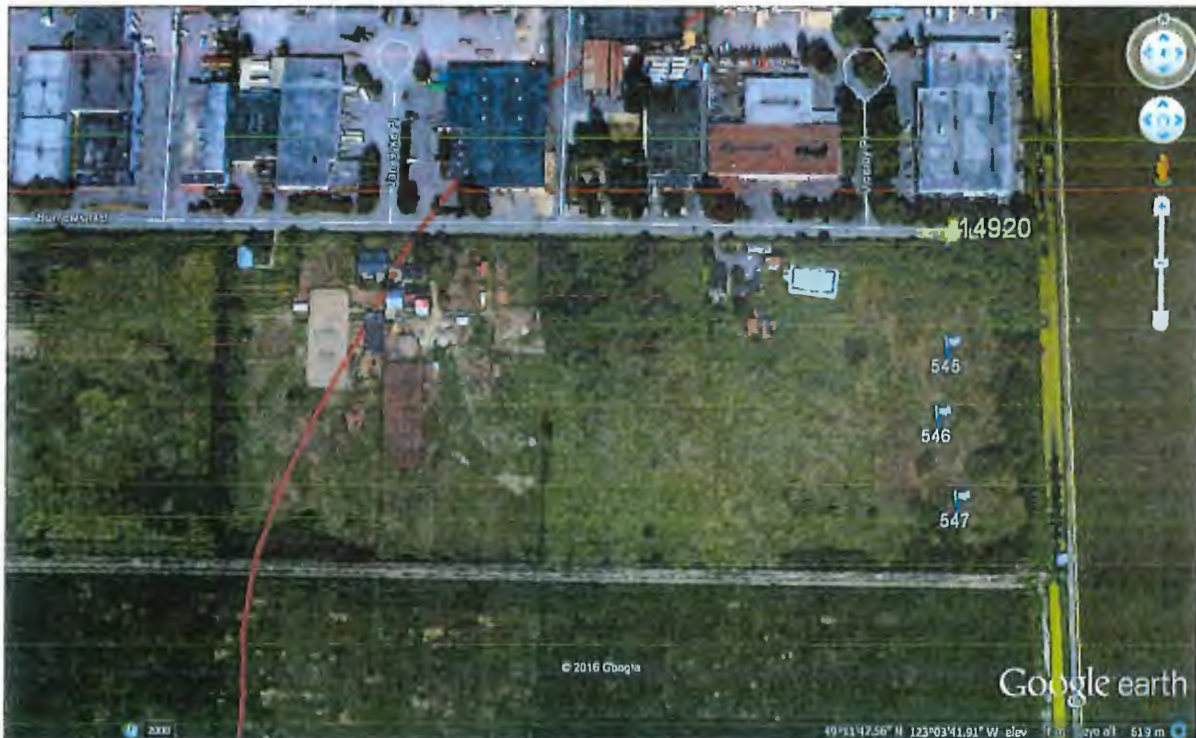
Figure 1 Soil sampling sites

Three detailed field investigations were conducted at GPS locations 545, 546 and 547 as seen in Figure 1. At each site an excavator was used to dig the soil to depths of 120-190 cm. For each site the soils were described in terms of profile morphology including: horizonation, depths, soil textures, coarse fragments, mottles, and depth to water table. The site landscapes were described in terms of landform, surficial materials, surface stoniness, slope, and soil drainage. The soils observed were identified to soil series and were then compared to the existing soil mapping for the subject property (See Figure 2).

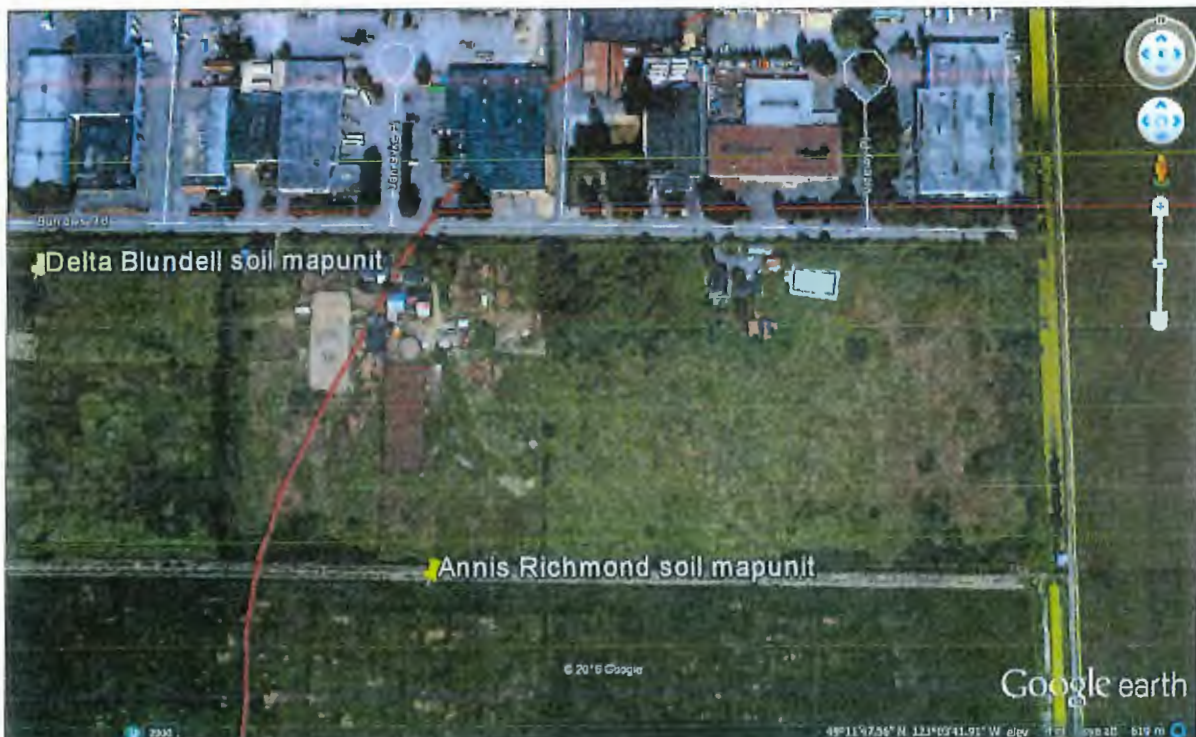
Figure 2 Existing soil mapping

All three sample sites fell within the existing soil mapping polygon AN 60%, RC 40%/b, S0 and were classified as belonging to the Annis soil series (Table 1). No Richmond soil was observed on the subject property.

Luttmerding 1980 Scale 1:25,000

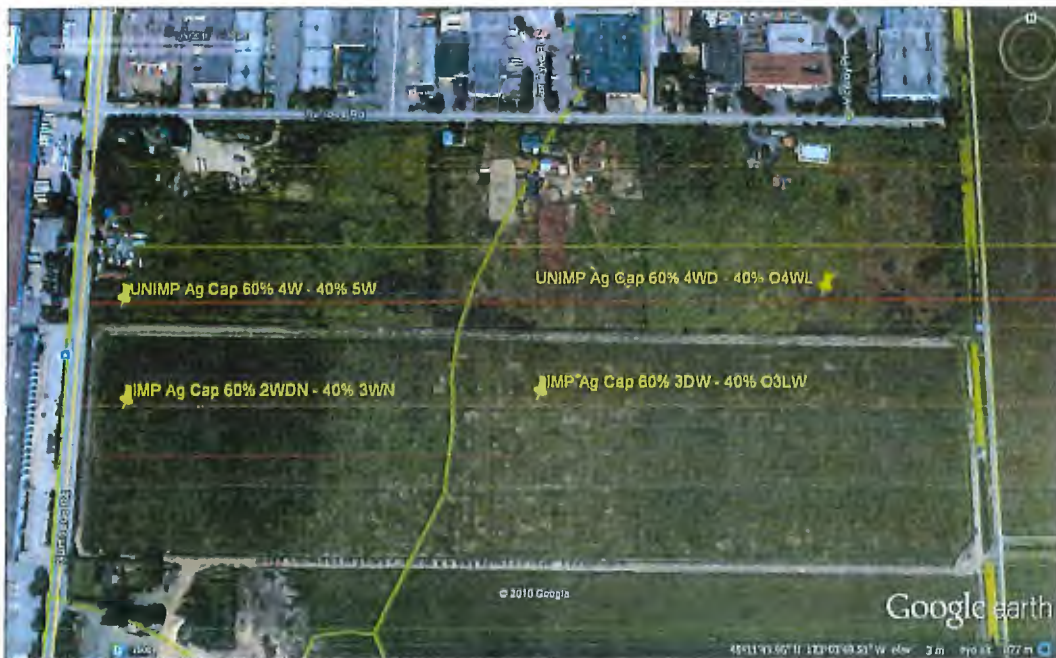
Figure 3 Historical agricultural capability mapping

The interview with the landowner and review of the Hydrologist's report correspond with the soil observations and confirm the unimproved 4W capability classification.

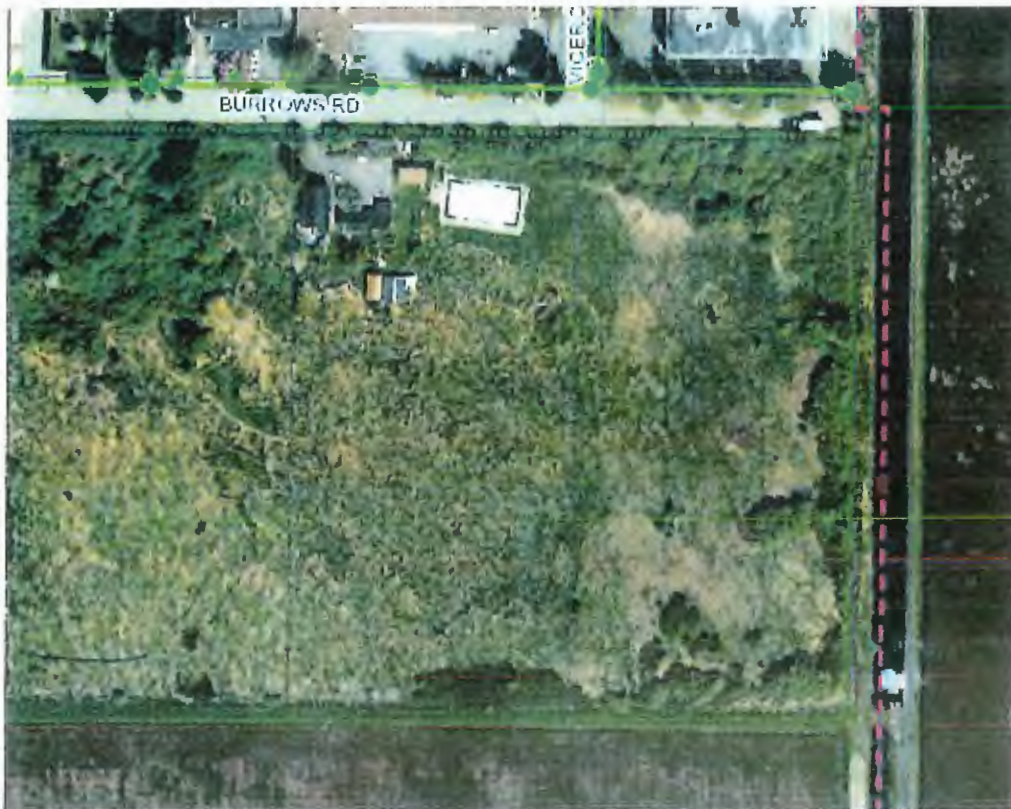
Figure 4 Drainage channel directly east of the property

For field agriculture production (other than pasture) to be viable on this property drainage must be improved. This requires the installation of subsurface drainage and having a drainage ditch of adequate depth for the subsurface drains to discharge. At the present time there are no ditches available for gravity discharge and the only potential outlet option would be to install a pumping station to discharge water into the large drainage channel directly to the east of the property.

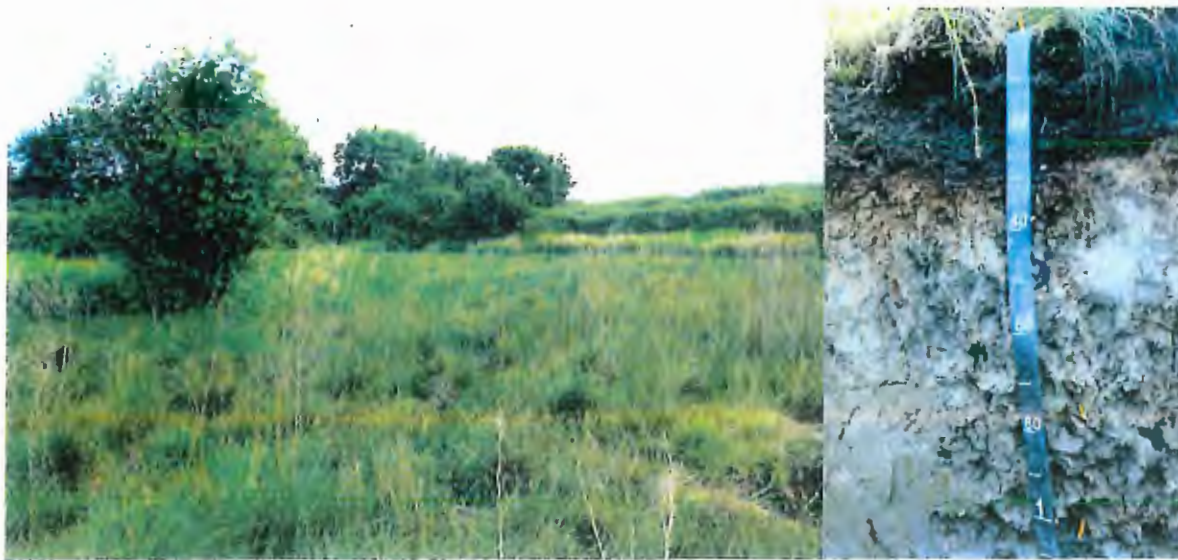
Vegetation and soil at Site 545

Horizon	Depth (cm)	Coarse fragments (% by volume)	Texture	Moisture	Comments
Op	30-0	0	Humic	moist	Well decomposed organic matter
Bgj	0-9	0	SiCL	moist	Yellow brown colour, few, fine faint mottles, well structured, contains roots
BCg	9-77	0	SiC	moist	Many, fine-medium prominent mottles, well structured, contains roots
Cg1	77-110	0	SiC	moist	Common, medium, prominent mottles, more massive, contains roots
Cg2	110-156	0	SiCL-SiC	wet	No mottles, more massive, contains roots, contains sand lenses along crack faces, water table at 150 cm
Cg3	156-160+	0	SCL	wet	No mottles, more massive, contains few roots

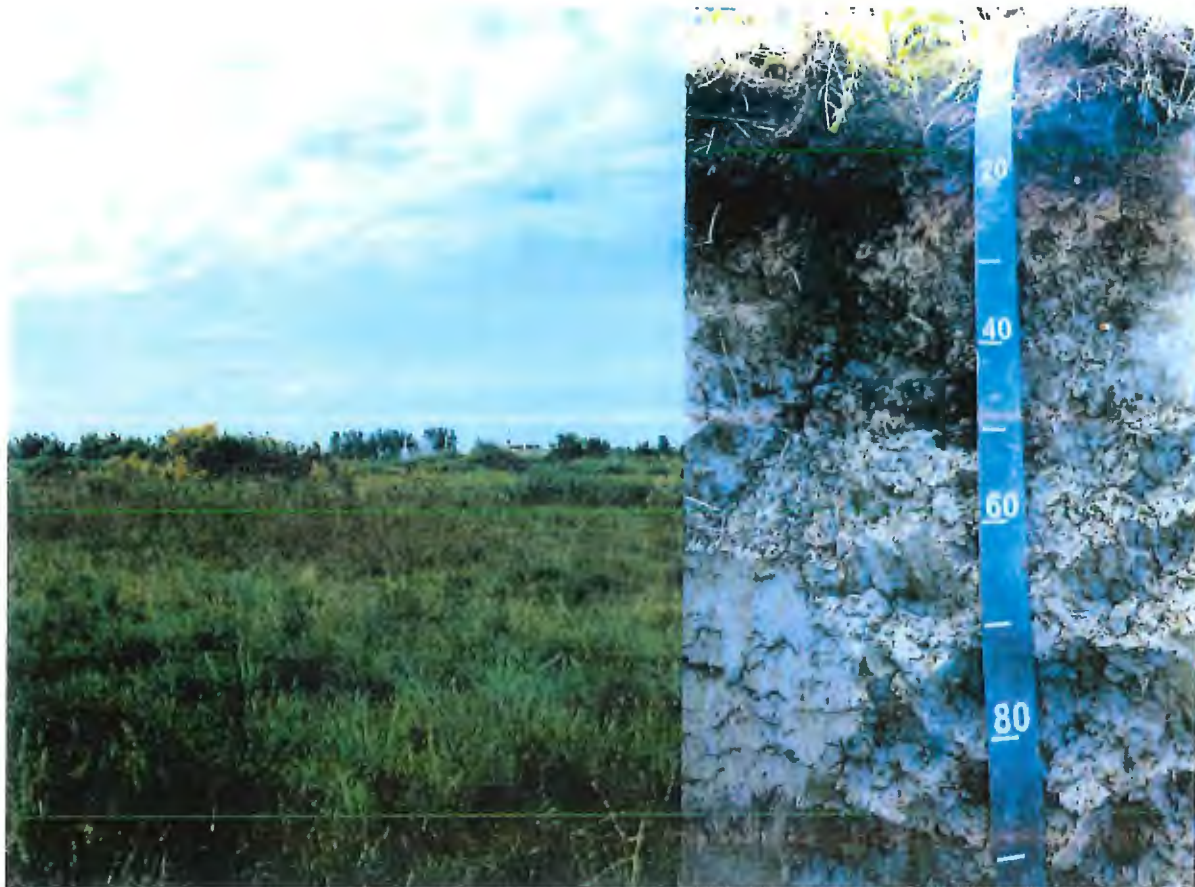
Vegetation and soil at Site 546

Horizon	Depth (cm)	Coarse fragments (% by volume)	Texture	Moisture	Comments
Op	22-0	0	Humic	moist	Well decomposed organic matter
Bgj	0-9	0	SL	moist	Yellow brown colour, few, fine faint mottles, contains roots
II Bgj	9-27	0	SiC	moist	few, fine faint mottles, well structured, sticky, contains plentiful roots, contains organic materials
II BCg	27-54	0	SiC	moist	Common, medium, prominent mottles, contains roots, charcoal and wood debris
III BCg	54-65	0	LS	moist	Common, medium, distinct mottles, contains roots
IV Cg1	65-100	0	SiC	moist	Common, medium, prominent mottles, contains roots, and wood debris, has some structure
IV Cg2	100-160+	0	SiC	wet	contains some roots and sand lenses, no structure - massive

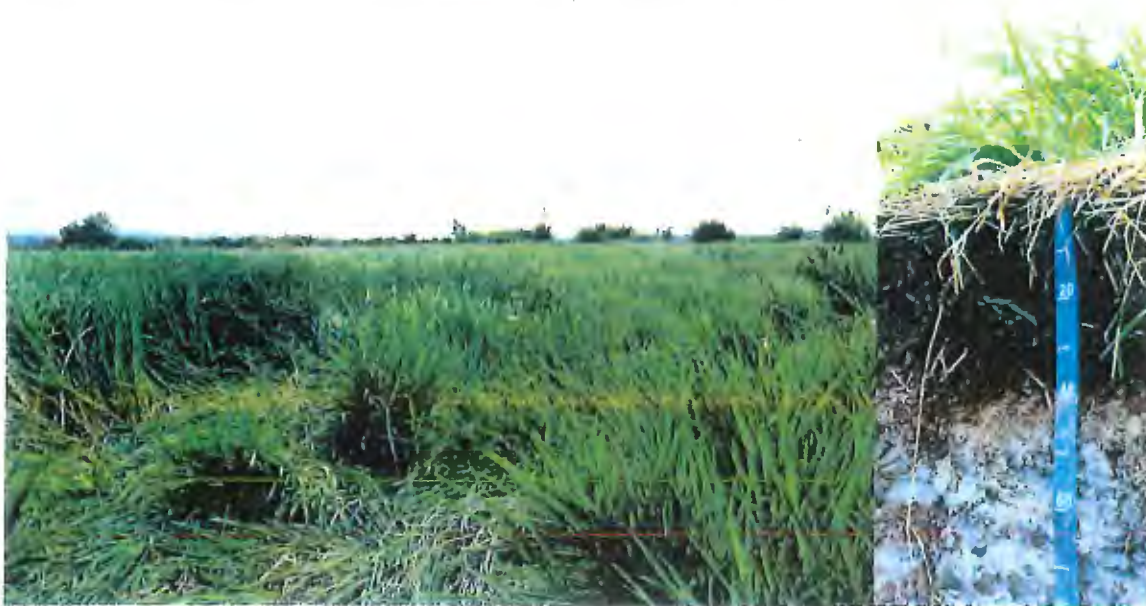
Vegetation and soil at Site 547

Horizon	Depth (cm)	Coarse Fragments (% by volume)	Texture	Moisture	Comments
Op	28-0	0	Humic	moist	Well decomposed organic matter
Bgj	0-19	0	SiCL	moist	Few, fine faint mottles, well structured, contains roots
BCg	19-96	0	SiC	moist	Common, medium prominent mottles, well structured, contains roots
Cg	96-135	0	SiC	wet	No mottles, no structure - massive
