**Heritage Revitalization Agreement  
(3831 Moncton Street) Bylaw No. 10741  
(HRA 23-016568)**

## Conservation Plan

**CONSERVATION PLAN**  
**3831 MONCTON STREET, RICHMOND** 4

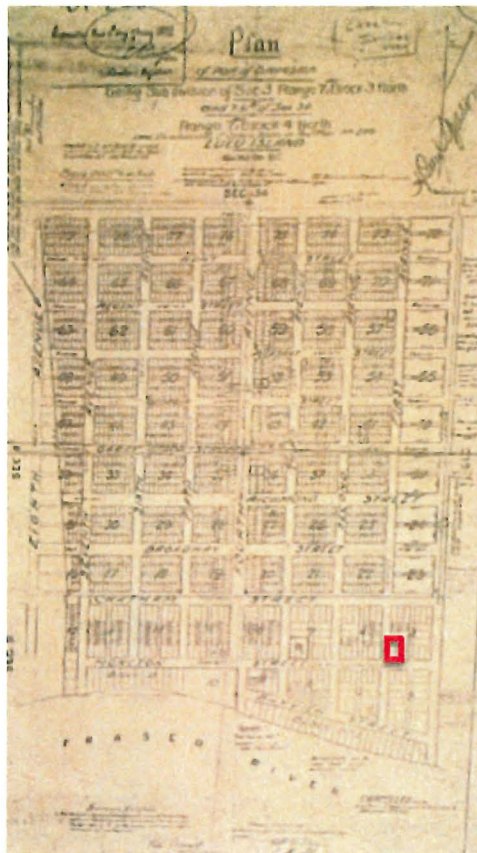
**Figure 4: Original 1892 Survey Plan, City of Richmond Archives Map 1990 14 6. Subject site outlined.**

Ikeda Dry Goods, built in 1924, is an illustration of some of the earliest commercial development in Steveston, as the village gradually began to grow in the early 1900s, with the focus of development along Moncton Street between 3<sup>rd</sup> Avenue and No. 1 Road, and the docks located along the mouth of the Fraser River (Cannery Channel). The original layout of the village, at the time was focused with its commercial core between Chatham Street and the Fraser River, as indicated on the survey plan from 1892 (Figure 4).

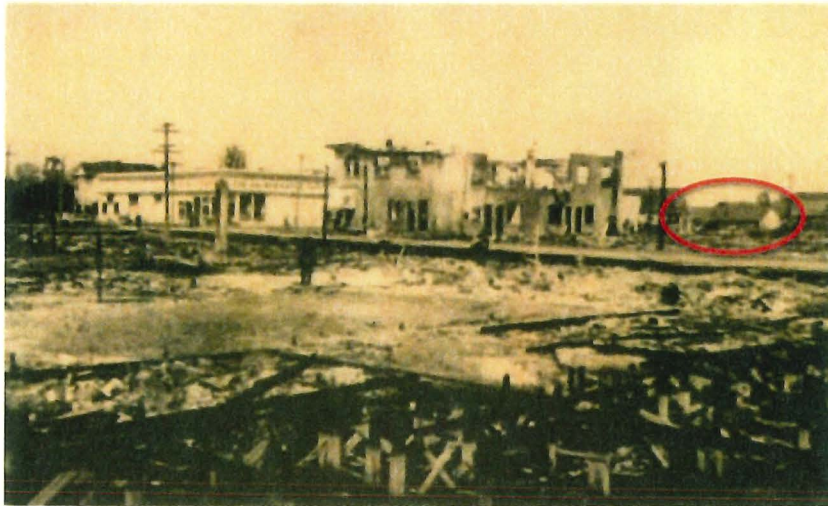
**Figure 8: Remaining buildings after the Steveston fire of 1918. Subject site circled.**  
Source: City of Richmond Archives 1978 5

While the Assessment records show no major improvements until 1920, photos documenting the results of the fire of 1918 do indicate a building with a similar front-gable form (but without the false front) located on the subject site, which corresponds with those earlier Fire Insurance Plans (Figures 8, 9 and 10).

- The roofline (as visible in Figures 8, 9 and 10) extends much further back than existing. If this were the existing building, a drop in the roofline would be evident toward the rear, where the smaller extension connects.
- The photo of the tenement building shows multiple windows facing First Avenue, presumably at least one for each unit, that are not evident in the

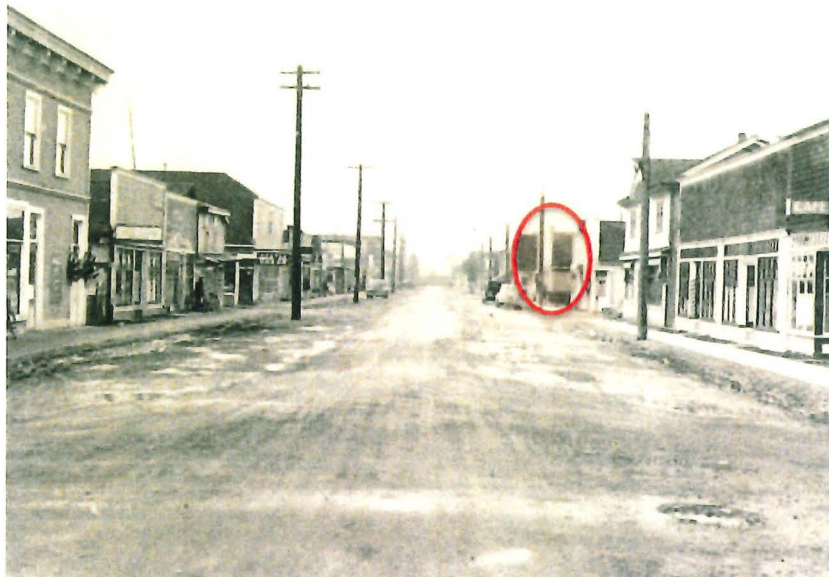
**Figure 15: Moncton Street looking west from No. 1 Road, 3831 Moncton Street circled. Source: City of Richmond Archives RCF 274. Presumed date is late 1930s based on the automobiles visible.**

The storefront has undergone the most notable changes over time – both the windows and doors, along with the false front. It is presumed that there was a full-height false front in place from the time of its construction, as there is no archival evidence to suggest otherwise. However, the false front did change slightly in appearance, from a straight horizontal top visible in the 1930s (Figures 15 and 16) to the “stepped” one that is in place today and, in those earliest years, prior to the mid-1940s, no vertical blade sign was on the building.

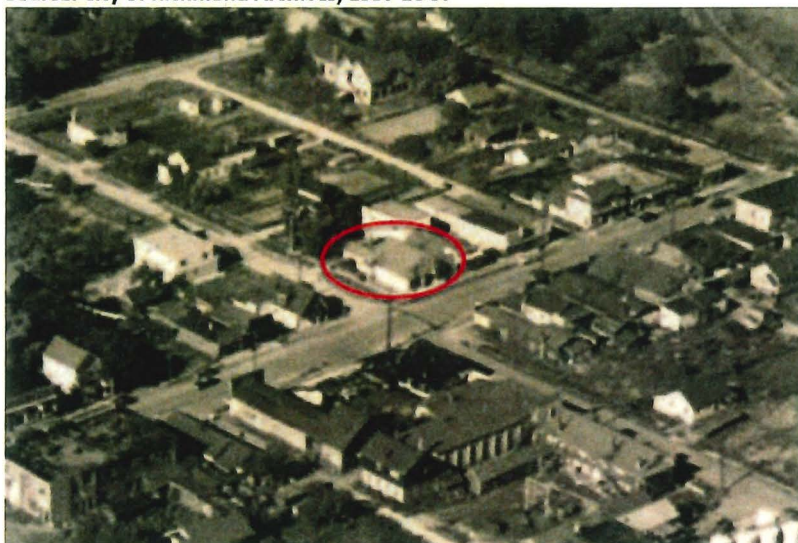
**Figure 18: Aerial photograph of the Steveston waterfront, townsite and south Richmond as seen from southwest (partial), 1952. Subject site circled.**  
**Source: City of Richmond Archives, 1997 16 86**

Records indicate that this major change took place between 1948 and 1952, based on air photographs from those two years (Figures 17 and 18).

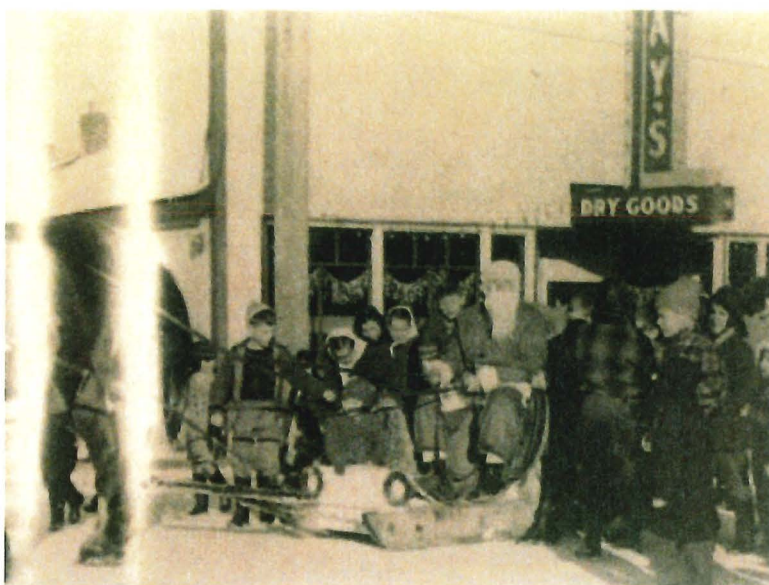
**Figure 19: Christmas in Steveston, 1940. City of Richmond Archives, Centennial Collection, Photograph 1978 23 12.**

The store front window frames and proportions, the placement of the main entry, along with signage and added canopy are all alterations that are evident on the front. The original false front, wooden storefront windows, blade sign and recessed entry are evident in a 1940s photograph (Figure 19).<sup>10</sup>

- Retain and where necessary, restore components of the storefront trim, window frames and sills based on archival evidence.
- The rehabilitation of the recessed entry will result in a window incorporated on either side of the door, along with small windows on the angled sides leading to the door. In addition, the storefront windows will comprise two sections divided by a prominent vertical mullion, with muntins to create three panes across the top with one vertical muntin extending down to the bottom to create two equally sized panes. The proportions of the angled entry – both the door and windows immediately adjacent – should match that as closely as possible to the images found in Figures 19 and 20 of this report.

The chimney of Ikeda Dry Goods should be replaced in full, as the concrete block currently in place is not original or period-appropriate. The restored chimney should be re-built with red brick and match the dimensions and height of the existing concrete block chimney, unless BCBC requires the height to match the roof peak. (Note: it will not be a functioning chimney, so the height may not be an issue.) The chimney should have a modestly corbelled brick edge at the top, on which would be placed a concrete cowl as similar as possible to the one seen in Figure 19, Section 2.2. of this report.

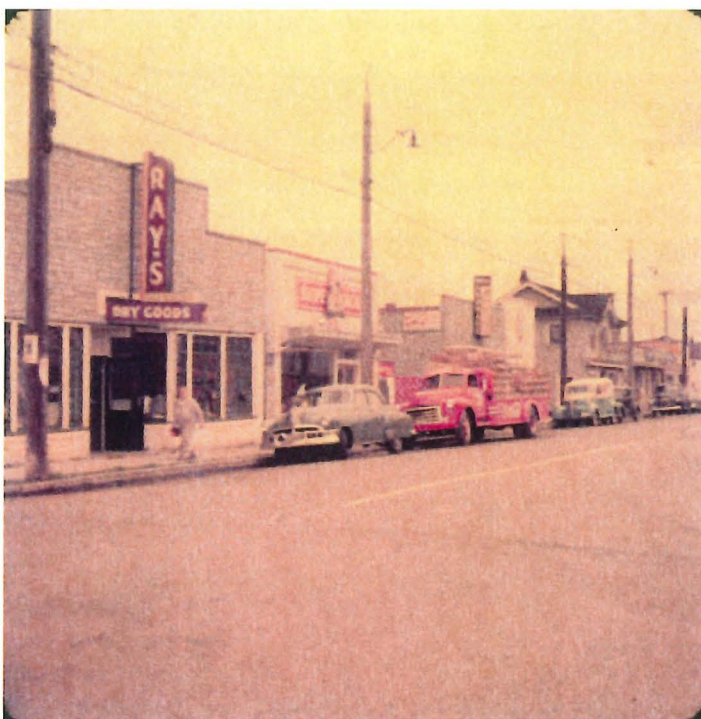
**Figure 20: Ray's Drygoods and neighbouring buildings on Moncton Street, c. 1950.<sup>11</sup>**  
**Source: City of Richmond Archives, Noel McConnell Fonds, Photograph 2012 62b.**

<sup>11</sup> Richmond Archives lists this photograph as c. 1950, and based on the age of the cars, and given that there is no canopy in place, it is assumed to be 1952 since the air photo presented earlier shows the parapet. It is certainly earlier than the photograph presented as Figure 21 in this report (which is also listed by the Archives as c. 1950)

A slightly later photo, noted by the Richmond Archives as c. 1950, shows the same neon sign in place and the same wood frame storefront arrangement with the exception of the raised “parapet” – this allowed for the height of the blade sign to roughly match the top face of the false front. This is likely the same time that the grey asphalt shingles were applied to the front face, which would have masked the alteration to the false front to give it a “parapet” face appearance: stepped down on either side of the roof peak (Figure 20).

The early storefront windows – namely those that existed prior to the mid-1950s, as seen in the photograph from around 1952 (Figure 20 of Section 2.2 and Figure 47) – were large plate glass with muntins creating a multi-pane effect and had strong vertical divisions (i.e. mullions). The wall surface below consisted of drop siding that appears to be similar or identical to the first layer of drop siding on the west and east walls, and which is still visible on the upper face of the rear wall. It is not known, however, if this is the original surface of the storefront base wall or whether that siding was taken from other locations on the building as part of repairs.

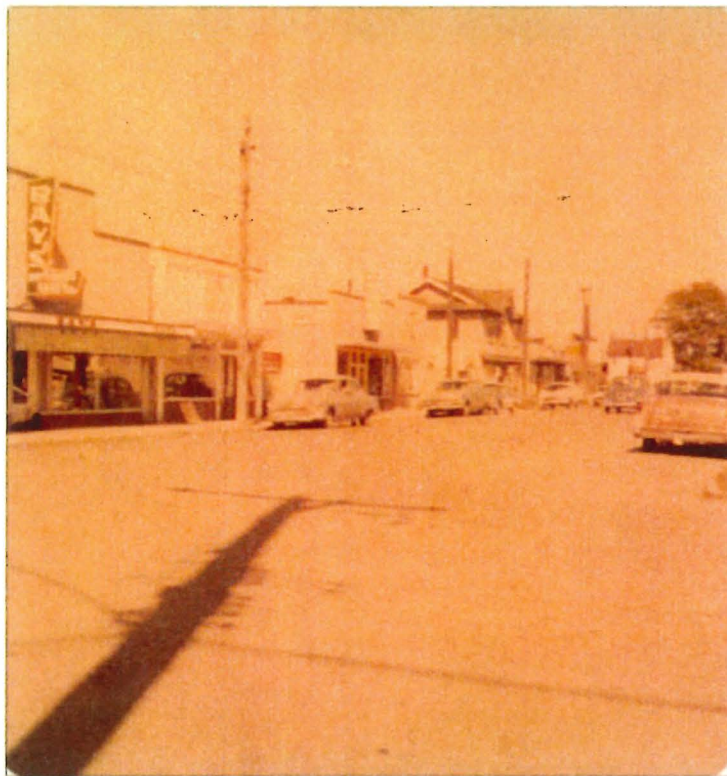
**Figure 21: Moncton Street looking east from First Avenue, showing various commercial buildings, including Ray's Drygoods (far left), c. 1950.<sup>12</sup>**

<sup>12</sup> While the Richmond Archives lists this photograph c. 1950, based on the age of the car (far right) and given that there is a canopy in place, it is assumed to be late 1950s – a later date than the Figure 20 photograph in this report, which would be early 1950s.

However, by the late 1950s, a flat canopy was added spanning the entire storefront and a more period-appropriate neon sign installed – in any case the previous sign's placement would have interfered with the new full-width canopy (Figure 21). The multi-pane storefront windows were replaced by more modern storefront windows – a fixed single-pane form divided by a single mullion – and remain in place today; the retail entry was also altered, with removal of narrower angled windows that formed the recessed entry. That entry door was retained and surrounding glazing was brought forward, to create a more unified front wall face.

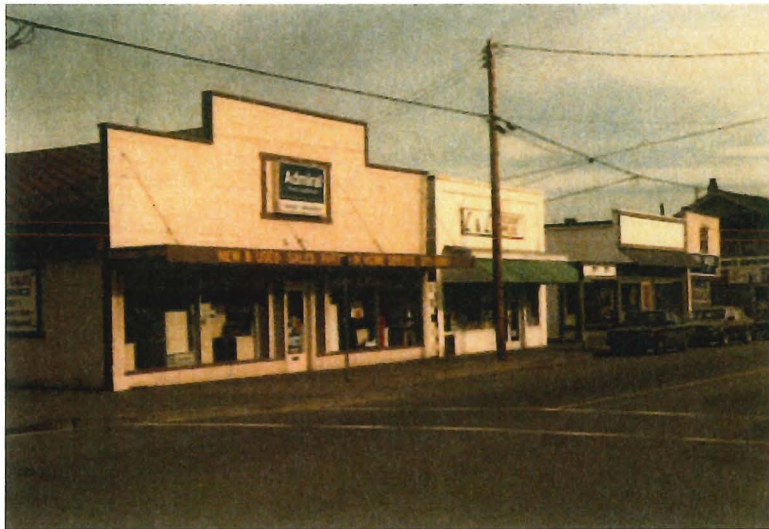
**Figure 22: Budget Appliances, 3831 Moncton Street, c. 1984. City of Richmond Archives, David Fleming Fonds, Photograph 2010 47 19.**

The building has retained most of its character that remains visible today; it has survived many decades with only very minor changes. By the mid-1980s, the neon blade sign was removed, and more modern cladding was installed over the existing, but its overall form and general appearance (as it appeared in 1952) is much the same (Figure 22). The entry door, although older, is not original but is period-appropriate. It certainly appears to have remained intact from the time it was replaced in the 1950s (with only the loss of the angled push-bar).

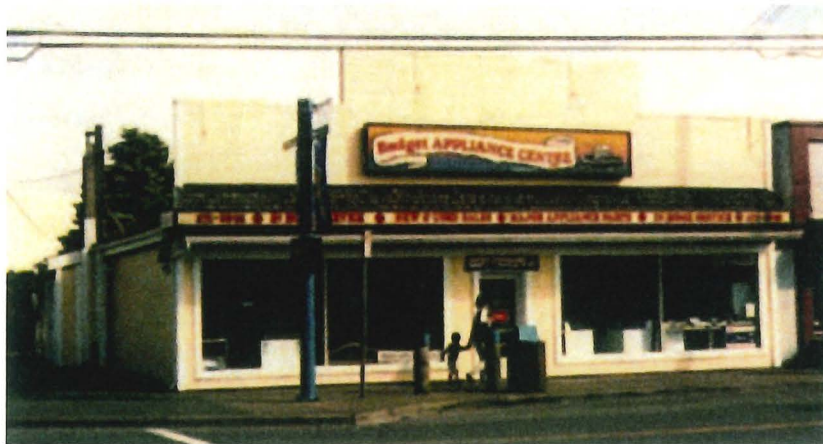
**Figure 23: Ikeda Dry Goods, which in 2000 was known as Budget Appliance Centre. City of Richmond Heritage Inventory.**

Sometime between the mid-1980s and 2000, the flat-roof canopy was either entirely replaced by or supplemented with a modest sloped-roof shingled overhang providing weather protection similar to the earlier canopy. The additional structural supports that are still in place today can be seen in a photograph from 2000 (Figure 23). The wrap-around horizontal sign that was, until recently, in place, was added during that time.

In addition, the cladding above the canopy was altered from larger panels (likely asbestos shingles) to lap siding, evidenced by the photograph from 2000. That lap siding is not original: evidence is the original drop siding still intact on the east and west sides and the rear. It is partly visible from the street, on the narrow space on the east side, and is most evident as seen from the interior, during the early stages of preparing this report.

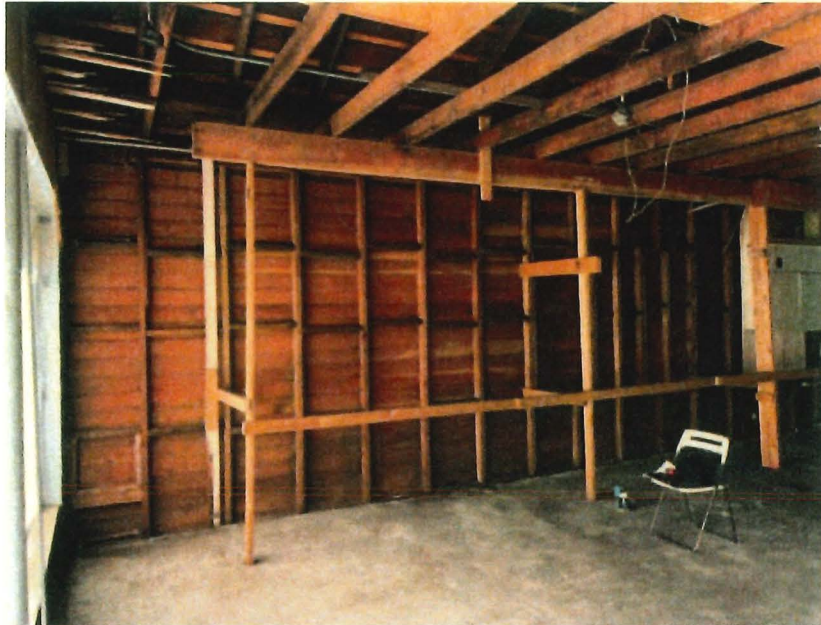
The west side reveals the evolution of the siding. The first layer, a cove-cut drop siding, is set directly on the studs, with no backing or tar paper (and which is identical to that on the east side) (Figure 24).

**Figure 24: West side wall with back face of cove-cut drop siding intact and visible**

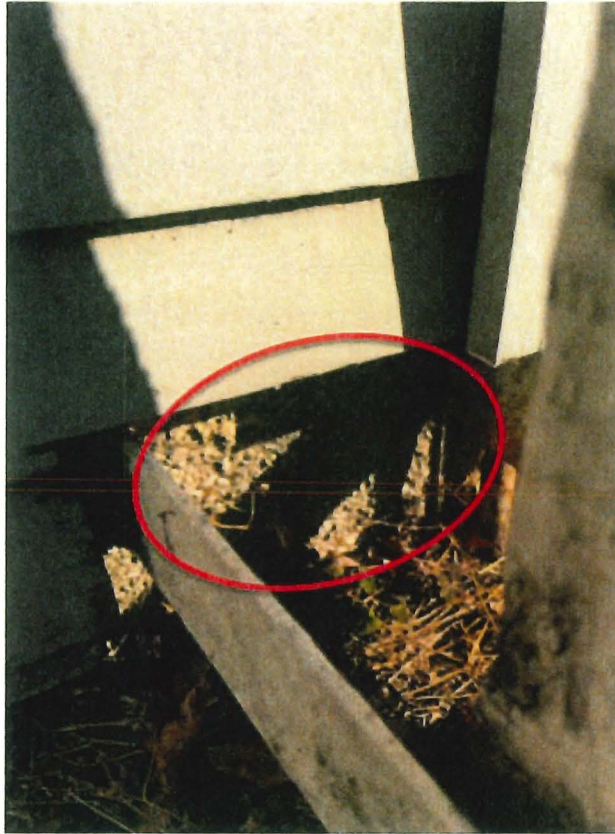
White rock-dash stucco was added to the drop siding, allowing for a gap between the wood and the stucco; this also served as a rudimentary form of insulation (Figure 25).

**Figure 25: White rock-dash stucco under lap siding (west side, circled)**

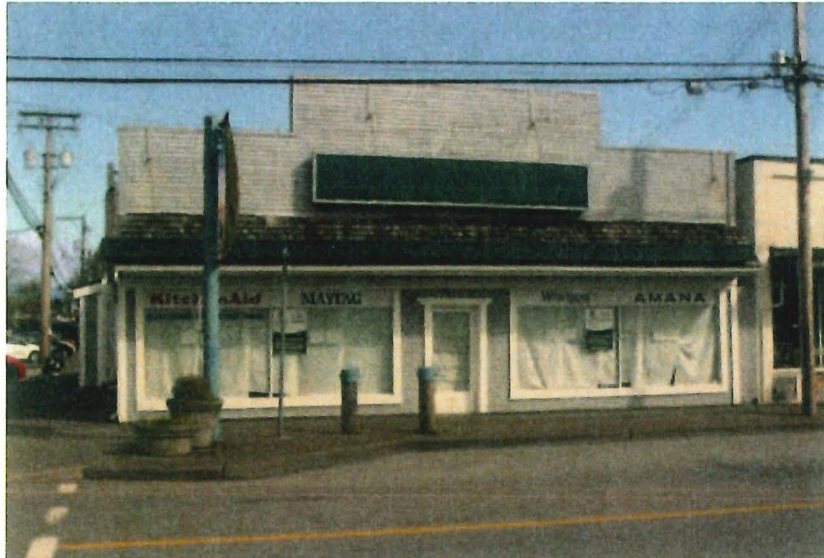
Figure 26: Storefront windows and single door with shingled canopy and older signage attached, 2022.

Finally, the lap siding in place today was added sometime between the mid-1980s and 2000 (Figures 26 and 27). Nevertheless, the lap siding is period-appropriate and has become a character-defining element over time (see Section 3).

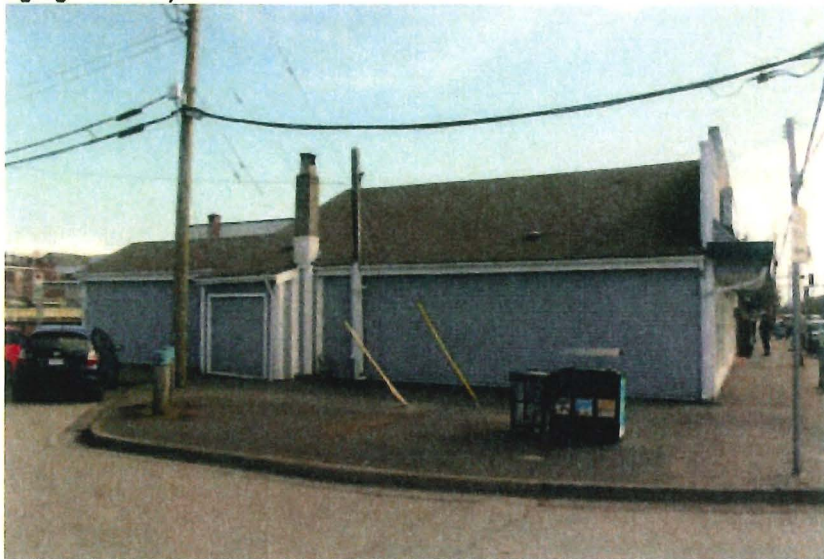
Figure 27: Building as seen from First Avenue

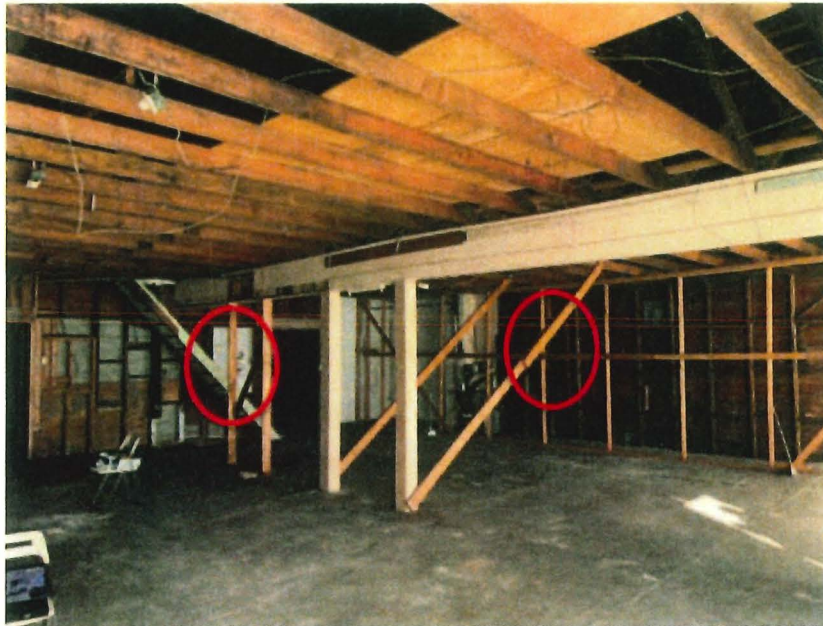
The examination of the interior revealed other clues about the original appearance of this building. On both sides and along the original rear wall, single-set windows were in place early, or were original, to the building. They were most likely identical to the one that is still in place on the rear wall, double hung with multi-pane upper and lower sashes; one single-set window was in place on the east side (Figure 28).

**Figure 28: Exposed interior showing one original window still in place, painted white and on rear wall (left, circled above) and a single window frame on the east wall (right, circled above); magnified rear window, below.**

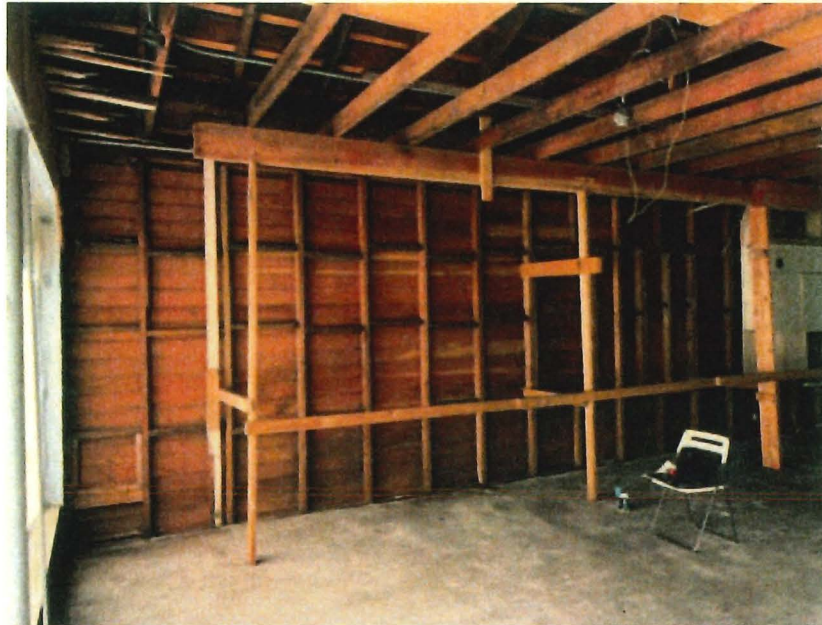
**Figure 29b: Broader view of the exposed west side**

Similarly, on the west side facing First Avenue, there were three single-set windows, and two of these frames were entirely exposed on the interior (Figure 29). They were boarded up with salvaged drop siding with a cove profile, indicating that this work happened prior to, or at the same time as, stucco applied to the west side wall.

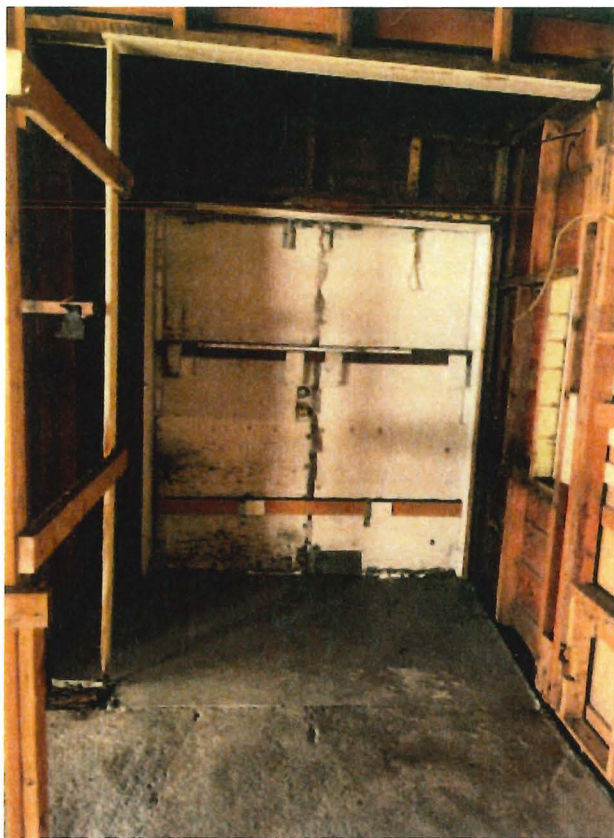
**Figure 31: Loading doors on west side as seen from interior, with wall face extended out.**

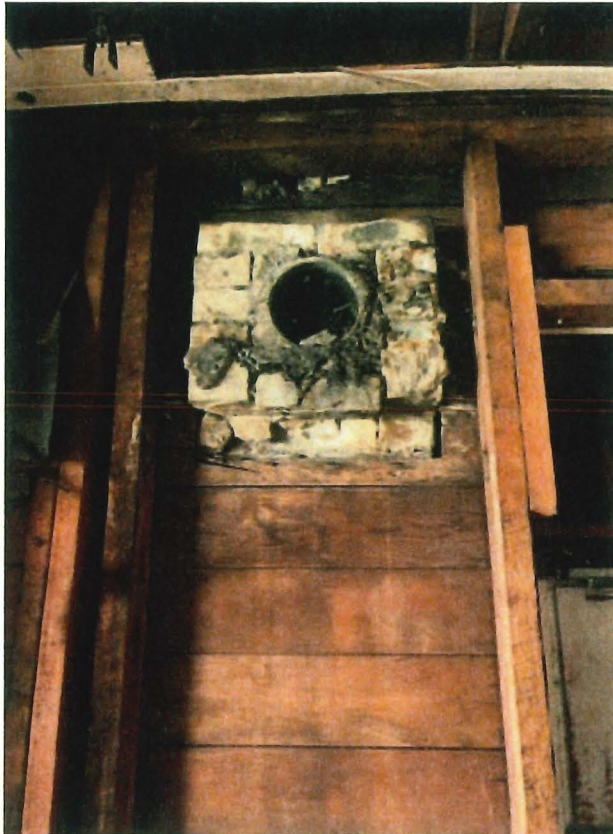
**Figure 32: Interior of west wall chimney connection illustrating its original brick form.**

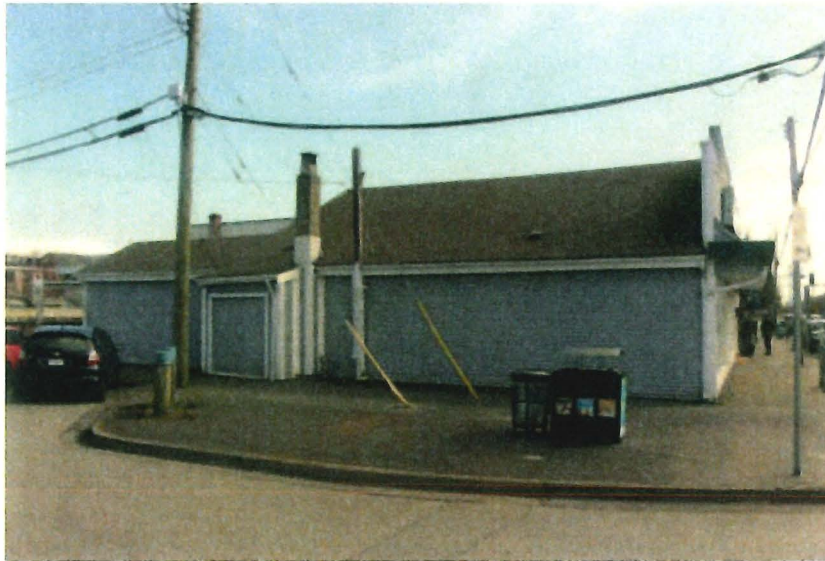
Figure 33: West side of subject site, with paired loading door, chimney and utility pole along First Avenue.

Further alterations made at the rear include a gabled extension behind the loading doors (c. 1930) and an additional flat roof with pediment storage or loading area setback further from First Avenue completed in 1987; the history of these components have been further discussed – see Section 2.1 of this report (Figures 33 and 34).

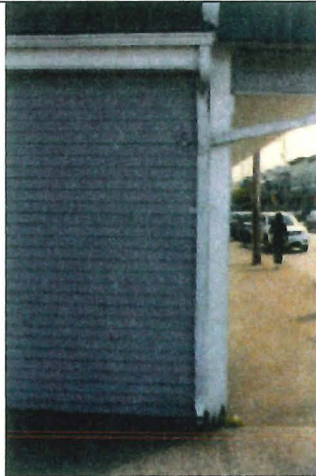
| | DESCRIPTION AND CONDITION | PHOTO DOCUMENTATION |
|---|---|---|
| <b>5.3<br/>FOUNDATION<br/>AND<br/>PERIMETER</b> | <p>The original section of Ikeda Dry Goods, the tall gabled portion, was never set on a foundation. The walls were placed directly on the ground with no protection. The interior floor is a poured-in-place concrete slab. Along with the lack of a foundation, there is little vertical clearance between the sidewalk and the cladding and cornerboards on the west side, and between the ground and wall on the east side. It is likely that when it was built, there was either no sidewalk along First Avenue, or the level of the sidewalk was lower, which would have provided a more substantial exposed height of the foundation wall.</p> <p>The front face was built with a brick base which has provided some protection, unlike the west and east sides.</p> <p>The east side perimeter structure - base and wall studs - is in extremely poor condition: the entire base of the wall frame has rotted, and most of the wall studs were no longer connect to the ground: this has been addressed with a new base foundation. The west side structure is in fair condition: some of the base of the base wall frame has deteriorated, but likely due to better overall protection (i.e. multiple layers of cladding and accessibility) it is much better than the east wall. The studs are in good condition.</p> <p>The front wall is in good condition.</p> <p><b>NOTE: As of November 2025, the west and east walls have had their foundation set to bring the base of the wall up to an acceptable level.</b></p> | |

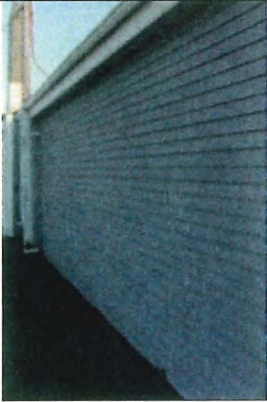
| | DESCRIPTION AND CONDITION | PHOTO DOCUMENTATION |
|---|---|---|
| 5.4<br>CLADDING | <p>The outer layer of cladding on the main floor, west wall, is lap siding. This side is illustrated in the first photo. It is in generally good condition, although the first several strips along the bottom have some paint deterioration, evidently due to rain water backsplash due to the minimal degree of separation between the wood wall and sidewalk. This includes the area of the chimney enclosure. The condition of the first layer of cladding, the original drop siding, appears from the inside to be in good condition. The condition of the middle layer of cladding, the rock-dash stucco, was not visible except for a small section at the bottom, so it is inconclusive as to its overall condition.</p> <p>The cladding on the east wall is in poor condition, and is missing significant sections due to long-term deterioration (as noted in Section 5.3). However, the cladding on the rear elevation, set below the gable roofline, has the same coved profile as the east side, and appears to be in good condition.</p> <p>There are sections of the newer rear extension where the wood at the lowest level has been replaced and is separating from the original lap siding above. Otherwise, the cladding is in good condition.</p> <p>The cladding on the rear extension, on the east side facing the neighbouring property, is concrete block, confirming that this is a newer addition.</p> <p>The cladding in the upper section of the rear (original section of building) is intact drop cove siding, original to the building. It is assumed this encompasses the entire rear face, most of which is covered by the addition.</p> | <div><p>West wall lap siding</p></div> <div><p>Partially exposed cove siding, east wall</p></div> <div><p>Original cladding in upper section of rear gable</p></div> |

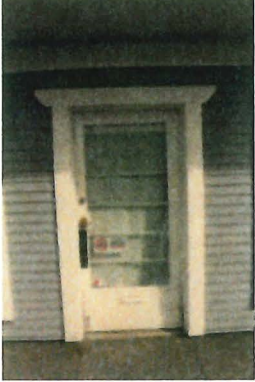
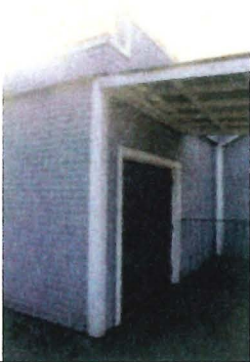
| | DESCRIPTION AND CONDITION | PHOTO DOCUMENTATION |
|---|---|---|
| 5.6 DOORS | <p>The storefront door is in good condition, having been relocated at some earlier time from what was a recessed entry to its position aligned with the new storefront wall. There has been some minor damage from installing additional locks and hardware. There has been a plywood panel added to the bottom in lieu of a kickplate and there is some heavy paint build-up on the door frame, but otherwise the door appears to be in good condition.</p> <p>The paired door on the west side situated in the shed roofed bump-out is in poor condition. The door is evidently not original, as it is partially clad in plywood, which is showing signs of wear, with paint spalling and general paint deterioration and warping due to water backsplash. The bottom edge of the plywood section is separating from the door. The opening itself, though, while not original, does express the evolution of the building.</p> <p>The other paired door on the west side, set further to the rear as part of the more recent addition, is in good condition as it is largely protected by the fiberglass roof overhang. The doors are steel clad, making them more durable.</p> | |

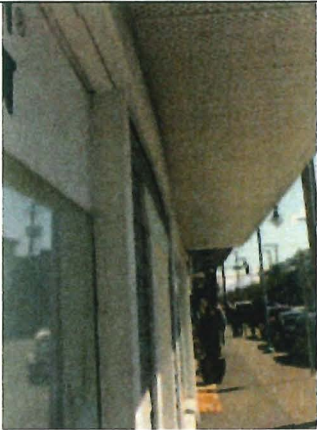
| | DESCRIPTION AND CONDITION | PHOTO DOCUMENTATION |
|---|---|---|
| <b>5.7<br/>WINDOWS,<br/>SILLS AND<br/>TRIM</b> | <p>The storefront windows are in very good condition. These windows are more recent alterations to the building, where the recessed entry was moved forward to the front property line. The windows had originally been angled inwards to connect with the entry door frame, and likewise were moved forward. The door itself is in the same setting, although moved forward, and centrally-set between the two large storefront windows. The trim and sills of both storefront windows, and the door, are in very good condition.</p> <p>The fascia board above the storefront windows, immediately below the soffit, is showing minor signs of warping but generally it is in good condition.</p> <p>The frames of the remainder of windows that are visible from the interior, comprising three on the west side and one on the east side, are in excellent condition.</p> <p>There is a single window remaining in the rear wall of the original building, which appears to be intact and in good condition, although the glazing has been painted over.</p> | <p>Storefront detail</p> <p>Modified storefront</p> <p>Original window, now set on interior wall, rear</p> |

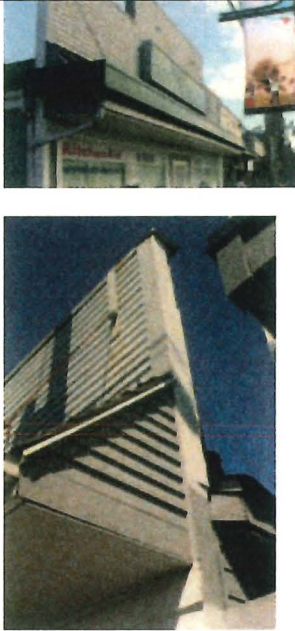
| | DESCRIPTION AND CONDITION | PHOTO DOCUMENTATION |
|---|---|---|
| <b>5.8 CANOPY AND SIGNAGE</b> | <p>The canopy is in fair condition, although the cedar shingles are nearing the end of their life cycle and require replacement. The structural integrity of the canopy was recently assessed, and the necessary improvements have been made under the auspices of an engineer: cable supports run up into the false front pediment. The wood lap siding set into the sides, as well as the aluminum soffit, are in good condition. The wrap-around signage attached to the canopy is in fair condition, and the plastic panels have been spray painted over. However, it is important to note that this has already been removed and deemed to be neither viable to reinstall (based on investigation of the overall condition that was undertaken as part of this report), nor historically important (see Section 6.8).</p> | |

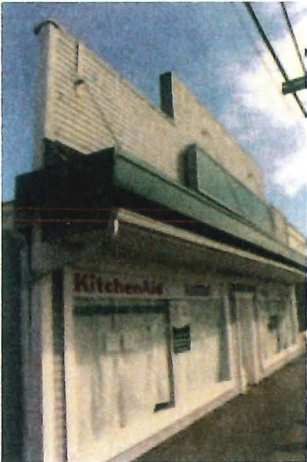
| | DESCRIPTION AND CONDITION | PHOTO DOCUMENTATION |
|---|---|---|
| 5.9 PARAPET | <p>The parapet is in generally good condition, with lap siding on the front face and shingles on the rear face. There is some minor warping in the lap siding. The section of the backside where the asphalt shingles of the roof meet the wall shingles of the parapet is in fair condition, showing signs of minor deterioration due to the lack of flashing and long-term contact with rainwater on the roof.</p> | <br><br> |

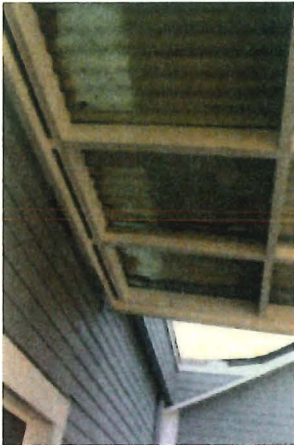
| | DESCRIPTION AND CONDITION | PHOTO DOCUMENTATION |
|---|---|---|
| 5.10 ROOF, GUTTERS AND DOWNSPOUTS | <p>The main roof is covered with asphalt shingles. They are in generally good condition, although the section that is in the shadow of the parapet has some moss build-up.</p> <p>The shed roof extension over the rear addition has a fiberglass cover which is in poor condition, with broken sections and various holes visible. The wooden structural support for the fiberglass appears to be in good condition.</p> <p>The flashing around the front pediment, and around the pediment for the rear extension is in fair condition.</p> <p>The gutter on the west side, between the utility pole and the chimney, is sloping away from the downspout, creating an opportunity for water retention and penetration. The gutter between the utility pole and the storefront corner has some minor damage but is intact.</p> <p>Along the west side, the downspouts drain on to the open sidewalk – there is no perimeter drainage except by the rear extension which has a storm drain and the downspout set on the section behind the chimney has no extender at the bottom.</p> <p>Similarly, the downspout at the rear has no extender and rain water discharge is allowed to flow out unimpeded.</p> | |

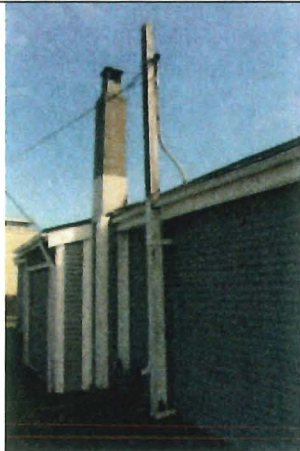
| | DESCRIPTION AND CONDITION | PHOTO DOCUMENTATION |
|---|---|---|
| <b>5.11<br/>CHIMNEY<br/>AND UTILITY<br/>POLE</b> | <p>There is a narrow concrete block chimney on the west side, set toward the rear of the original portion of the building. It is generally in good shape, and the concrete block is a later reconstruction of what was originally an earlier brick chimney of similar proportions.</p> <p>There is also a wooden utility pole set a few feet away from the chimney. It is in poor condition, showing advanced signs of deterioration at the base.</p> | |

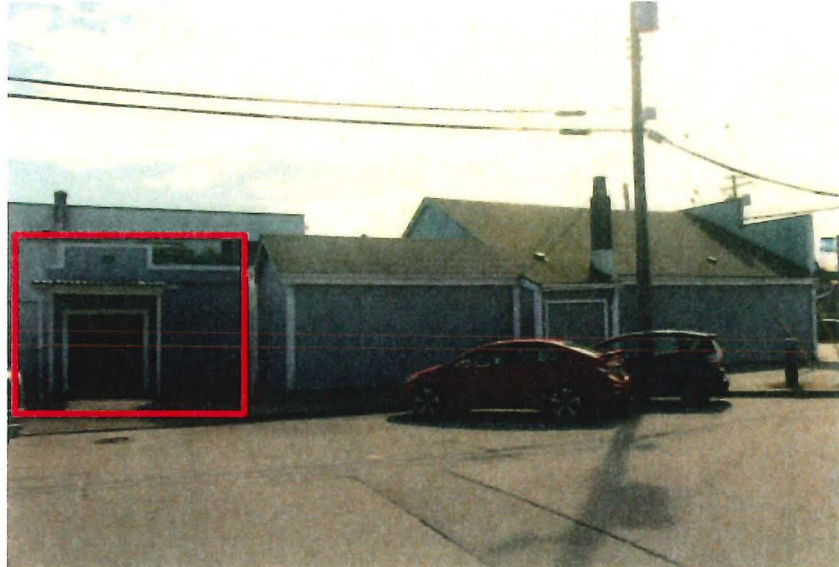
**Figure 35: Portion of building proposed to be removed, comprising the 1987 addition (red outline).**

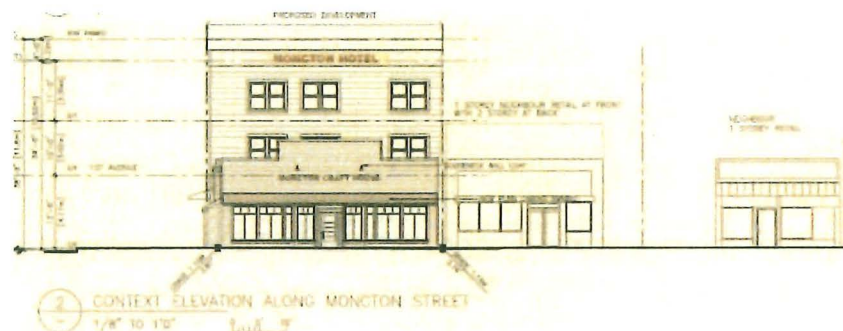
**Figure 36a: Proposed Moncton Street Elevation - Context**

The development will include a detached three-storey building serving as a boutique hotel fronting First Avenue (contextual elevations, Figure 36).

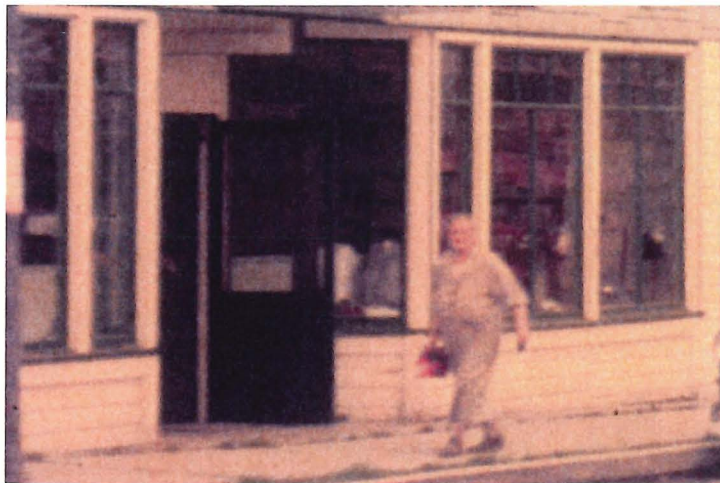
**Figure 47: Magnified view of storefront windows and base wall from c. 1950.**  
**Source: City of Richmond Archives, Noel McConnell Fonds, Photograph 2012 62b.**
