**Development Permit Panel  
Wednesday, September 26, 2012**

**2. Development Permit 12-597695**

**Re: Damage Assessment Report- Newbury Townhouse Development  
7771 Bridge Street, Richmond, BC**

On September 17<sup>th</sup>, 2012 GeoPacific Consultants Ltd. conducted a condition assessment of the Newbury Townhouse Complex at 7771 Bridge Street in Richmond, for which we were the original geotechnical engineer on record. The review was undertaken to determine the impact of neighbouring construction activities on the subject property and document visible damage within 15m of the complex's north property line. The review was based on visual inspection alone. The following summarizes the general condition of the Newbury townhouse development in the vicinity of the north property line, as well as photographs of any defects or deficiencies noted.

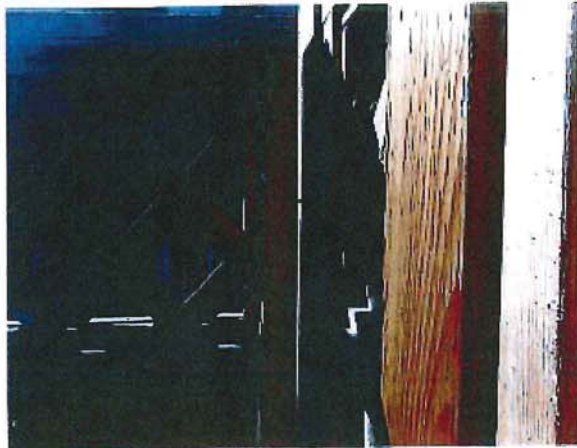
**Photo No.10**

Considerable ground movements and resulting impacts on serviceability of exterior structures were noticed along the north sides of units 1, 4, and 6. These included separations of fence sections up to 20mm wide (photos 10 & 11), movements of fence gates up to 55mm (photos 13, 21, & 23), stress cracks in soil up to 25mm wide running parallel to and at a distance of approximately 1.0m from the preload boundary (photos 12, 14, & 22), separation of paving bricks up to 30mm (photos 14 to 20, & 26), and settlements (<30mm) and cracks (<15mm) in concrete curbs (photos 16, 17, 18, & 25)

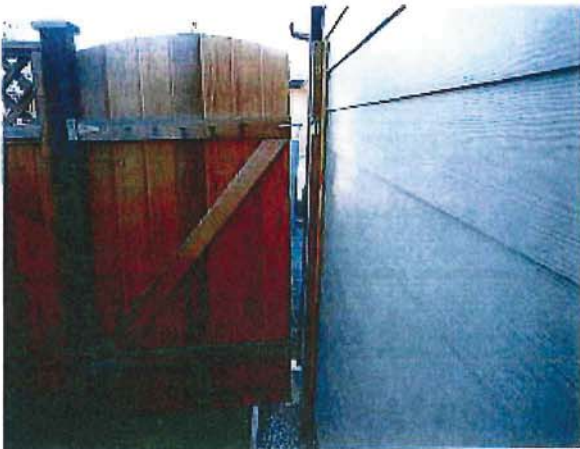
**Photo No.12**

9	Unit 6 interior- garage	Crack in wall paint (<1mm)
10	Unit 6 exterior	Fence section separation (<20mm)
11	Unit 6 exterior	Fence section separation (<20mm)
12	Unit 6 exterior	Soil stress crack (<25mm)
13	Unit 6 exterior	Movement of fence door (<55mm)
14	Unit 6 exterior	Soil crack and paving stone separation (<30mm)
15	Unit 6 exterior	Paving stone separation (<30mm)
16	Unit 6 exterior	Paving stone separation and curb settlement (<30mm)
17	Unit 6 exterior	Curb settlement (<30mm)
18	Unit 4 exterior	Paving stone separation and curb settlement (<30mm)
19	Unit 4 exterior	Paving stone separation (<30mm)
20	Unit 4 exterior	Paving stone separation (<30mm)
21	Unit 4 exterior	Movement of fence door (<30mm)
22	Unit 4 exterior	Soil stress crack (<20mm)
23	Unit 4 exterior	Movement of fence door (<10mm)
24	Unit 1 exterior	Crack in concrete curb (<15mm)
25	Unit 1 exterior	Example of non-damaged paving brick
26	Unit 1 exterior	Paving stone separation (<20mm)

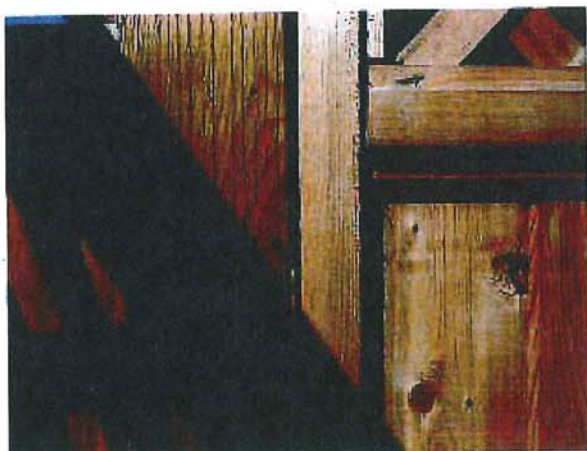
**Photo No.11**

Considerable ground movements and resulting impacts on serviceability of exterior structures were noticed along the north sides of units 1, 4, and 6. These included separations of fence sections up to 20mm wide (photos 10 & 11), movements of fence gates up to 55mm (photos 13, 21, & 23), stress cracks in soil up to 25mm wide running parallel to and at a distance of approximately 1.0m from the preload boundary (photos 12, 14, & 22), separation of paving bricks up to 30mm (photos 14 to 20, & 26), and settlements (<30mm) and cracks (<15mm) in concrete curbs (photos 16, 17, 18, & 25)

9	Unit 6 interior- garage	Crack in wall paint (<1mm)
10	Unit 6 exterior	Fence section separation (<20mm)
11	Unit 6 exterior	Fence section separation (<20mm)
12	Unit 6 exterior	Soil stress crack (<25mm)
13	Unit 6 exterior	Movement of fence door (<55mm)
14	Unit 6 exterior	Soil crack and paving stone separation (<30mm)
15	Unit 6 exterior	Paving stone separation (<30mm)
16	Unit 6 exterior	Paving stone separation and curb settlement (<30mm)
17	Unit 6 exterior	Curb settlement (<30mm)
18	Unit 4 exterior	Paving stone separation and curb settlement (<30mm)
19	Unit 4 exterior	Paving stone separation (<30mm)
20	Unit 4 exterior	Paving stone separation (<30mm)
21	Unit 4 exterior	Movement of fence door (<30mm)
22	Unit 4 exterior	Soil stress crack (<20mm)
23	Unit 4 exterior	Movement of fence door (<10mm)
24	Unit 1 exterior	Crack in concrete curb (<15mm)
25	Unit 1 exterior	Example of non-damaged paving brick
26	Unit 1 exterior	Paving stone separation (<20mm)
