RIVER ROAD (NO. 6 TO WESTMINSTER HIGHWAY) CITY OF RICHMOND

Traffic Operations Safety Review

Prepared by: **Watt Consulting Group**

Date: February 20, 2018

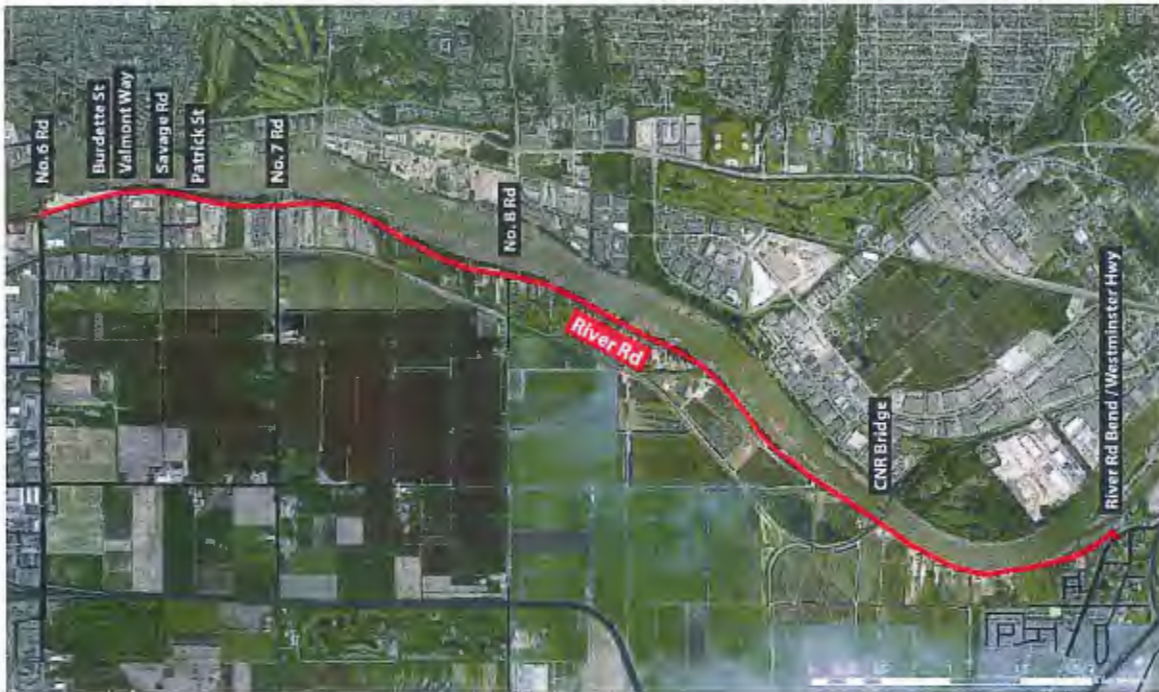
Figure 1: Study Area

The study area is shown in **Figure 1**. River Road is a two-lane secondary arterial road on a dyke bordering the Fraser River. It is rural in design and adjacent land uses, with no curbs or sidewalks. The posted speed limit is generally 50 km/h, except 30 km/h for trucks, although there is also section in the middle of the corridor that currently has speed humps installed, and in this area the posted speed limit is 30 km/h for all users. The road serves area residents and businesses (including commercial/industrial land uses along the western portion of River Road). The road also serves as a popular touring cyclist route on weekends. It is designated as an informal cycling route - shared lane facility per the City's Recreational Trails & Cycling Map. It is

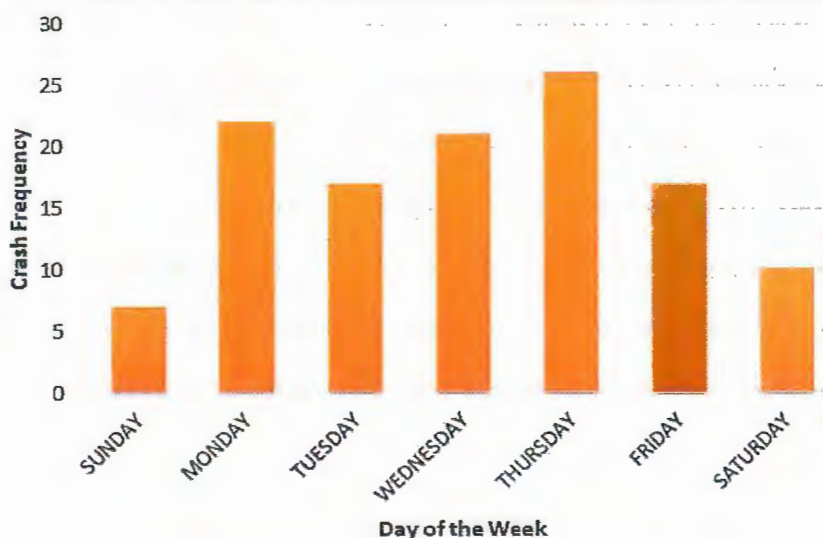
Figure 4: 2011-2016 Daily Collision Distribution

The 2011-2016 daily collision distribution is shown in **Figure 4**. The data indicates that the weekdays experienced the highest numbers of crashes.

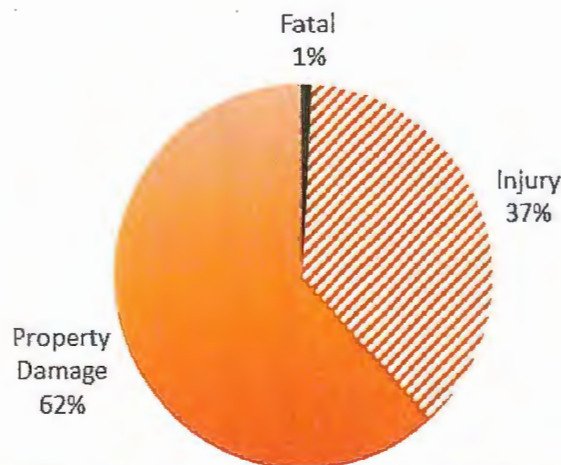
Figure 6: 2011-2016 Collision Severity Distribution

The 2011-2016 collision severity of the recorded crashes is illustrated in **Figure 6**. Slightly more than one-third of the crashes were injury or fatal collisions. This is consistent with the provincial average for similar roads (urban two-lane roads with AADT between 0 and 5,000 vehicles/day) and so collisions on River Road are not considered more severe than elsewhere in British Columbia. The data included one fatal collision that occurred in 2016 involving a cyclist. A second fatal collision occurred more recently outside the crash record period, involving a single vehicle going off-road.

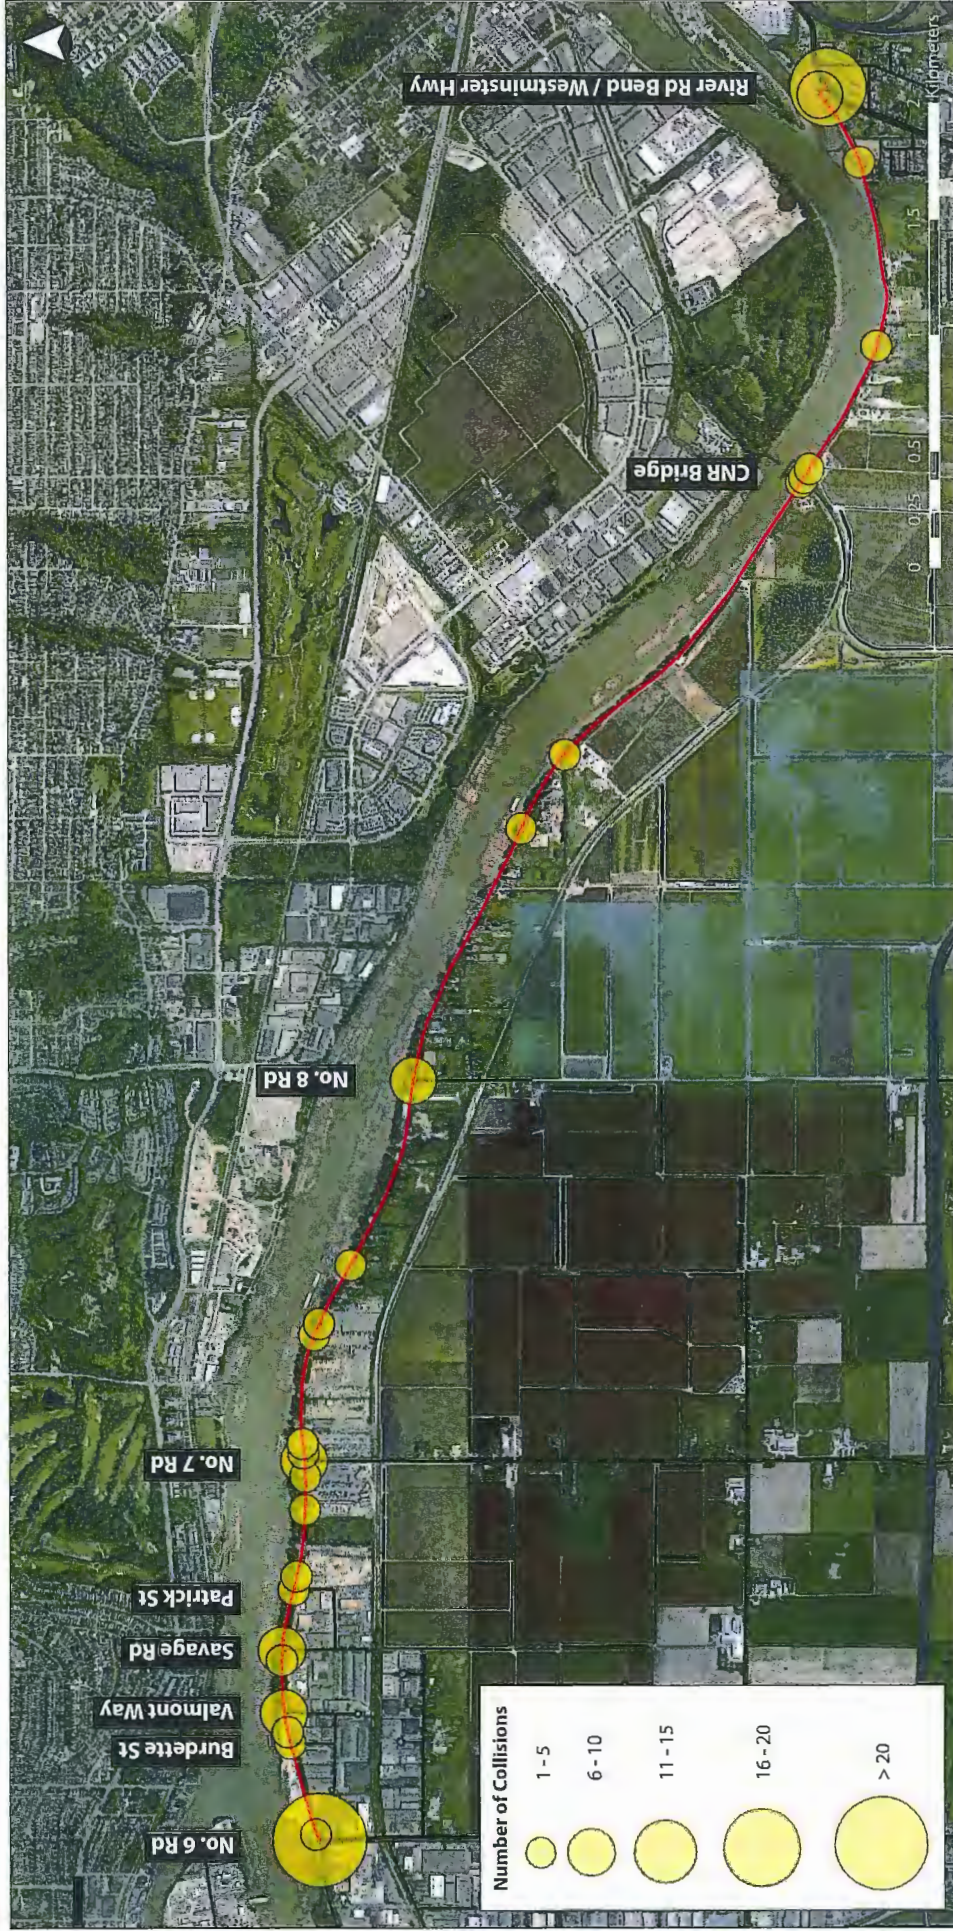
Frequency of Reported Collisions, 2011-2016

Figure 8 shows the collision diagram.

In the study corridor, the locations with the highest frequency of collisions are:

- No. 6 Road and River Road (22 percent of total collisions), and
- River Road and Westminster Highway curve and intersection (21 percent of total collisions).

Other than the curve locations, there are in general no other specific locations that are notably higher in collision frequency than others. There are, however, more collisions in the western half of the corridor than the eastern half.

Cyclist collisions occur at locations along the corridor, although there are more cyclist collisions in the vicinity of the curve at Westminster Highway than other areas of the corridor (two at or near the curve, as well as one at Westminster Highway itself).

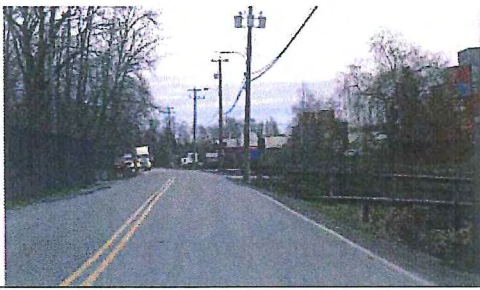
The roadway design is a two-lane rural road cross-section, with generally narrow lanes of variable width. There is also limited or no road-side shoulder in most areas. There is a steep drop-off to a ditch on the south side of the road in many areas which would be non-recoverable should a vehicle leave the roadway. There are utility poles, fire hydrants, trees, and fences close to the road in many areas (less than one metre away from edge of pavement in some cases).

River Road Looking East (west of No. 7 Road). Narrow Road, Minimal Shoulder, Steep Ditch to the Right. Fence near Road to the Left

The road is classified as a secondary arterial which suggests that the road surface should be widened to standard, shoulders installed, and roadside hazards located sufficiently far from the edge of road or protected. As well, given the nature of the road adjacent the river and the recreational use it attracts, pedestrian and cycling facilities (and possibly equestrian facilities) should be considered. It is acknowledged that these improvements would come at a high cost and likely be done when the dyke is re-built and therefore an interim option should be considered.

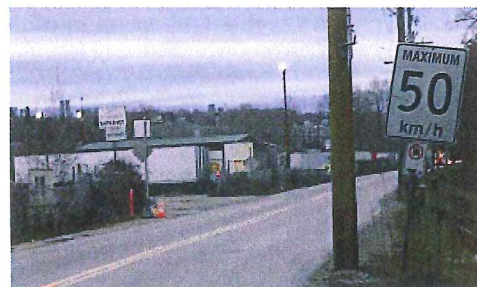
River Road Looking East (near No. 6 Road). Utility pole close to edge of road.

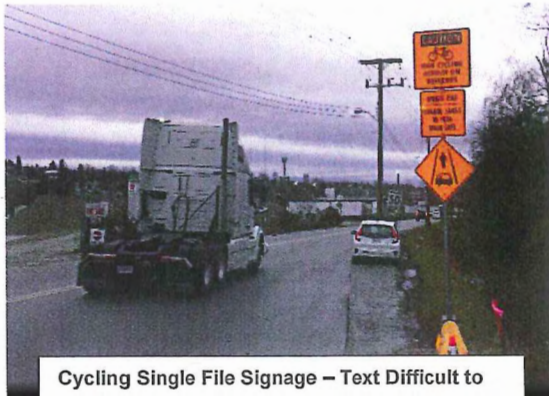
- The text is small and difficult to read, and the messages are long. This can make it very difficult for motorists to interpret the message while driving by at speed. This is exacerbated by combining multiple messages on the same pole.
- The message to change lanes to pass when safe does not match the majority of the pavement markings along the corridor, which are (in most areas) double yellow. This prohibits lane changing, which is contradictory to the warning signage message.

Cycling Single File Signage – Text Difficult to Read and Interpret At-speed

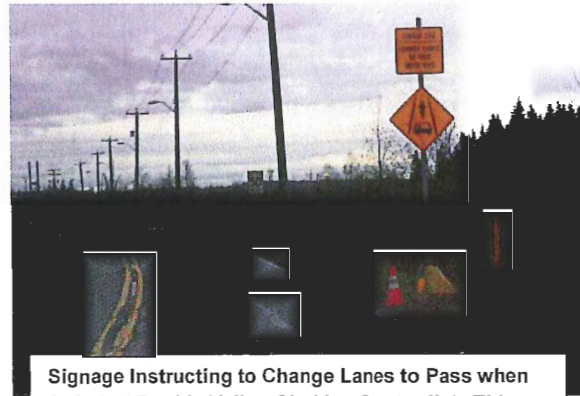
Signage Instructing to Change Lanes to Pass when Safe, but Double Yellow Marking Contradicts This
