# City of Richmond

## Report to Committee

**To:** General Purposes Committee  
**From:** Cecilia Achiam  
General Manager, Community Safety  
**Date:** August 27, 2020  
**File:** 12-8080-12-01/Vol 01  
**Re:** **Soil Use for the Placement of Fill Application for the Property Located at 8511 No. 6 Road (Jiang)**

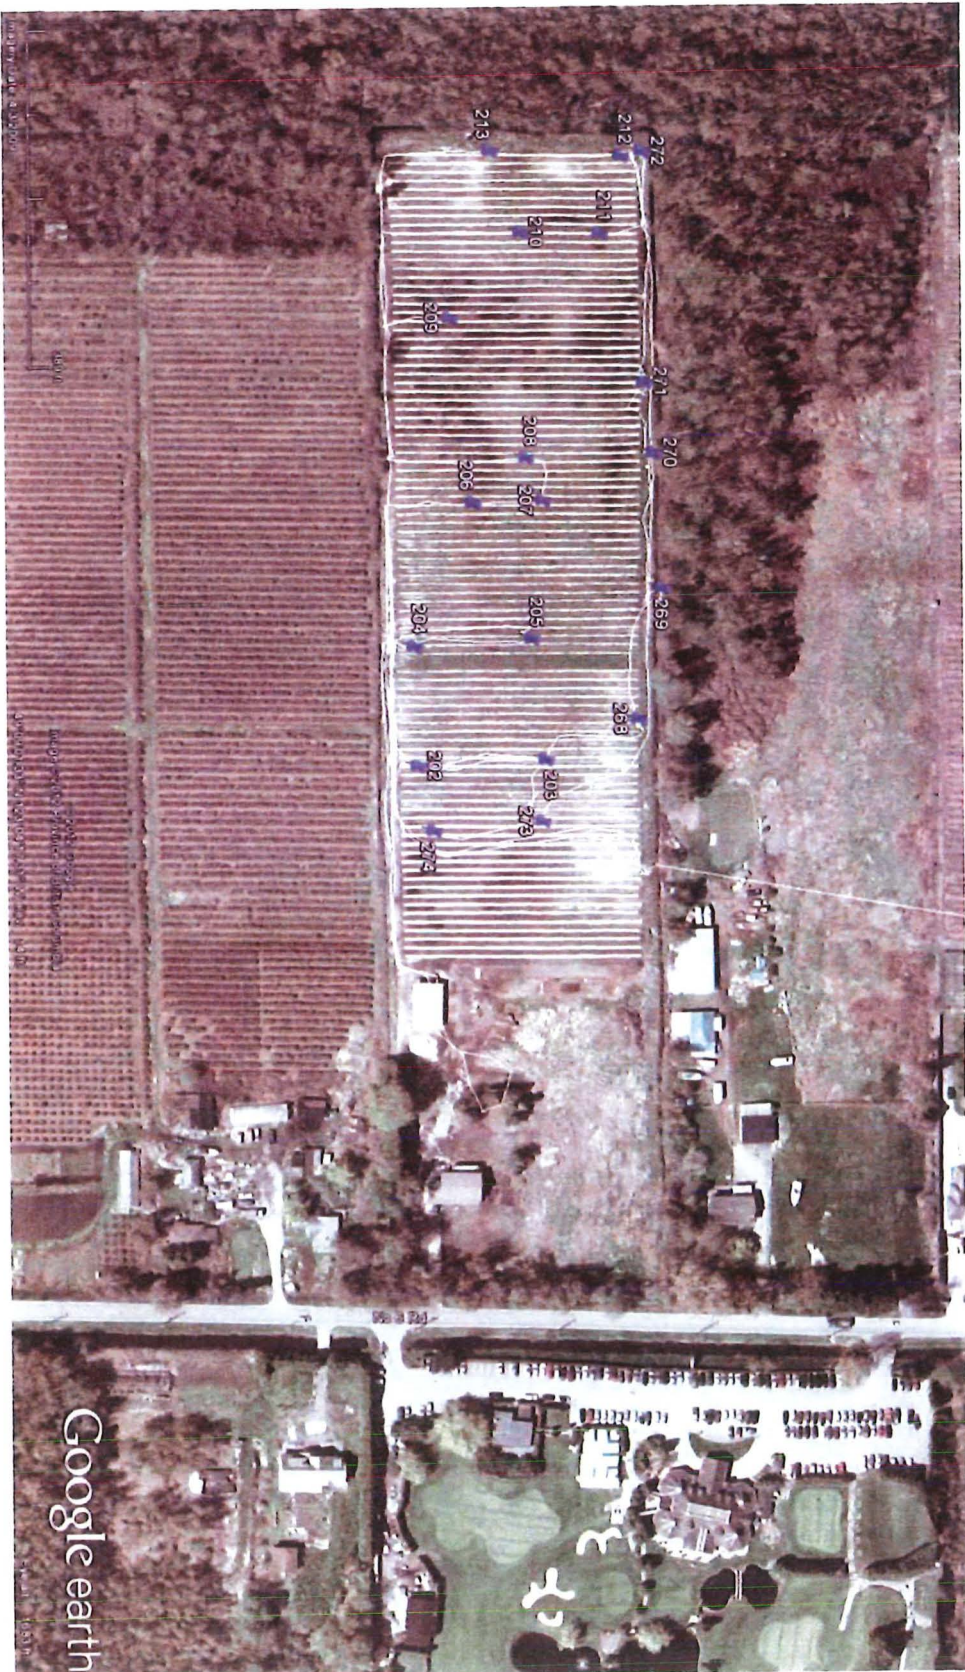
**Figure 1: Site and Sampling Locations**

Nineteen soil pits were dug on the site. The pits were located in positions to observe typical soils and depth of wood waste burial on the site. The sampling locations are shown on Figure 1 while Figure 4 shows a typical sample of the wood waste debris found on the site, Figure 5 shows typical depth of soil capping wood waste and Figure 6 shows an example of the cedar shavings (hog fuel) found on the site. Figure 7 shows the undisturbed organic soil from Pit WP 272, in the northwest corner of the property.

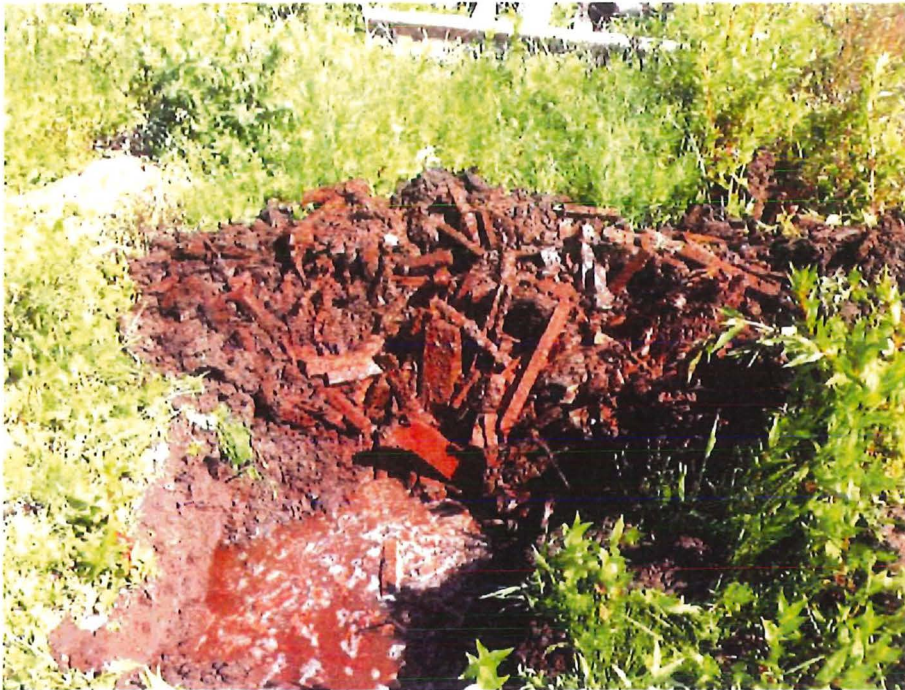
**Figure 4: Typical Wood Debris found buried on the Farm**

Most of the buried wood waste was in almost fresh condition with no signs of decomposition as can be seen in figure 4 and 6. It appears that the high water table and the soil capping are keeping the wood waste in anaerobic conditions and no microbial

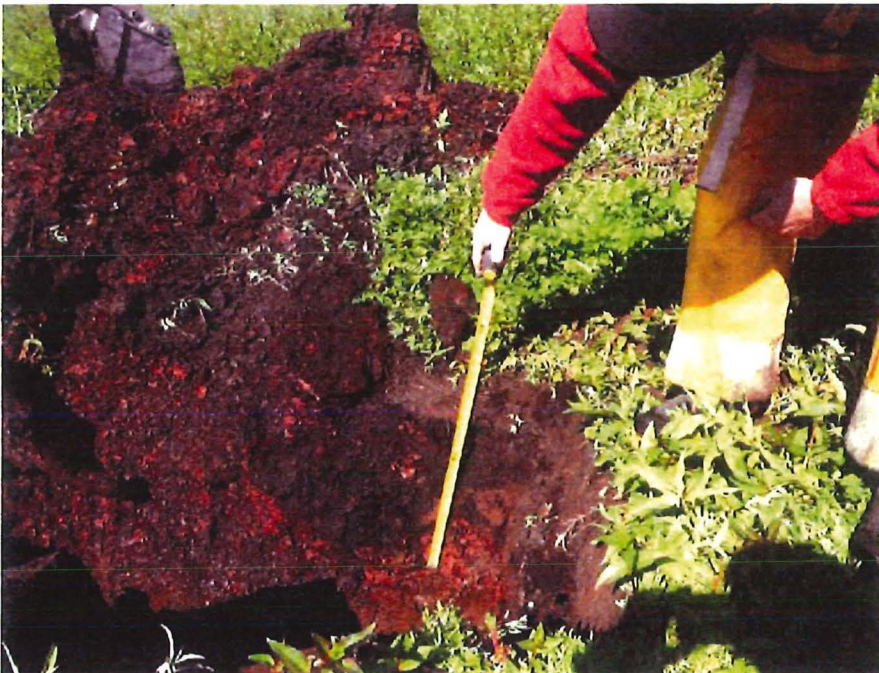
**Figure 5: Cedar Shaving Buried on Site**

The wood waste has been buried on this site for at least 30 years and as can be seen in figure 5 and 6, it is in virtually the same condition as when it was buried. The fine textured deltaic deposits that underlay the wood waste and the fine textured soil barrier between the wood waste and the ditches to the south and north has effectively sealed this site<sup>7</sup>. One of the key considerations in keeping the wood waste in an anaerobic condition is to ensure that the ground water is recharged at historical rates, as these have kept the wood waste submerged for most of the year. For this reason it is recommended that the cap depth be increased by 25 cm using silty clay loam or silty clay and not compacting to a state of impermeability. This cap will allow water to move slowly through and assist in the recharge of the water table on the site. There will of course be some recharge from the lateral and vertical movement of water into the site from the natural water table.

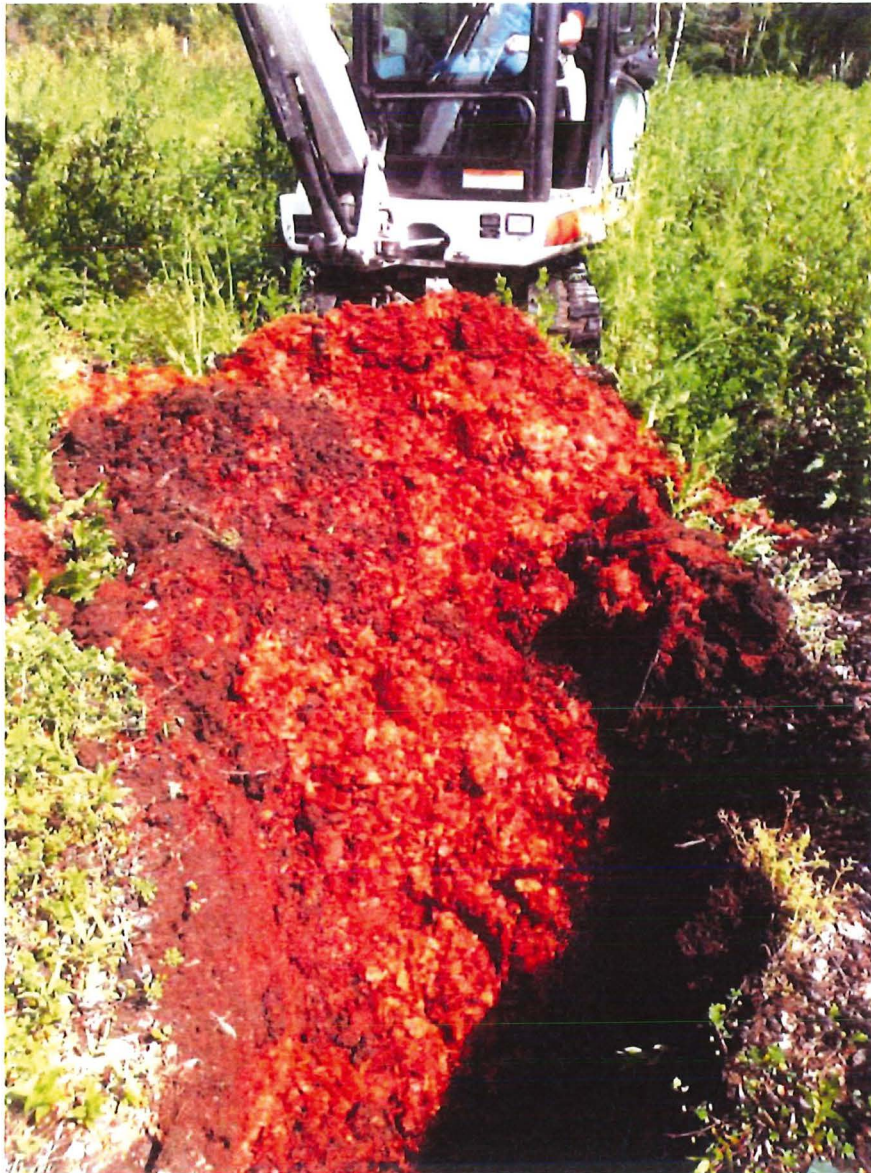
**Figure 6: Buried Wood waste**

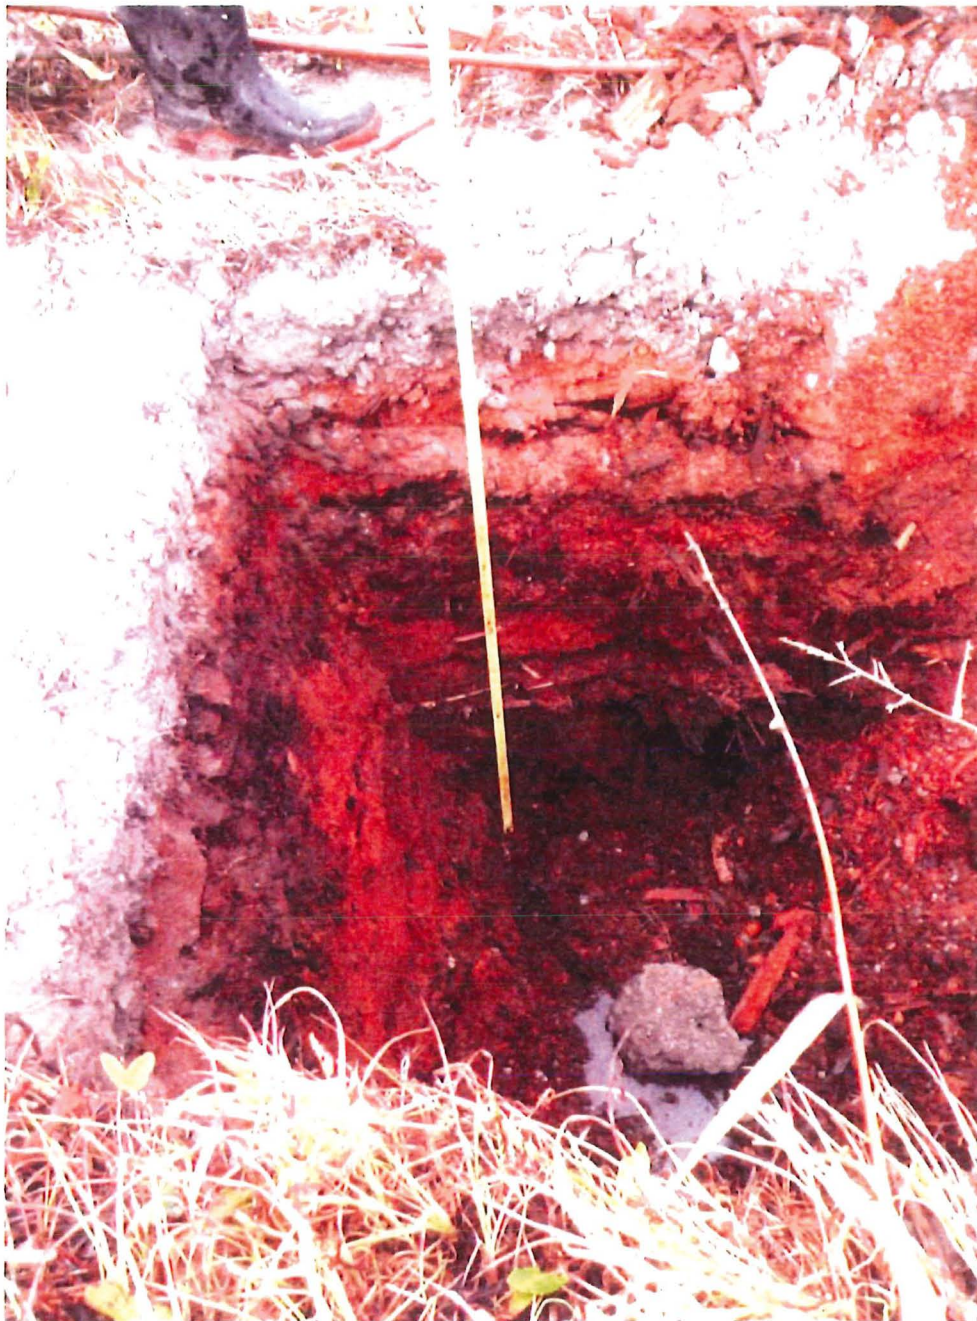
**Figure 7: Undisturbed Soil Profile**

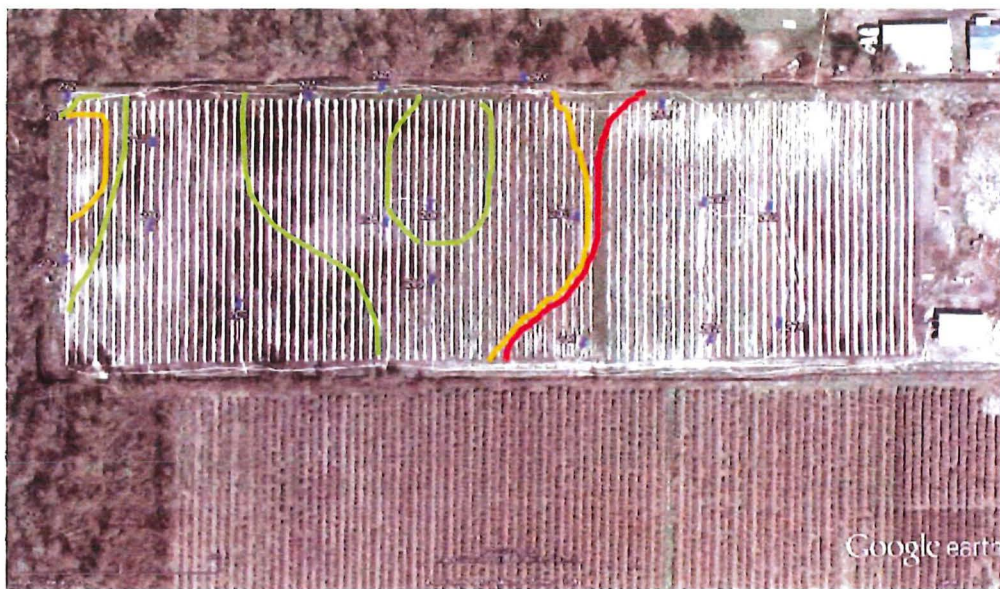
**Figure 8: Depth of Wood Waste on Site (contour in cm)**

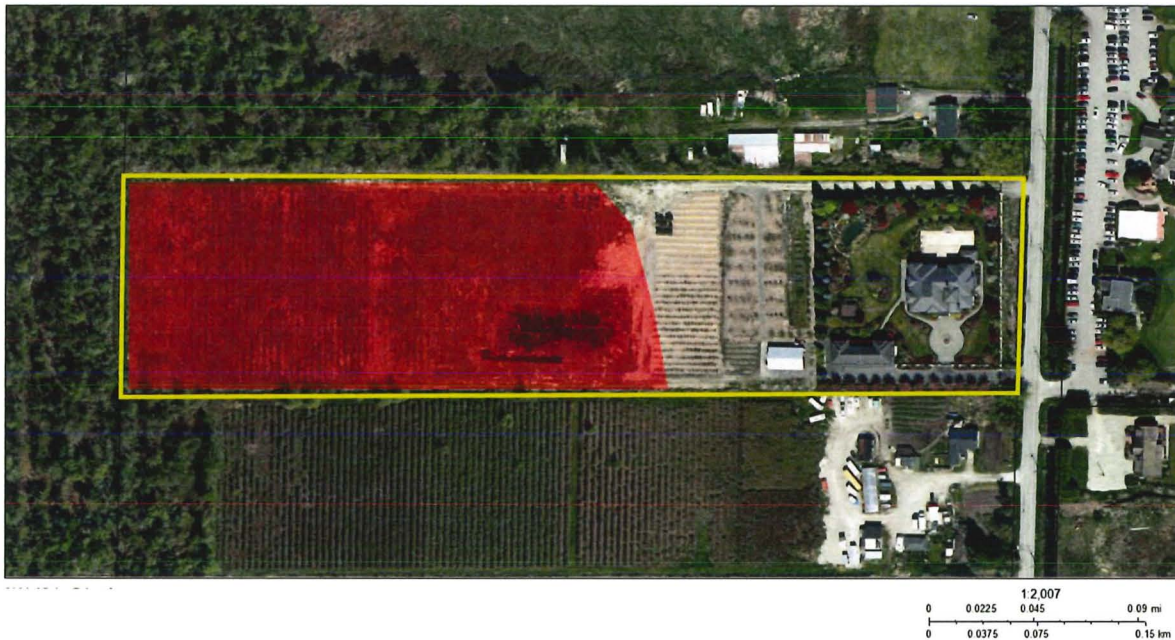
**FIGURE 1. SATELLITE IMAGERY OF 8511 NO.6 ROAD OUTLINED IN YELLOW. THE RED SHADED AREA REPRESENTS TO PROPOSED AREA FOR SOIL IMPORTATION. IMAGE PROVIDED BY THE CITY OF RICHMOND AND DATED AS TAKEN IN 2018.**
