City of Richmond

Report to Committee

To: General Purposes Committee **Date:** August 27, 2020
From: Cecilia Achiam **File:** 12-8080-12-01/Vol 01
 General Manager, Community Safety
Re: **Soil Use for the Placement of Fill Application for the Property Located at 8511 No. 6 Road (Jiang)**

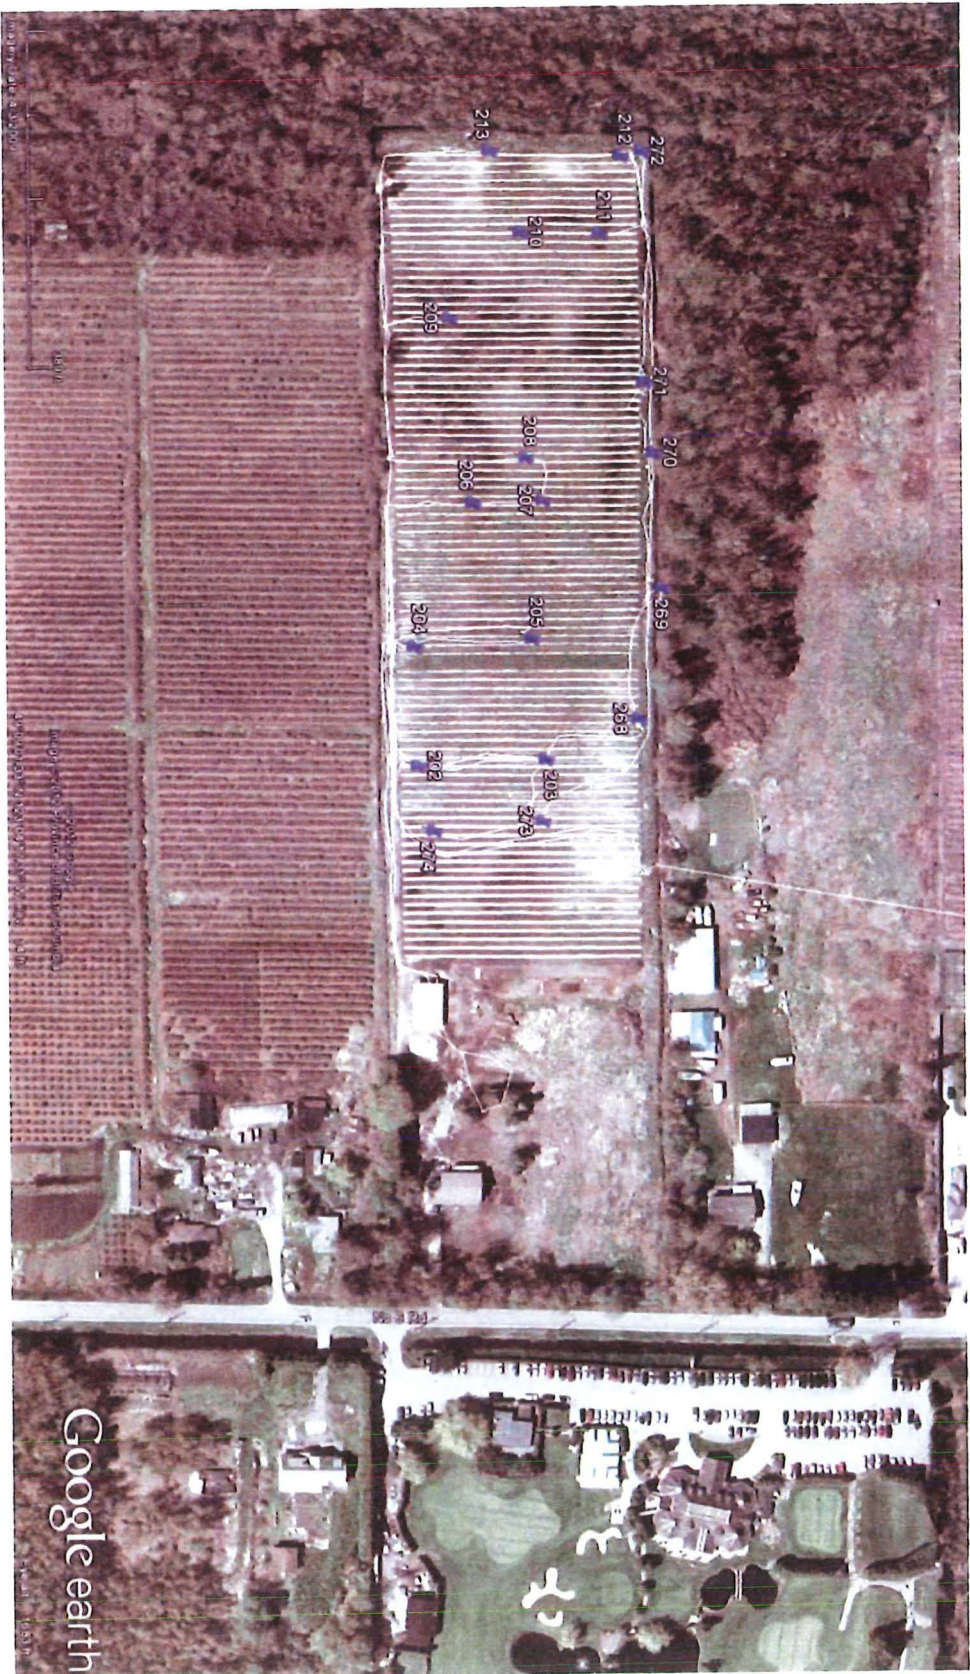
Figure 1: Site and Sampling Locations

Nineteen soil pits were dug on the site. The pits were located in positions to observe typical soils and depth of wood waste burial on the site. The sampling locations are shown on Figure 1 while Figure 4 shows a typical sample of the wood waste debris found on the site, Figure 5 shows typical depth of soil capping wood waste and Figure 6 shows an example of the cedar shavings (hog fuel) found on the site. Figure 7 shows the undisturbed organic soil from Pit WP 272, in the northwest corner of the property.

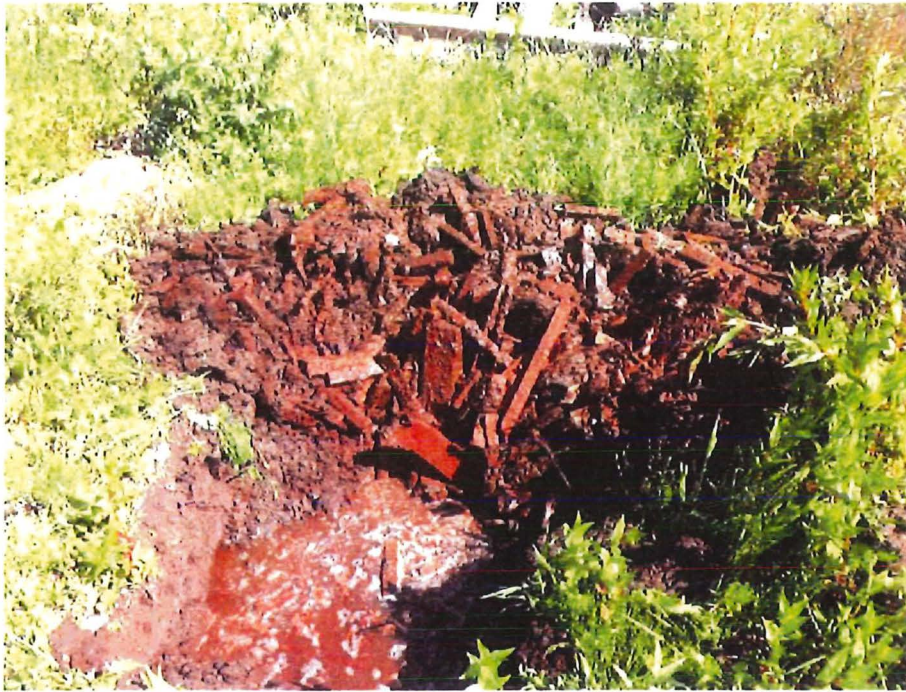
Figure 4: Typical Wood Debris found buried on the Farm

Most of the buried wood waste was in almost fresh condition with no signs of decomposition as can be seen in figure 4 and 6. It appears that the high water table and the soil capping are keeping the wood waste in anaerobic conditions and no microbial

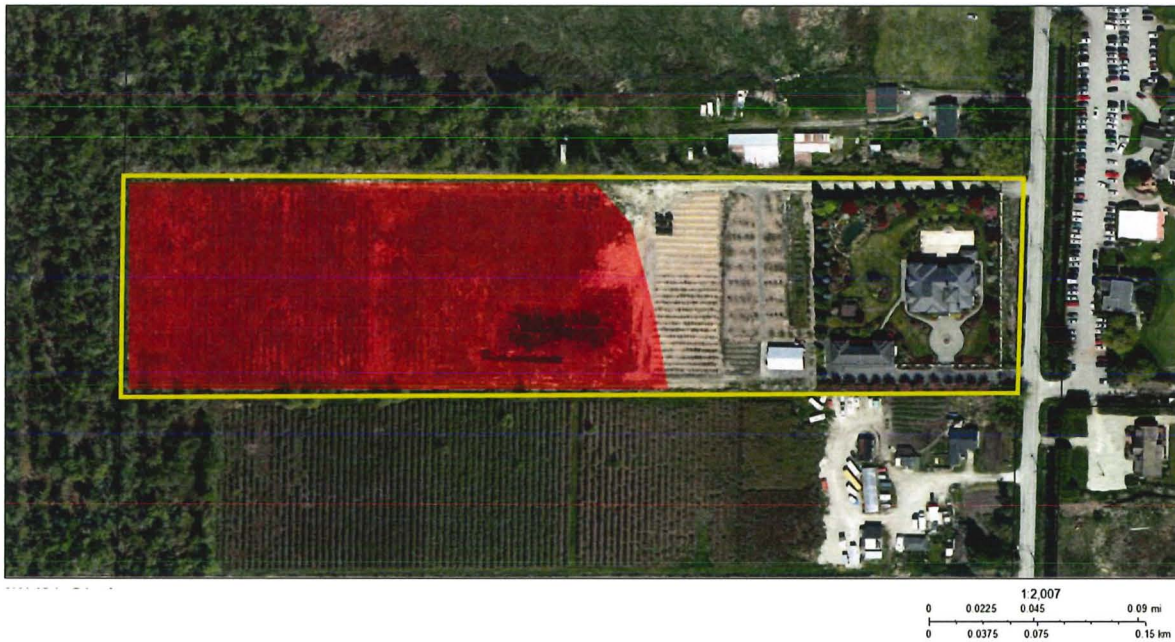
FIGURE 1. SATELLITE IMAGERY OF 8511 NO.6 ROAD OUTLINED IN YELLOW. THE RED SHADED AREA REPRESENTS TO PROPOSED AREA FOR SOIL IMPORTATION. IMAGE PROVIDED BY THE CITY OF RICHMOND AND DATED AS TAKEN IN 2018.
