City of Richmond

Report to Committee

To: General Purposes Committee **Date:** November 3, 2022
From: Mark Corrado **File:** 12-8350-05-AMANDA
 Director, Community Bylaws & Licencing #/Vol 01
Re: **Soil Use for the Placement of Fill Application for the Property at 22040 River Road (Thandi)**

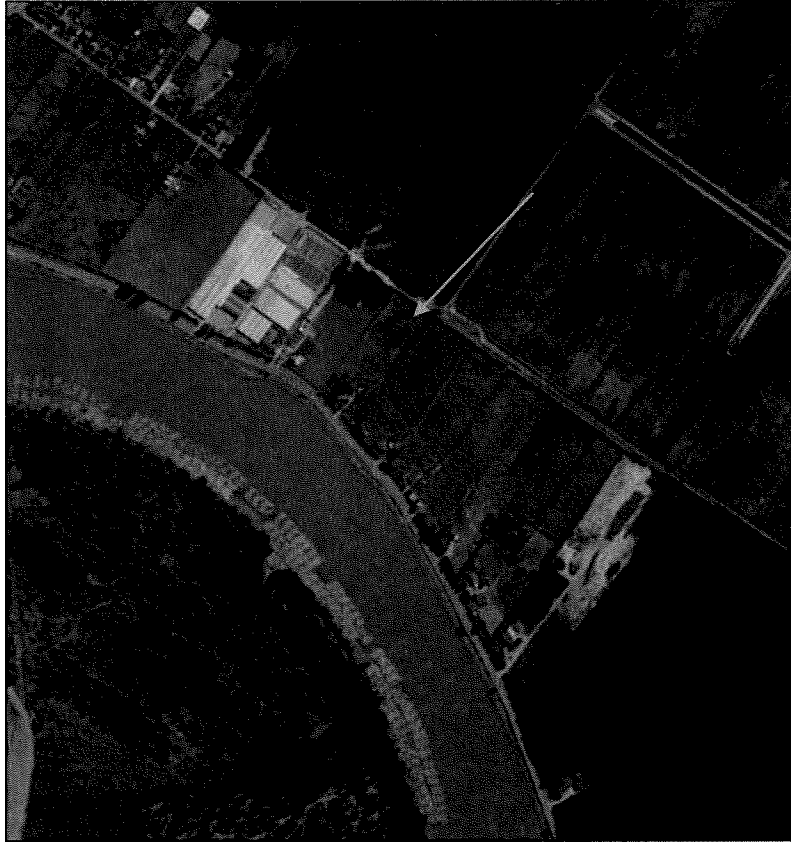
PHOTO 1: 1986 AIRPHOTO (BEFORE MR. THANDI PLANTED BLUEBERRIES) SHOWING VISIBLE WET SWALES/DEPRESSIONS IN THE MAJORITY OF THE LOT SOUTH OF THE RESIDENCE.

These are indicated by the blue arrow.

1986	30BCC535 No. 187	<p>Large portion of the cleared area (where the current blueberry farm is) is visibly wet. This shows up as a darker colour. Appears to be two connected, wet swales.</p> <p>Gilley Road right of way appears to have been recently cleared,</p> <p>The wetland/peat bog has re-vegetated. The subdivision was completed in 1993 – development works likely started sometime in the late 1980's to early 1990's.</p> <p>West neighbouring property – cultivated field, possibly a pasture/hay crop.</p>
2009	30BCC09001- 287	<p>Access roads, preparations for new residence on eastern neighbouring property (reduced crop production)</p> <p>West neighbouring – former crop cleared, possibly filled with soil (rear 2/3 of property). Large residence and tennis court constructed.</p> <p>Mr. Thandi's blueberry farm occupies majority of property and is of similar size and extent as modern day.</p> <p>Large subdivision built to south and southeast – small strip of forest still exists directly south of Mr. Thandi's property, on the east side of the cranberry farm. This strip of forest exists today. It may be city land or crown land (no property identification on BC Assessment).</p>

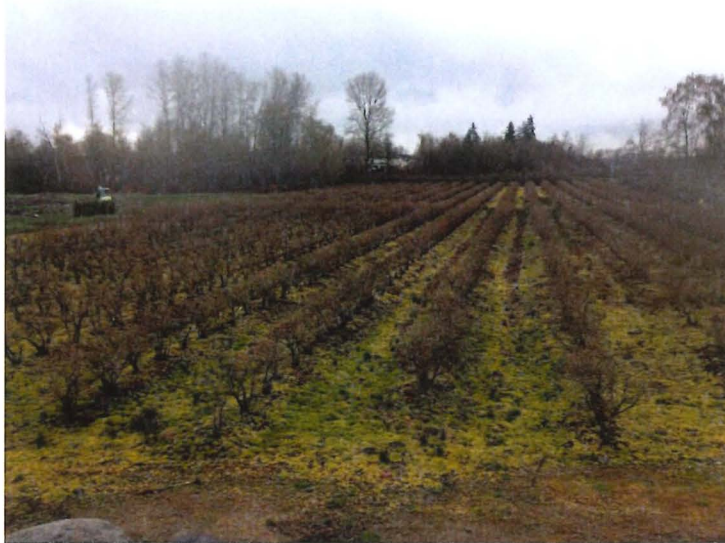
PHOTO 2. LOOKING DUE SOUTH ACROSS THE BLUEBERRY FIELD ON THE SUBJECT PROPERTY.

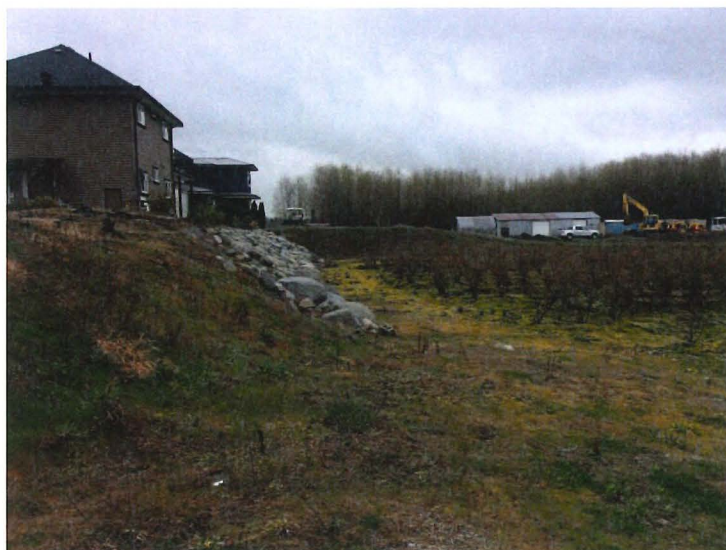
PHOTO 3. LOOKING EAST WHERE THE BLUEBERRY FIELD (NATURAL GRADE OF THE LAND) MEETS THE BERM (COMPACTED BOULDERS) CONSTRUCTED TO RAISE THE RESIDENCE TO THE FLOOD CONSTRUCTION LEVEL (3.5 M GSC).
The residence is on the top left of the photo.

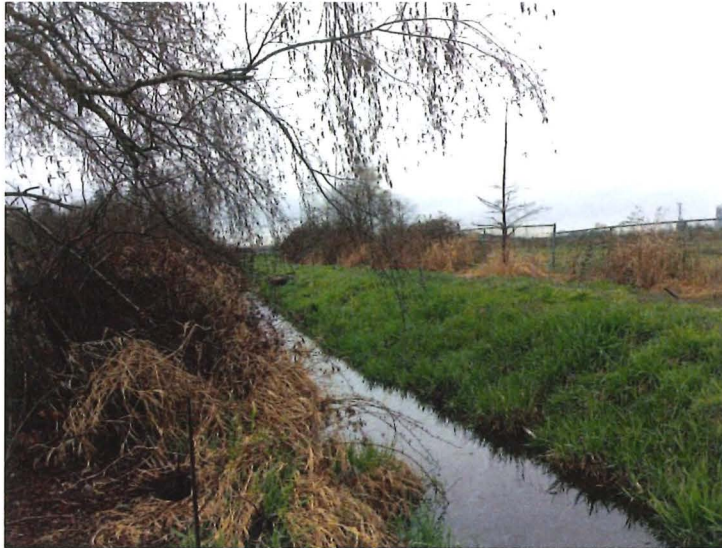
PHOTO 4. RMA/WATERCOURSE SITUATED ALONG THE WESTERN PROPERTY LINE. THIS IS NEAR SOIL PIT 2.
Note high ditch water levels – I measured the distance between the current water levels and the natural grade of the land at the bank on the left (Mr. Thandi's property) and found this to be 25 – 30 cm.

Shrublands⁶. The ditch that runs along the entire western edge of the property is a designated Riparian Management Area (RMA). There is a 15 m Riparian Management Area setback for this ditch – **agricultural use (farming) is exempt from this setback**. The RMA is partly vegetated by native trees and shrubs; this extends for approximately 3 m from the edge of the ditch (top of bank).

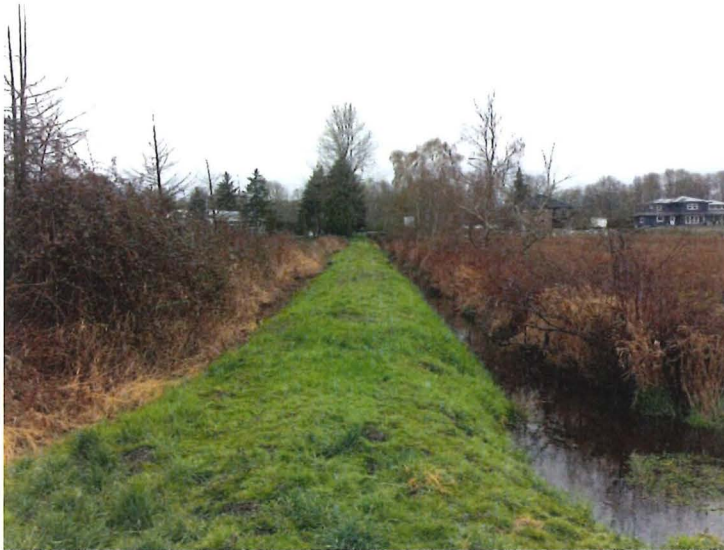
PHOTO 5. PIPELINE (UNDER THE GRASS IN THE CENTRE) INSTALLED FOR THE CRANBERRY FARM SITUATED TO THE SOUTHWEST.

This was installed on the west side of the ditch/watercourse. It pumps water from the Fraser River as an irrigation source for the cranberry farm. Mr. Thandi's property is on the right side of the photo. note the pipeline has raised the west side of the bank of the ditch – water therefore overflows eastwards (Mr. Thandi's property) during periods of high water levels in the ditch.

Flooding may be exacerbated over the property due to the higher bank on the west side of the ditch (see also, Photo 5 above which clearly shows this). The bank is higher due to the irrigation pipeline installed here – it runs parallel to the ditch and under the Gilley Road right of way to the south. This was constructed in the 1980's by B.K. Ranch Limited Partnership, the owner (at the time) of the cranberry farm situated to the southwest of Mr. Thandi's property (21551 Westminster Highway). The pipeline and associated pump were negotiated as an easement agreement with the Corporation of the Township of Richmond and Cranberry Management Consultants Ltd. (representing B.K. Ranch LP) in 1982¹³. Essentially when water levels in the ditch are high, water overflows eastwards onto Mr. Thandi's property which is situated at a lower elevation.

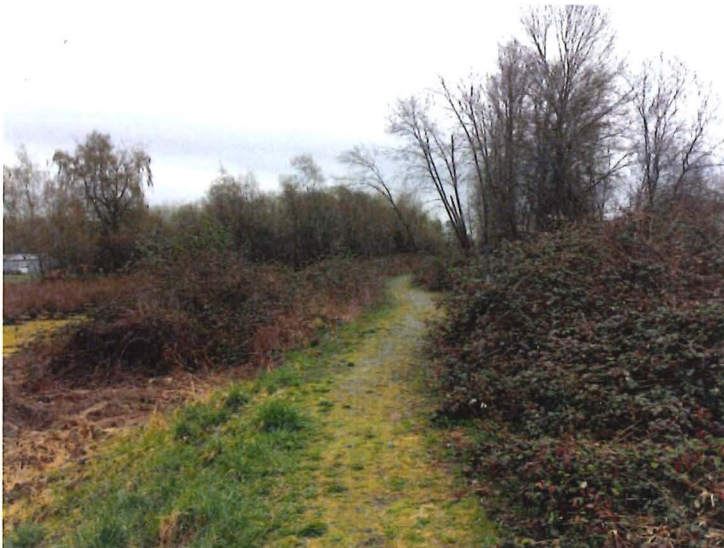
PHOTO 6. GILLEY ROAD RIGHT-OF-WAY (NON-STATUS ROAD).

The left side of the photo is the southern portion of Mr. Thandi's property, which is an ESA. The ESA is overgrown with blackberry.

Soil will ideally be spread from the south end of the property first (**ending at the small strip of blackberry comprising the ESA such that the ESA will not be disturbed, as shown on Photo 6**), progressing northwards towards the berm situated at the base of the residential farm home plate. Once the soil has been spread and graded, the stockpiled topsoil (which is native peat from the property) will be spread over the surface to construct a consistent soil profile across the filled area.

- That no soil is placed in the ESA (strip of blackberry on Photo 6, to the north of the right-of-way) situated along the very southern edge of the property, which is currently overgrown with blackberry.

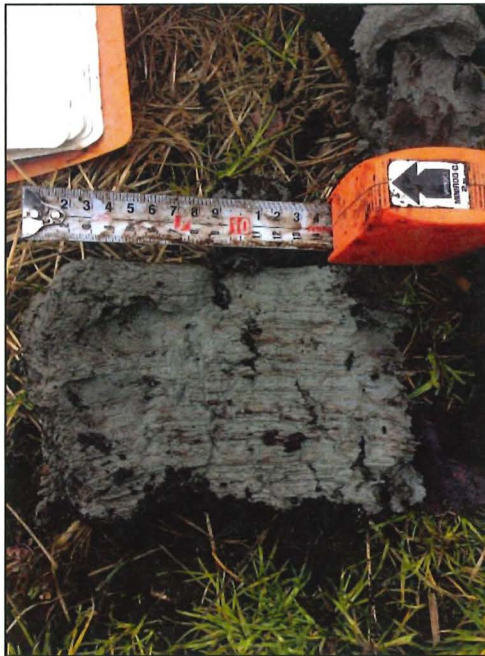
PHOTO 7. Cg HORIZON IN SOIL PIT 3, WHICH WAS EXCAVATED IN THE SOUTHERN END OF THE PROPERTY.

Note partly decomposed plant remains.

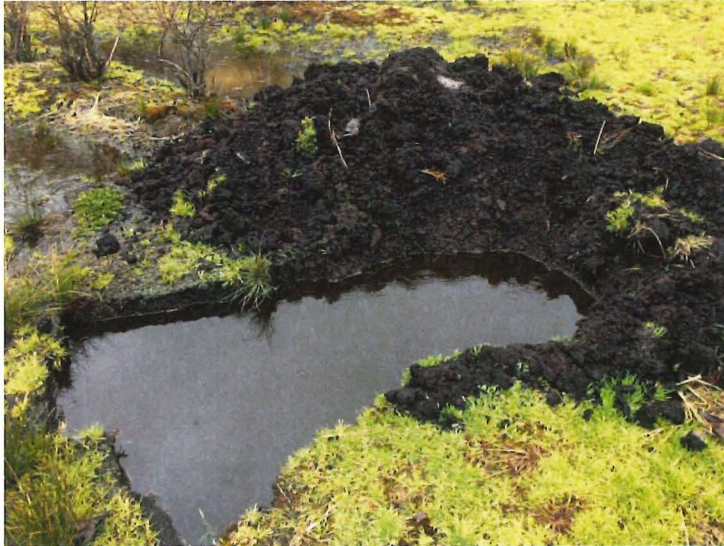
PHOTO 9. SOIL PIT EXCAVATED NEAR PIT 3 IN THE PREVIOUS WEEK THAT FILLED WITH WATER AND HAD TO BE ABANDONED.

We waited for precipitation to diminish before conducting our soil assessment.

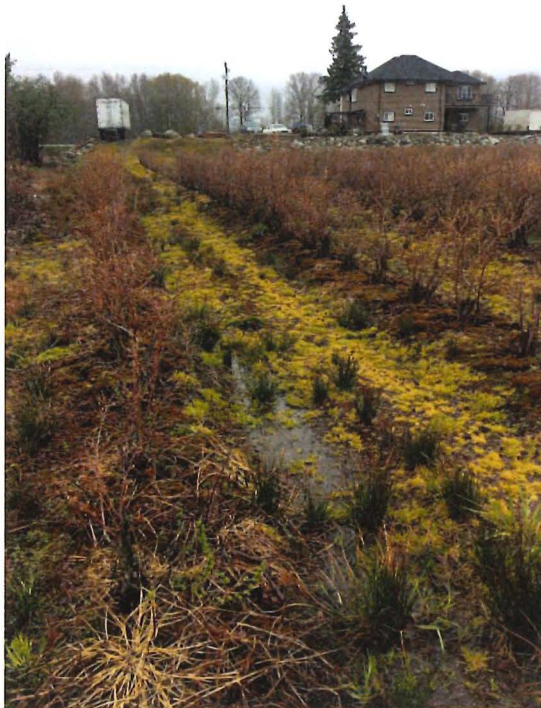
PHOTO 10. STUNTED BLUEBERRY PLANTS IN THE NORTHWEST CORNER OF THE FIELD.

These are affected by overflow from the ditch (watercourse) situated along the western perimeter of the property, in addition to the poorly drained soils of this entire area.

According to Mr. Thandi, the blueberry bushes situated along the western perimeter and in the northeast corner of his field are stunted and several are dying. I understand that Mr. Thandi has leased his farm to a third-party farmer for several years. The farmer has stated that the flooding has resulted in difficulties farming the property and would like to work with Mr. Thandi on resolving the flooding issues. A copy of this letter is supplied in Appendix V.

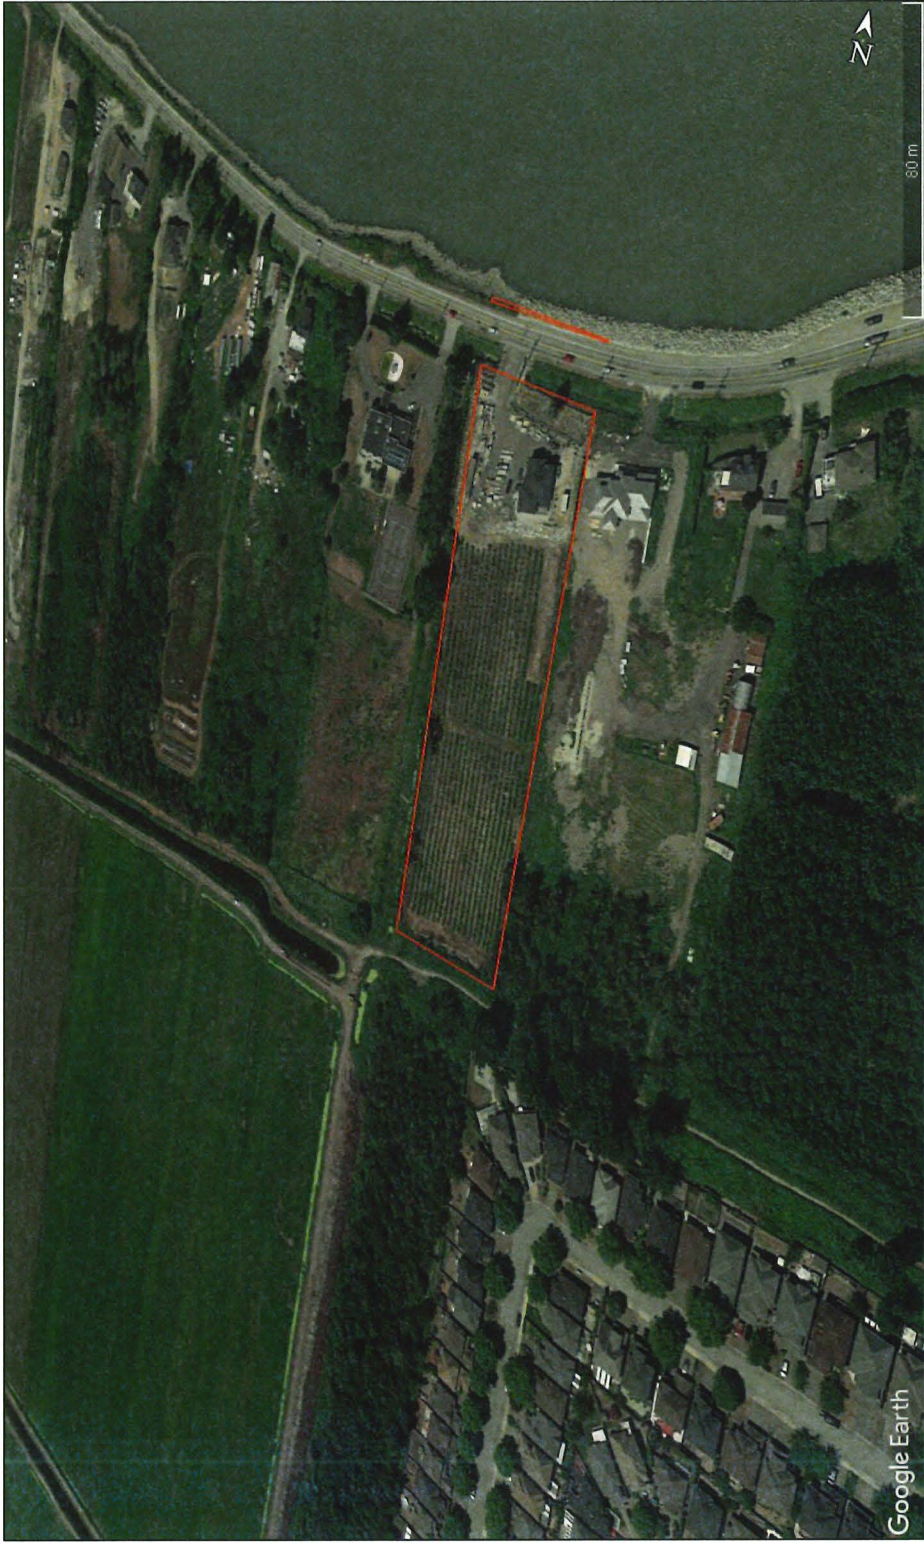
FIGURE 1. OVERVIEW OF THE SUBJECT PROPERTY (OUTLINED IN ORANGE) FACING WEST. THE ORANGE OUTLINE AT THE FRASER RIVER IS INCLUDED IN THE PARCEL MAP BC EXPORT BUT IS NOT BELIEVED TO BE PART OF THE PROPERTY.

Mr. Thandi's property at 22040 River Road, Richmond, BC, is approximately 22.7 km east of downtown Richmond (Figure 1). The property is situated on the south side of the Fraser River on River Road. The legal description of the property is: Lot 10 Block 5N Plan NWP8644 Section 35 Range 4W Land District 36 (PID: 000-651-672).

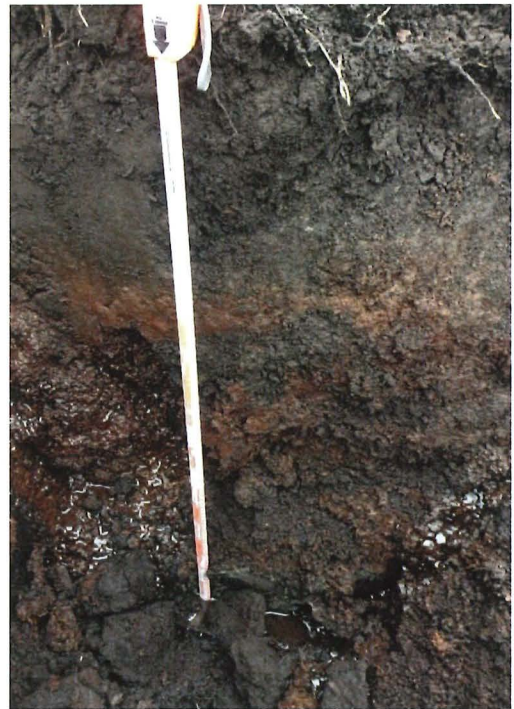
Pit 1 – Soil Profile Description (Placemark 3, Figure 2)

Horizon	Depth (cm)	Description
Oh1	0 - 40	Dark brown to black, humic (von Post class 7), plentiful fine roots, stratified.
Om2	40 - 90	Medium to light reddish brown, mesic (von Post class 5), friable to firm, plentiful fine to medium roots, weakly stratified
Cg	90 - 120+	Light blue-grey, silty clay loam, firm, no roots, no coarse fragments. Identifiable organics: sedge, woody plants remains.

- Located in the approximate centre of the blueberry field.
- Water encountered at bottom and sides of pit (seeping in quickly) - 1.2 m deep.
- Soil classification: Terric Mesisol

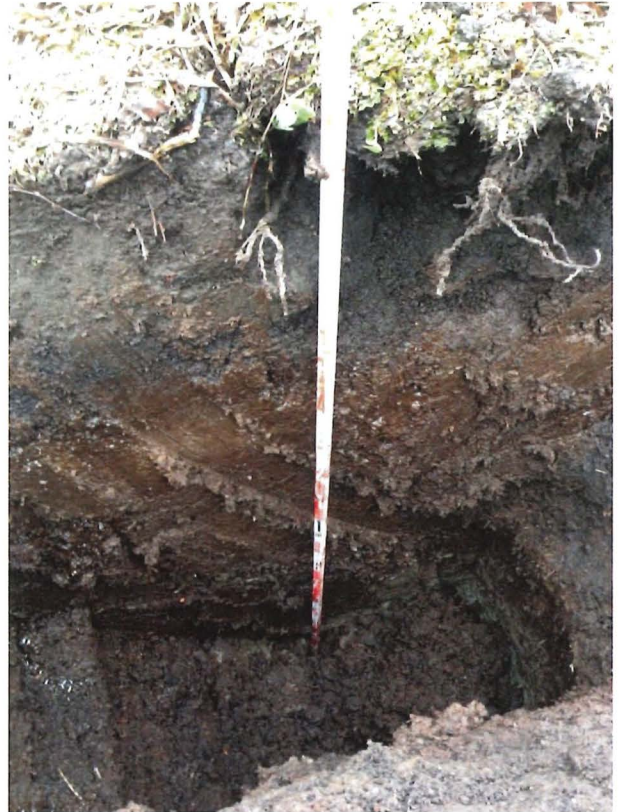
Pit 2 – Soil Profile Description (Placemark 4, Figure 2)

Horizon	Depth (cm)	Description
Oh1	0 - 40	Dark brown to black, humic (von Post class 7), plentiful fine roots.
Om2	40 - 170	Medium reddish brown, fibric to mesic (von Post class 4-5), plentiful fine to medium roots, plentiful undecomposed plant material (reeds, sedges)
Cg	170 - 180+	Medium blue-grey, silty clay loam, firm, no roots, no coarse fragments. Woody plants remains.

- Located along the centre-west property line (near the RMA/watercourse) where blueberry bushes are stunted.
- No water in this pit – there a buried drainage pipe from the blueberry field leading into the watercourse here.
- Deepest organics excavated on the property – over 1.7 m deep
- Soil classification: Terric Mesisol

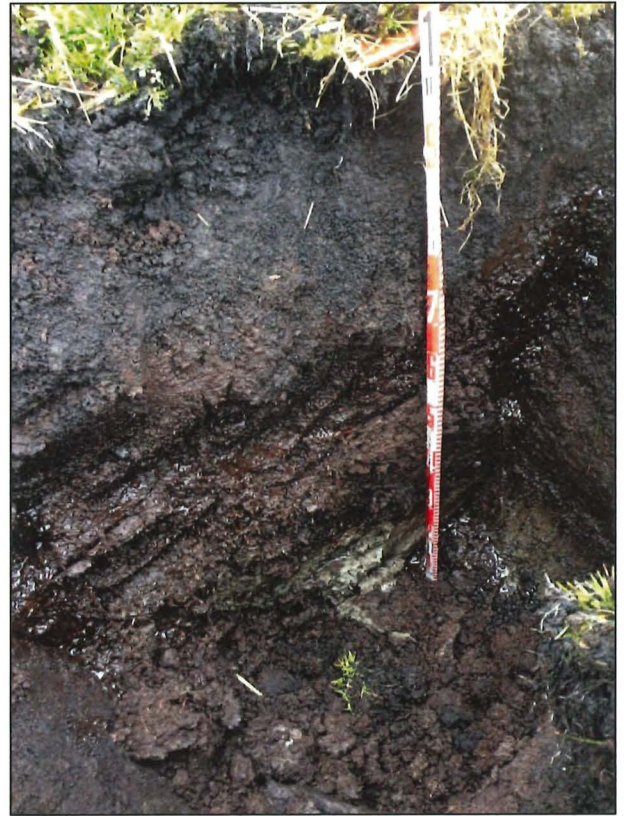
Pit 3 – Soil Profile Description (Placemark 10, Figure 2)

Horizon	Depth (cm)	Description
Oh1	0 - 40	Dark brown to black, humic (von Post class 7), plentiful fine roots.
Om2	40 - 80	Medium reddish brown, fibric to mesic (von Post class 4), plentiful fine to medium roots, weakly stratified, wet.
Cg	80 - 100+	Light blue-grey to olive grey, silty clay loam, firm, no roots, no coarse fragments. Identifiable organics: sedge, woody plants remains.

- Located in the southeast corner of the blueberry field near the ESA.
- Water encountered at bottom of pit – seeping in slowly. 1.0 m deep.
- Soil classification: Terric Mesisol

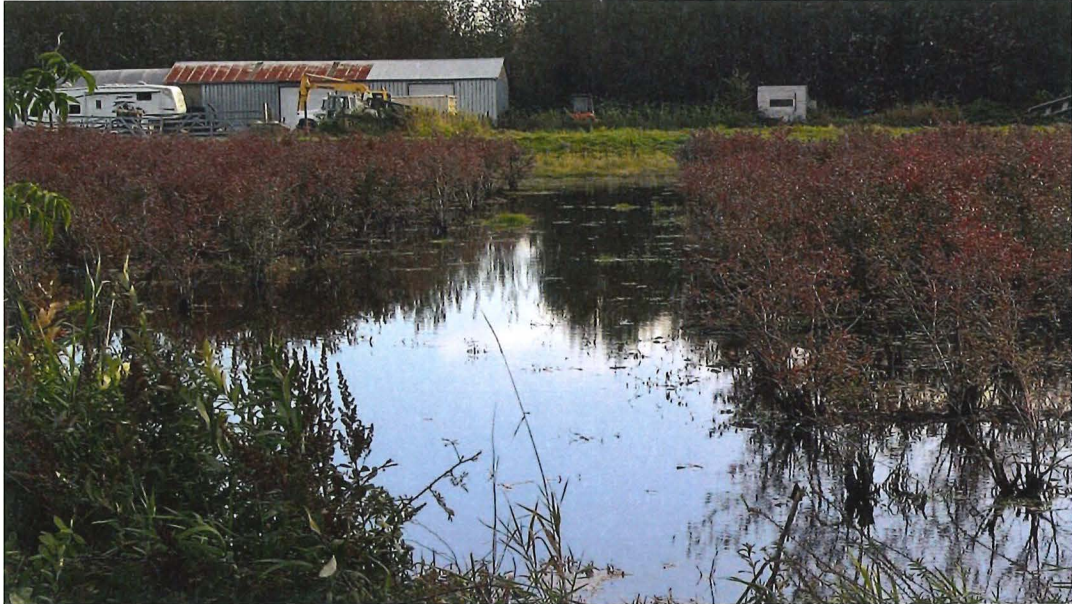
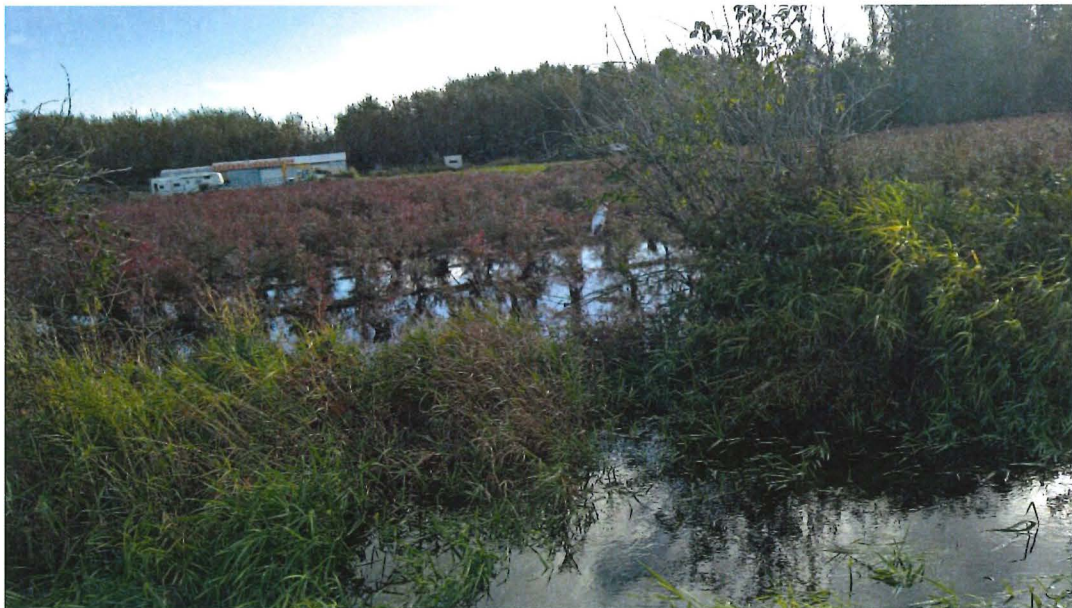
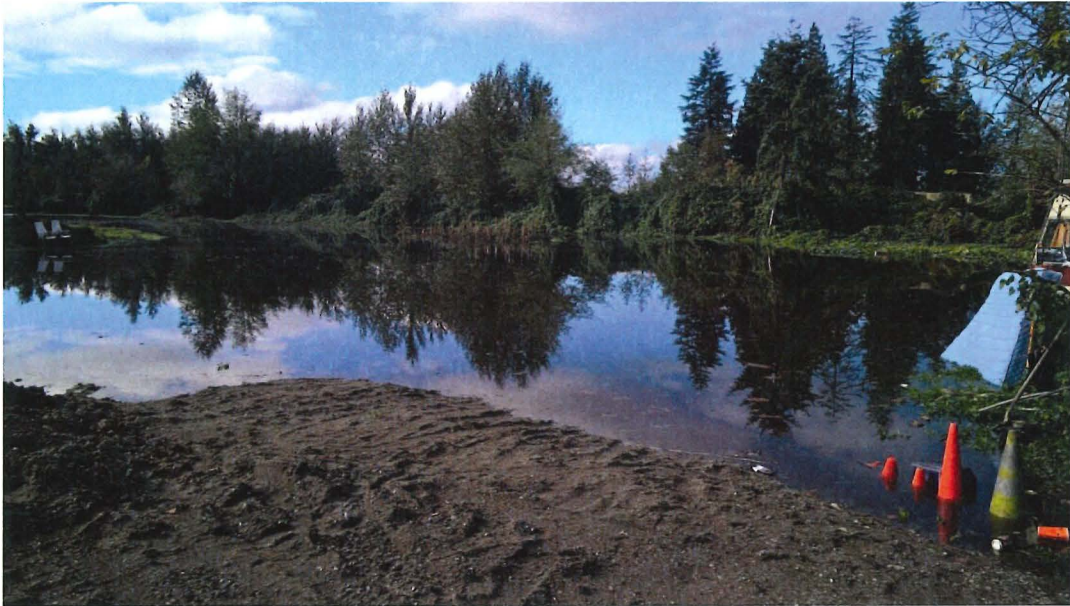
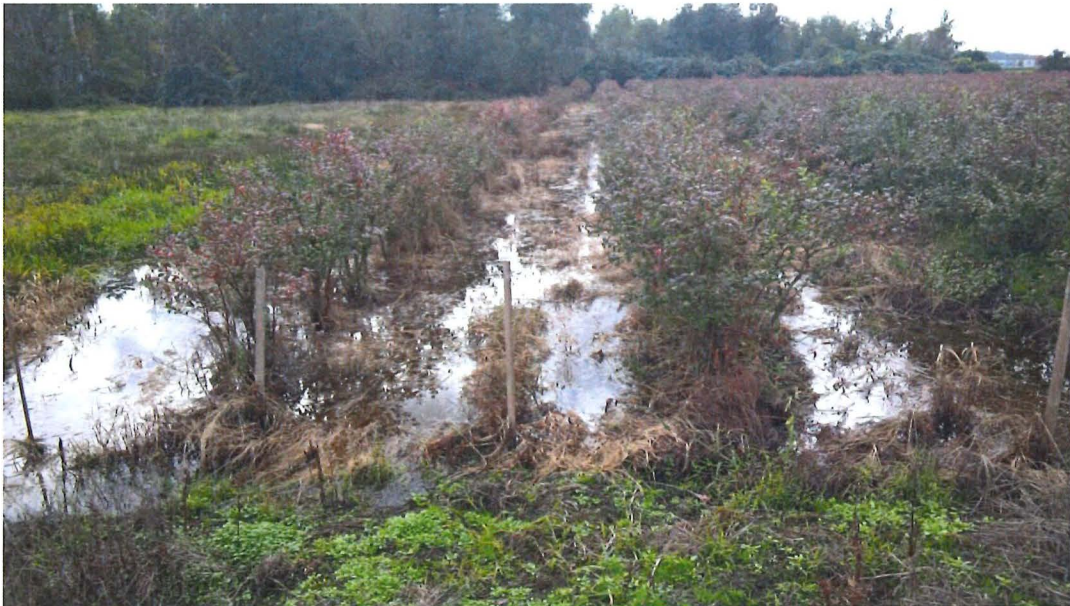
Client Photos of Flooding

supplied by the client – these photos are in Appendix II. Flooding from the ditch more than 7 days a year correlates to an inundation limitation at the Class 5I level. During my field assessment, I measured water levels in the ditch relative to the top of the east bank, which is Mr. Thandi's land at the natural grade (just over 1 m above sea level). The water levels were between 20 and 30 cm of the top of the bank. The bank is lowest near PM 4 on Figure 2.
