# City of Richmond

## Report to Committee

**To:** General Purposes Committee **Date:** December 20, 2022  
**From:** Mark Corrado **File:** 12-8080-12-01/Vol 01  
 Director, Community Bylaws and Licencing  
**Re:** **Soil or Fill Use Application for the Property at 8251 No. 5 Road (Garcha)**

## Agrologists Report

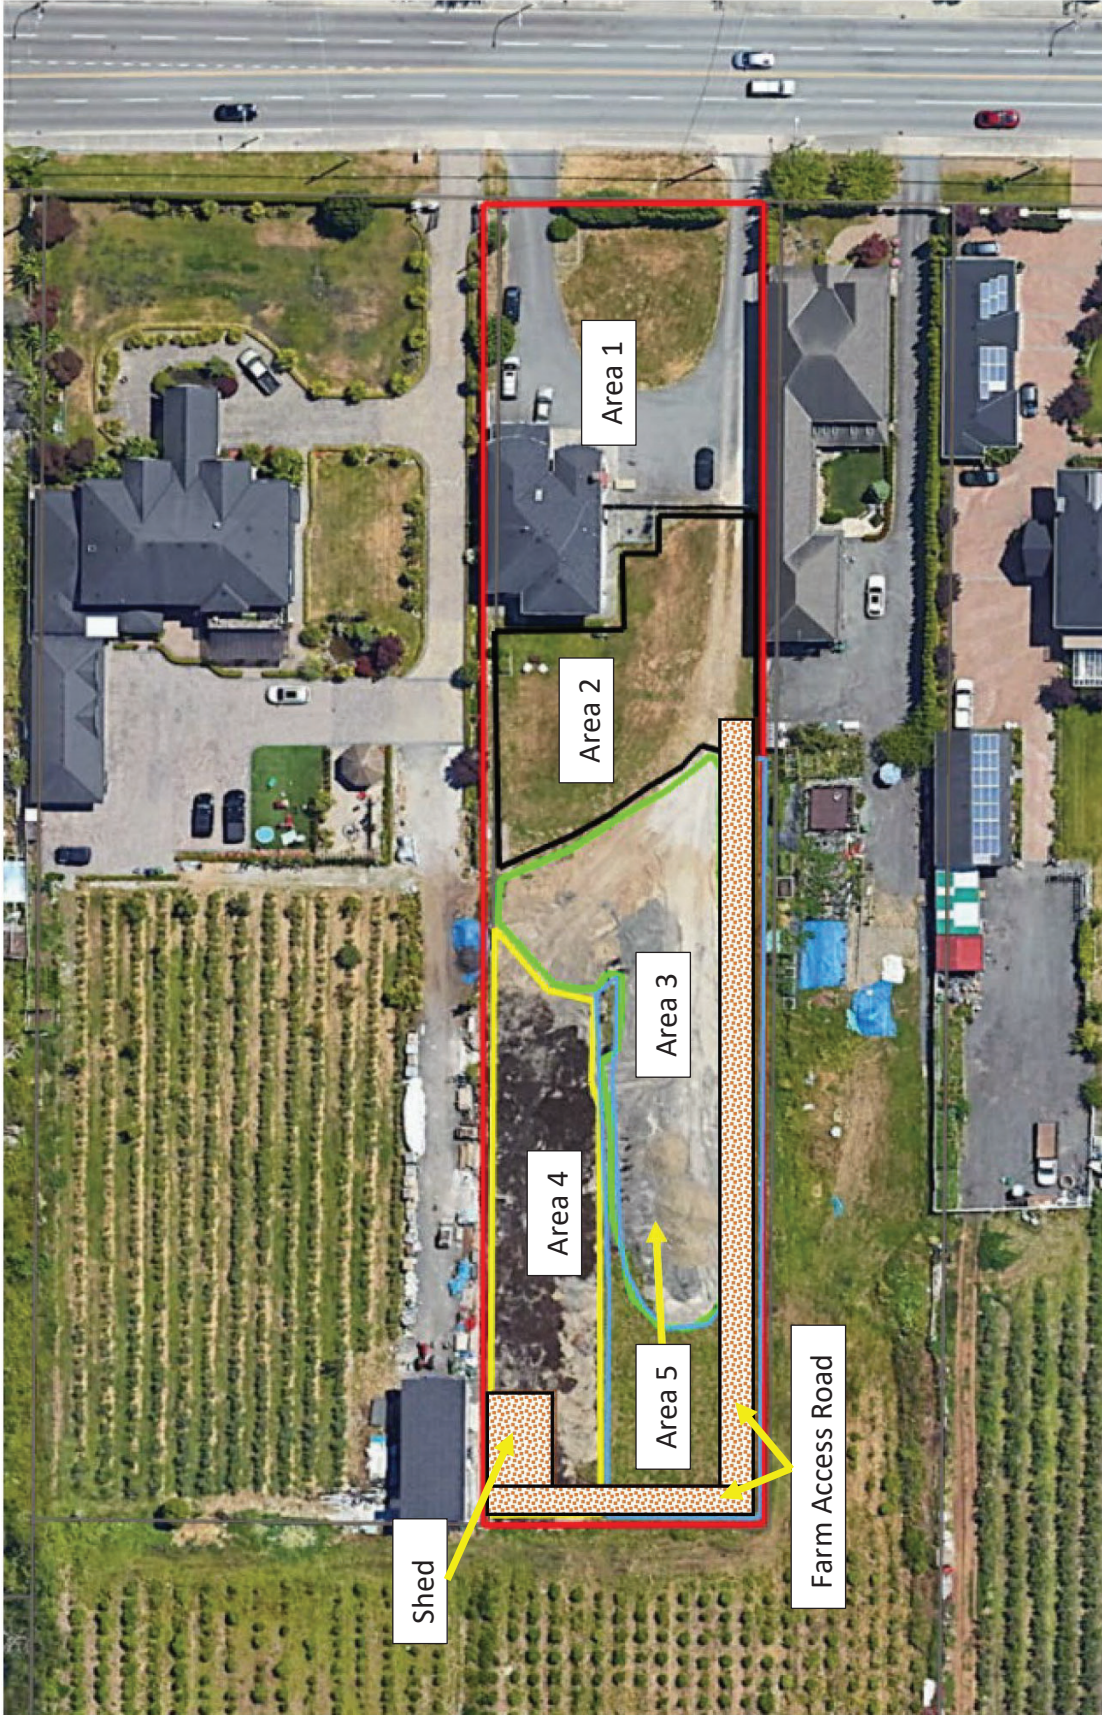
Figure 1: Location of Farm Access Road, Shed, and Areas Referred to in the Report

- Salvage the topsoil in Area 4 and 30 cm of peaty topsoil in Area 5 and stockpile on Area 2.
- Area 4 is slightly higher in elevation than Area 3 and 10 cm will be scooped off to be used to fill the depression created by peat soil salvage in Area 5 and to provide the base for the farm road in Area 5.
- Area 3 does not have topsoil and 20 cm of mineral soil should be scooped off to replace the salvaged peat in Area 5, fill depressions in Area 3, and provide the base for the farm road in Area 5.
- The above steps will result in a mineral base on which 20 cm of topsoil will be applied.
- Poultry manure and/or compost should be applied and worked into the soil after the topsoil is spread out to provide organic matter and increase fertility.

Table 1 indicates the estimated volume of material involved in the salvage, stripping, and spreading operations.

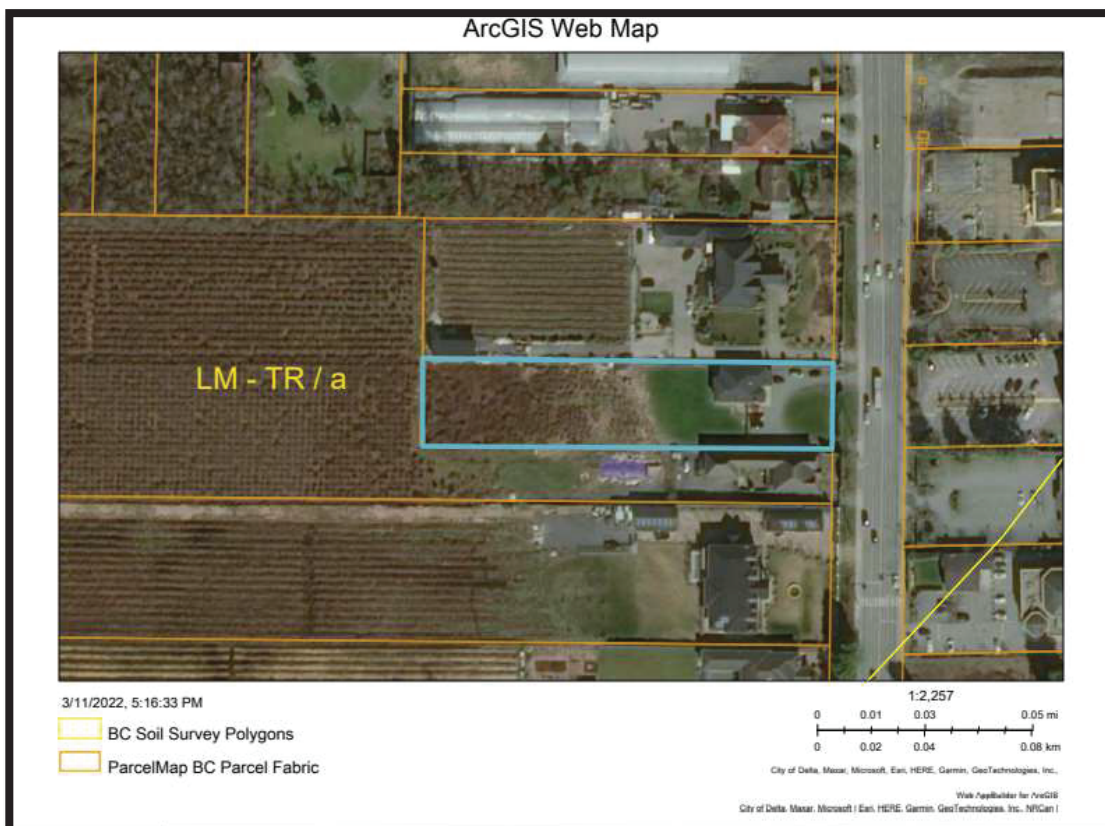
Figure 1 Mapped soil polygons

This mapping (Figure 1) indicated the presence of two soil series (Lumbum (L), and Triggs (T). on the assessed parcel. These are primarily developed on nearly level deep organic deposits at least 160 cm thick over moderately fine to fine textured Fraser River and deltaic deposits. A summary of the mapped soils series is provided below.

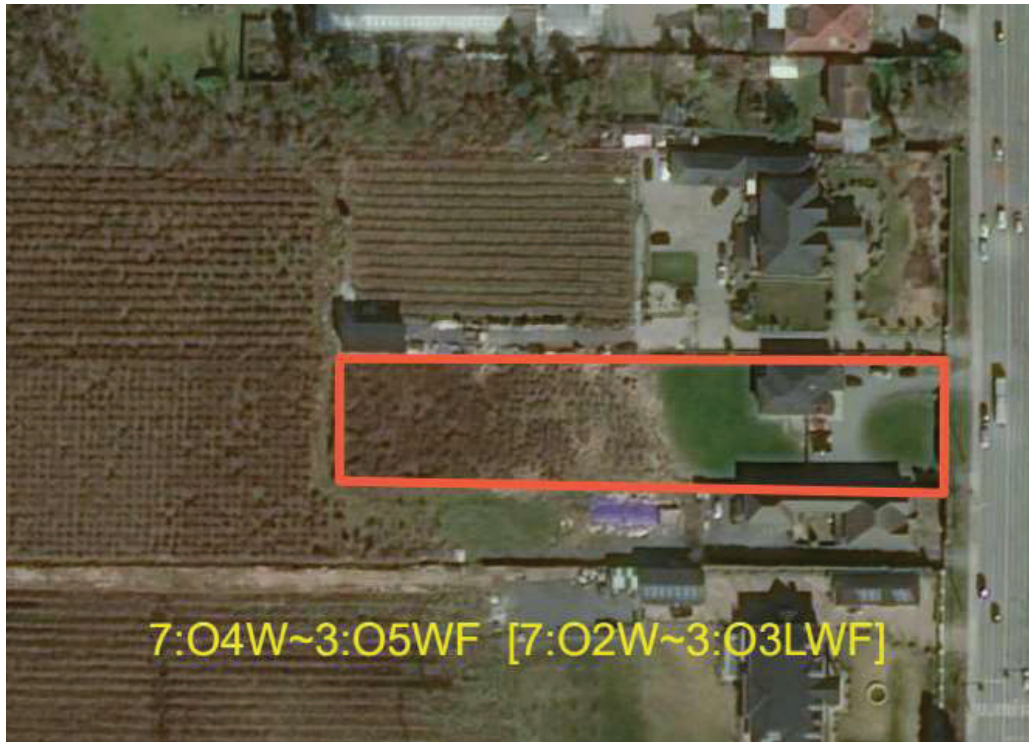
Figure 2 Agricultural Capability Classification (unimproved and [improved])

Mapped Agriculture Capability (source: BCSIFT)	
<b>Capability Class (CC) Label</b>	7:O4W~3:O5WF
<b>Class</b>	<p><b>Class O4</b> = land has more severe limitations that require reduce the range of crops and require special management practices or inputs</p> <p><b>Class O5</b> = land has limitations that restrict its capability to producing only perennial forage crops or other specially adapted crops</p>
<b>Improved Class (IC) Label</b>	[7:O2W~3:O3LWF]
<b>Class</b>	<p><b>Class O2</b> = land has minor limitations that would require on going management practices in order to achieve good crop growth for a range of crops</p> <p><b>Class O3</b> = land has limitations that require moderately intensive management practises or moderately restrict the range of crops, or both</p>
<b>Limitations (subclass):</b>	<p><b>W</b> = excess soil moisture due to highwater table or seepage/runoff (improvable with drainage)</p> <p><b>F</b> = low fertility due to soil characteristics (acidic and low cation exchange capacity)</p> <p><b>L</b> = degree of decomposition affects the movement of water into, through and out of the soil layers</p>

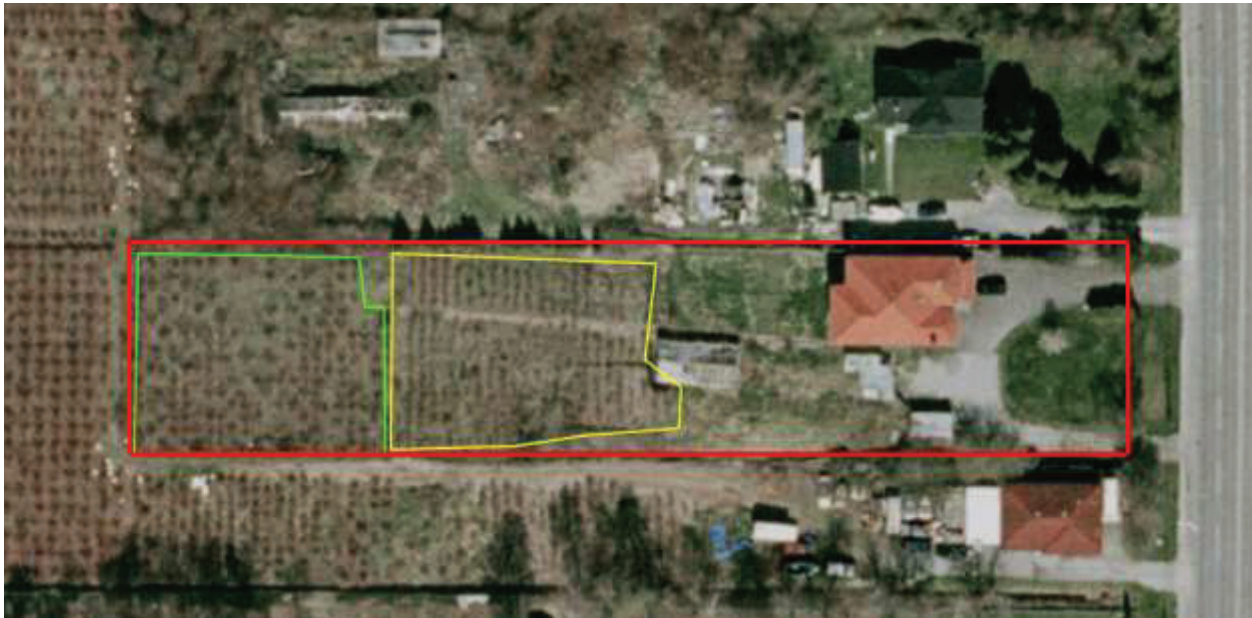
Figure 3 March 2004 – previous crop areas, residence structures and historic fill on east half

Images from 2004 and 2009 (Google Earth), as well as observations made on March 10<sup>th</sup>, provided some indication that the western half of the parcel had been previously cleared and may have been historically used for blueberry farming. Figure 3 shows two cropped areas on west half (outlined in green and yellow). There was little evidence of this crop other than possible mowed root wads in the most westerly part of the parcel at the time of the site visit.

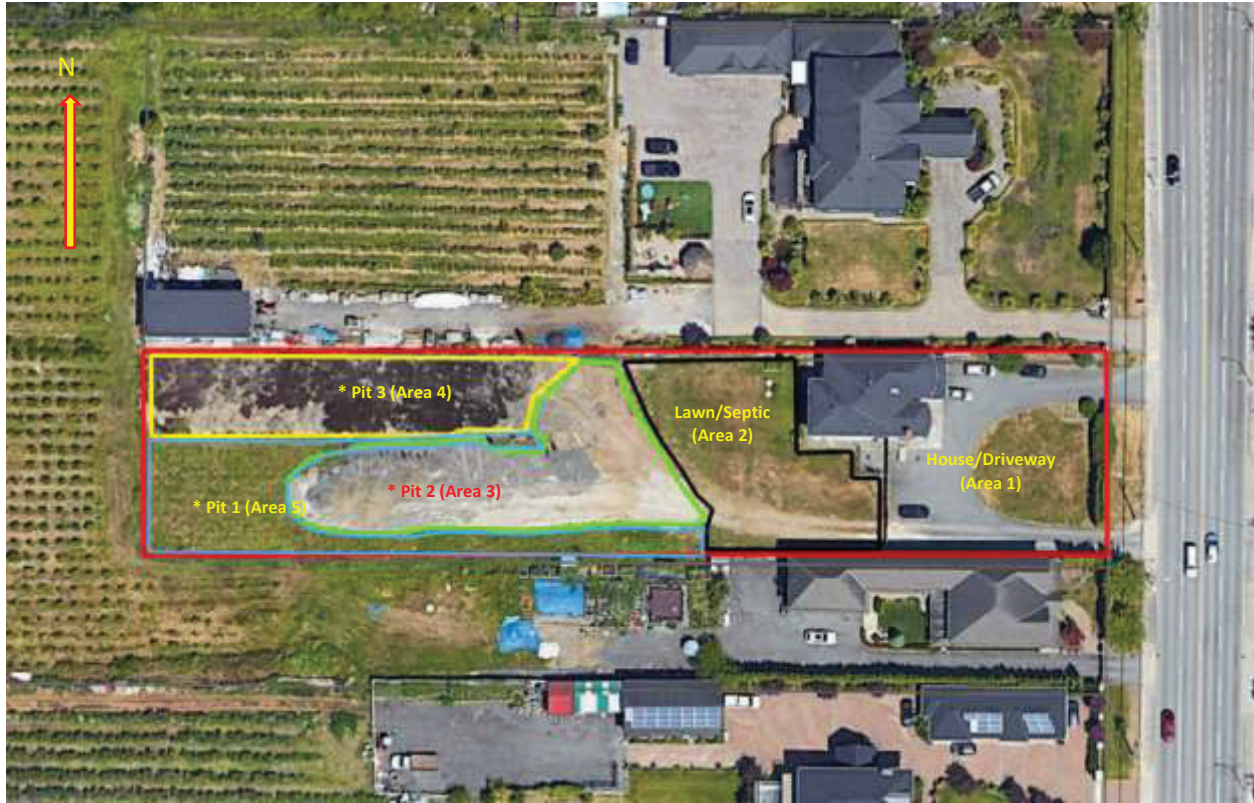
Figure 4 Delineated areas of disturbance

At the time of the site visit the following structures or items were observed. These are noted in Figure 4 as an overlay on the 2021 Google Earth Image.

Area	Outline colour	Description	Size (m <sup>2</sup> )
1		house/driveway - historic fill/solid surface – based on historic aerial imagery	1,720
2	black	back yard/lawn/septic field – historic mineral fill – based on surface observation	795
3	pale green	mineral fill mainly glacial till - mixed silts and some gravels and underlain by native peat	975
4	yellow	disturbed fibrous peat over sandy gravelly fill	790
5	pale blue	native peat	715
Total			4,995

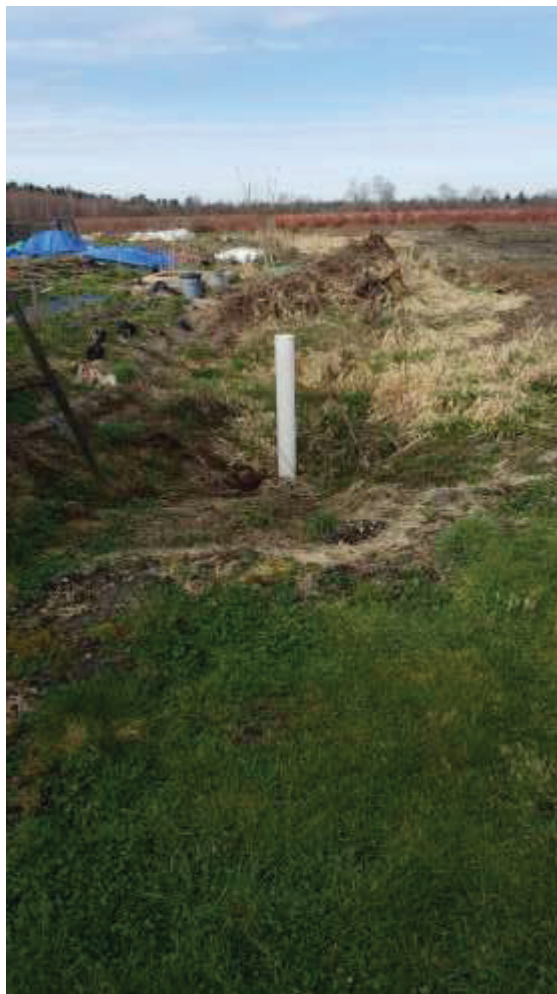
- Buried pipe inlet near southwest corner of back lawn (Area 2) which owner understood was connected to storm drainage on No 5 Rd. (See Figure 5)
- Shallow swale/partially filled ditch on southern parcel boundary and no other drainage channels elsewhere on parcel (see Figures 6 and 7)
- Slight differences in elevation between subject property and adjacent lands to west and south (likely caused by historic land/soil management) but did not appear to be likely to impact water flow on or off the parcel
- Parcel to north was elevated by at least 30 cm (appears to be fill – historic imagery/observation from parcel)
- Some minor surface ponding on water between Areas 3 and 4 (water could be trapped between the two fill pads)
- No subsurface drainage infrastructure (like Big-O) was observed or reported in Areas 3, 4 and 5.

*Figure 5 Surface Inlet to storm drain (looking west along southern parcel boundary at SW corner of Lawn area*

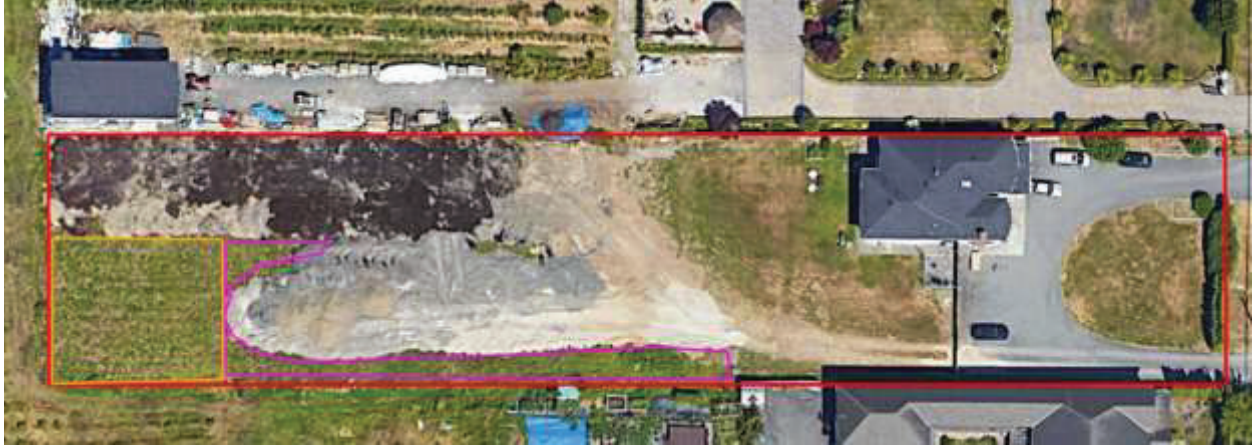
Area	3- Mineral Fill	4- Disturbed Peat/Mineral Fill	5- Native Peat
Required amendments of practices	Requires incorporation of organic matter, pH modification and nutrient application as well as appropriate tillage, drainage and irrigation practices	Requires cover cropping and possibly irrigation to prevent subsidence of peat. Will require nutrient application.	Requires water control (drainage and irrigation) – limited range of crops. Careful nutrient application and cover cropping to maintain peat soils.
Additional fill or other soil materials required	Yes - as above, addition and incorporation of organic matter  Existing mineral fill should be regraded to extend and square off south edge within 4 m of to parcel boundary allowing for gradual slope and drainage swale running east to storm drain inlet. West could be squared off as outlined in purple on Figure 8 No additional fill would be required.	Yes, some additional peat may be required at the west end to create a uniform layer at a similar depth the remainder of this area (~ 25 m <sup>3</sup> )	No, unless this remnant area is filled to level it with Areas 3 and 4. Some of peat could be salvaged for incorporation into the previously imported fill. Volume of mineral soil required ~300 m <sup>3</sup> . (Outlined in orange on Figure 8)

*Figure 8 Fill areas requiring alteration (grading and/or more fill)*

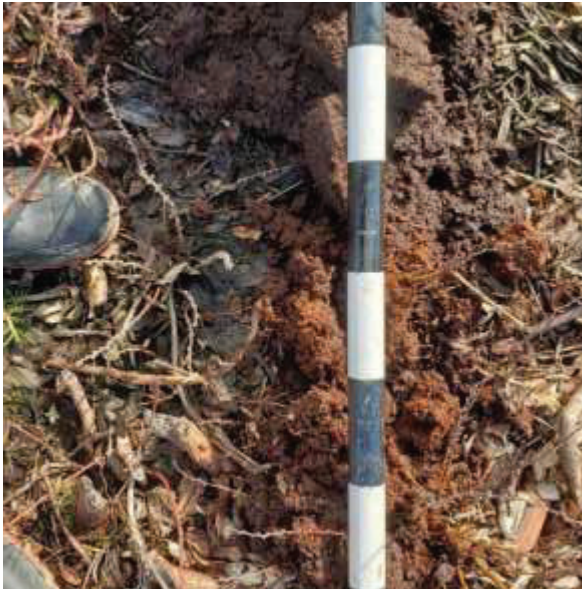
Shovel/auger pit located on a level area at the western end of the parcel in mowed brush. A thick root matt contained well decomposed Humic materials overlying less decomposed peat. Three distinct layers were noted within 100 cm of the surface. No coarse fragments or apparent mineral lenses were observed. Shallow groundwater at about 20 cm depth. No surface ponding was observed in the immediate are of the soil pit however there was some limited ponding on other areas that did not have fill placed. Abundant roots in upper layers.

*Figure 9 Soil Pit 1 West*

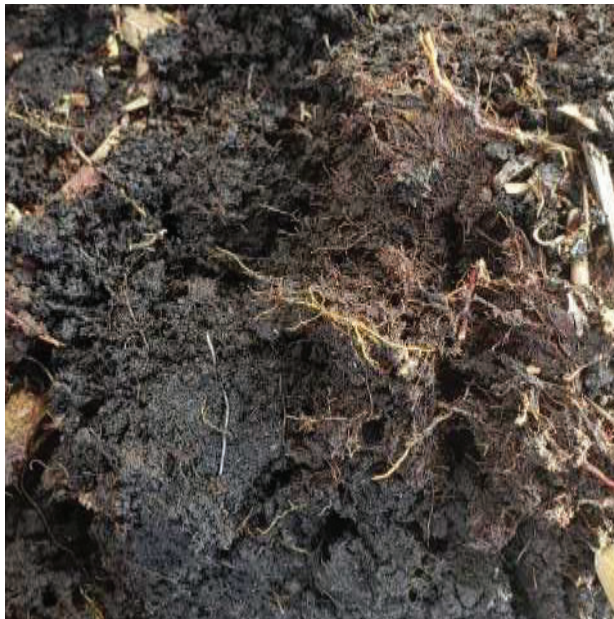
*Figure 10 Oh (topsoil) horizon Pit 1*

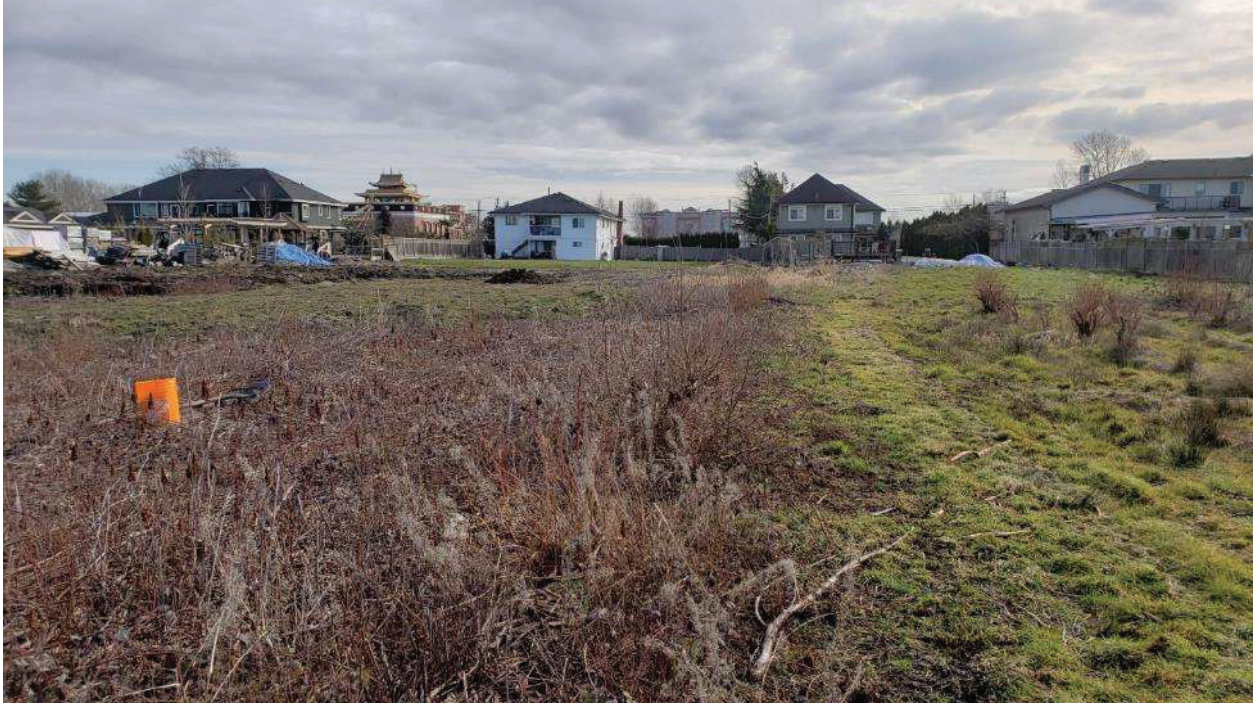
*Figure 11 Pit 1 - landscape looking east*

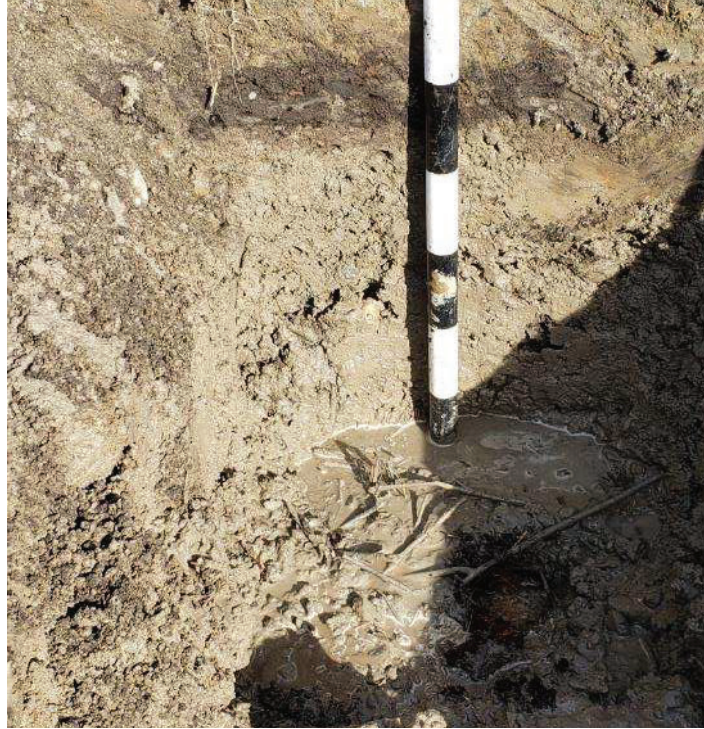
Figure 12 Pit 2 center south

The pits 1 and 2 indicated poor or very poor drainage with high water tables. Pit 1 had a water table within 20 cm of the surface. In Pit 2 the lower 15 cm of mineral fill was fully saturated although the free water table was observed to settle at about 5 cm above the mineral – peat interface. There was no observed water table with the upper 120 cm of Pit 3 although the soil was very moist.

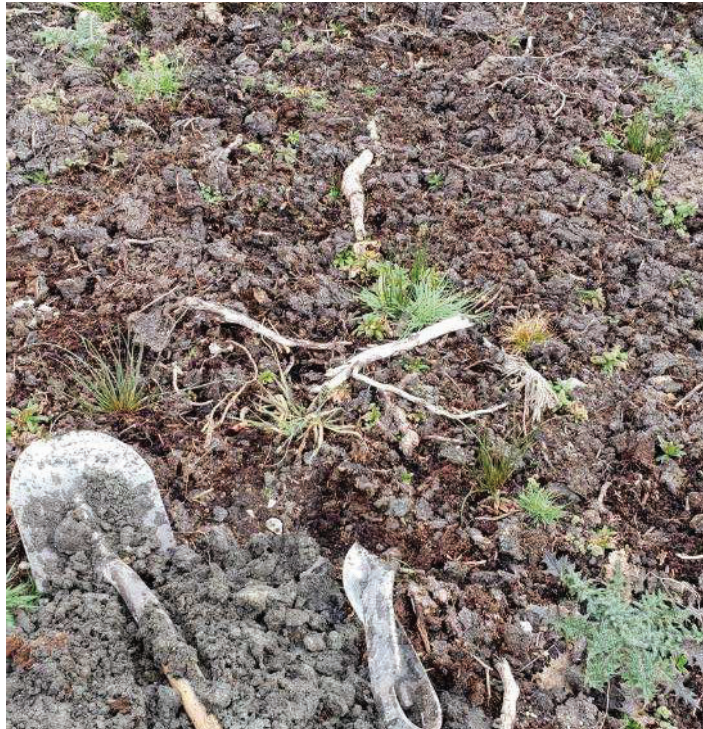
*Figure 15 Pit 3 - mineral fill (left) in contrast with peat fill (right)*

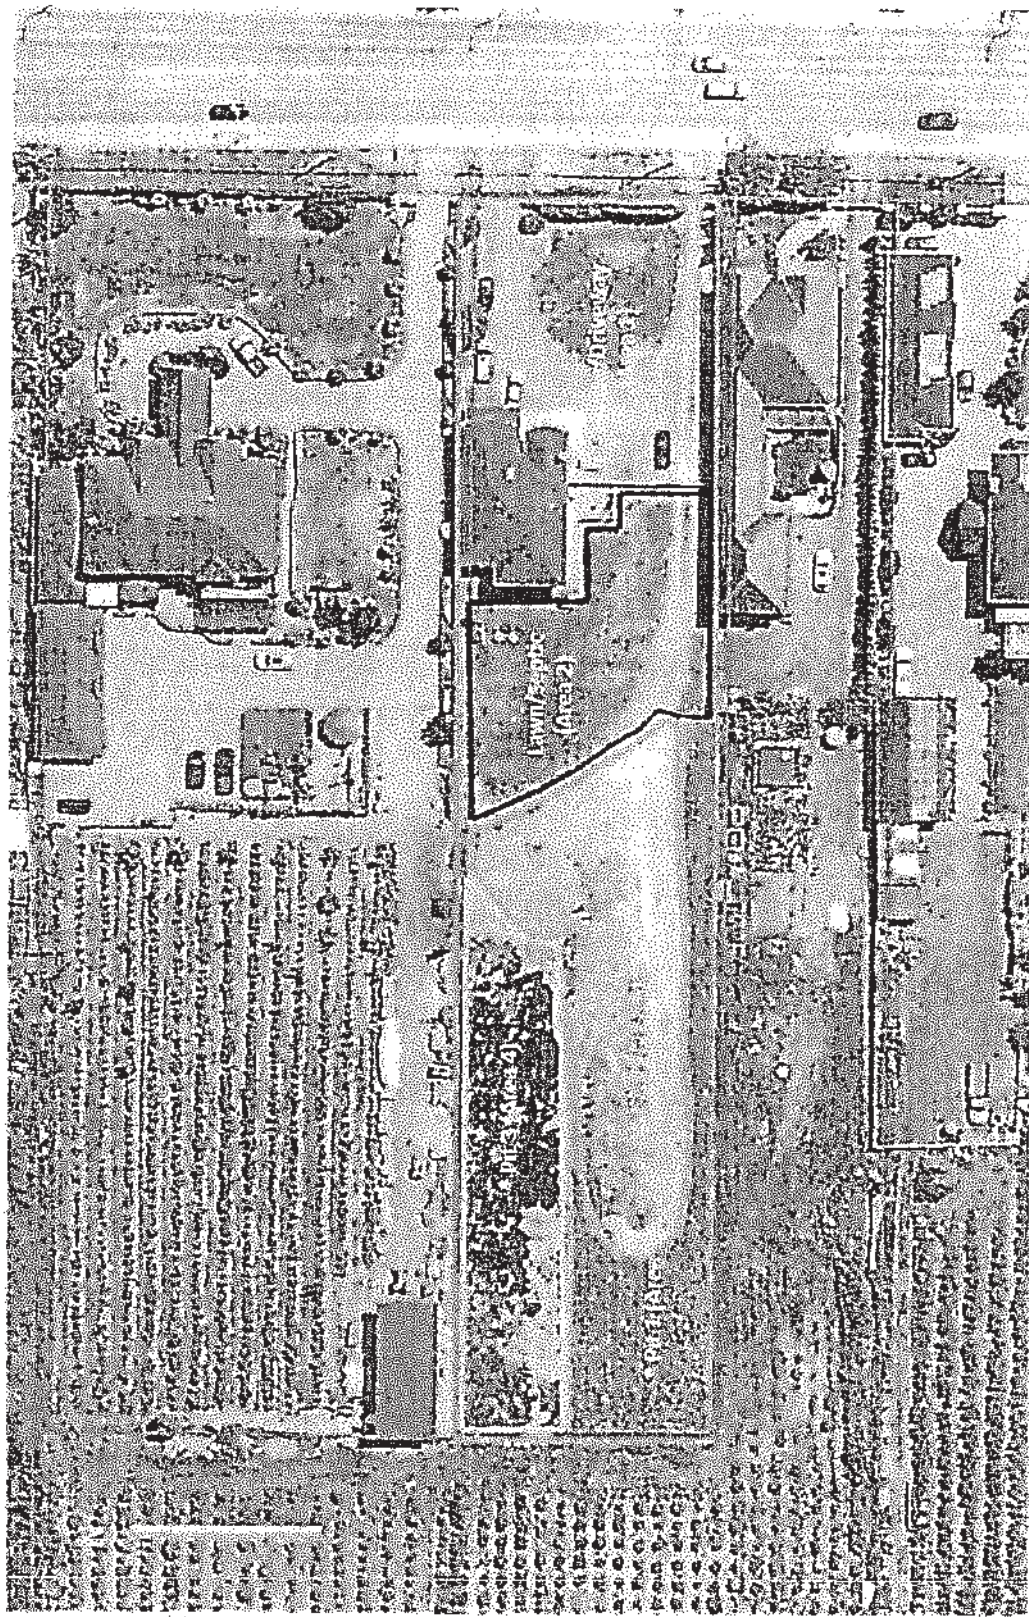
Figure 1 Delineated areas

Area	Color	Description	Area (m <sup>2</sup> )
1		house/driveway - historic fill/solid surface – based on historic aerial imagery	1,720
2	black	back yard/lawn/septic field – historic mineral fill – based on surface observation	795
3	pale green	mineral fill mainly glacial till - mixed silts and some gravels and underlain by native peat	975
4	yellow	disturbed fibrous peat over sandy gravelly fill	790
5	pale blue	native peat	715
Total			4,995
