# City of Richmond

## Report to Committee

**To:** Community Safety Committee **Date:** June 19, 2020  
**From:** Cecilia Achiam **File:** 12-8080-12-01/Vol 01  
General Manager, Community Safety  
**Re:** **Soil Use for the Placement of Fill Application for the Property Located at 19740 River Road (Sidhu)**

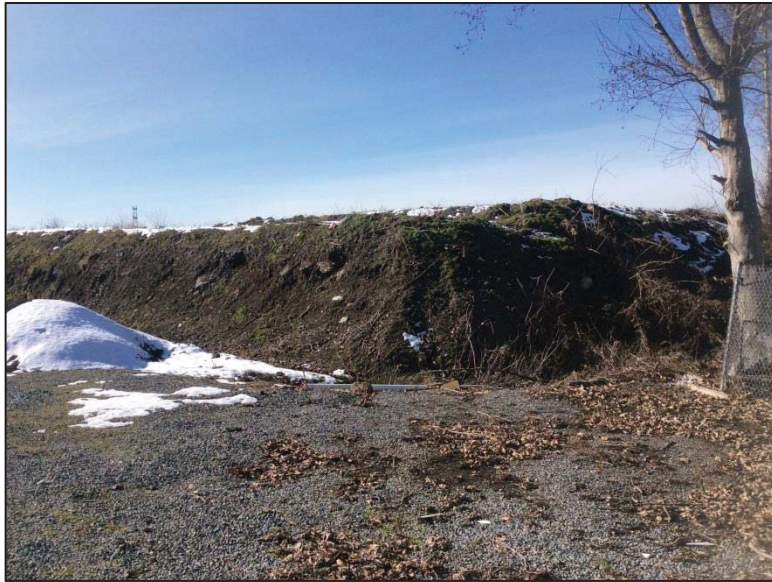
**PHOTO 2. APPROXIMATELY 2.5 M OF FILL HAS BEEN PREVIOUSLY PLACED**

Over the northwest corner of the property, including where the farm storage facility is situated at the River Road entrance.

The landscape has been altered by soil importation in the northwest corner; this has raised the land by an estimated 2.5 m (and up to 3 m) above the natural elevation (see **Photo 2**, below). The remainder of the site has not been elevated by fill; a geodetic control marker located in the southern part of the property (in the cranberry field, **Photo 3**) is situated at approximately 1.8 m above sea level<sup>11</sup>. This is the main topographic information I have found for this area; there is no topographic land survey data (available through Jagbar Farms) or contours available from iMapBC or the Richmond Interactive Map.

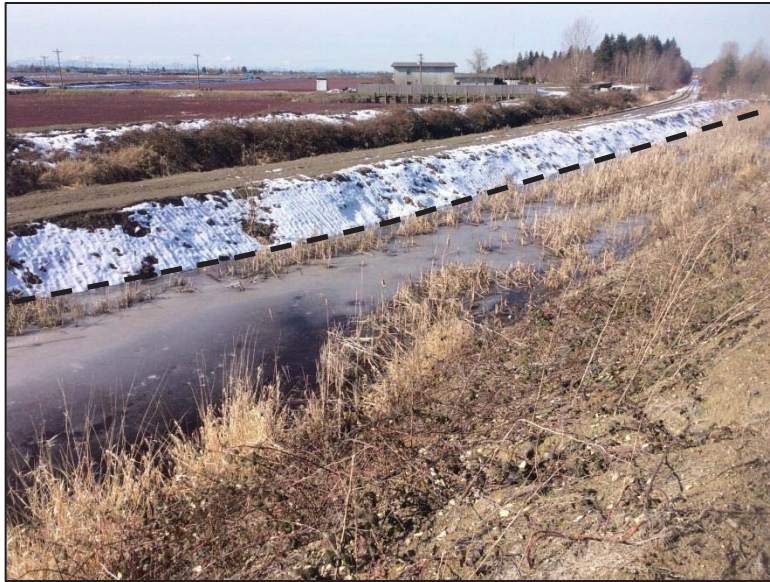
**PHOTO 5. LOOKING NORTHWEST**

Along the western property line at the reservoir, access road/dike, and the CN Railway. The property boundary is indicated by the black dashed line.

On the west side of the proposed soil placement area, I observed that an approximately 0.5 m high berm has been installed. Beyond this, there is a water reservoir constructed for irrigation. Adjacent to this reservoir, there is an access road and dike that is owned by CN Rail. The railway is situated to the west of the access road. Beyond the railway there are the neighbouring cranberry and blueberry farms.

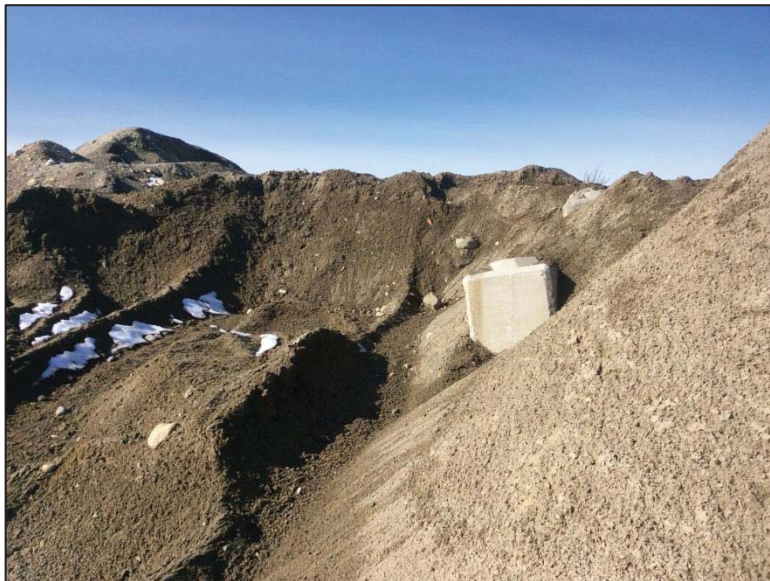
**PHOTO 6. STOCKPILE OF COARSE SAND AND GRAVEL**

Situated at PM 18 on the property – this will be used to construct dikes around the imported peat, which will allow cranberry farming.

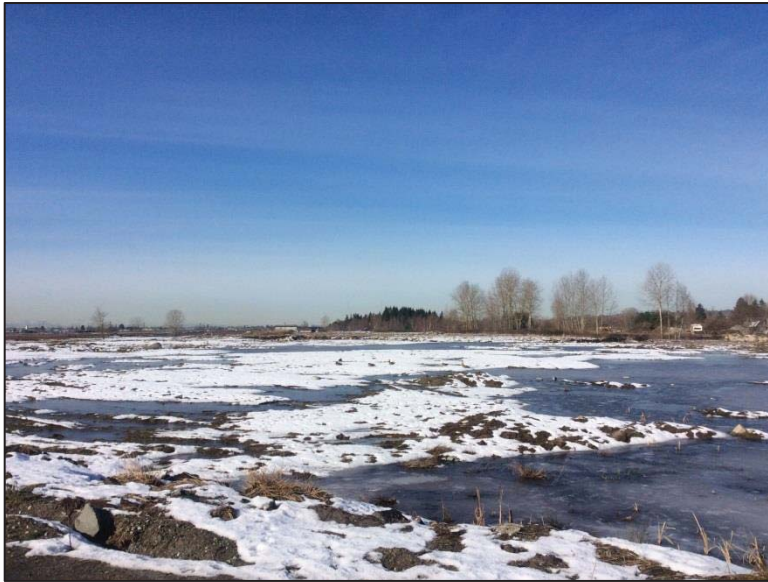
**PHOTO 7. LOOKING NORTHWARDS**

Across the proposed soil placement area, which has been filled as of 2005 and does not feature any vegetation.

The proposed soil placement area does not have any vegetation nor has it been prepared for farming (i.e. decompacted, raked, diked, or planted). There was some snowmelt and ice accumulation on the surface. During our excavation, the pits filled somewhat quickly with water from both the surface and from high water tables.

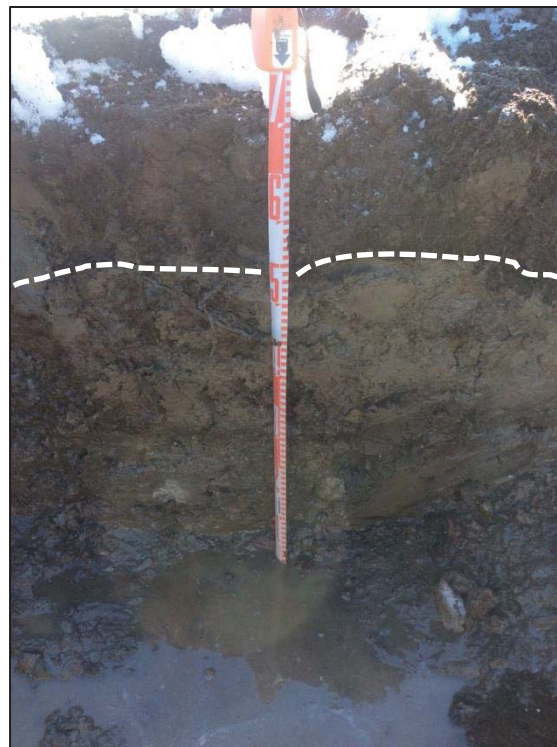
**Comments:** Approximately 20 cm of dark, grey brown sandy loam overlying a grey to olive grey sandy clay loam. The last horizon is a very firm, compacted, blue grey sandy clay loam. The very firm horizon at 50 cm correlates to a 3D limitation due to dense subsoils.

There is also a Class 3D limitation found in both Pits 1 and 3 due to very firm subsoils. In Pit 1, this starts at 0.5 m (very firm sandy clay loam) and in Pit 3 this starts at 0.55 m due to very firm loamy sand. This is due to compaction of the soil during placement activities. This can be improved somewhat through sufficient deep ploughing or ripping to break up the dense subsoil. Deep ripping must be done when the soil is not saturated, (generally

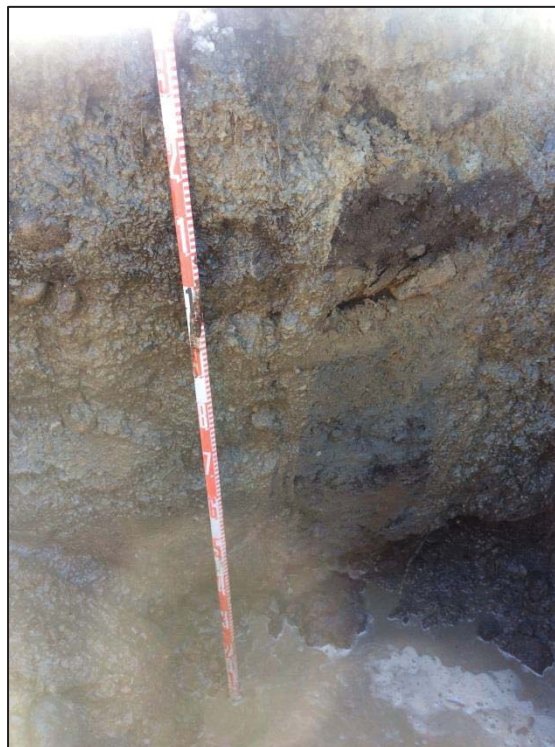
**Comments:** Approximately 1 m of olive grey sandy loam with fine gravel (approximately 10%) overlying grey brown, firm loamy sand (compacted). The sandy textures of this soil correlate to a reduced nutrient holding capacity (3F estimated). The 10% fine to coarse gravel in the upper 25 cm of the first horizon correlates to a 2P stoniness limitation.

Soil Pit 2 features approximately 1 m of sandy loam containing coarse sand and 10% coarse gravel. Below this, the texture is loamy sand with between 5 and 10% coarse gravel. The pit was very wet when excavated and quickly collapsed. The lower horizon extended to 1.3 m deep and was found to be firm due to compaction (similar to Pit 1).

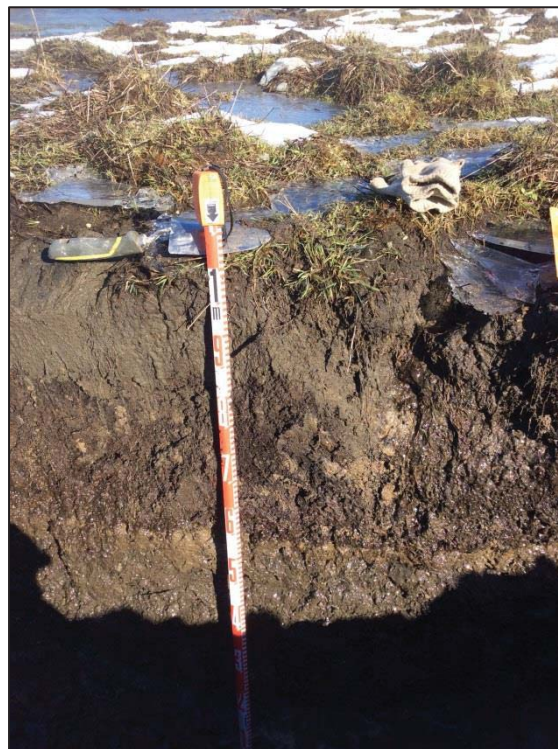
**Comments:** Dark brown to dark grey (variable as seen in photo) loamy sand overlying very firm (compacted) olive grey brown loamy sand. The loamy sand textures in this soil correlate to a reduced nutrient holding capacity (3F estimated in absence of soil testing for this project).

The last pit, Pit 3, was found to contain exclusively loamy sand to a depth of 1 m. The upper B horizon, which extends to approximately 55 cm, has dark grey to dark brown colouring that is highly variable, and contains approximately 5% coarse gravel. The lower horizon has 10% coarse gravel and is an olive brown to olive grey colour.

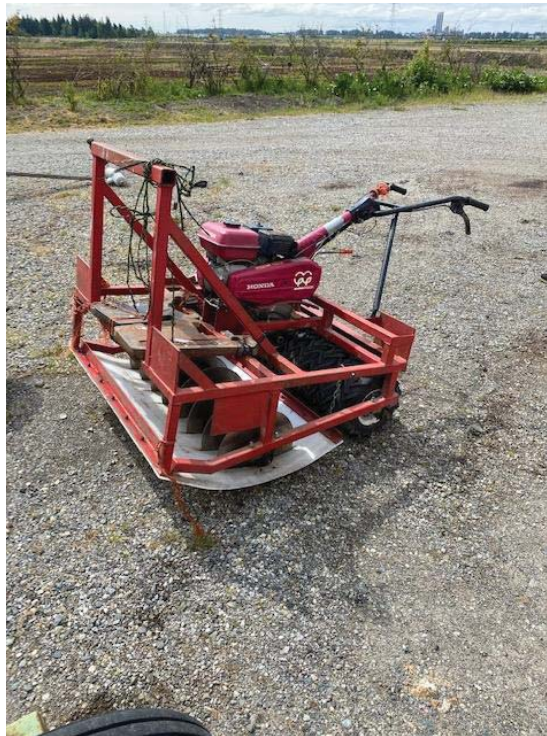
**PHOTO 1. CRANBERRY VINE PLANTING MACHINE OWNED BY JAGBAR FARMS**

- Approximately 3,000 lb/acre<sup>4</sup> of vines are required to plant the field (5.3 ha is 13.1 acres, therefore approximately 39,000 lbs of vines are required).
- The vines are obtained from pruning of existing field and are bundled (approximately 90%, the remaining 10% are to come from a neighbouring farm at no cost).
- The planting consists of distributing the vines in the field and disking (see photo of planting machine below)

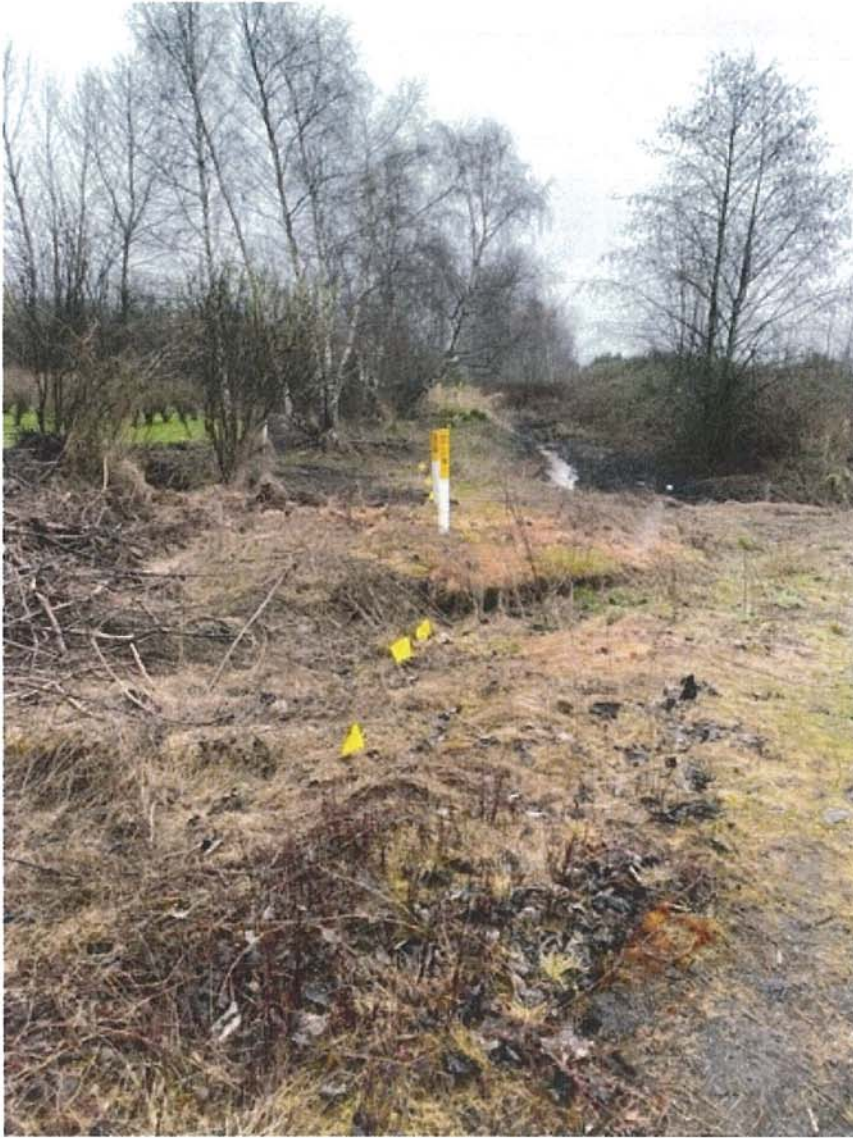
Figure 2  
Kinder Morgan pipeline ROW adjacent to northwest boundary of Jagbar Farms. ROW is separated from soil deposit by buffer including ROW, ditch, and embankment at right.
