To: General Purposes Committee
From: Carli Williams, P.Eng.
Manager, Business Licence and Bylaws
Jason Ho, P.Eng.
Manager, Engineering Planning
Date: January 13, 2020
File: 12-8080-12-01/Vol 01
Re: **Non-Farm Use Soil Deposit Proposal for the Property Located at 21700 River Road**

The owners of the property located at 21700 River Rd, Richmond, BC have requested permission to import soil to improve their land for crop production.

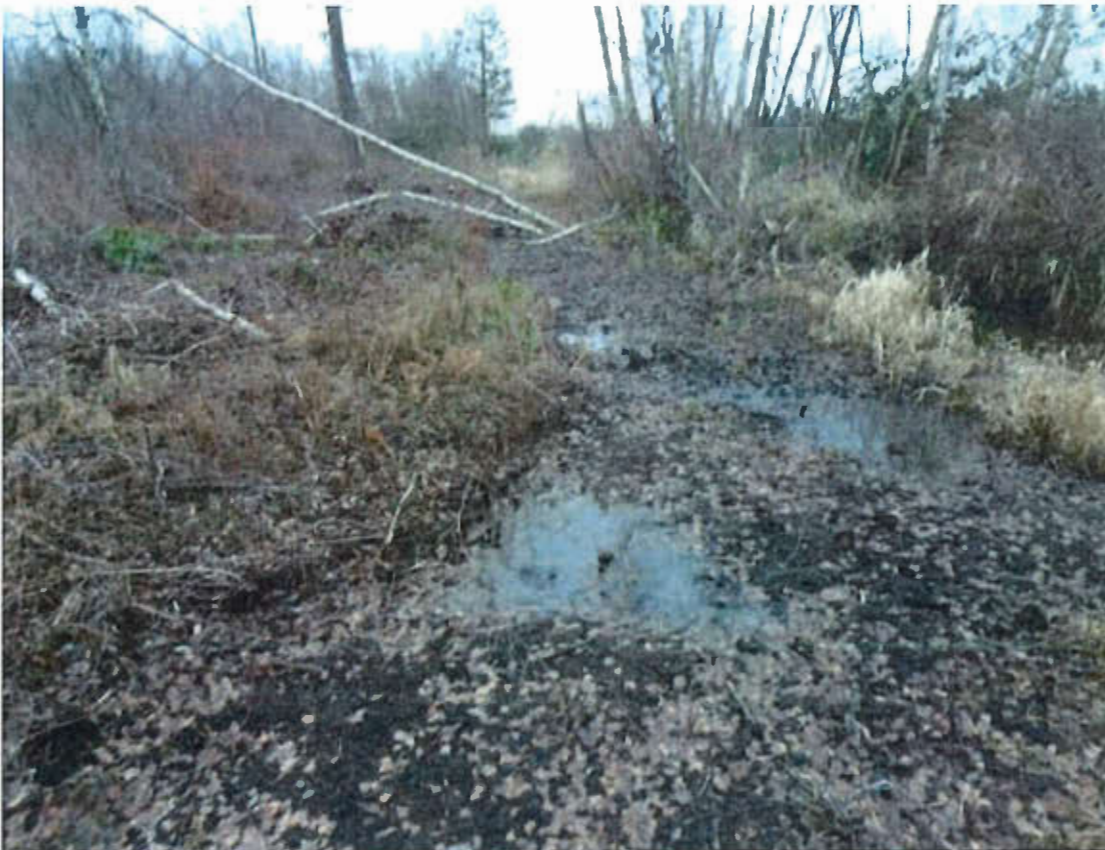
Figure 1. Photo of the southern portion of the property (Jan 8, 2019)

After failed attempts to establish a berry crop, the soil is populated with grasses, shrubs and some deciduous trees common to poorly drained soils.

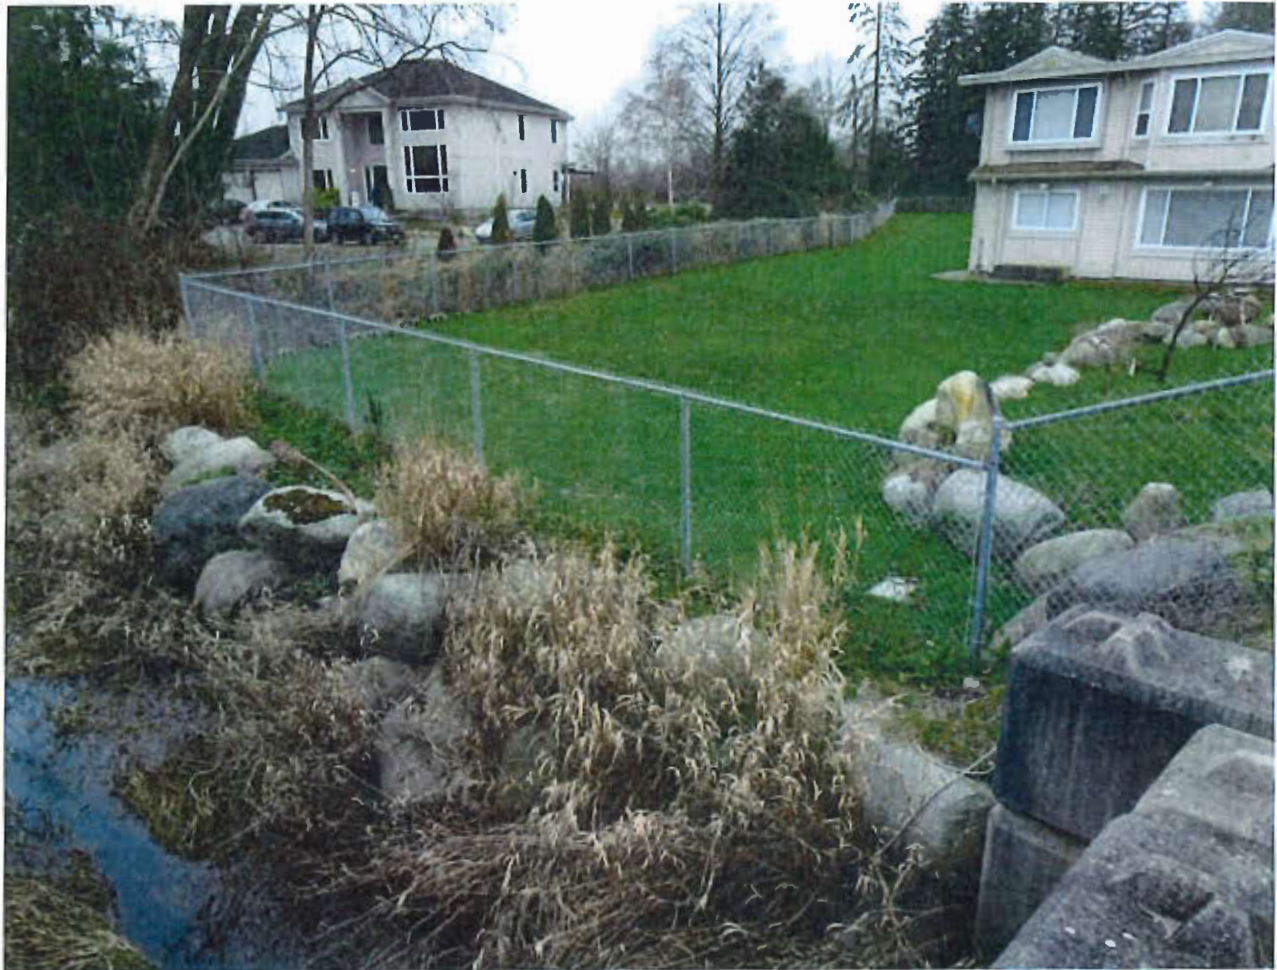
Figure 7. View of front of property (northeast corner) from the road. Owners indicated regular flooding of the front yard (see photos in Appendix B).

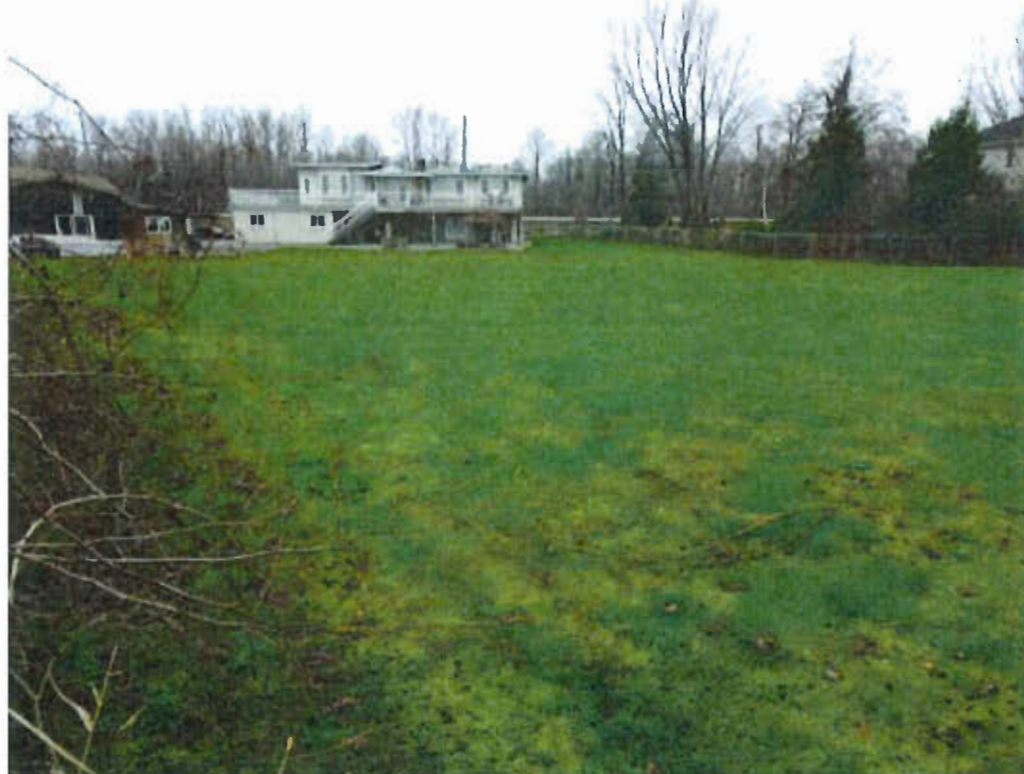
Figure 9. View of property looking south along the west boundary. Land surface on property to the west is 2-3 m higher than surface of the property at 21700 River Rd.

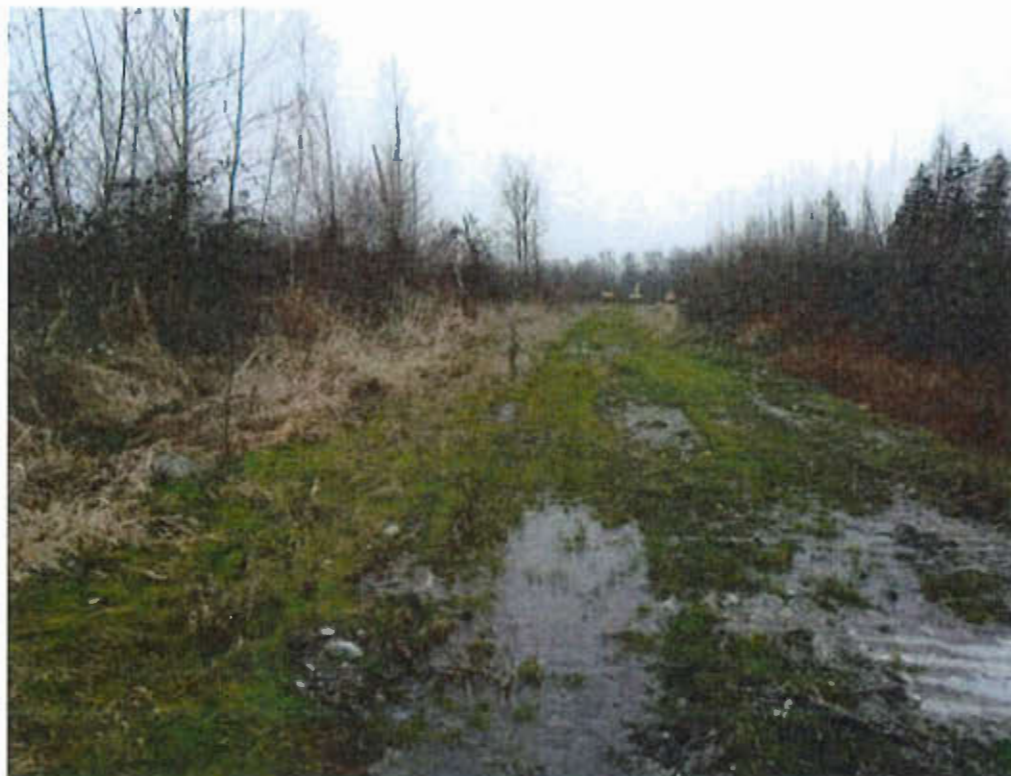
Figure 10. View of the vegetation and the water ponding in the southwest corner of the property.

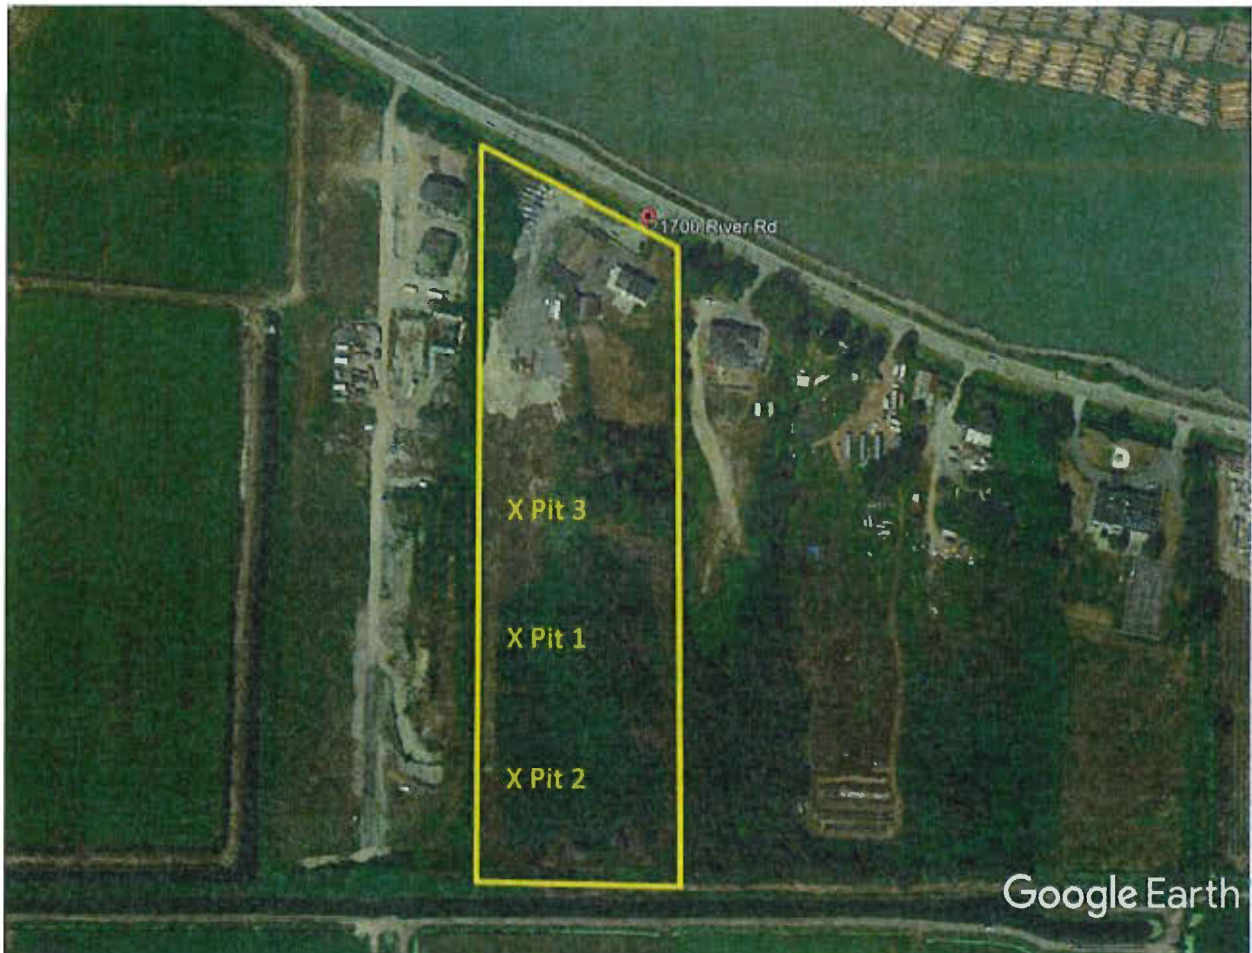
Figure 10. Approximate location of each of the three soil pits excavated on the property on May 15, 2019

A total of three soil pits were excavated. The primary purpose of pits # 1 and # 2 were to verify the depth of the peat, and to visually assess its quality.

The estimated depth to the clay layer underneath the peat as observed in Pits 1 and 2 was 8 ft (240 cm).

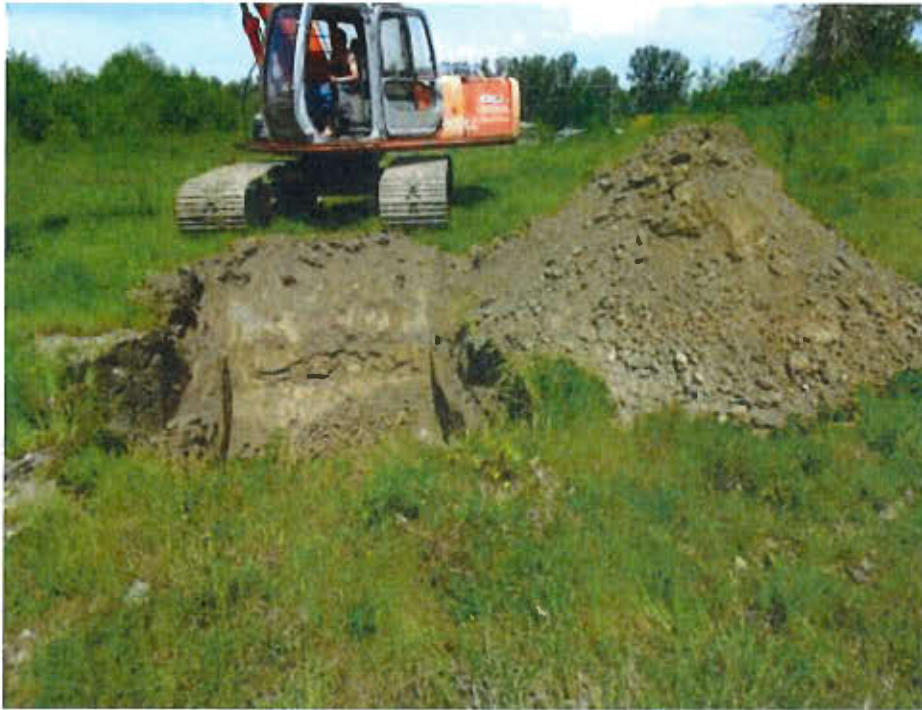
Figure 20. Inspection of the imported soil in Hole # 3 did not reveal any contamination.

The fill that had already been imported as observed in Pit # 3 was clean and free of debris.

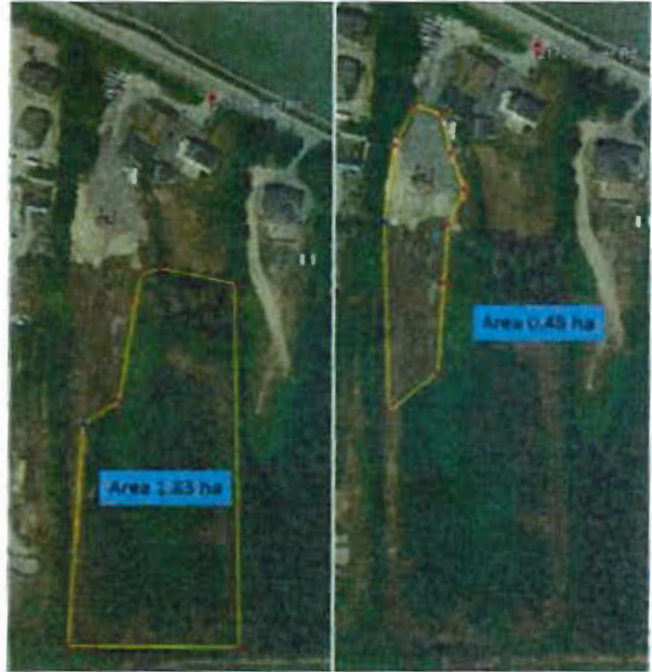
Figure 21. Area measurements at 21700 Riverside Rd delineating the area already filled, and the area requiring fill (from Google Pro)

Area	Size (m ²)	Elevation (ave meters)	Target Elevation (m)	Volume Soil Required (m ³)
Undisturbed	18300	1.3	2.73	26,169
Filled	4800	3.25	2.73	-2,496
Total Fill Area	23100			23,673

Based on the area measurements in Figure 15, and the elevations found in Appendix A, we obtain a volume requirement of 23, 673 cubic meters over a total fill area of 2.31 ha.

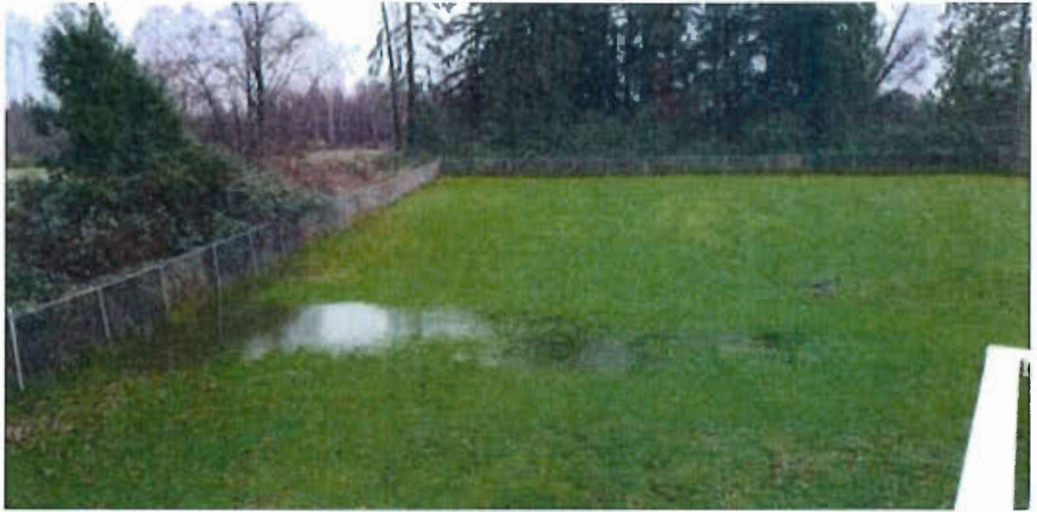
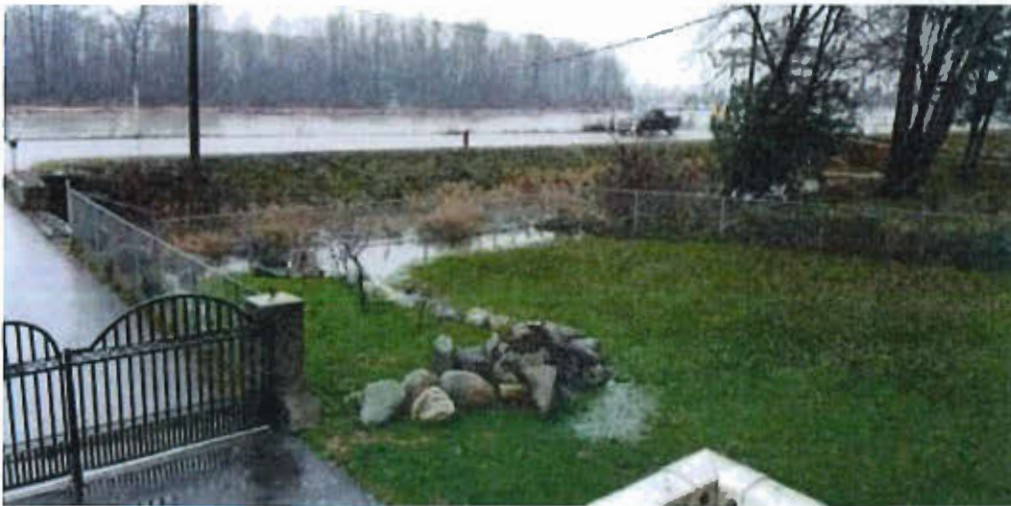
Figure 2. View of backyard showing high water table

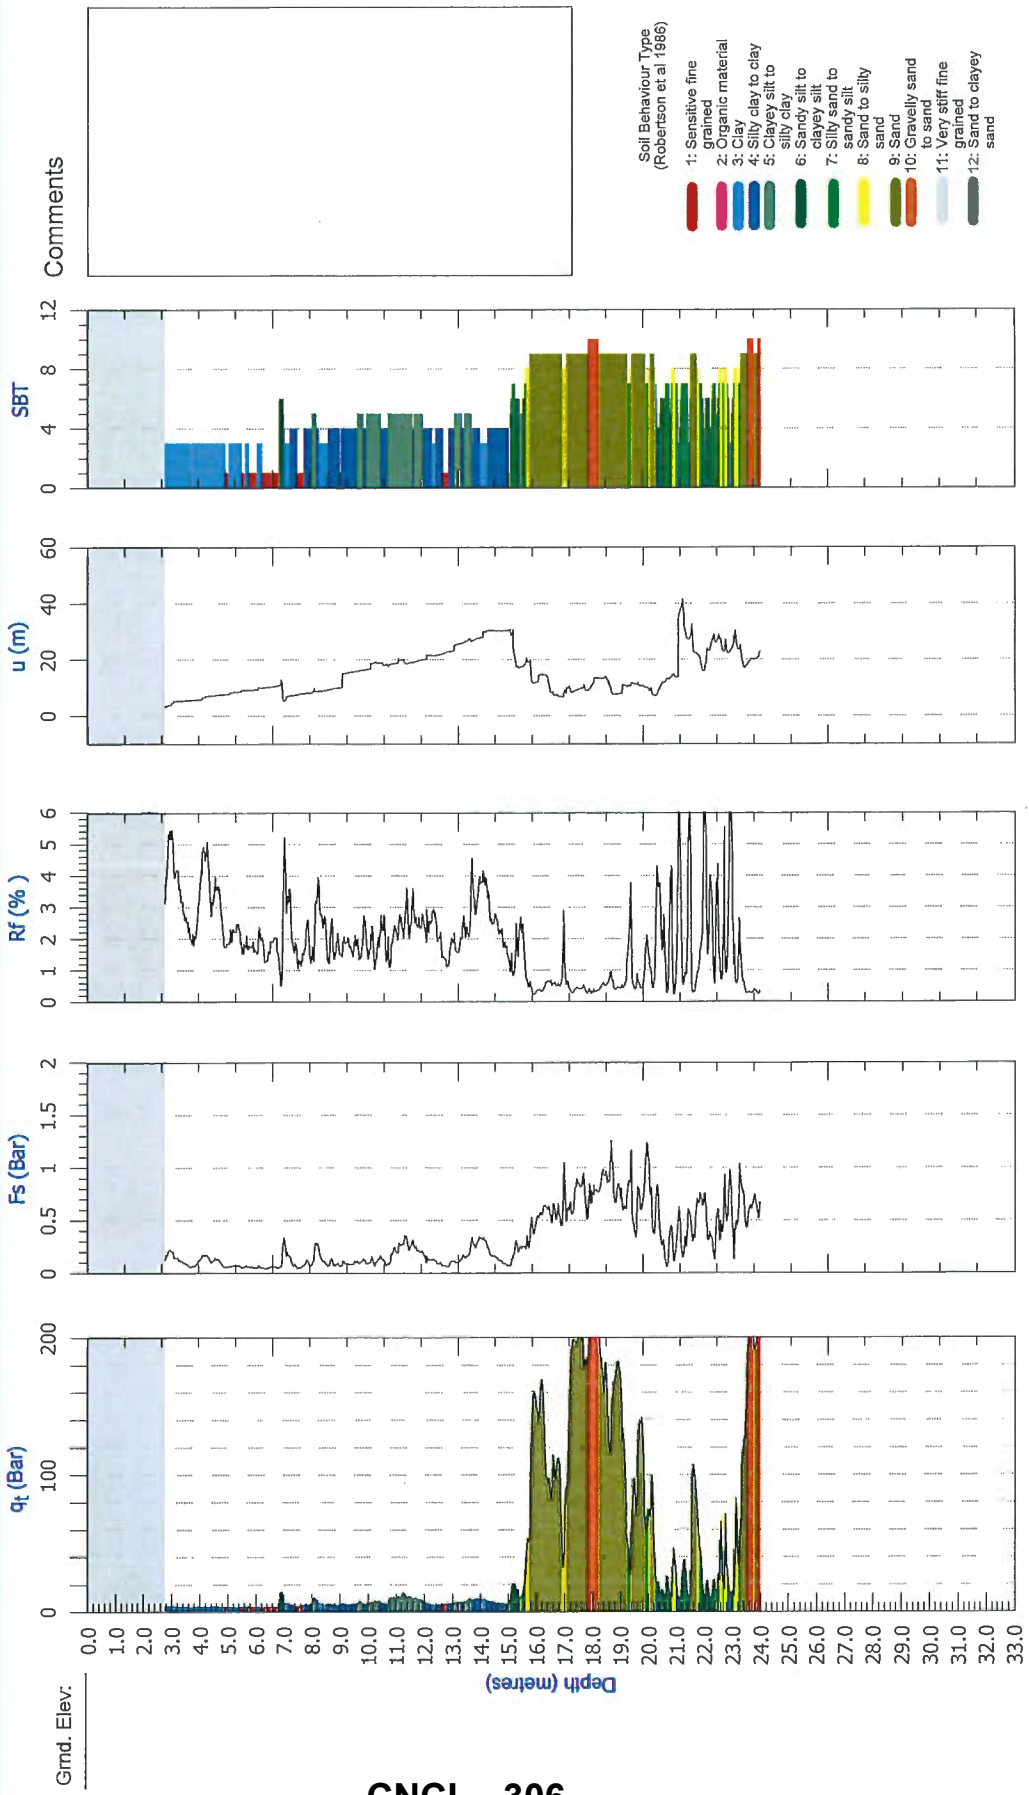
Job No: 113-3353
 Date: 13-June-2013
 Site: 21700 River Road, Richmond
 File: 113-3353 - 21700 River Rd - CPT2
 Soundings: 2
 Test Hole: 002
 Coords: N49°10.809', W122°59.043'
 Cone: I-CFXYP20-10 120317
 Max Depth: 31.8 m
 Depth Inc: .020 m
 Ave Int:
