Report to Committee

Non-Farm Use Fill Application by Sixwest Holdings Ltd. No. BC1025692 for

Property Located at 14791 Westminster Highway

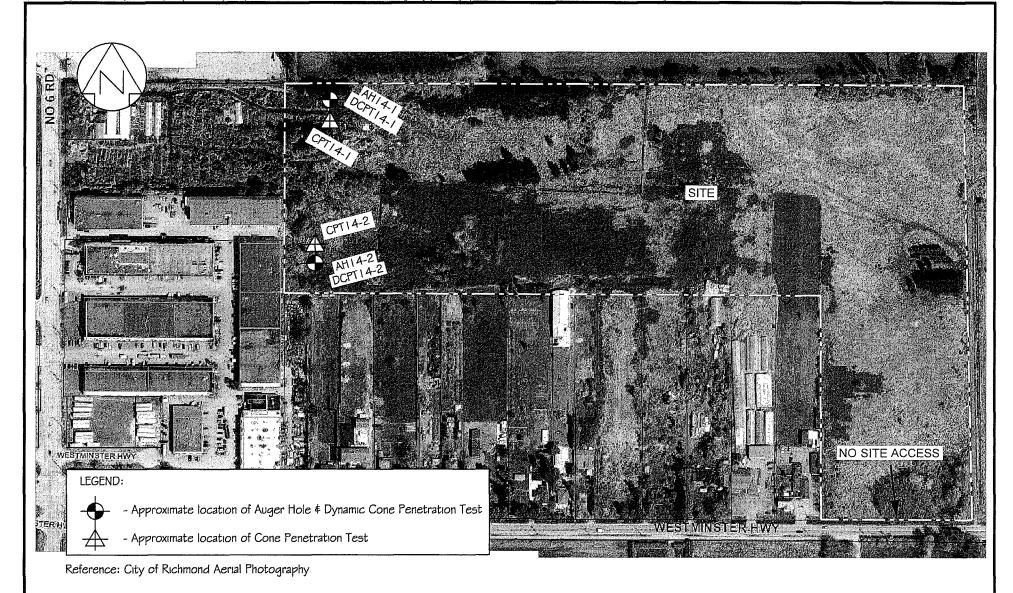
PROPOSED DEVELOPMENT 14791 Westminster Hwy, Richmond, BC TEST HOLE LOCATION PLAN CNCL - 340
