City of Richmond

Report to Committee Planning and Development Division

Re: **Agricultural Land Reserve Application by Dagneault Planning Consultants Ltd. for Non-Farm Use and Subdivision at 9500 No. 5 Road**

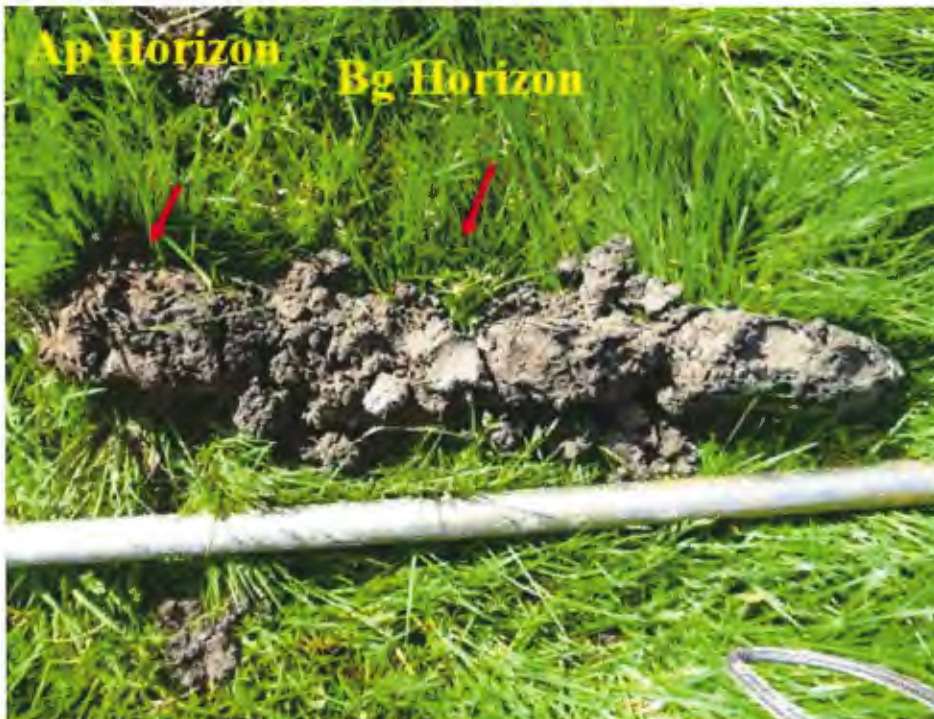
Figure 5 Typical soil profile of fairways

The hand textures of the Ap horizon indicate that soils ranged from sandy clay; silty clay; to silt loam. Since texturing was done by hand it is possible that some of the sandy textured soils are sandy clay loams or clay loams (Figure 5). It was assumed that the soils of the fairways represented the natural soil because there was a clear Ap horizon. However the samples are lower in organic matter and higher than normal in sand for Delta soils. This is probably due to sand topping of the fairways in an attempt to improve drainage.

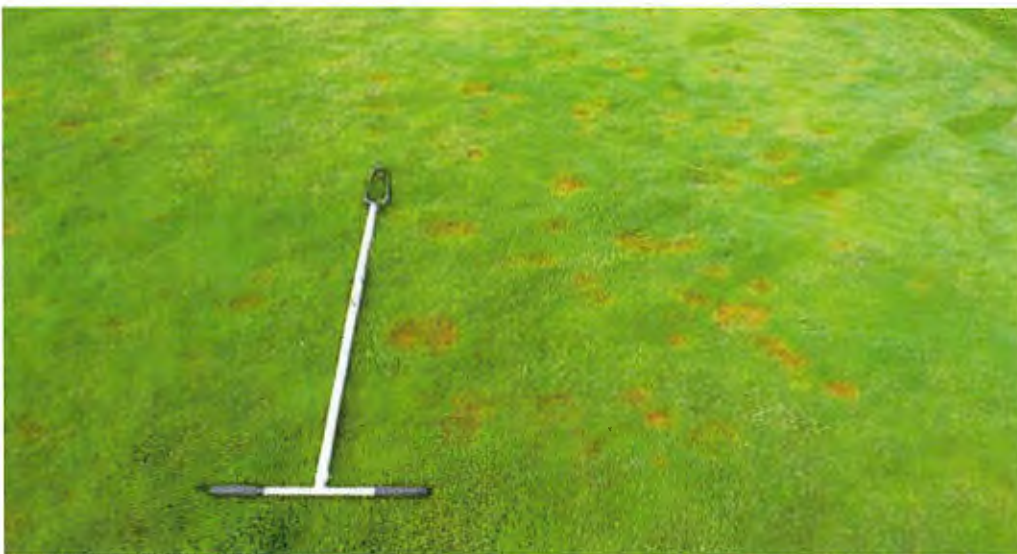
Figure 6 Reddish-brown spots indicating fungal disease on greens

All greens were impacted by fungal infections (see reddish-brown spots, Figure 6). A number of fungal diseases are common on bent grass golf greens these include dollar spot, pink snow mold (Microdochium patch and Fusarium patch), Anthracnose, and Pythium diseases (including Pythium blight and Pythium root rot or dysfunction). The obvious presence of fungal disease indicates that the golf course would have had a fungal control program that would have included extensive use of fungicides to control these diseases when the course was in operation. The major concern in terms of agricultural conversion of the golf course is not the actual presence of fungal diseases, but the types of fungicides that may have historically been used for control.

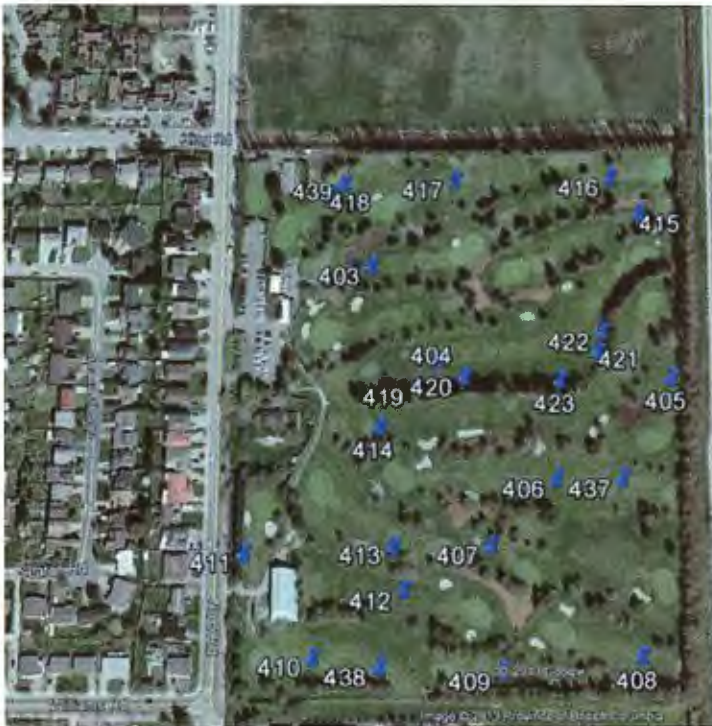
Figure 8 Sample locations 2013

The 2013 sampling indicated that the large berm running east to west along fairway 14 (GPS locations 419 to 421) contained occasional pieces of concrete and asphalt (consistent with 2015 findings). The soil in this berm also contains some gravel and is of a texture more consistent with glacial till. This berm turns north at sample location 421 (Figure 8) and 660 (Figure 7). The section of the berm running north is constructed with soil material from the subject property.

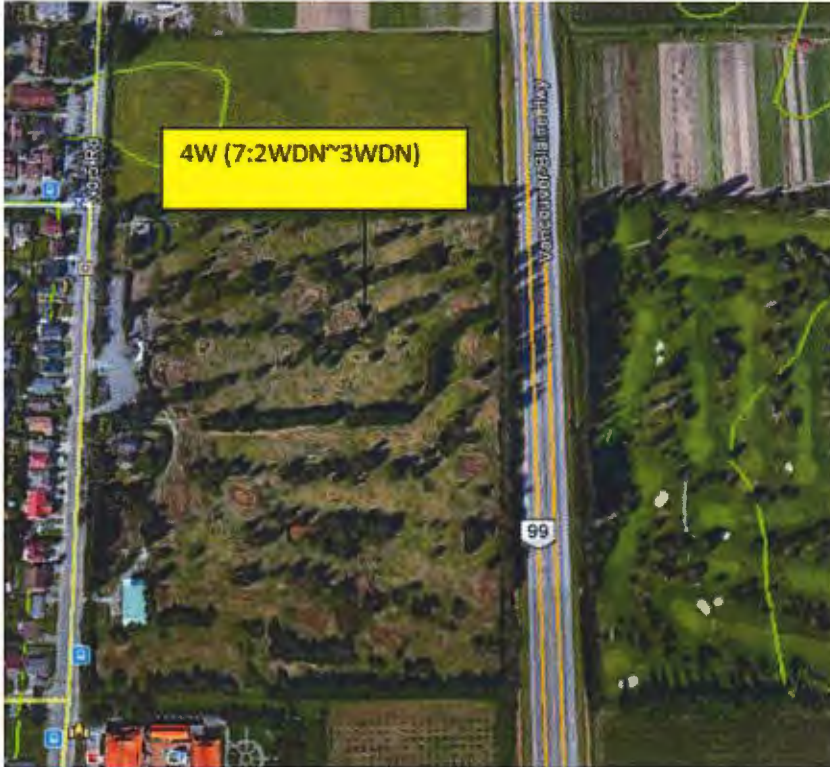
Figure 9 Land capability for agriculture

Site observations on the subject properties show soils to be consistent with the current land capability rating of 4W. Evidence of prolonged wetness was observed on the majority of the fairways. Mottling was present in many of the soil pits, indicating prolonged water saturation in the soil profile. This is common for Delta soils, which are classified as Orthic Humic Gleysol.

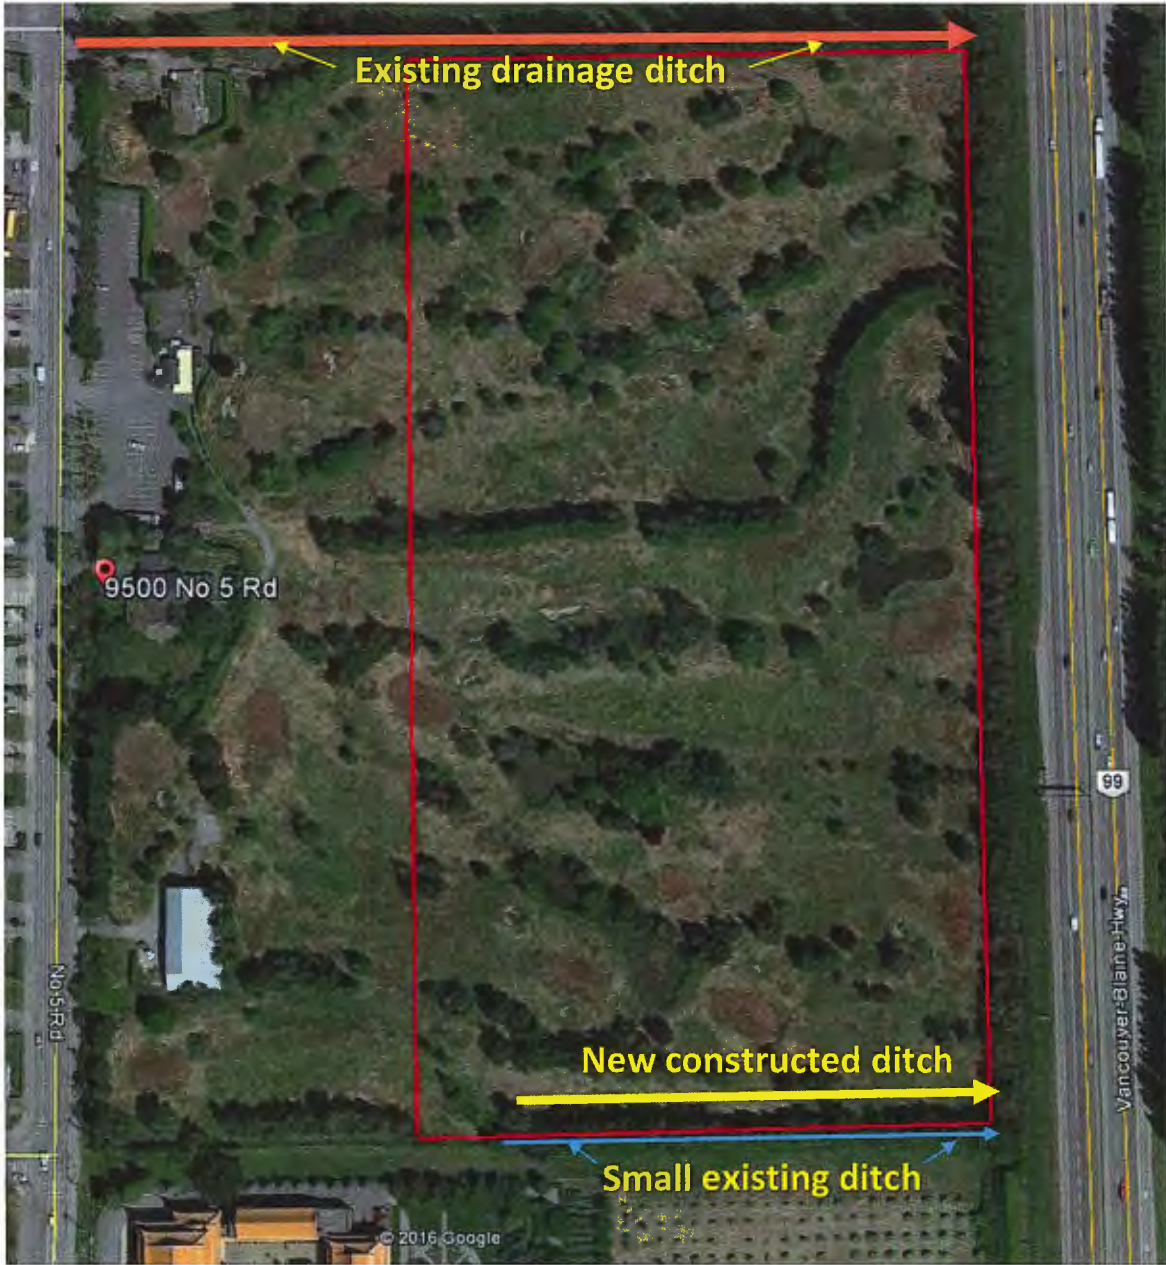
Figure 10 Location of surface drainage features

The sloping and crowning of the agricultural area will ensure that all drainage from the site flows to the Highway 99 drainage ditch. Water will be transmitted by the existing ditch on the north of the property, by the newly installed ditch on the south of the property and by overland flow directly to the highway 99 ditch.

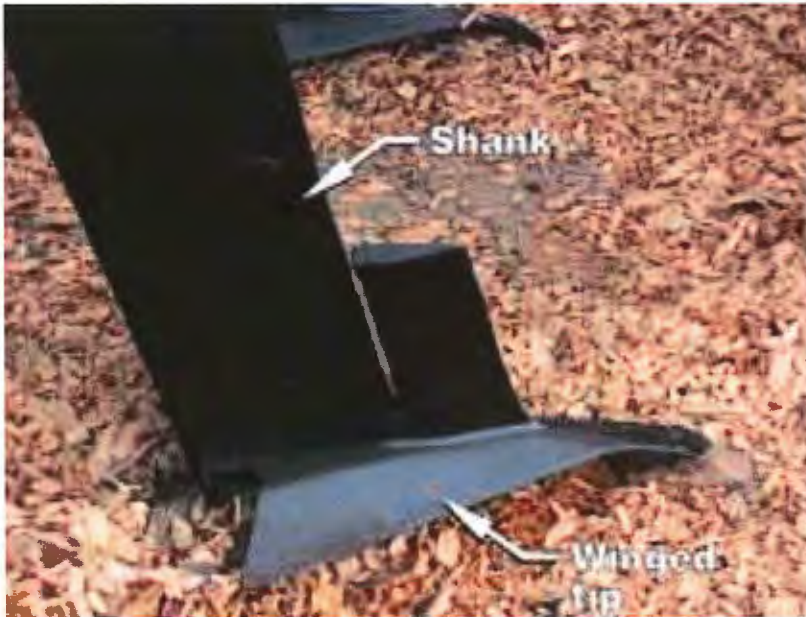
Figure 11 Example of a winged tine subsoiler

Deep compaction which restricts water infiltration and root development can be improved by subsoiling with a wing-tined subsoiler to depths of 0.75 m (Figures 11 and 12). Criteria for effective subsoiling include:

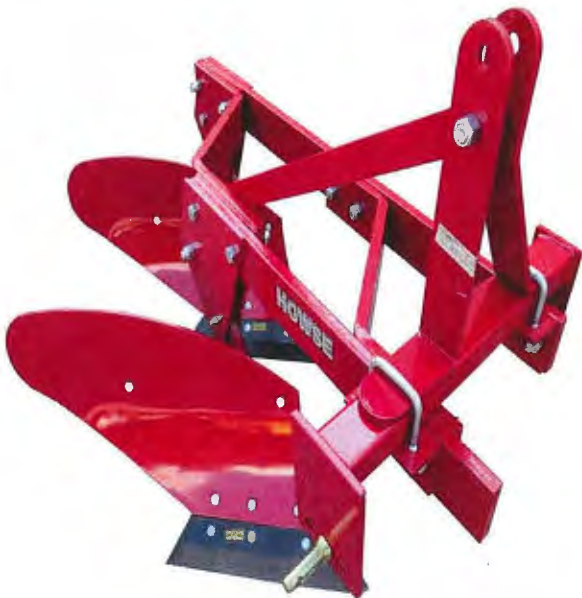
Figure 14 Moldboard plough

Ploughing should be done using a large mouldboard plough (see Figure 14) with a plough depth of at least 30 cm (12 inches).
