To: Mayor and Councillors
From: Carli Williams, P.Eng.
Manager, Business Licence and Bylaws
Date: April 23, 2021
File: 12-8080-12-01/Vol 01
Re: **Response to Council Referral for Soil Use for the Placement of Fill Application for 8511 No. 6 Road (Jiang)**

The City of Richmond received a 'Soil Use for the Placement of Fill' application for the property located at 8511 No. 6 Road (the "Property"). The intent of the application is to address damage to a large portion of the Property due to past activities of a previous landowner(s) approximately 38 years ago, which included excavating and removing the native soil and replacing the soil with untreated woodwaste. The Applicant is proposing to improve the agricultural capability of the Property from its current Class 6 or 7 rating to a Class 1 rating to allow for the development of a blueberry farm.

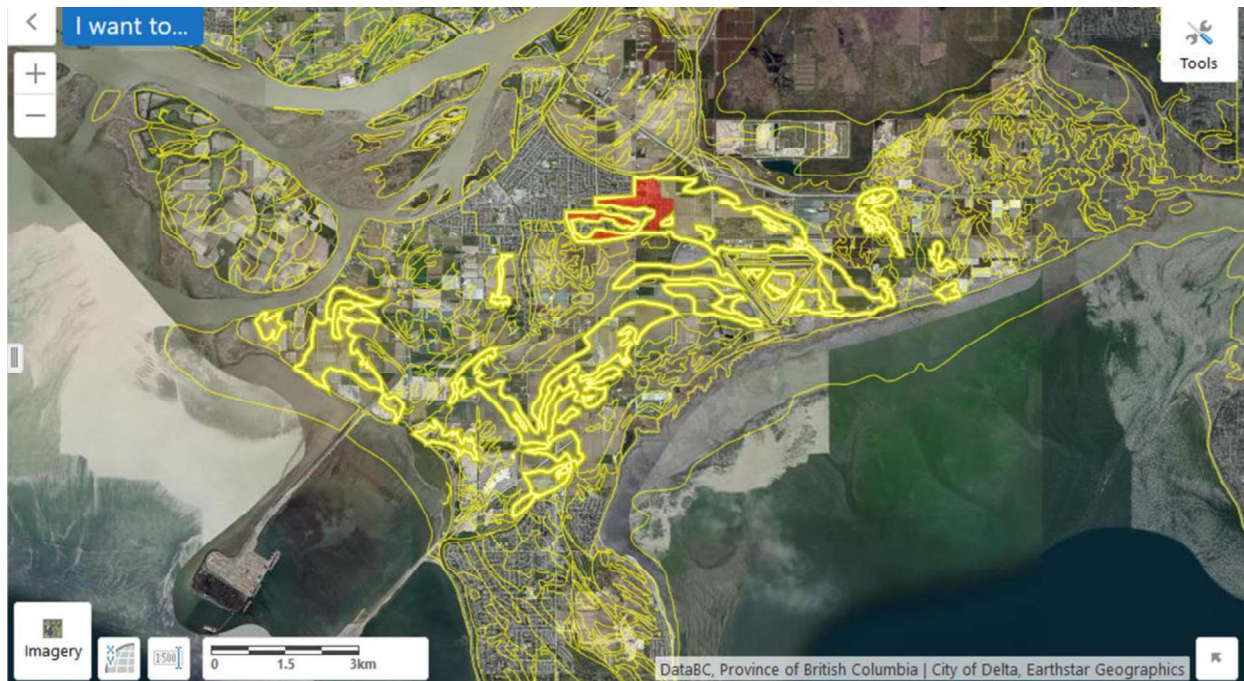
Characteristics: Silt loam texture, 0% coarse fragment content (stone-free), poorly drained

Mapped distribution: Found mostly in agricultural areas in Delta. Limited distribution in residential areas.

FIGURE A5. DELTA SOIL SERIES MAPPED LOCATIONS - OUTLINED IN SOLID YELLOW. LOCATIONS HIGHLIGHTED IN RED REPRESENT THE MOST IDEAL AREA(S) FOR SOURCING OF THIS PARTICULAR SOIL ASSOCIATION.

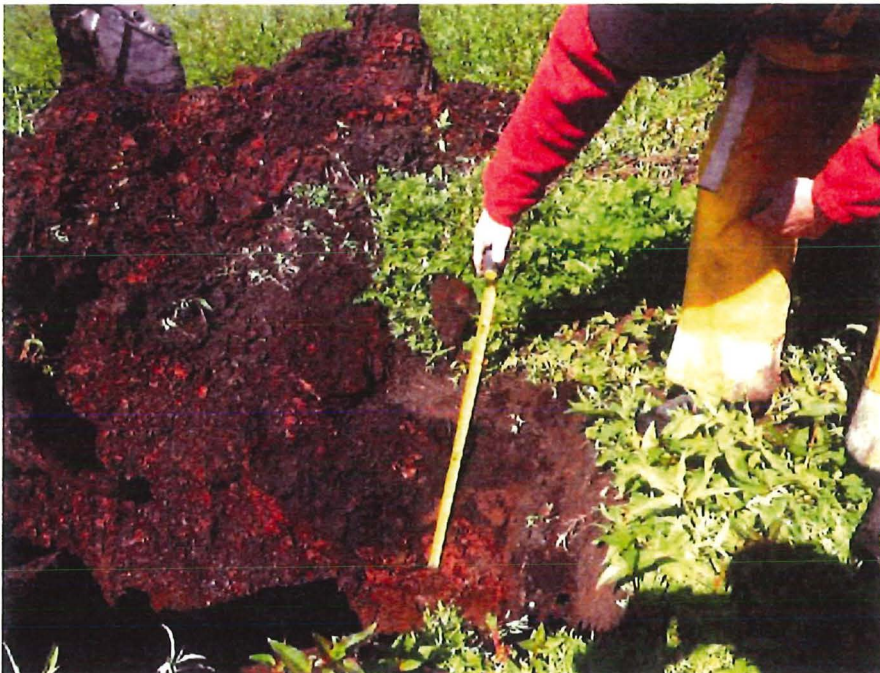
Figure 5: Cedar Shaving Buried on Site

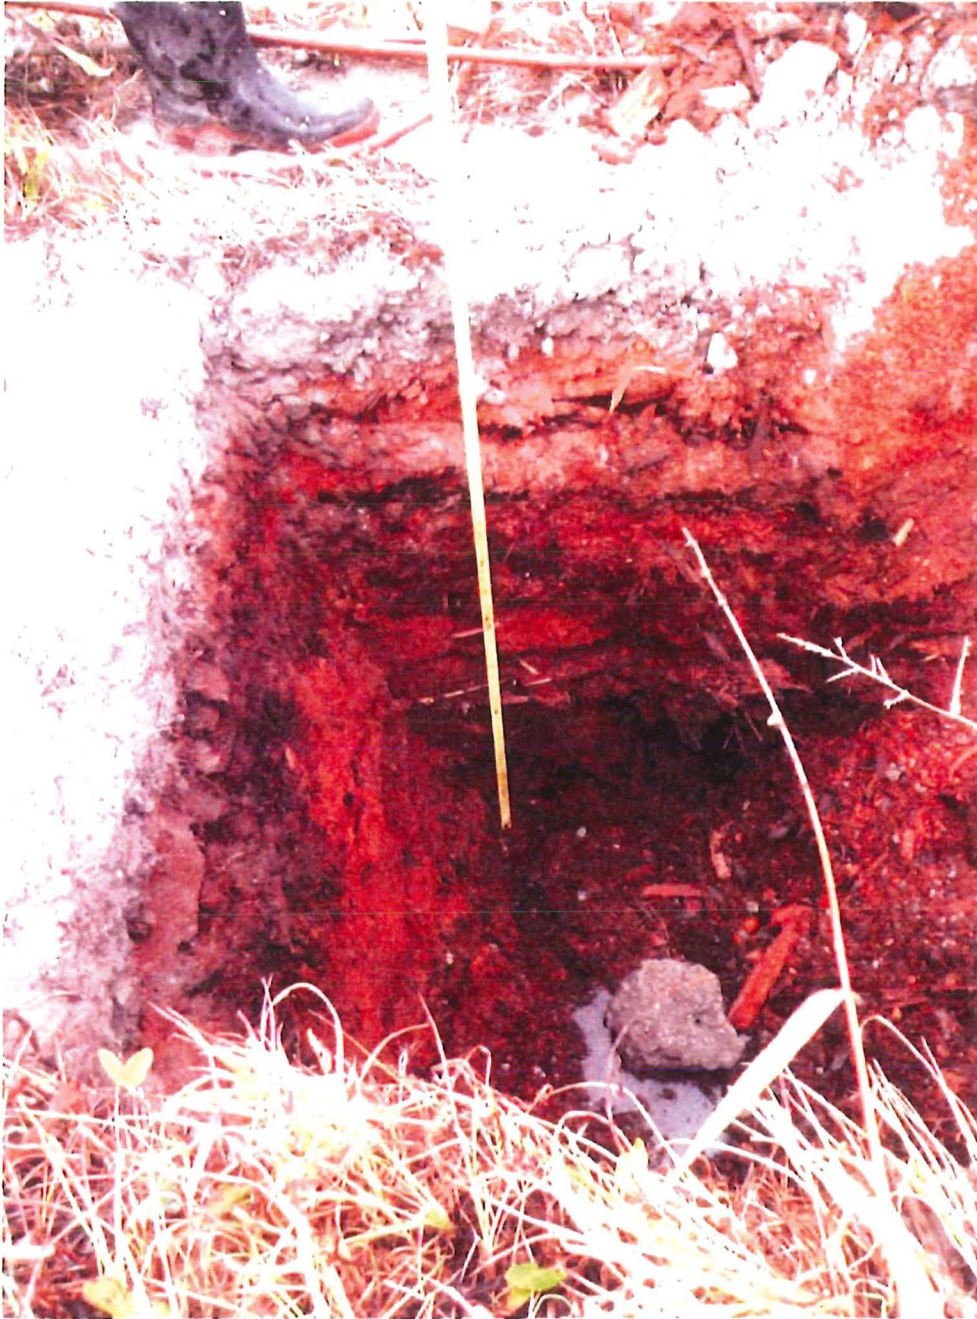
Figure 7: Undisturbed Soil Profile

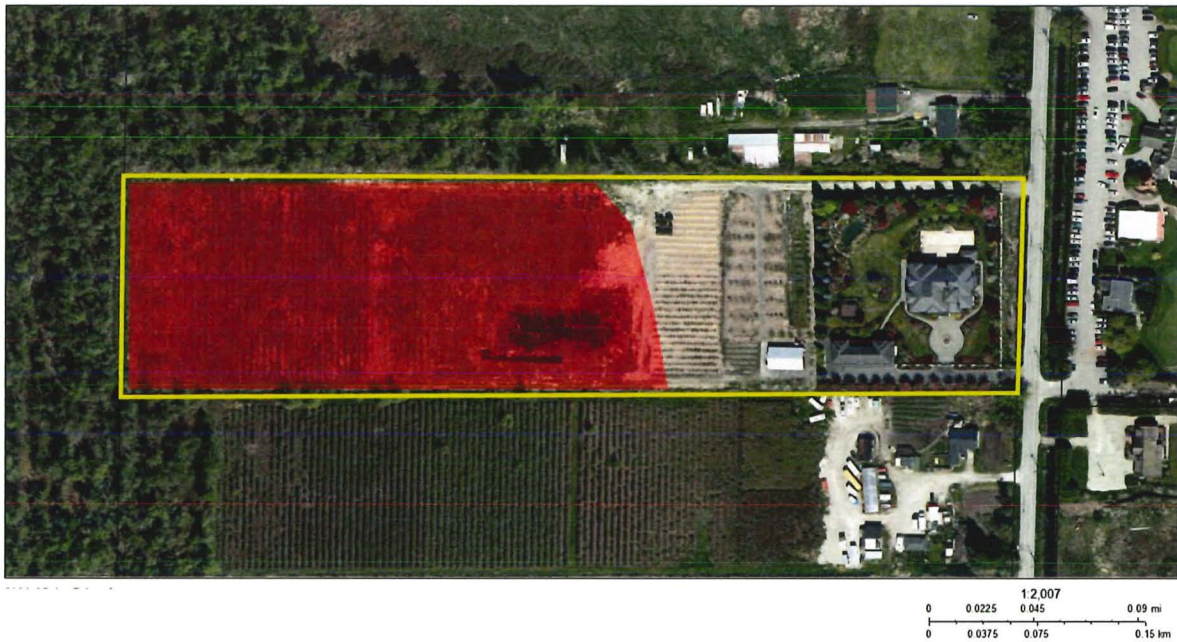
FIGURE 1. SATELLITE IMAGERY OF 8511 NO.6 ROAD OUTLINED IN YELLOW. THE RED SHADED AREA REPRESENTS TO PROPOSED AREA FOR SOIL IMPORTATION. IMAGE PROVIDED BY THE CITY OF RICHMOND AND DATED AS TAKEN IN 2018.

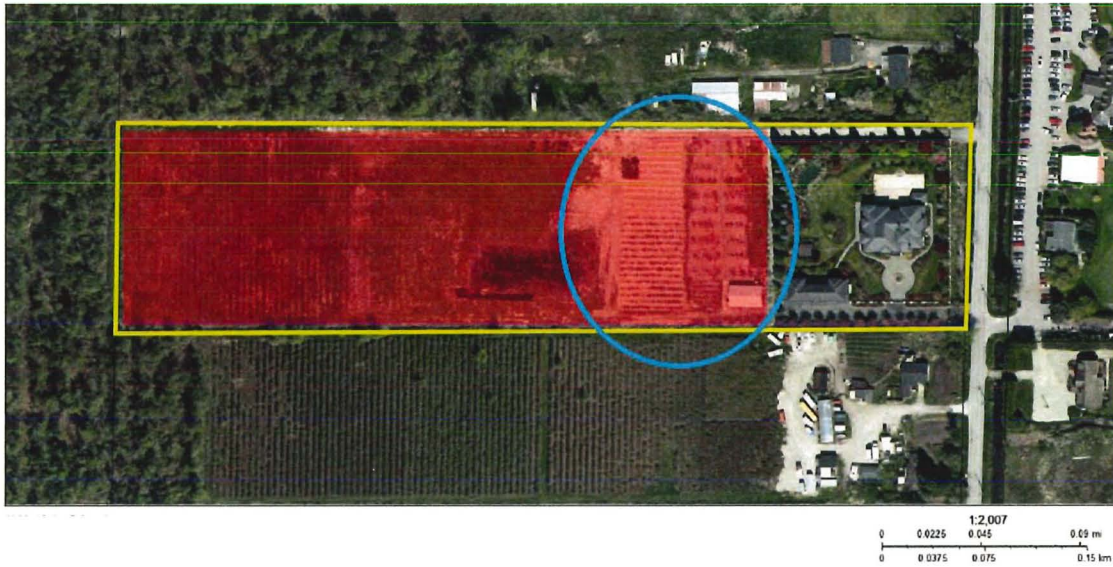
*Raised area identified in blue

FIGURE 1. SATELLITE IMAGERY OF 8511 NO.6 ROAD OUTLINED IN YELLOW. THE RED SHADED AREA REPRESENTS TO PROPOSED AREA FOR SOIL IMPORTATION. IMAGE PROVIDED BY THE CITY OF RICHMOND AND DATED AS TAKEN IN 2018.
