City of Richmond

Report to Committee

To: Community Safety Committee **Date:** June 19, 2020
From: Cecilia Achiam **File:** 12-8080-12-01/Vol 01
 General Manager, Community Safety
Re: **Soil Use for the Placement of Fill Application for the Property Located at 19740 River Road (Sidhu)**

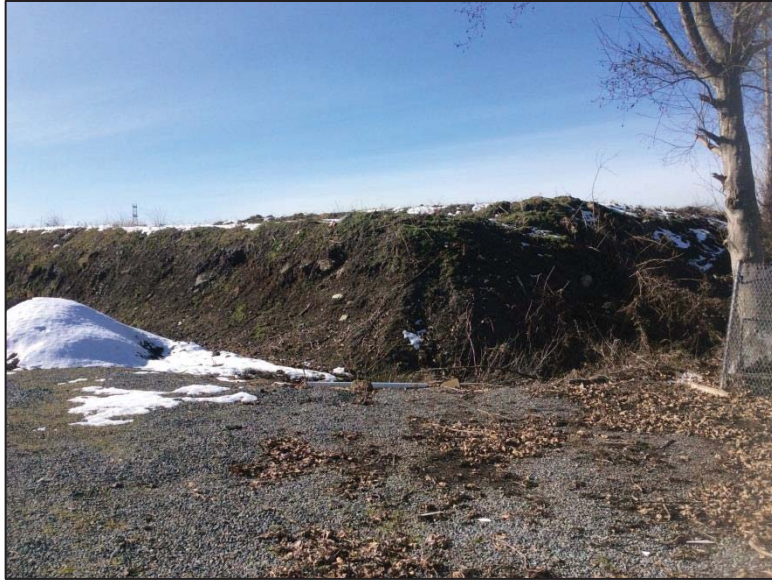
PHOTO 2. APPROXIMATELY 2.5 M OF FILL HAS BEEN PREVIOUSLY PLACED

Over the northwest corner of the property, including where the farm storage facility is situated at the River Road entrance.

The landscape has been altered by soil importation in the northwest corner; this has raised the land by an estimated 2.5 m (and up to 3 m) above the natural elevation (see **Photo 2**, below). The remainder of the site has not been elevated by fill; a geodetic control marker located in the southern part of the property (in the cranberry field, **Photo 3**) is situated at approximately 1.8 m above sea level¹¹. This is the main topographic information I have found for this area; there is no topographic land survey data (available through Jagbar Farms) or contours available from iMapBC or the Richmond Interactive Map.

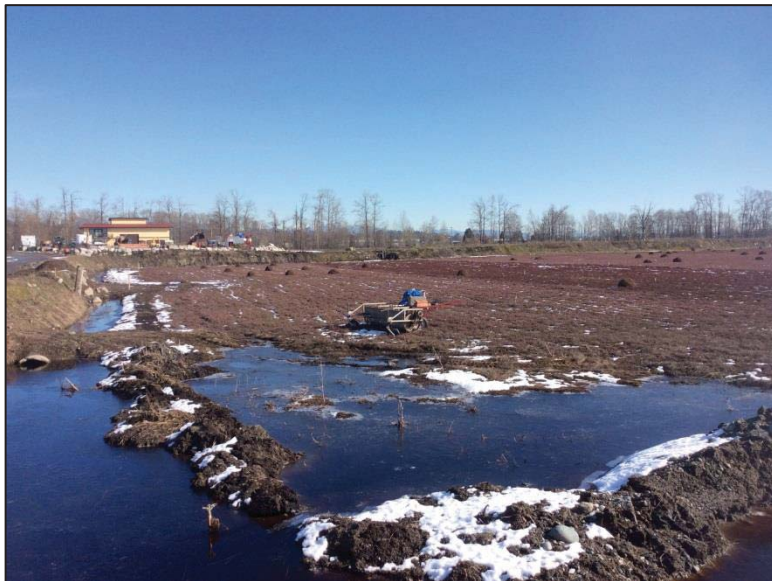
PHOTO 3. LOOKING NORTHEAST

Across the cranberry farm. This photo was taken from an access road that also acts as a dike. The field is partly flooded by melting snow and ice.

The majority of cranberry farm is situated in a flooded peat bog that has been diked for over 30 years. Mr. Sidhu and I did not excavate the peat soils due to flooded conditions; furthermore, we did not want to damage the producing cranberry plants. The mapped and assessed soils are described in detail in the next sections of this report.

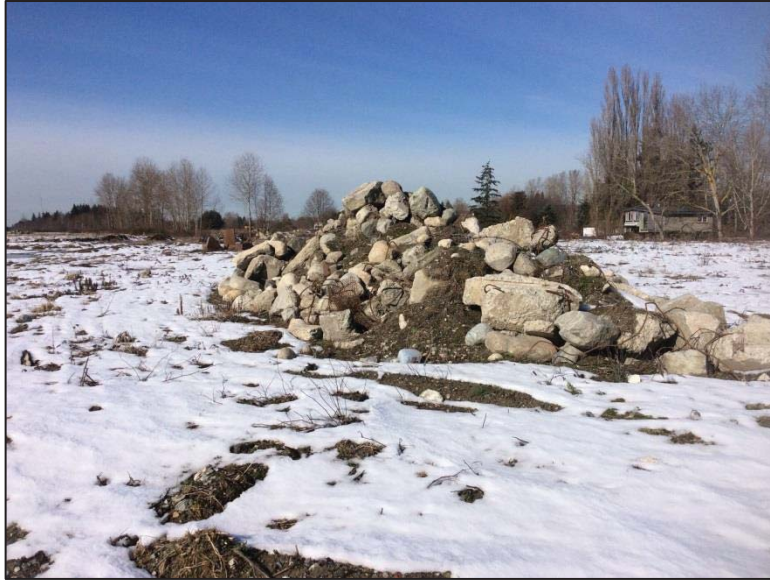
PHOTO 4. BOULDER, CONCRETE STOCKPILE SITUATED AT PM 7 IN THE PROPOSED PLACEMENT AREA.

Slopes over the northwest area are less than 2% (near level). At Placemarks 7, 9, and 14, I observed three stockpiles between 10 m³ and 20 m³ containing boulders, concrete, rebar, and gyproc. As outlined in the Soil Placement Plan (Section 5.0), these should be removed prior to peat placement.

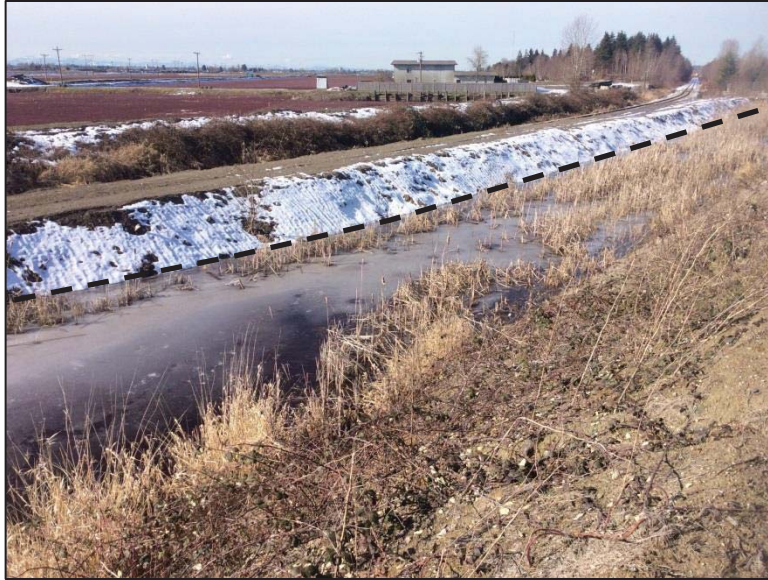
PHOTO 5. LOOKING NORTHWEST

Along the western property line at the reservoir, access road/dike, and the CN Railway. The property boundary is indicated by the black dashed line.

On the west side of the proposed soil placement area, I observed that an approximately 0.5 m high berm has been installed. Beyond this, there is a water reservoir constructed for irrigation. Adjacent to this reservoir, there is an access road and dike that is owned by CN Rail. The railway is situated to the west of the access road. Beyond the railway there are the neighbouring cranberry and blueberry farms.

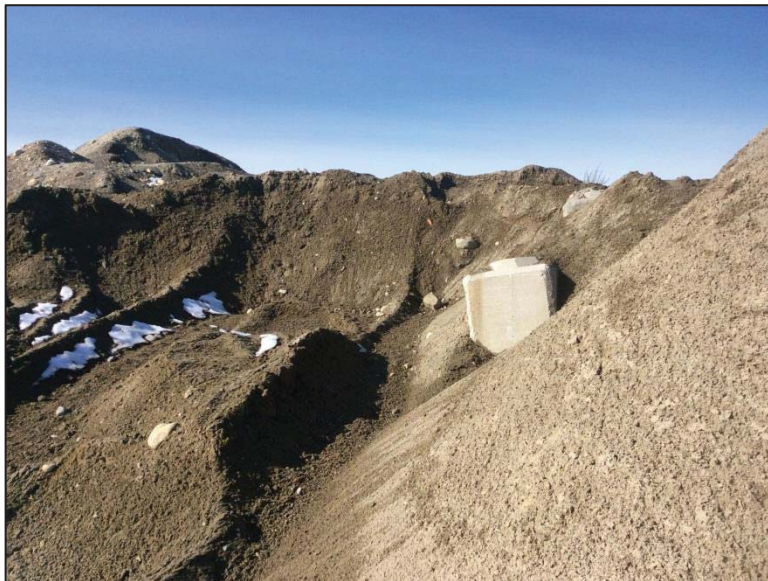
PHOTO 6. STOCKPILE OF COARSE SAND AND GRAVEL

Situated at PM 18 on the property – this will be used to construct dikes around the imported peat, which will allow cranberry farming.

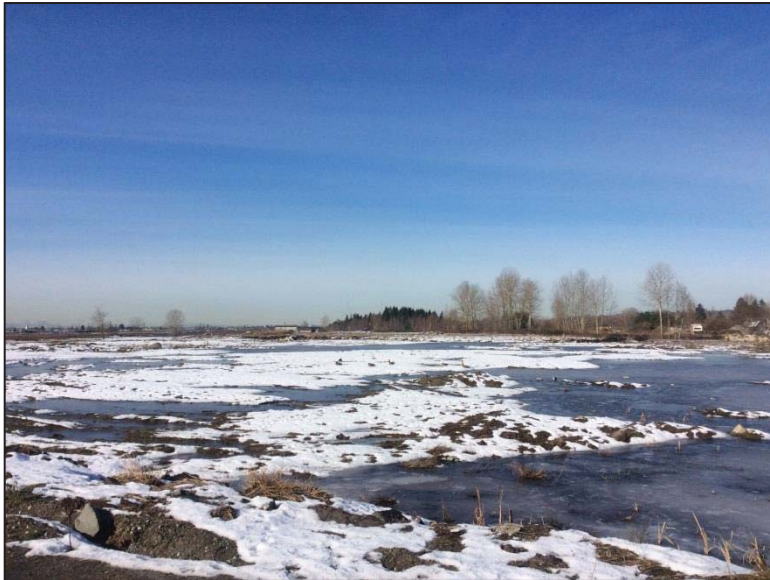
PHOTO 7. LOOKING NORTHWARDS

Across the proposed soil placement area, which has been filled as of 2005 and does not feature any vegetation.

The proposed soil placement area does not have any vegetation nor has it been prepared for farming (i.e. decompacted, raked, diked, or planted). There was some snowmelt and ice accumulation on the surface. During our excavation, the pits filled somewhat quickly with water from both the surface and from high water tables.

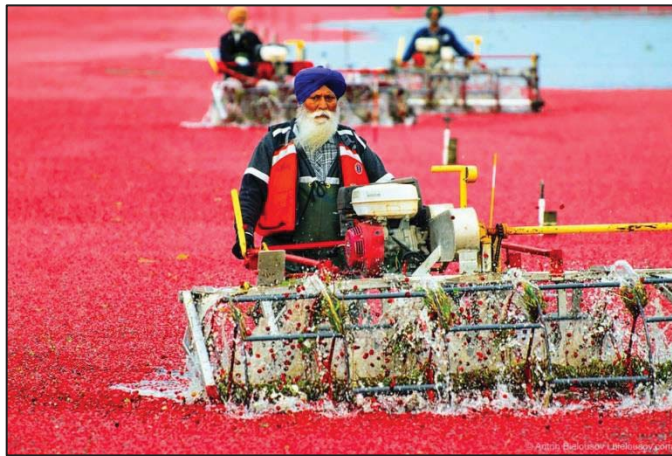
PHOTO 8. CRANBERRY THRESHING MACHINE DURING WET PICK IN OCTOBER.
Photo Credit: Anton Bielousov. <http://sakvoiazh.ru/>

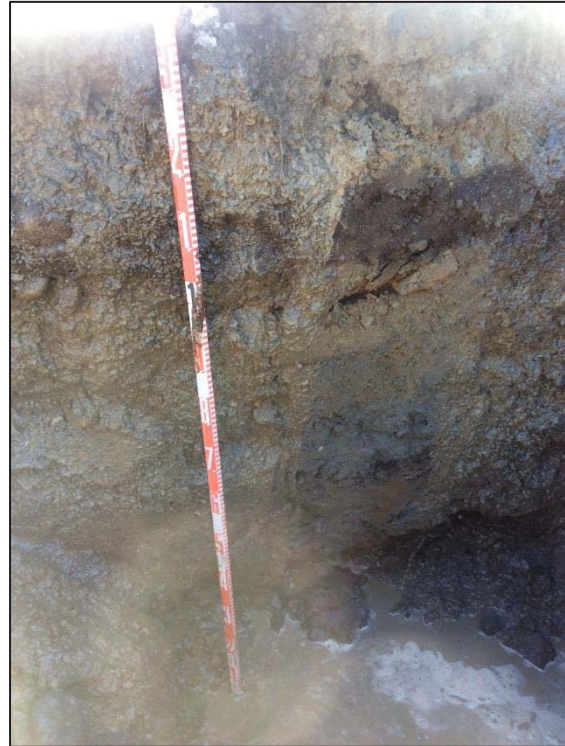
Pit 2 – Soil Profile Description (Placemark 3, Figure 1)

Property	Value
Pit Depth	1.3 m
# of soil horizons	2
Horizon	Depth (m)
0-1.0	Bgj
1.0-1.3+	IIBg
Land Capability (unimproved)	2P, 3F, 2W

Comments: Approximately 1 m of olive grey sandy loam with fine gravel (approximately 10%) overlying grey brown, firm loamy sand (compacted). The sandy textures of this soil correlate to a reduced nutrient holding capacity (3F estimated). The 10% fine to coarse gravel in the upper 25 cm of the first horizon correlates to a 2P stoniness limitation.

Soil Pit 2 features approximately 1 m of sandy loam containing coarse sand and 10% coarse gravel. Below this, the texture is loamy sand with between 5 and 10% coarse gravel. The pit was very wet when excavated and quickly collapsed. The lower horizon extended to 1.3 m deep and was found to be firm due to compaction (similar to Pit 1).

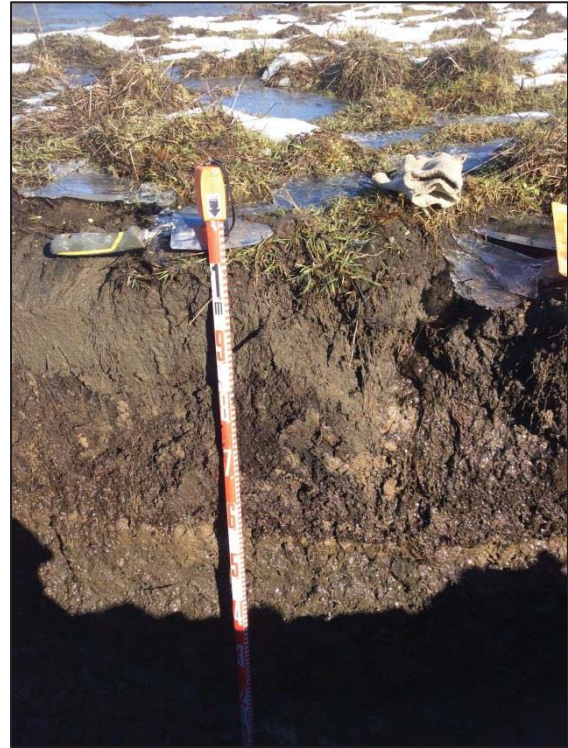
Pit 3 – Soil Profile Description (Placemark 4, Figure 1)

Property	Value
Pit Depth	1.0
# of soil horizons	2
Horizon	Depth (m)
Bm	0-0.55
IIBg	0.55-1.0+
Land Capability (unimproved)	3F, 3D, 2W

Comments: Dark brown to dark grey (variable as seen in photo) loamy sand overlying very firm (compacted) olive grey brown loamy sand. The loamy sand textures in this soil correlate to a reduced nutrient holding capacity (3F estimated in absence of soil testing for this project).

The last pit, Pit 3, was found to contain exclusively loamy sand to a depth of 1 m. The upper B horizon, which extends to approximately 55 cm, has dark grey to dark brown colouring that is highly variable, and contains approximately 5% coarse gravel. The lower horizon has 10% coarse gravel and is an olive brown to olive grey colour.

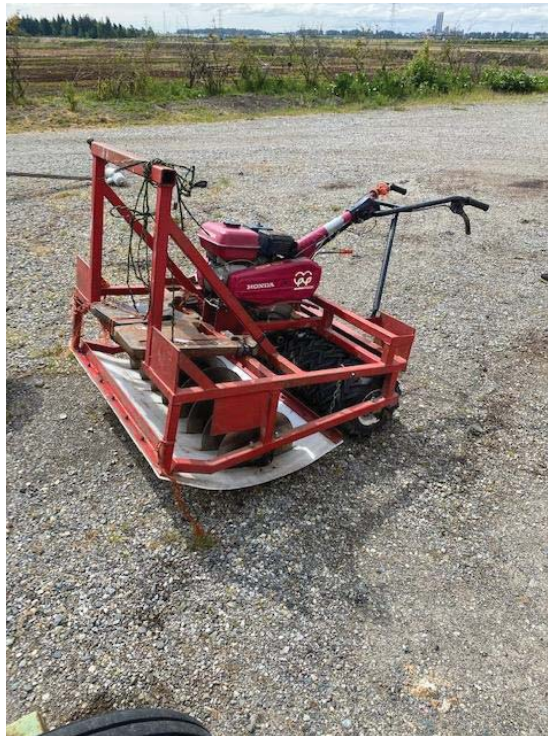
PHOTO 1. CRANBERRY VINE PLANTING MACHINE OWNED BY JAGBAR FARMS

- Approximately 3,000 lb/acre⁴ of vines are required to plant the field (5.3 ha is 13.1 acres, therefore approximately 39,000 lbs of vines are required).
- The vines are obtained from pruning of existing field and are bundled (approximately 90%, the remaining 10% are to come from a neighbouring farm at no cost).
- The planting consists of distributing the vines in the field and disking (see photo of planting machine below)

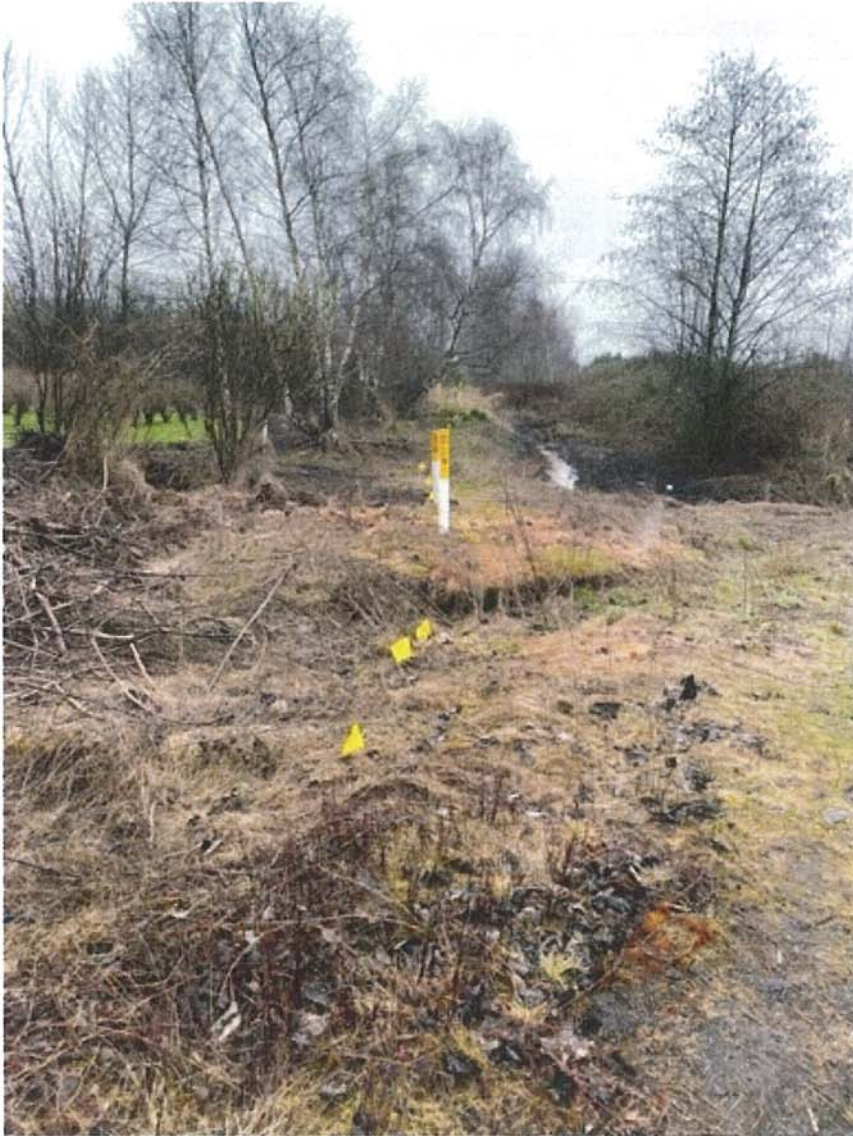
Figure 2
Kinder Morgan pipeline ROW adjacent to northwest boundary of Jagbar Farms. ROW is separated from soil deposit by buffer including ROW, ditch, and embankment at right.

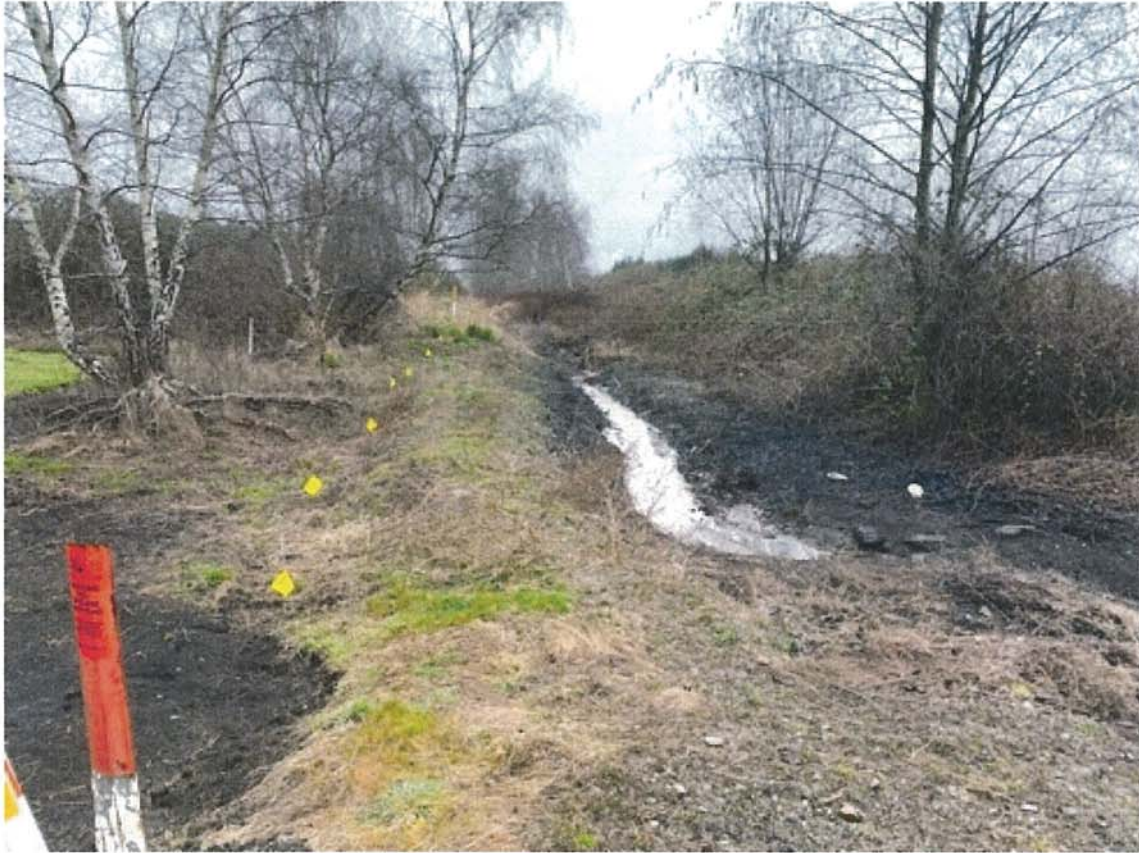
Figure 3
Kinder Morgan ROW at left. Jagbar Farms at right.
