# **Report to Committee**

Application by Sanstor Farms Ltd. for an Agricultural Land Reserve Non-

Farm Use (Sand Storage) at 14671 Williams Road

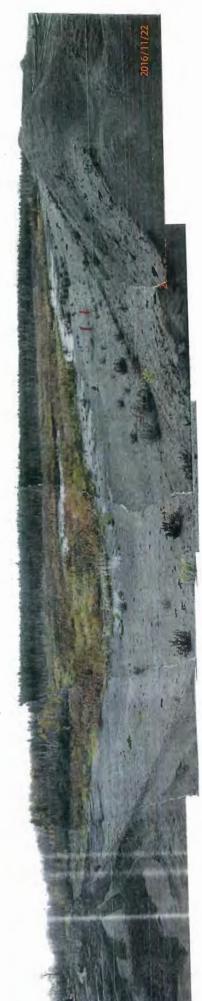
Pan view of sand stockpile along Savage Road ROW alignment

We have noted that encroachment of the sand pile has occurred onto the City of Richmond Savage Road right of way. This encroachment extends partially onto the Ecowaste Industries land lying to the west and formerly used as a radio transmission grounding site. A review of historic aerial photography shows that these encroachments have been occurring for at least twenty years without apparent concern or action by either land owner. A series of these photographs with the bounds of the encroachment shown are attached hereto. Bruce Mathers has informed me that they have removed most of the sand spillage from the Ecowaste site and re-exposed the underlying peat soil but a small area is still impacted by the main sand storage pile. The sand pile still encroaches on the Savage Road ROW. A topographic plan showing the 2011 conditions in the affected area of the site is attached.

I attended to a site inspection of the current sand storage area on the Ecowaste site with Bruce Mathers on November 22, 2016. I observed the active dredging and placement of sand on the site. The encroachment onto the Savage Road ROW and the Ecowaste site was observed from the top of the sand pile. Photographs of the site and sand placement operation area attached. Mr. Mathers explained the operation and actions recently taken to remove sand from the Ecowaste site which had spilled periodically in the past when containment dykes had been breached. He indicated that they were in discussion with the City of Richmond regarding a cooperative procedure for rehabilitation of the Savage Road ROW to meet City plans for use of this corridor.

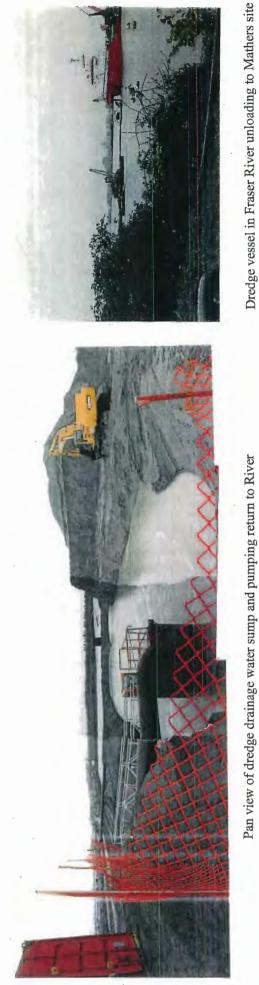
Pan view of dredge drainage water sump and pumping return to River

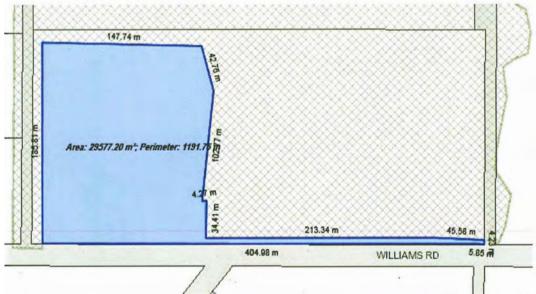
Figure 1. The blue area shows that portion of the subject property (surrounding rectangle) that is excluded from the Riverport East ESA. It is an agricultural field and residence. The hatch marks indicate the area covered by the ESA; the large area on the eastern half if forest. (Source: RIM 2017)

Table 2 shows the relative contribution of the ESA area on the subject property (hatched area in Figure 1) to the entire Riverport East ESA (Figure 2).

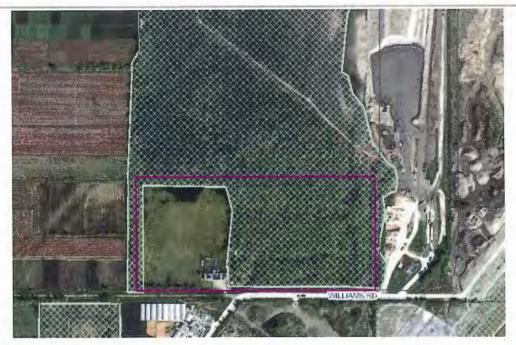
Figure 2. Environmentally Sensitive Areas (hatched area). The property is outlined in pink.

The City of Richmond's online mapping program (RIM: Richmond's Interactive Map) highlights the forested east half of the property as an Environmentally Sensitive Area (Figure 2). The main forest that comprises the east half of the property is connected to a larger forested area on the adjacent property to the north which is also considered an Environmentally Sensitive Area (Figure 2). Remnants of historical bogs are scattered throughout Richmond (Davis and Klinkenberg 2008) and these are considered of conservation concern because of their rarity in the lower mainland, their susceptibility to degradation (changes in hydrology) and the fact that they support rare and endangered plants and plant communities. Any land thought to have bog-associated attributes is considered of potential ecological significance.

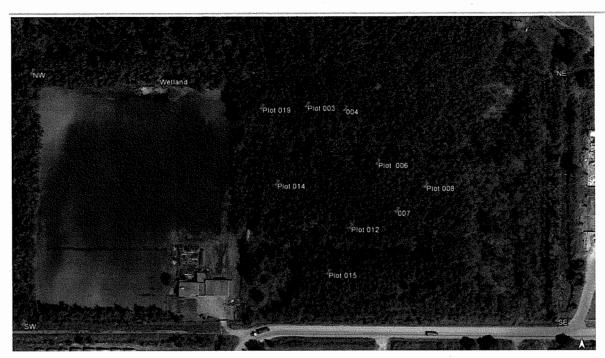
Figure 3. Key plot and feature locations.

Key locations highlighted in the text, including plot locations are shown in the map in Figure 3.

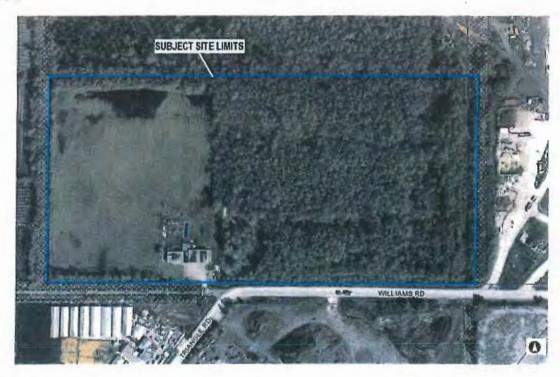
Figure 1.

- The eastern two-thirds of the subject site is treed with a stand of predominantly European birch (Betula pendula) trees growing with dense spacing and forming a partially closed-canopy form (modified through naturally occurring tree decline).
- The age class of the birch trees is estimated to be circa 40 years. This could be confirmed
  by undertaking a ring count of a representative sample from the stand.
