Re: Review of Collision Prone Intersections

Staff Report

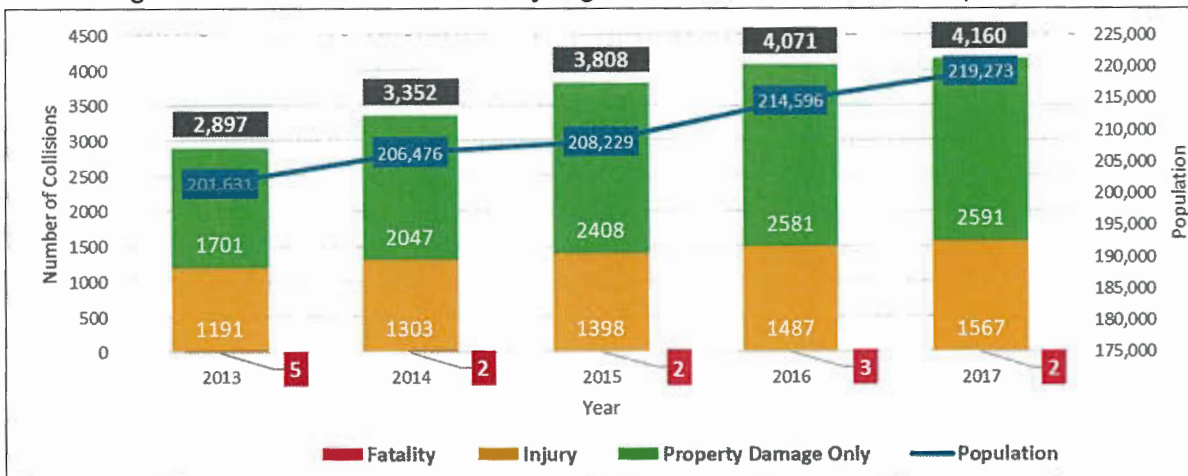
Figure 2 illustrates that the annual number of collisions at the 161 signalized intersections increased from 2013 (2,897 collisions) to 2017 (4,160 collisions), indicating an 8.7% annual growth rate that outpaces the population annual growth rate of 1.7%.

Figure 2: Annual Collisions at City Signalized Intersections and Population Trend

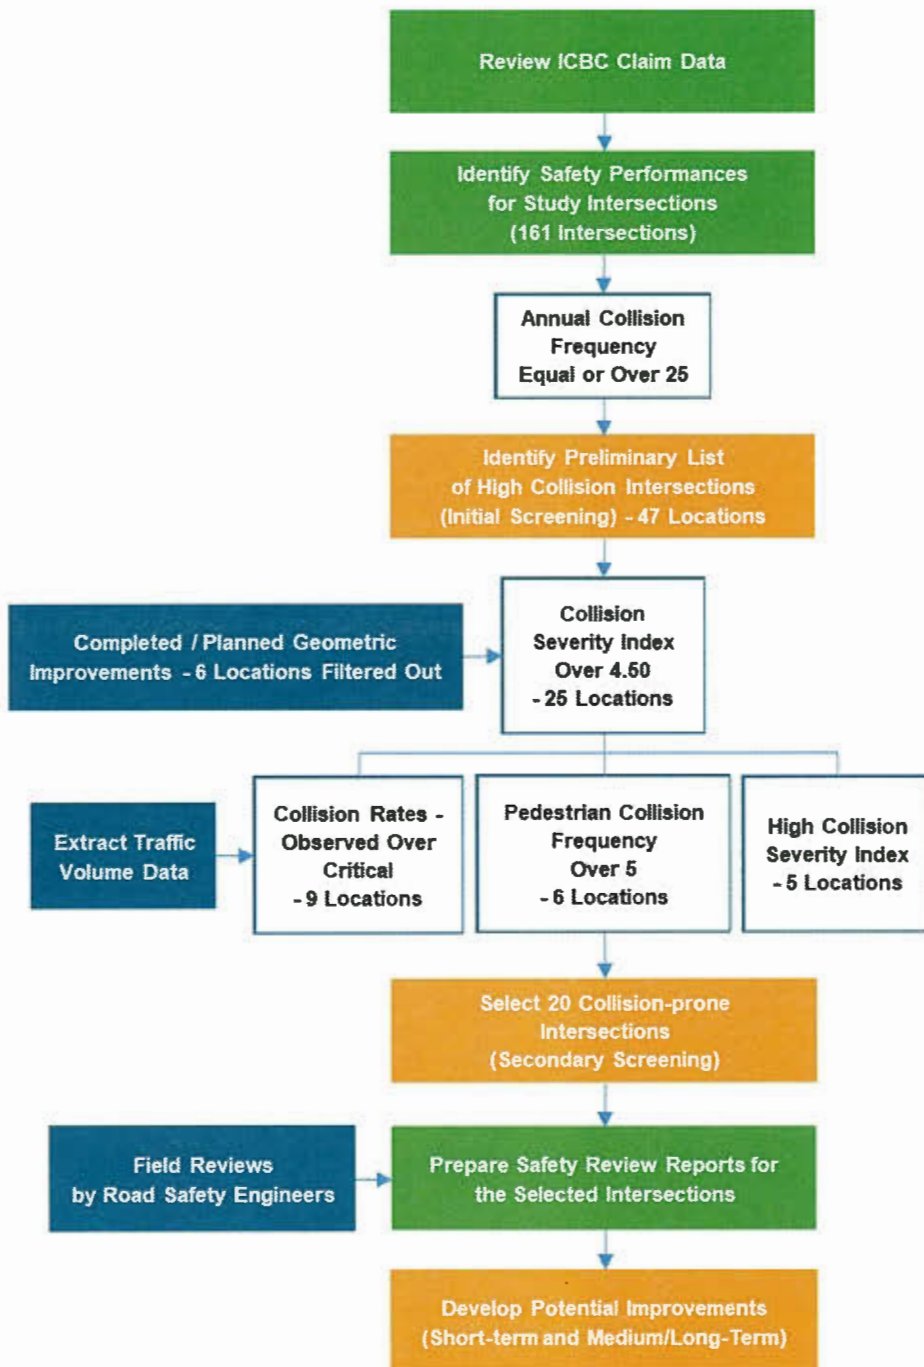
Figure ES.1 Study Methodology Flowchart

The study methodology was comprised of three key phases: Project Initiation, Initial Screening (Selection of Candidate Intersections), and Secondary Screening (Analysis of Selected Intersections). The methodology flowchart could be found in **Figure ES.1**.

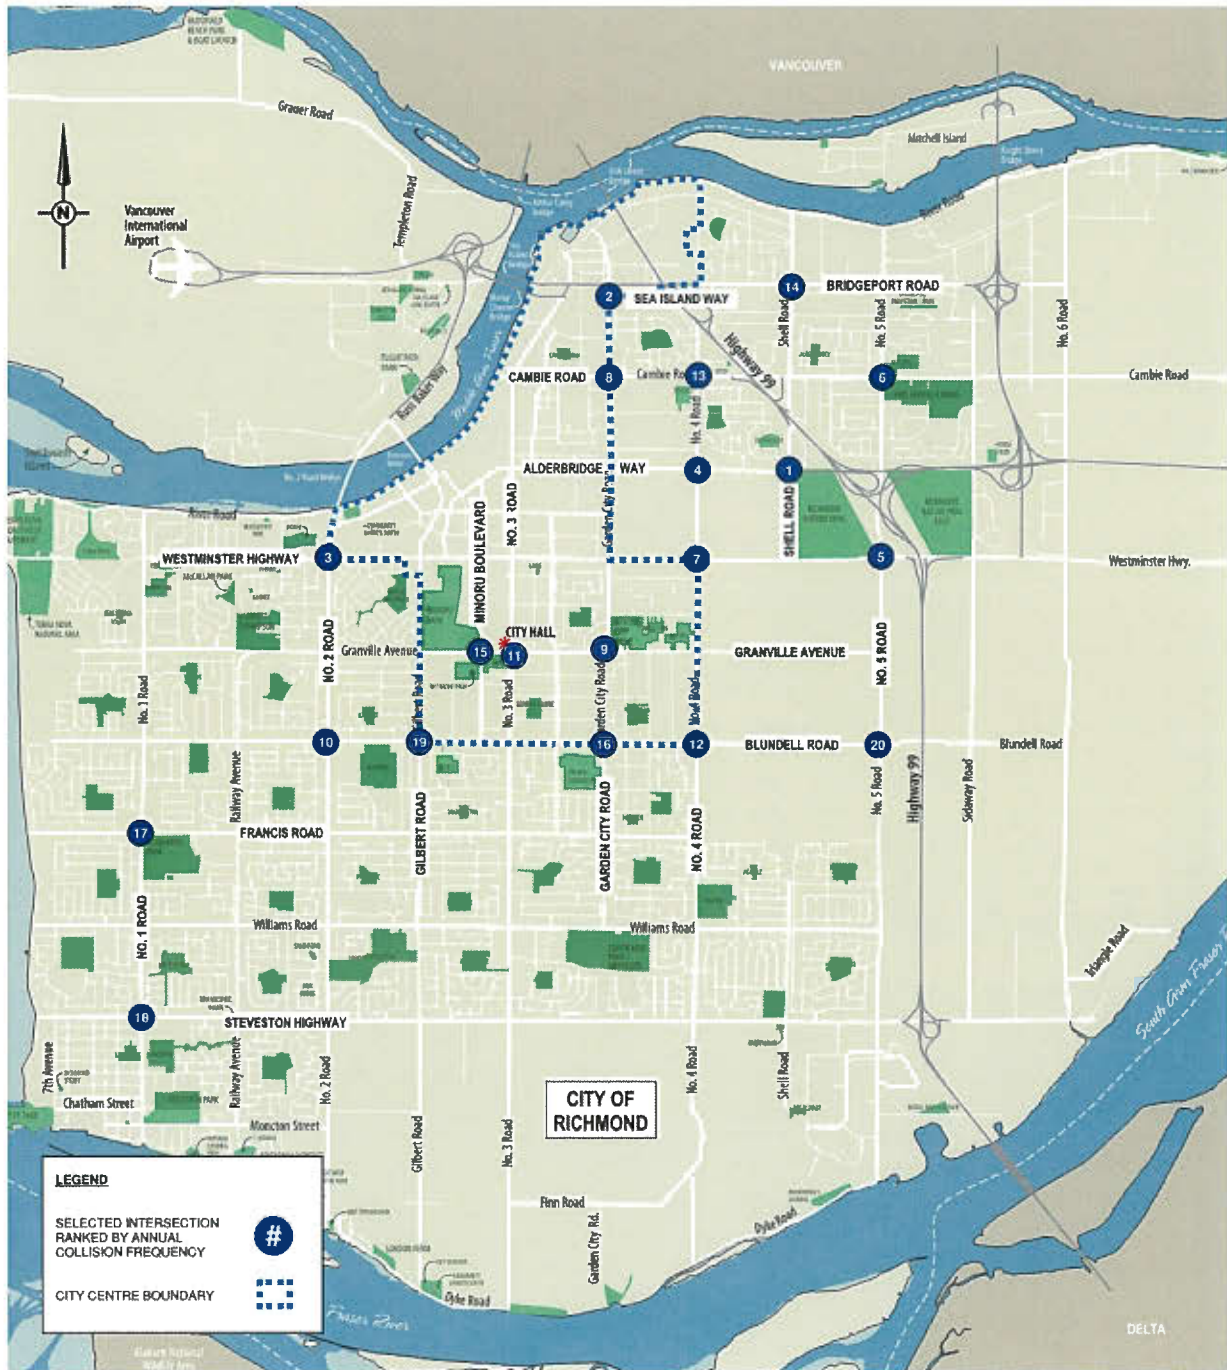
Figure ES.2 Locations of the 20 Selected Collision-Prone Intersections

Based on the selection criteria, the results could be found in **Table ES.2**. **Figure ES.2** included the locations of the selected 20 collision-prone intersections while **Table ES.3** shows the safety performance indicators for these locations.
