# City of Richmond

## Report to Committee

**Re:** **Steveston Channel Sheer Booms**

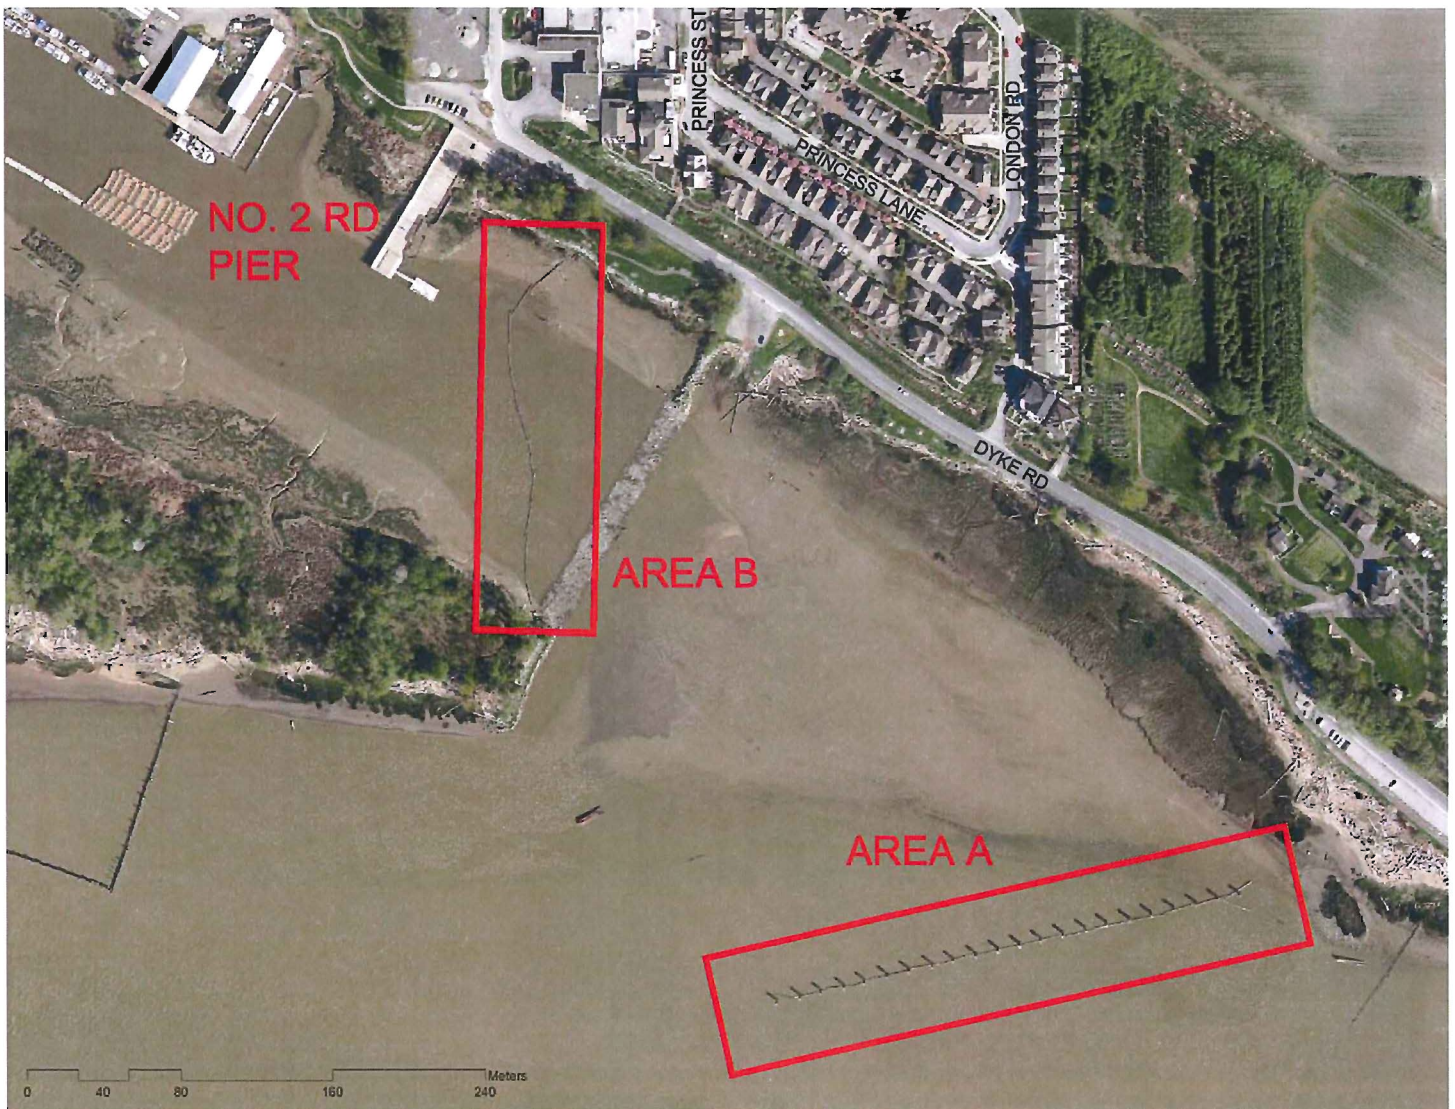
Steveston Channel Site Plan

There are two sheer booms located within the Steveston Harbour Channel east of No. 2 Road. These booms were installed to redirect and collect the flow of deadheads (abandoned floating logs) and other large floating debris from coming onto the harbour's shorelines and damaging waterfront amenities such as piers, piled buildings and floats (Attachments 1 and 2).

The sheer booms are in poor condition and have been abandoned due to the lack of maintenance funding from the Crown Province (Attachment 1 – Area A). With its current condition, the accumulation of log debris has increased substantially and the risk of floating deadhead and debris crashing into waterfront properties and assets has also increased (Attachments 3 and 4).

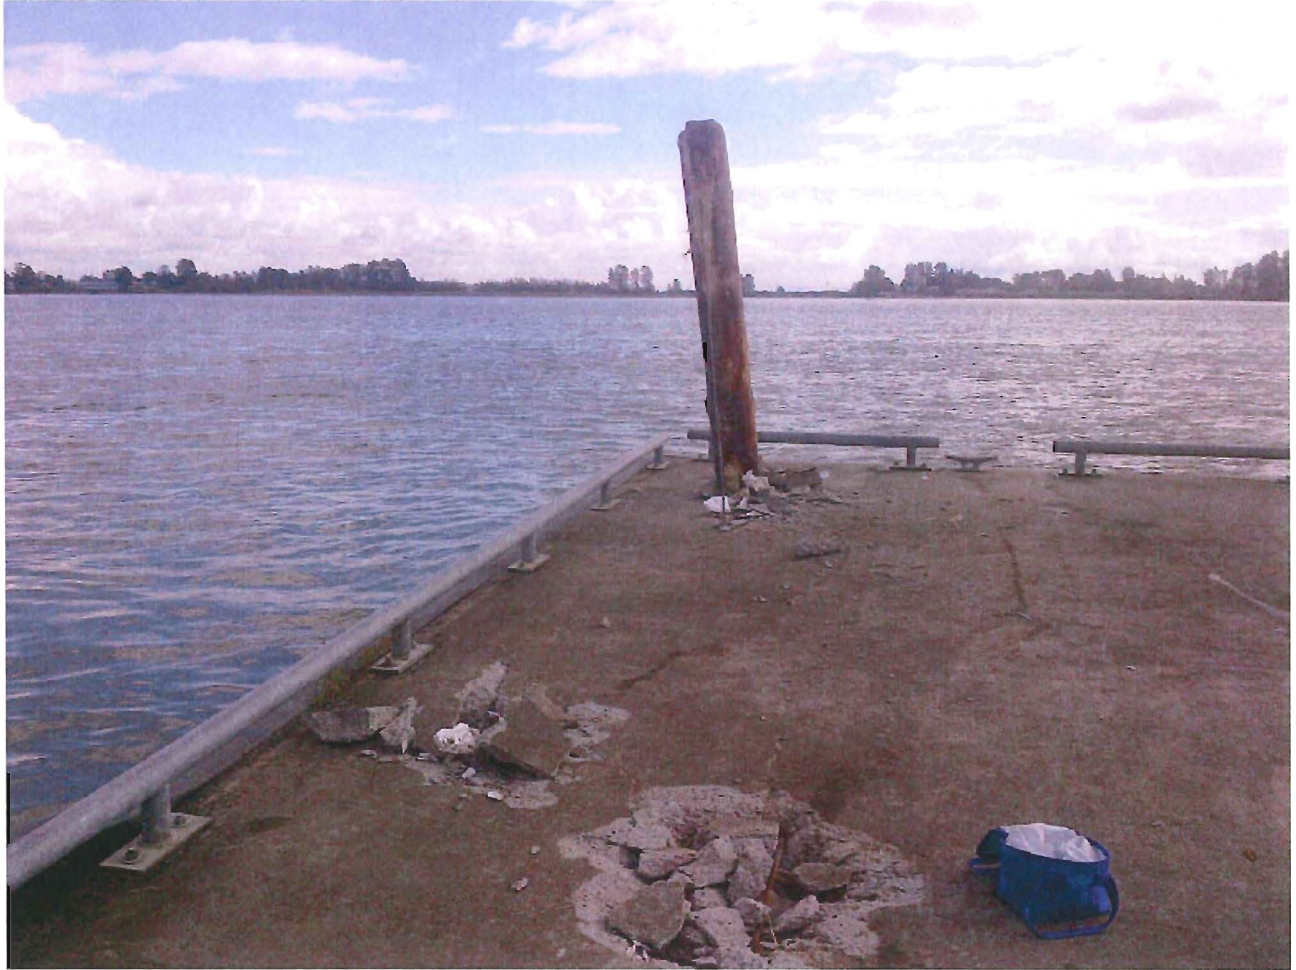
Deadhead log at No. 6 Road

A deadhead log spearing through and up a City concrete/steel rebar float at No. 6 Road.  
Illustration of damage log debris can cause during strong river current conditions.

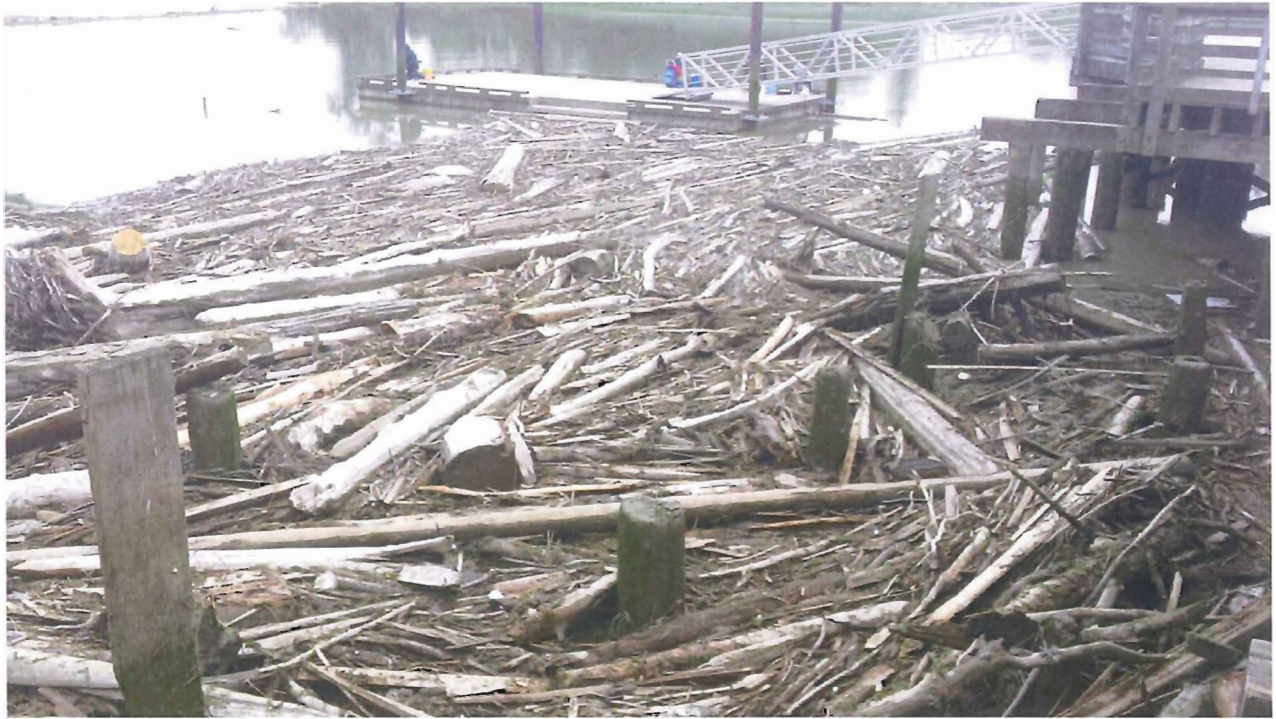
No. 2 Road Pier and Float

Accumulation of floating log debris around the City's No. 2 Road Pier and Floats.

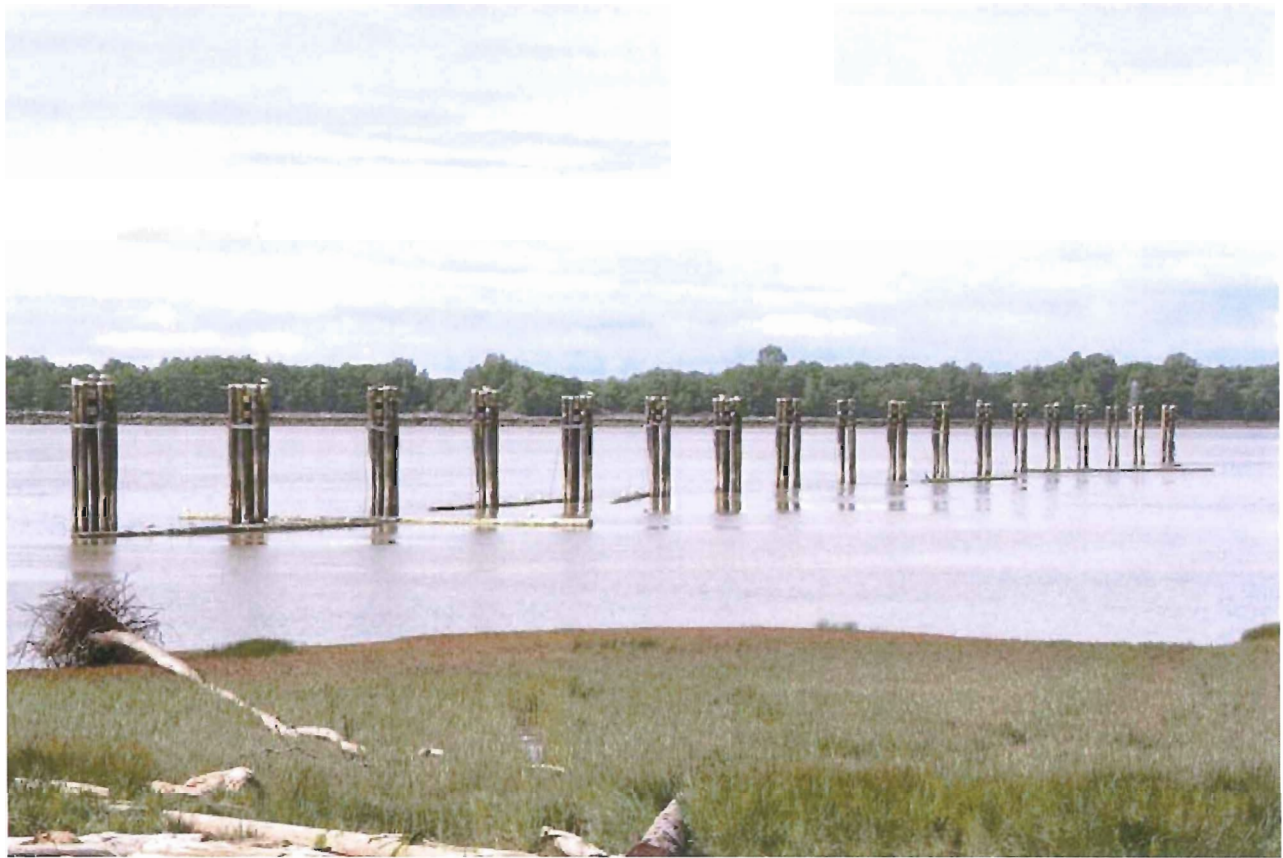
Main Sheer Boom – Existing Condition

The main sheer boom located south of London Farm's waterfront is a series of piles/dolphins connected to a line of floating logs (booms). They were installed by Public Works Canada and previously managed by the Canadian Coast Guard and now fall under the review of the Crown Province's Forest, Lands and Natural Resources Operations (FLNRO) and Transport Canada.

Estimates to replace the main sheer boom (location – Attachment 4) are approximately \$150,000. This option replaces all the deteriorating pile/dolphin structures and boom line with new ones. The current piles are not suitable for affixing a sheer boom to deflect floating debris in their current condition. Applications for permits to FLNRO, Transport Canada, and DFO with their approvals will be required to proceed with this option since it involves pile removal and replacement that impacts habitat vegetation in the river bed.

As these pilings are located on Crown land, staff are suggesting that these works are the responsibility of the Province and Transport Canada. It would be appropriate to send a letter to the Minister of Forest, Lands and Natural Resources Operations, the Federal Minister responsible for Transport Canada, Richmond's Members of Parliament, and Provincial Members of the Legislative Assembly to raise awareness of the debris issue, the continued hazards to navigation posed by it, and to seek their support to ameliorate the issue.

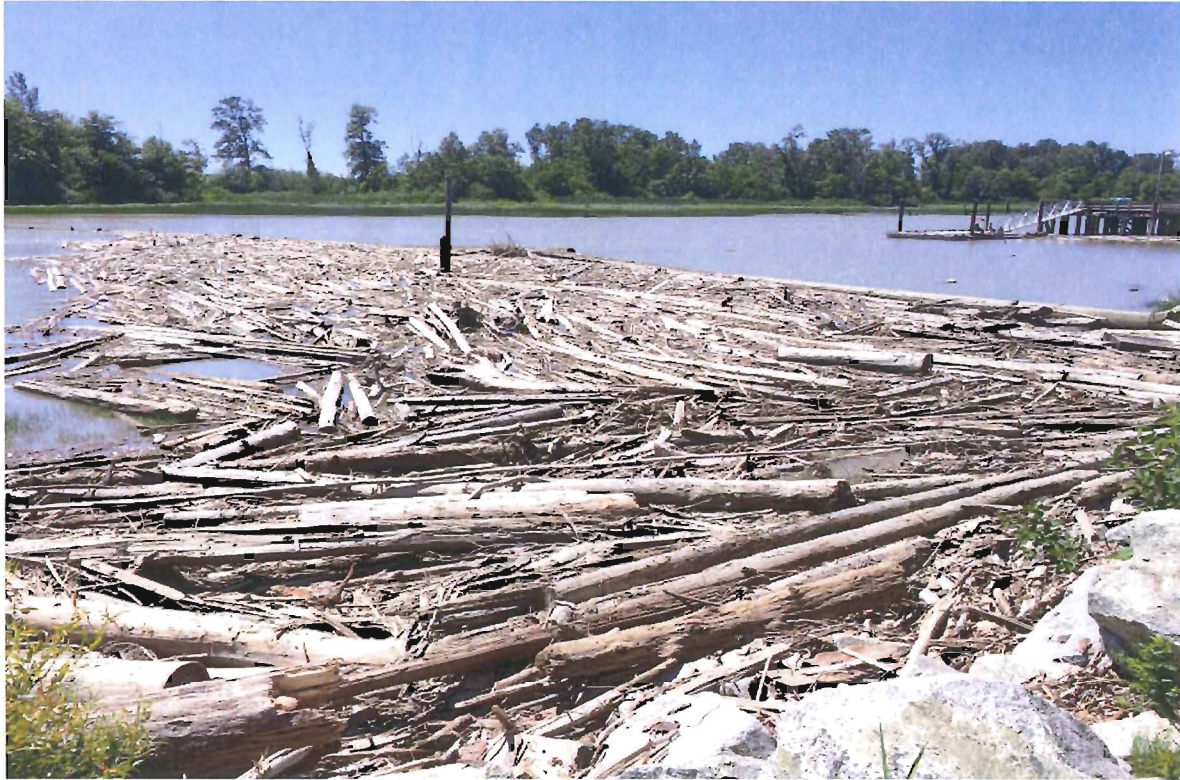
## Secondary Log Boom

The secondary sheer boom line (Attachment 5) located east of the No. 2 Road Pier/London's Landing was installed by Fisheries & Oceans Small Crafts Harbour and is currently managed by the Steveston Harbour Authority (SHA). This sheer boom was designed to deflect smaller floating debris that would occasionally pass through the main sheer boom structures; however, due to the poor condition of the main sheer boom, it is currently well over its capacity to withstand floating debris of all sizes. Maintenance requests to conduct repairs at this sheer boom are directed to the SHA for consideration and evaluation (Attachment 5).

Accumulation of log debris at the secondary log boom (managed by Steveston Harbour Authority)

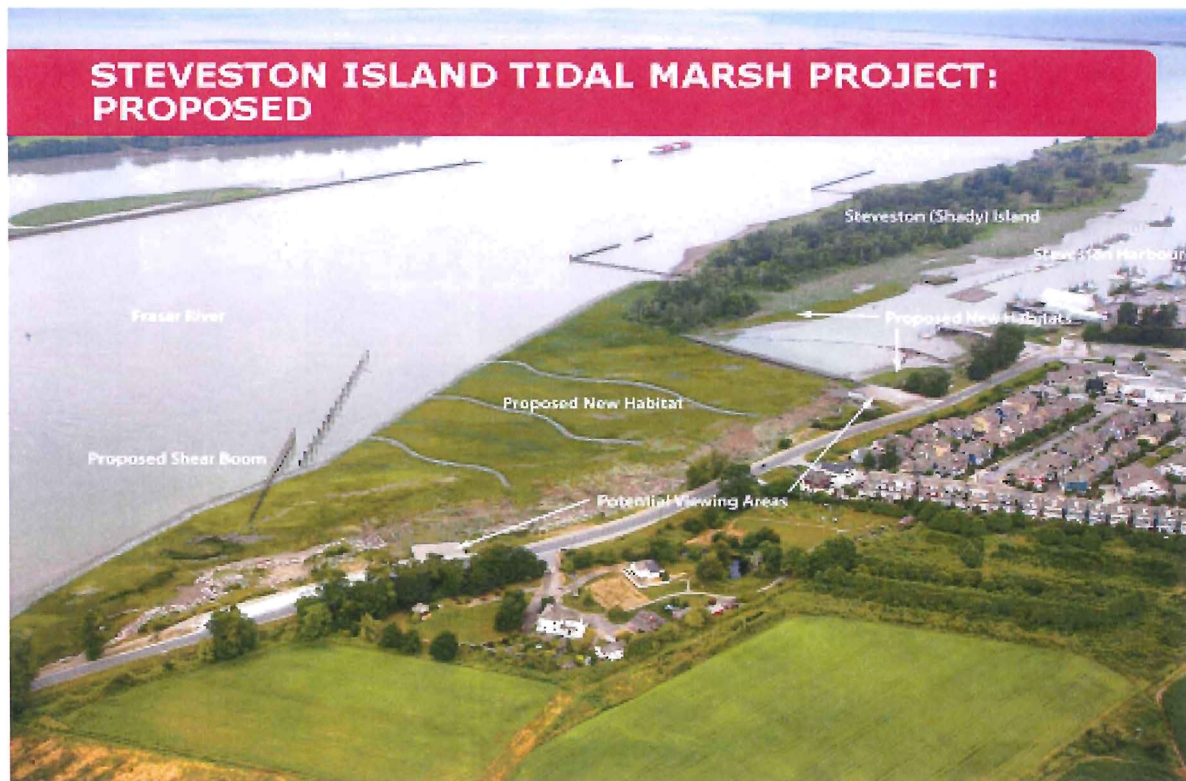
Port Metro Vancouver's Concept Proposal for Habitat Marsh Creation

Port Metro Vancouver's (PMV) Planning and Design staff has conceptually explored a proposal to support their Habitat Compensation Plan which involves the creation of a habitat marsh area that would cover the entrance of the secondary channel from the east end (Attachment 6). The concept plan also shows the existing sheer boom structures in place. At this stage, this is still a concept proposal and will need to be approved by the City as upland owner and Federal/Provincial regulatory agencies. It is unclear at this time on when or if this project from PMV would proceed.
