**General Purposes Committee**

**Monday, May 17, 2021  
4:00 p.m.**

The City of Richmond received a 'Soil Use for the Placement of Fill' application for the property located at 8511 No. 6 Road (the "Property"). The intent of the application is to address damage to a large portion of the Property due to past activities of a previous landowner(s) approximately 38 years ago, which included excavating and removing the native soil and replacing the soil with untreated woodwaste. The Applicant is proposing to improve the agricultural capability of the Property from its current Class 6 or 7 rating to a Class 1 rating to allow for the development of a blueberry farm.

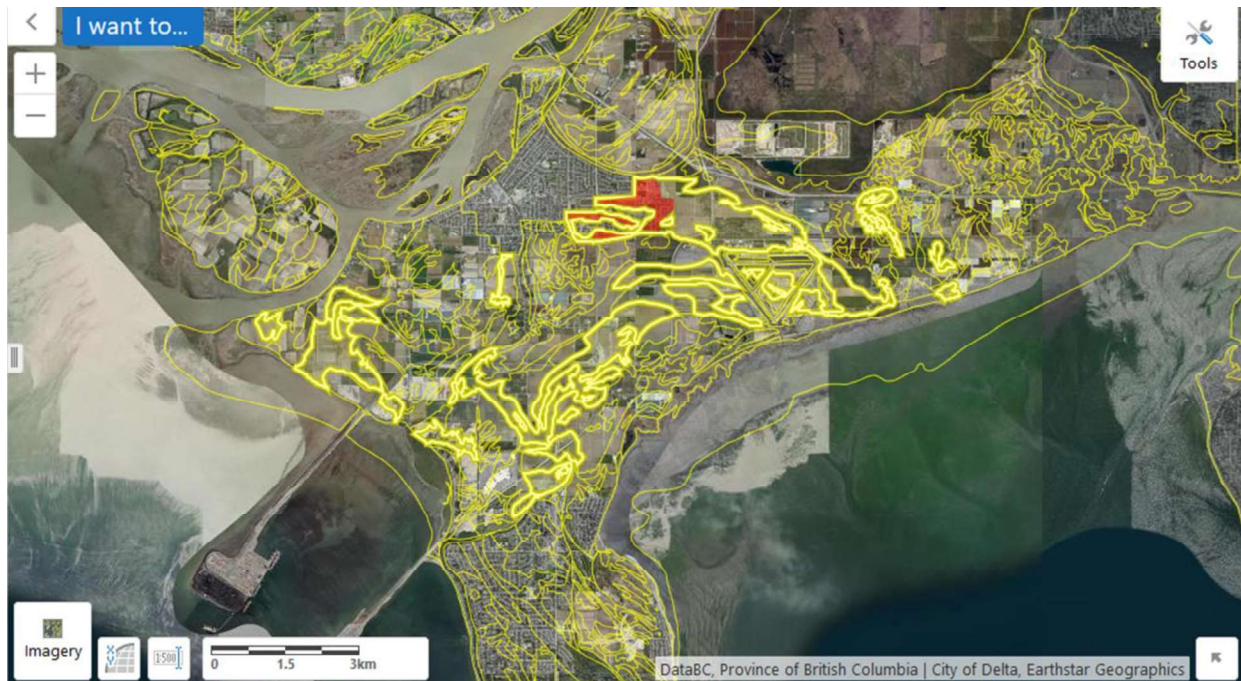
**FIGURE A5. DELTA SOIL SERIES MAPPED LOCATIONS - OUTLINED IN SOLID YELLOW. LOCATIONS HIGHLIGHTED IN RED REPRESENT THE MOST IDEAL AREA(S) FOR SOURCING OF THIS PARTICULAR SOIL ASSOCIATION.**

Characteristics: Silt loam texture, 0% coarse fragment content (stone-free), poorly drained

Mapped distribution: Found mostly in agricultural areas in Delta. Limited distribution in residential areas.

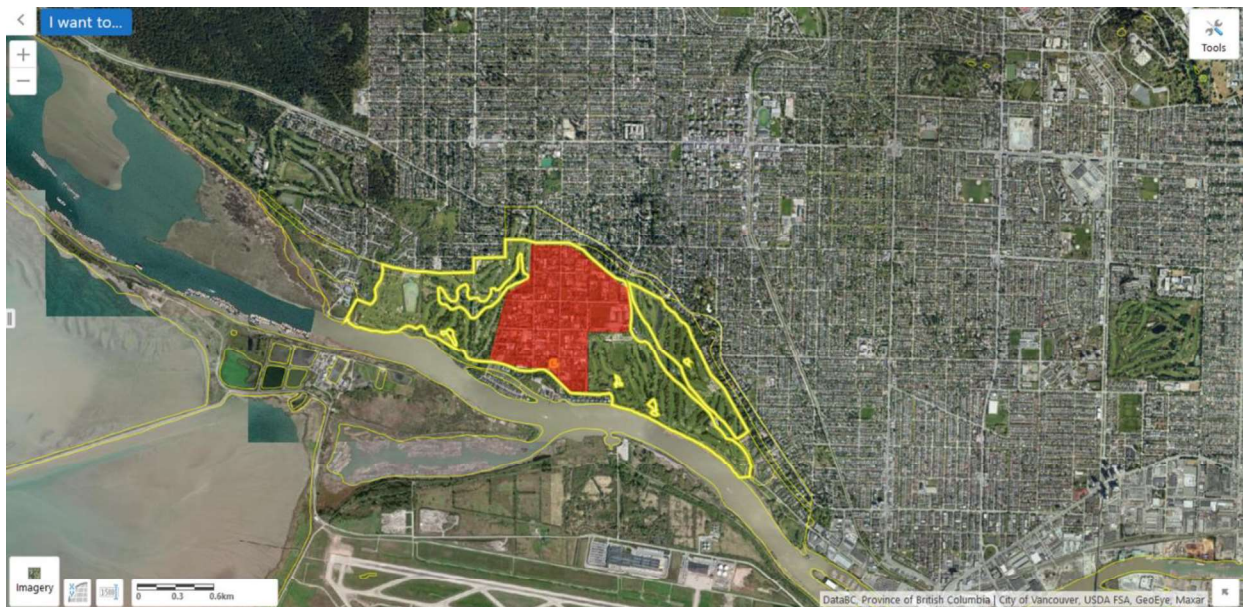
**FIGURE A6. LADNER SOIL SERIES MAPPED LOCATIONS – OUTLINED IN SOLID YELLOW. LOCATIONS HIGHLIGHTED IN RED REPRESENT THE MOST IDEAL AREA(S) FOR SOURCING OF THIS PARTICULAR SOIL ASSOCIATION.**

Characteristics: Silt loam texture, 0% coarse fragment content (stone-free), poorly drained

Mapped distribution: Found mostly on and proximal to the Point Grey Golf and Country Club in the residential areas immediately east.

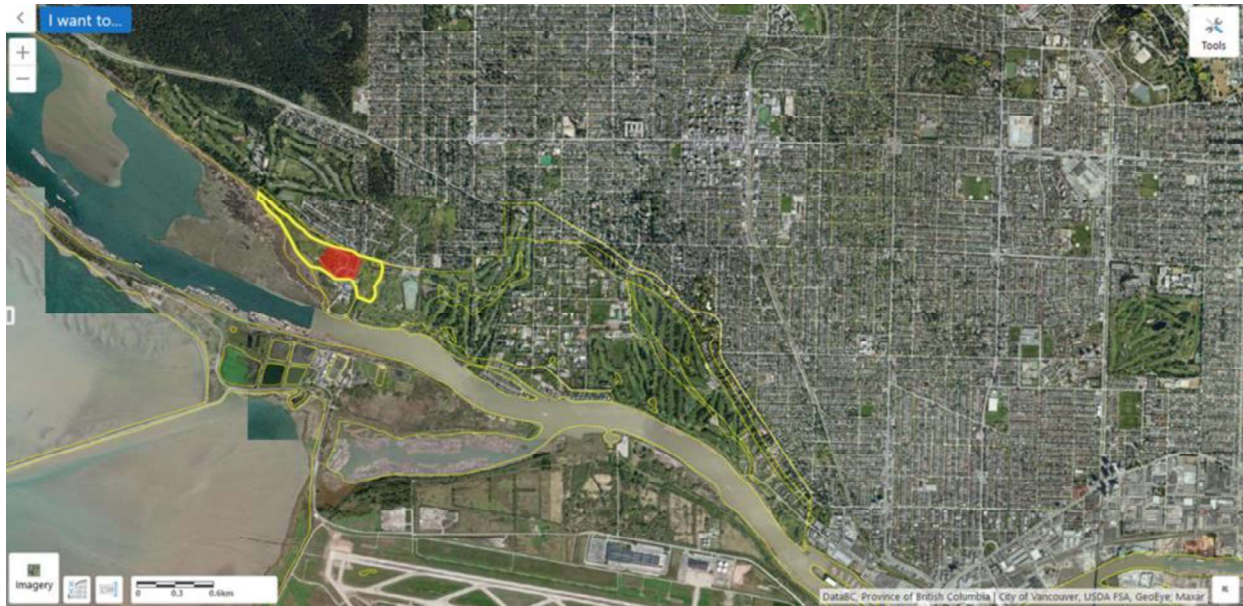
**FIGURE A7. BENSON SOIL SERIES MAPPED LOCATIONS – OUTLINED IN SOLID YELLOW. LOCATIONS HIGHLIGHTED IN RED REPRESENT THE MOST IDEAL AREA(S) FOR SOURCING OF THIS PARTICULAR SOIL ASSOCIATION.**

Characteristics: Loam texture, <5% coarse fragment content, poorly drained

Mapped distribution: Found proximal to the Point Grey Golf and Country Club in the residential areas immediately west.

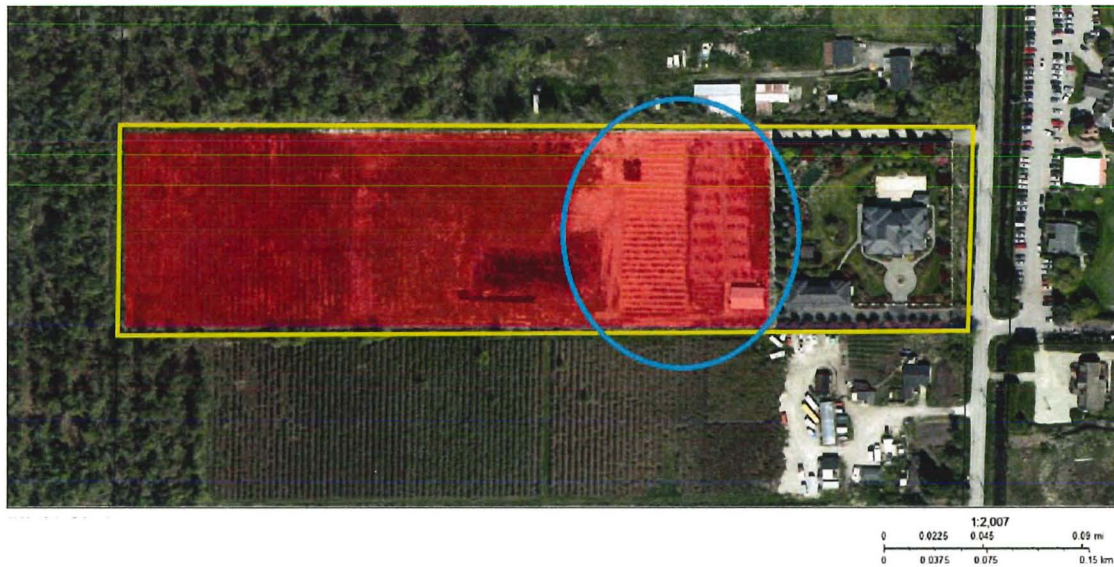
**FIGURE 1. SATELLITE IMAGERY OF 8511 NO.6 ROAD OUTLINED IN YELLOW. THE RED SHADED AREA REPRESENTS TO PROPOSED AREA FOR SOIL IMPORTATION. IMAGE PROVIDED BY THE CITY OF RICHMOND AND DATED AS TAKEN IN 2018.**

\*Raised area identified in blue
