Parks, Recreation and Cultural Services Committee

PRCS-19 2. MAINTENANCE AND MANAGEMENT OF THE FLEET AT BRITANNIA

MV "FLEETWOOD" ex "SKEEZIX"

PHOTO APPENDIX

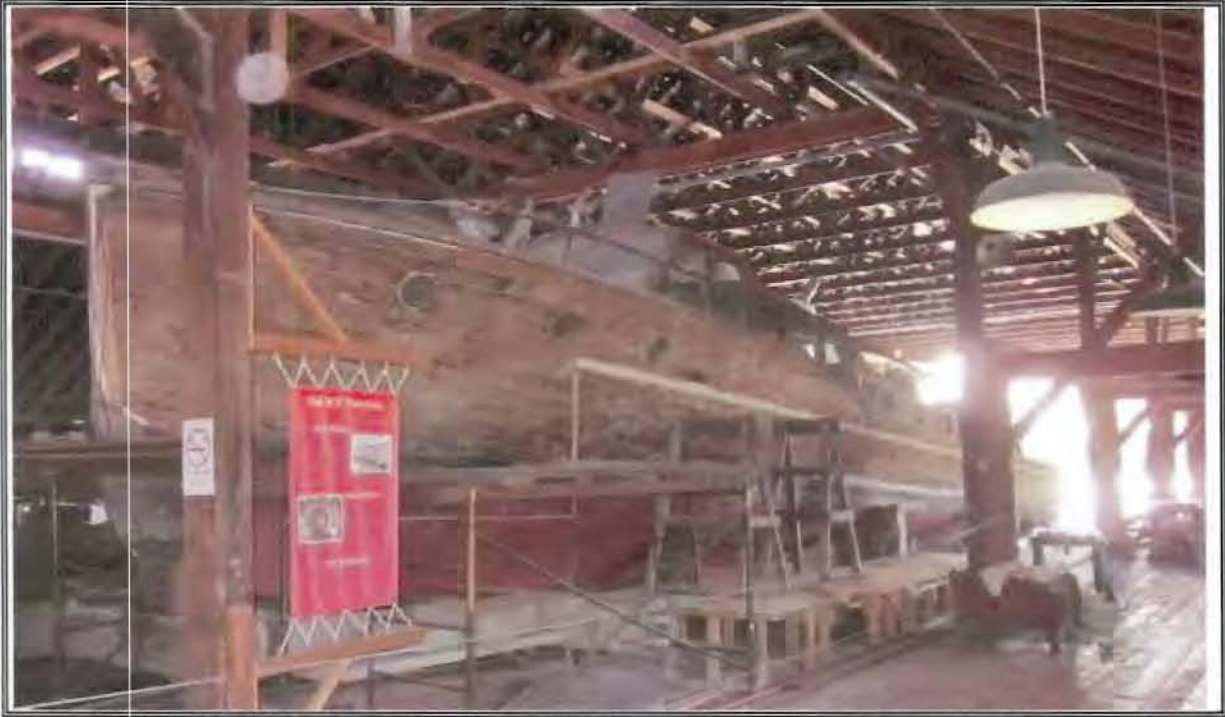
MV "FLEETWOOD" drydocked at Britannia Historical Shipyard, Richmond, B.C.

The vessel was found to be in poor condition with numerous deficiencies noted. Most of these conditions arise from the fact she has been drydocked for most of 20 years, possibly longer. The inner diagonal 1/2" planking has dried and the interface between the inner diagonal and outer carvel layer has failed with a subsequent loss of structural integrity. The light construction bent oak framing has pulled away from the hull, particularly in the underwater portions further degrading the structural integrity.

To preserve the "Fleetwood" in her present condition as a historical vessel for public display little needs to be done over the short term. Areas of deterioration could be preserved with anti-fungal treatments or sealed with resins. This could provide a safe platform for viewing. Interior lighting could be installed, sections of cabinetry fitted and the interior painted. Models, diagrams and pictures would convey the original character of the vessel.

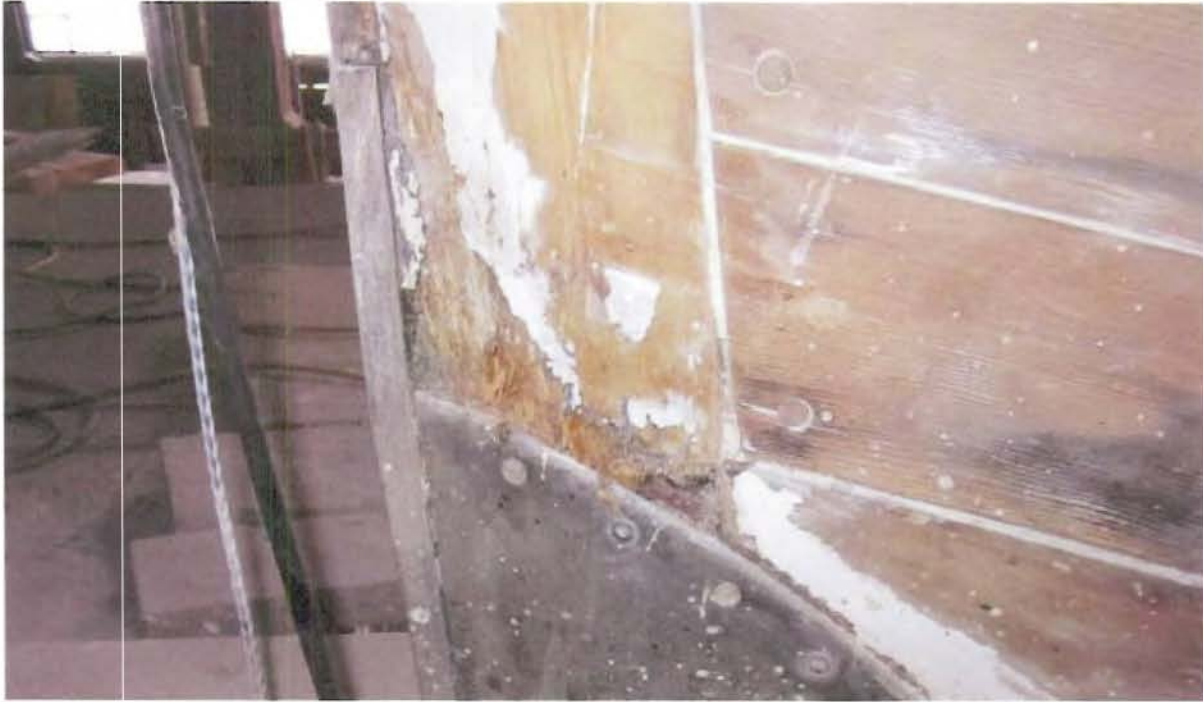
Photo #1 Damage of exterior stem structure

Structure	Condition & steps to repair
Centreline	
Stem & band	Decay of the stem above the metal guard. Photo #1 Repair; Remove the guard to reveal the stem structure; depending of the extent of deterioration it might be possible to scarph in a section. If decay is extensive it would not be practical to repair.
Keel & shoe	Keel generally appeared to be sound
Shaft log & deadwood	Appeared to be sound
Horn timber	Appeared to be sound
Transom frame/built-up transom & knee	Decay was noted in the port side of the transom planking and frame. Photo #2 Repair; Remove all deteriorated structure and replace with new.
Lower hull & bulkheads	
Floor timbers	Many pulled away from the hull with decay noted. Photo #3 Repair; Refasten in place in conjunction with other hull repair.
Bilge stringers (longitudinal members at turn of bilge)	None
Bulkheads	Various decayed particularly below the cabin sole. Photo #4 Repair; Remove deteriorated structure and replace with new. Work will have to be completed in conjunction with hull repair.

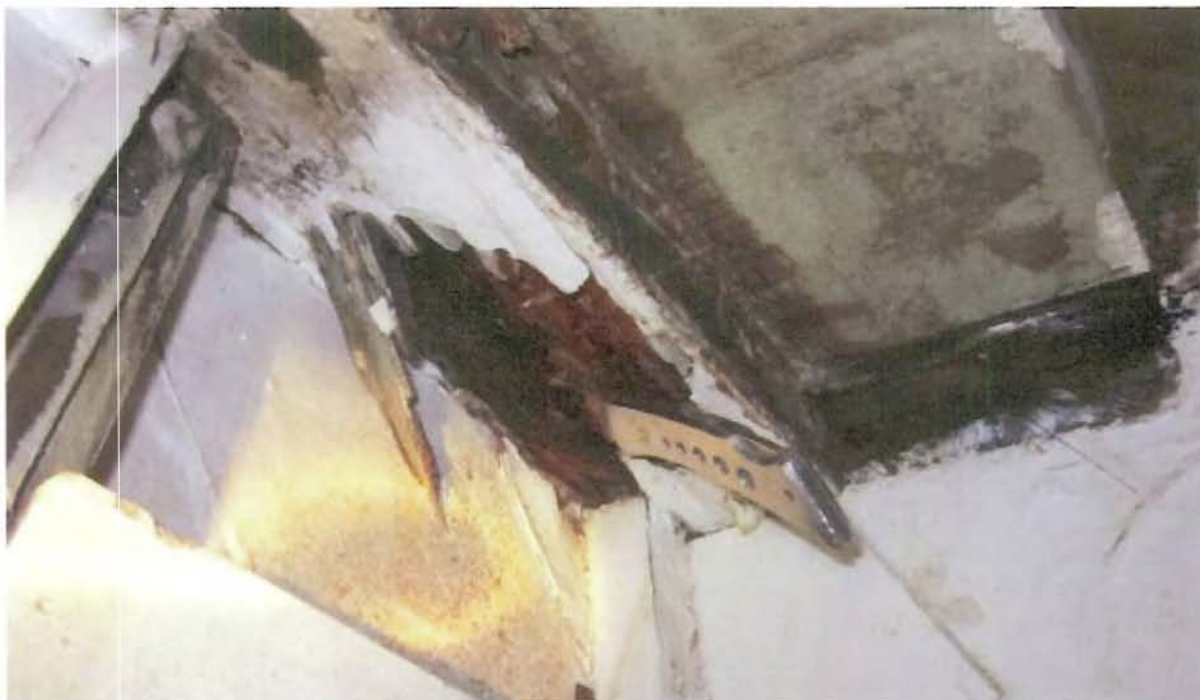
Photo #5 Deterioration of sheer clamp forward cabin

Hull to deck	
Deck/sheer clamp (longitudinal members supporting deck and upper hull shape)	Deteriorated over much of its length. Some sections have been replaced but do not provide designed structural integrity. Photo #5 Repair; Very difficult to repair, the best procedure would be to remove the covering boards to access the sections in conjunction with hull repair, and insert new via upper transom corners.

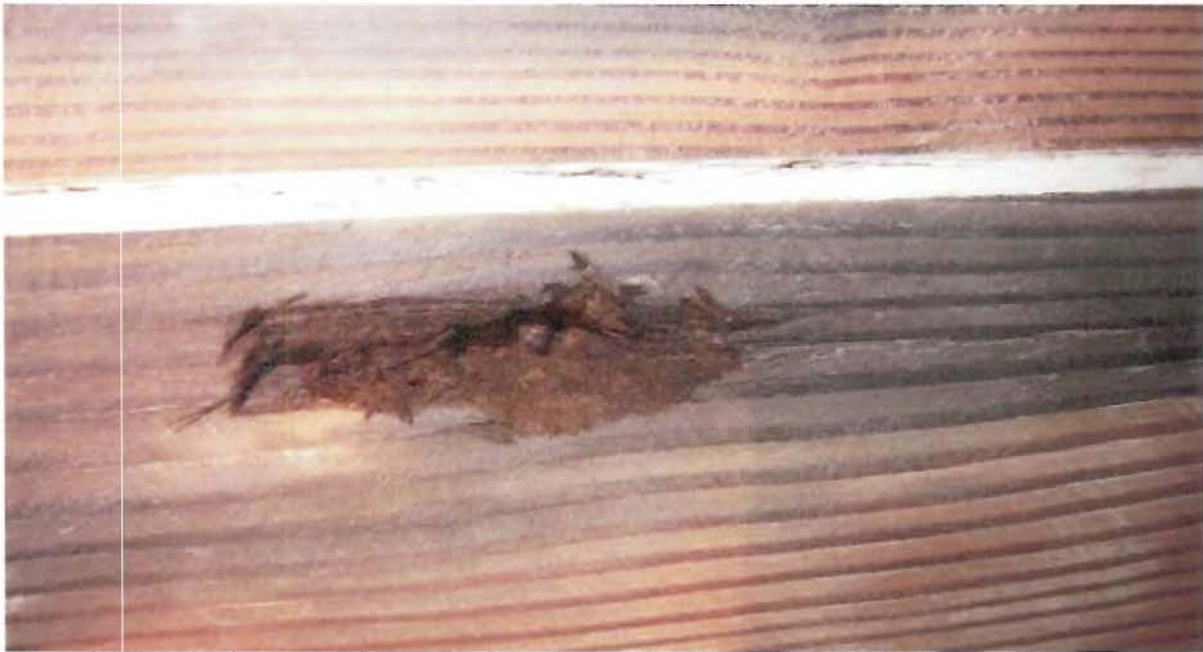
Photo #7 Detail of corroded fastener with adjacent deteriorated wood planking

Galvanized hull fasteners generally are corroded and provide no security between the planking. External planking is damaged; much if it from "nail sickness" (the steel composition of the fastener has oxidized, decaying the surrounding wood).

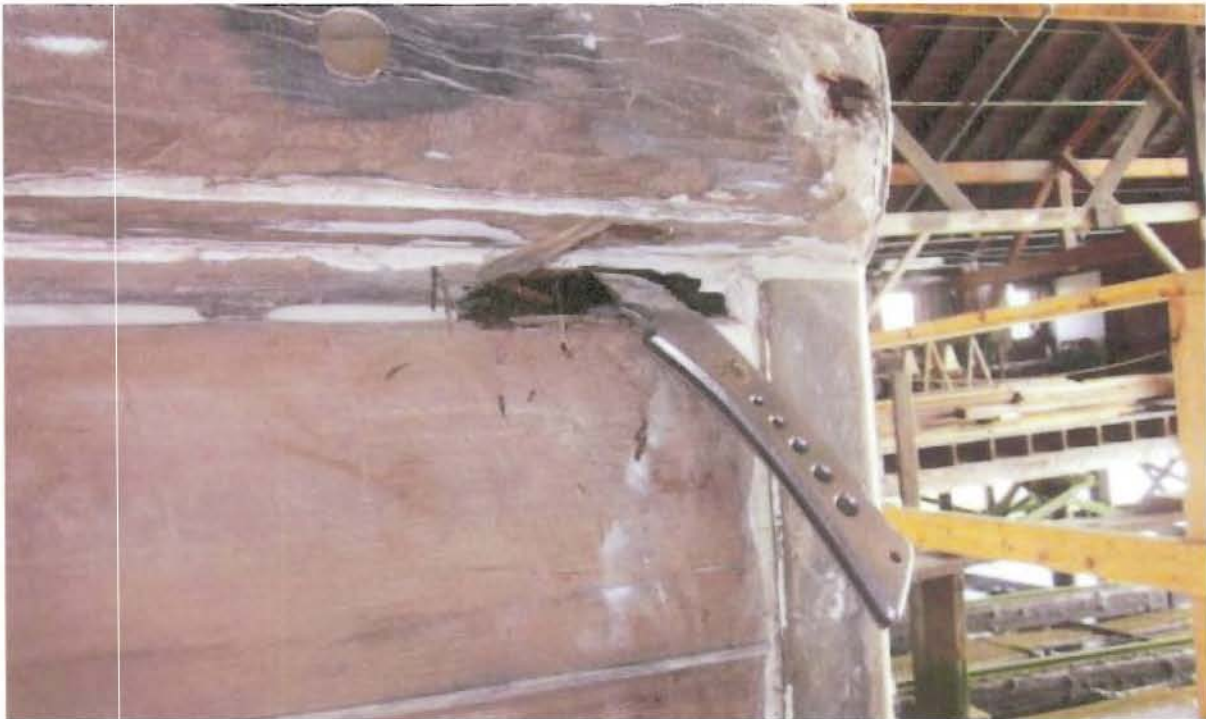
Photo #9 Deterioration of transom exterior planking starboard corner

Transom planks	Decay noted in various. Photo #9 Repair; Remove and replace damaged sections
Fasteners	Heavily rusted both inner and exterior. Photo #10 Repair; Replace fasteners in conjunction with replanking
Caulking	Will need to be recaulked after planking
Rub rail	Appeared to be sound
Hull fittings	
Shaft & rudder stuffing boxes	Appeared to be sound. Original (port & starboard) are still in place & should be removed.
Through-hulls/valves, hoses & hose clamps	All to be replaced.
Engine mount through-fastenings	Appear to be sound
Portholes	Appear to be sound
Deck	
Deck beams	Some decay noted in conjunction with deck. Repair; Remove decayed structure and replace in conjunction with deck sections
Carlins (longitudinal members under cabin sides)	Appeared to be sound
Deck & covering boards	We are advised the decks were replaced during this drydocking. Some decay was noted in the inner planking.

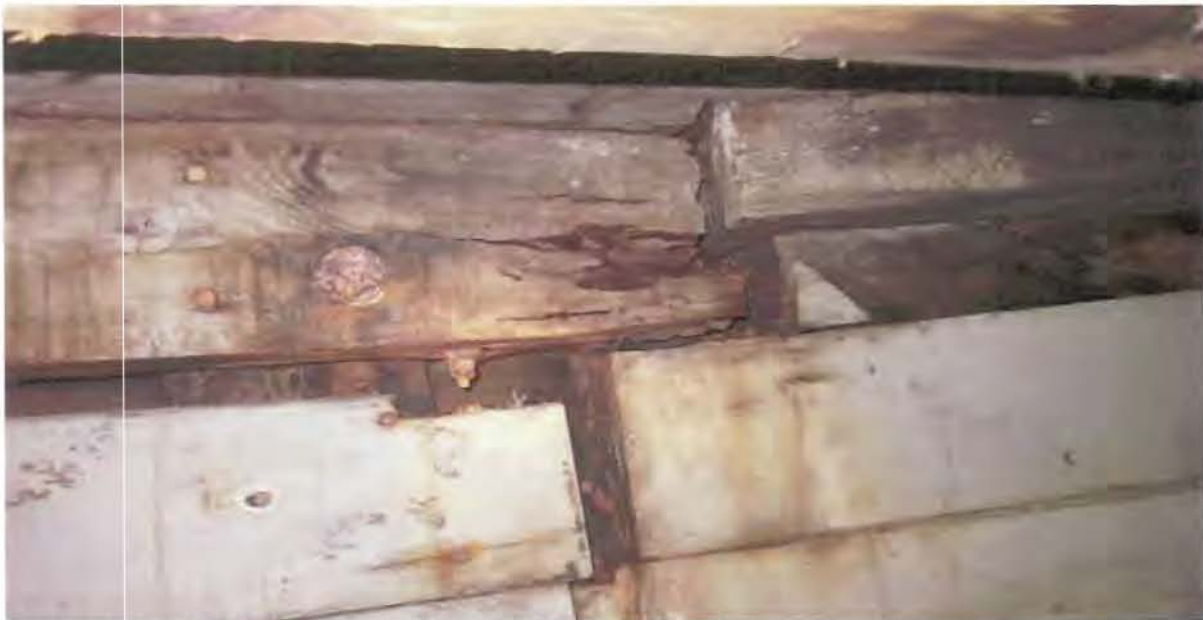
Photo #1 Detail of deterioration in hull framing stern section

The vessel is a heavily constructed example of a west coast fishing vessel. Hull framing and planking generally appear to be in reasonable condition where sighted with the exception of the stern section where extensive deterioration has occurred. We are advised additional underwater hull fastening and recaulking, occurred eight years ago, and bulwarks were replaced approximately 10 years ago.

In order to restore this vessel to a seaworthy condition it would be necessary to rebuild the superstructure, decks and hull stern section. Removal of the foam fish hold may reveal deterioration of the framing and planking which would necessitate their replacement. Reconfiguring "Shuchona IV" to a table seiner entails adding a table, mast, boom and rigging. This would require design research, building a rotating table and locating and fitting a suitable mast and boom.

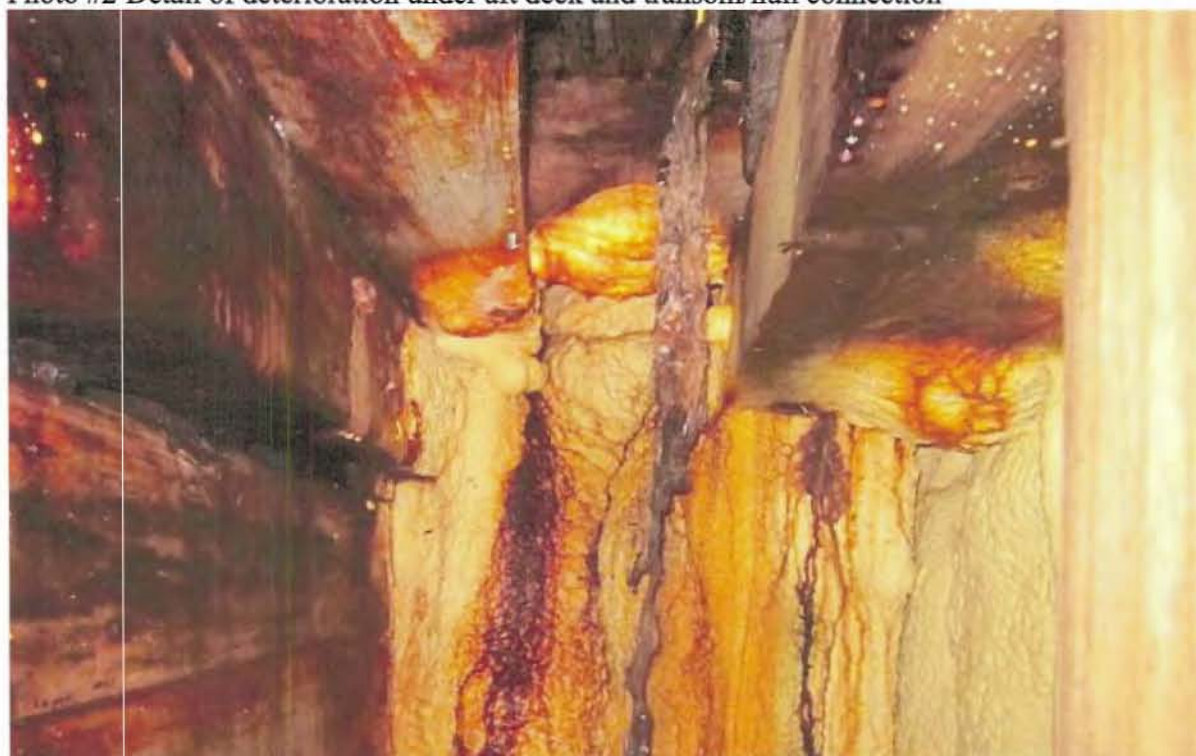
Photo #3 Detail of deterioration at fish hold foam/hull connection

The fish hold has been created with sprayed-in-place foam against the hull; this method of creating an insulated fish hold usually results in deterioration of the hull framing and planking behind the foam.

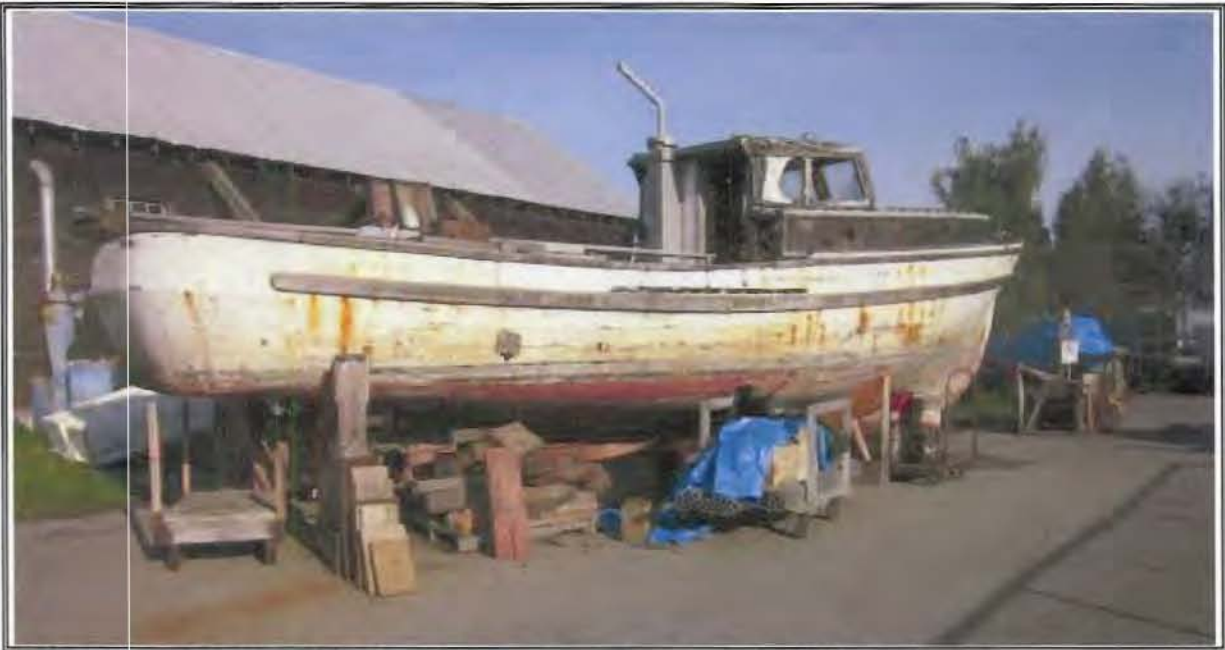
MV "STARLINER" on blocks at Britannia Historical Shipyard, Richmond, B.C.

The vessel was found to be generally in poor condition due to a great extent by the fact she has been unprotected and not maintained for many years.

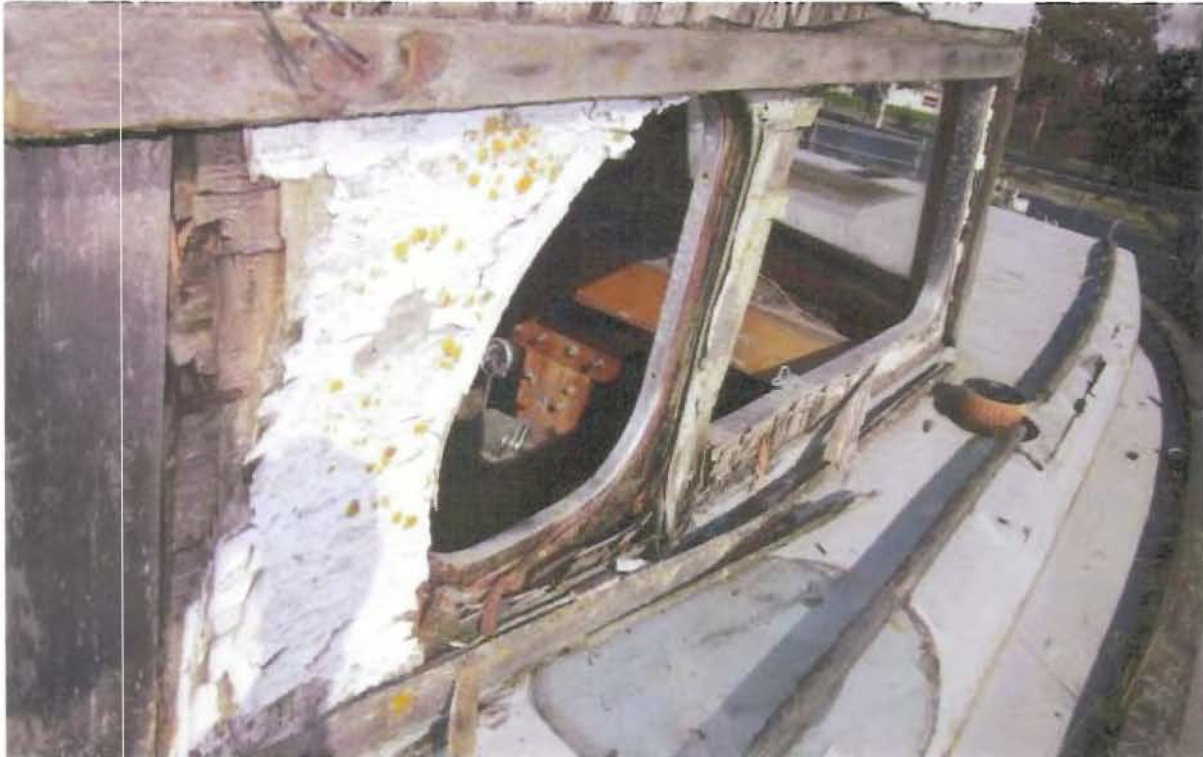
Photo # 3 Heavily deteriorated superstructure

Hull fittings	
Shaft & rudder stuffing boxes	To be replaced with replacement engine installation
Through-hulls/valves, hoses & hose clamps	All to be replaced in conjunction with plumbing system upgrade
Engine mount through-fastenings	To be replaced with engine replacement
Depth sounder, keel cooler, zincs, topside vents	To be replaced with engine replacement
Portholes	None
Swim grid	None
Deck	
Deck beams	Some may be reused forward; will likely all need replacing aft
Carlins (longitudinal members under cabin sides)	Solid yellow cedar under side decks. To be assessed during deck and superstructure replacement.
Deck & covering boards	To be replaced with deck replacement Photo # 2
Bulwarks & caps/toe rail	To be replaced with deck replacement
Hatches & covers	To be replaced with deck replacement
Deck fittings	None
Cabin	Heavy deterioration Photo #3 All to be replaced
Interior	
Sole (cabin floor)	To be replaced Photo #4
