### General Purposes Committee

Monday, November 15, 2021  
4:00 p.m.

2.    **SOIL USE FOR THE PLACEMENT OF FILL APPLICATION FOR THE PROPERTY PID: 005-480-663 (17260 BLOCK OF RIVER ROAD - SAHOTA)**  
(File Ref. No. 12-8080-12-01) (REDMS No. 6758919)

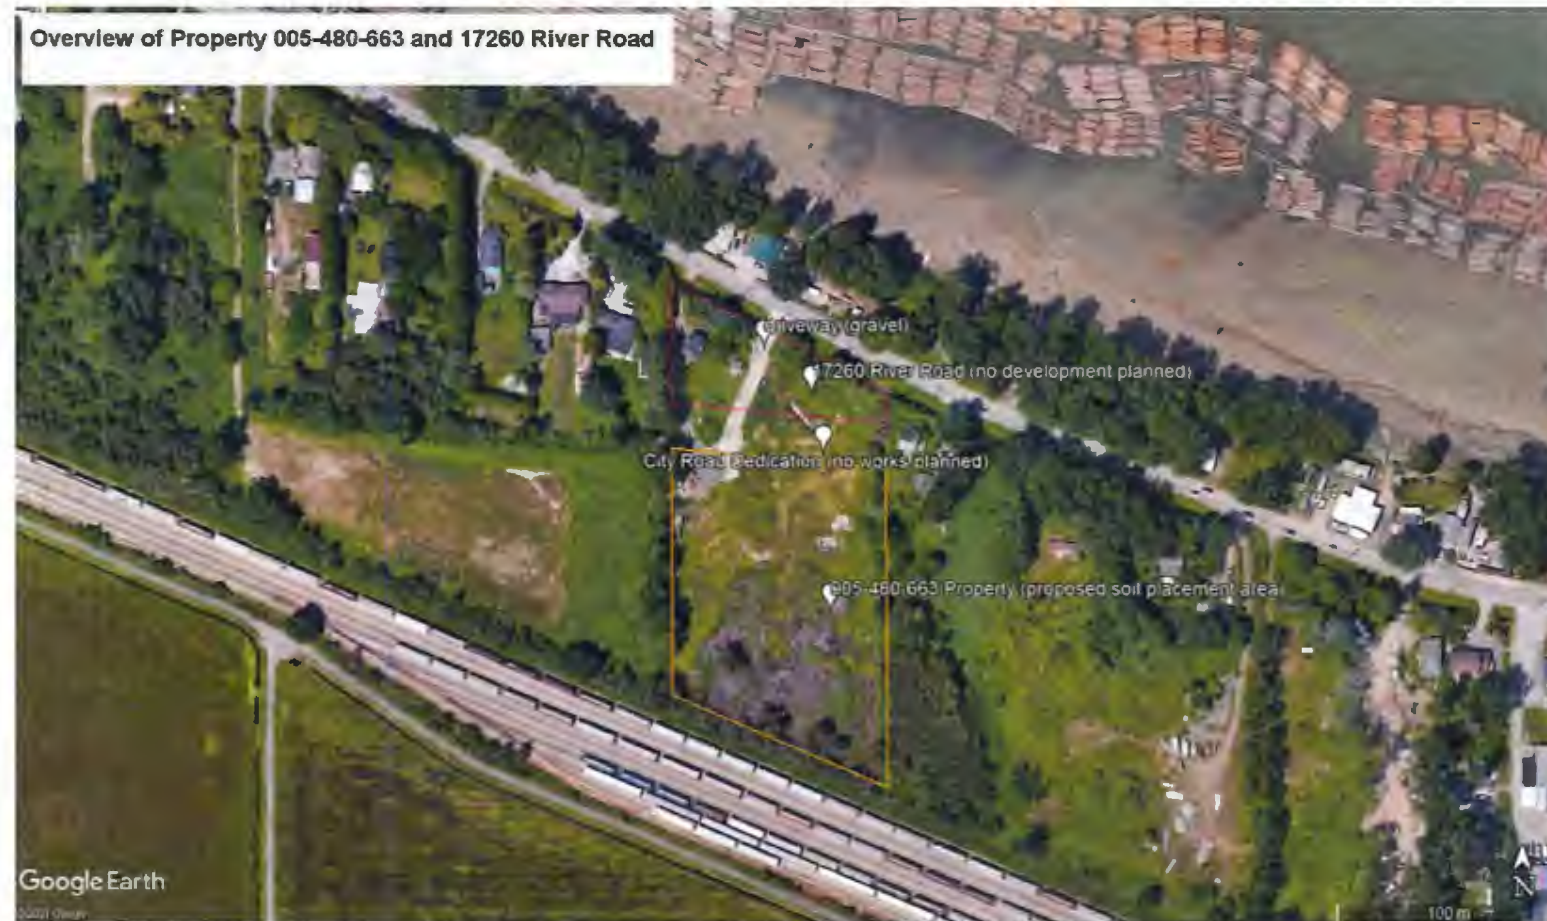
**FIGURE 1: OVERVIEW OF THE PROPERTY (ORANGE OUTLINE) AND 17260 RIVER ROAD (PINK OUTLINE). THE RIGHT-OF-WAY FEATURE SEPARATING THE LOTS IS INDICATED (NOT PART OF EITHER PROPERTY). THE PARCEL BOUNDARIES ARE FROM IMAPBC, WHICH IS A PROVINCIAL GEODATABASE.**

The 17260 River Road property is situated on the south side of the Fraser River on River Road, which is also a dyke constructed by the City of Richmond to protect from Fraser River flooding.

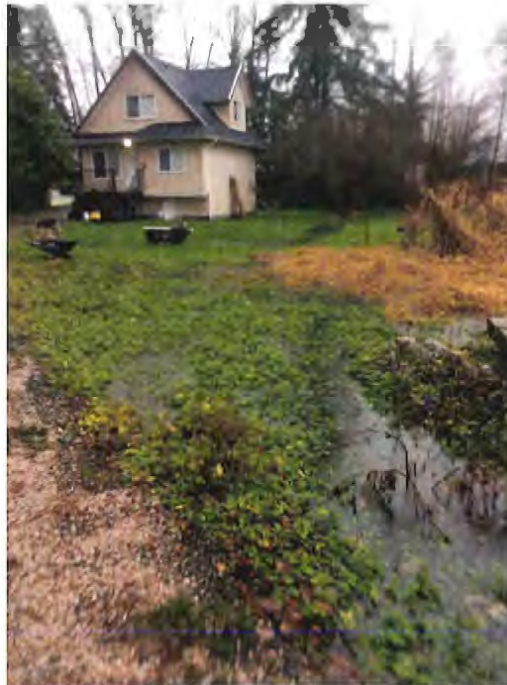
**PHOTO 2: THE RESIDENCE ON THE WEST END OF 17260 RIVER ROAD, ORIGINALLY CONSTRUCTED IN 1950 BUT RECONSTRUCTED FOLLOWING A FIRE. NOTE FLOODED CONDITIONS. THIS PHOTOGRAPH WAS TAKEN IN EARLY JANUARY.**

On the day of our assessment, there was standing water located throughout the Site, in particular near the residence of the 17260 property (Photo 2, above) and in the southwest corner of the proposed placement area. According to the land survey, the southwest side of the property is a topographic low. The lowest site elevations are recorded here, at 0.77 m GSC.

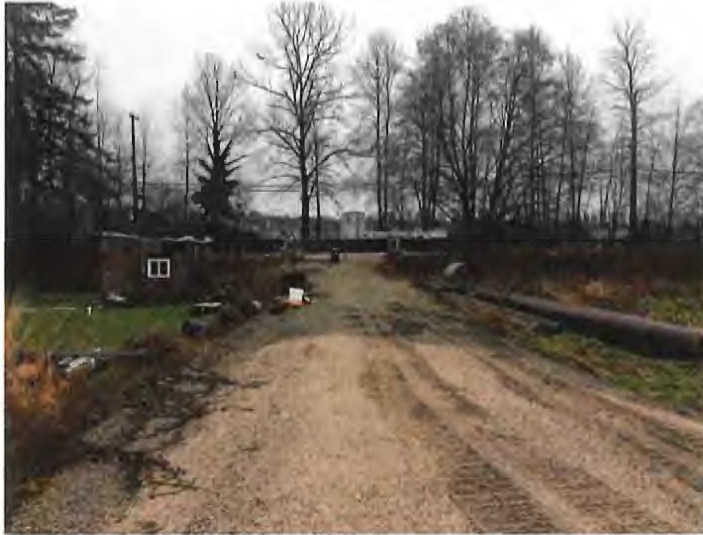
**PHOTO 3: NEW GRAVEL DRIVEWAY (AND CROSSING IN BACKGROUND TO THE CENTRE) THAT CONNECTS THE PROPERTY TO RIVER ROAD. THE DRIVEWAY HAS BEEN BUILT ABOVE THE NATURAL GRADE BY UP TO 0.5 M ACCORDING TO THE LAND SURVEY.**

Mr. Sahota recently (also in 2019) replaced the driveway crossing (that spans the large ditch on the south side of River Road) that was in the northwest corner of 17260 River Road with a new crossing that is approximately 40 m east-southeast. The old crossing was removed. There is a new gravel driveway that runs from the new crossing, through 17260 river Road, through the right-of-way, and terminates at the southwest corner of the Property subject to development. There are **no** plans to improve this driveway (e.g. pave, add more gravel, widen).

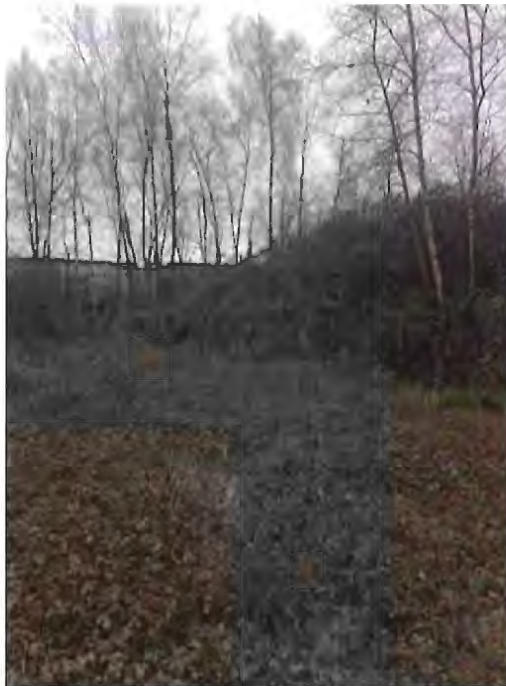
**PHOTO 4: STANDING WATER IN THE SOUTHWEST CORNER OF THE PROPERTY.**

The property was a former upland bog forest. The airphotos show that the property was essentially severed from the larger former bog to the south by the CN railway construction. There are still paper birch trees clustered along the southern, west, and east property lines however, the majority of the trees have been removed as of mid-2019. There are still native shrubs, grasses, and invasive Himalayan blackberry. The neighbouring property to the west (no civic address – it is confined between the railway and River Road lots to the north) has dense blackberry growth that is several metres tall. It is in fact, spreading onto the property, as seen in Photo 4, above.

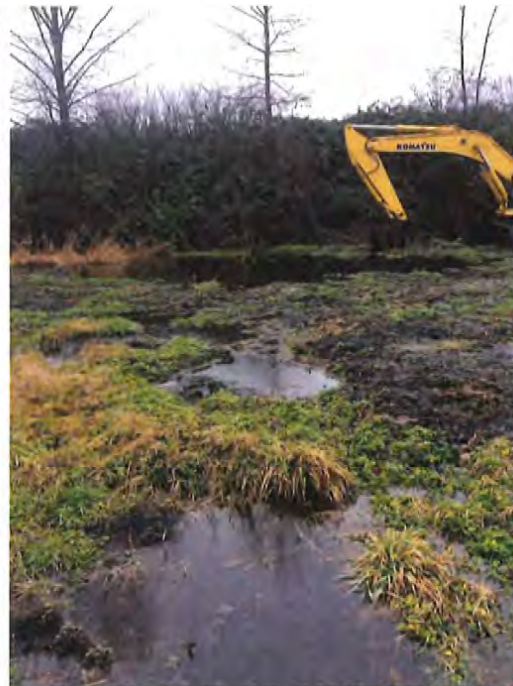
**PHOTO 5: FACING DUE WEST ON THE PROPERTY. THIS STANDING WATER IS OVER 0.3 M DEEP.**

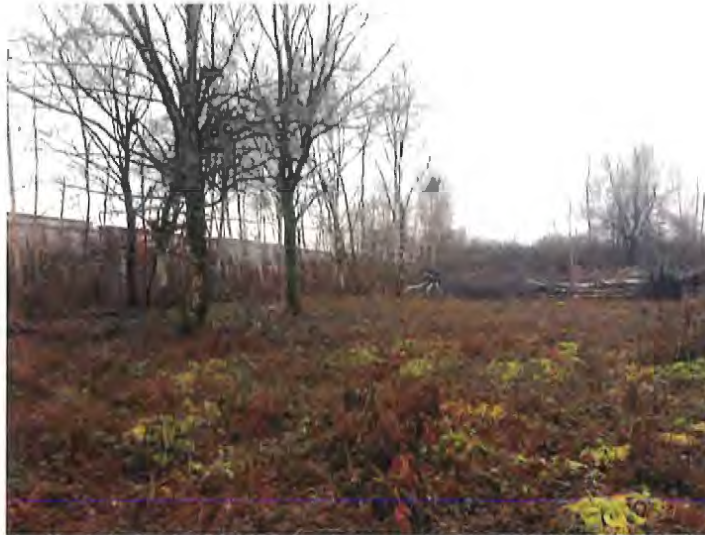
**PHOTO 6: LOOKING ACROSS THE SOUTHERN END OF THE PROPERTY, FACING WEST. THE TREES ON THE LEFT SIDE OF THE PHOTO REMAIN ON SITE (PAPER BIRCH). THE TRAINS ON THE LEFT ARE ON THE CN RAILWAY.**

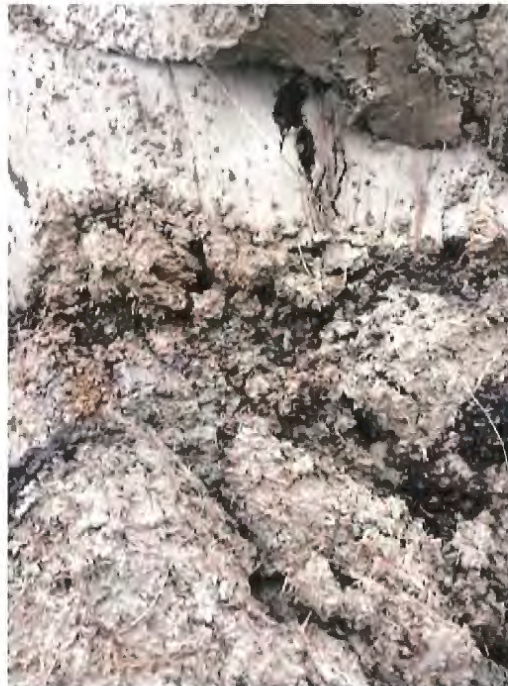
**PHOTO 7: SILT LOAM (LESS COMMONLY, SILTY CLAY LOAM) FOUND IN THE Cg HORIZON. NOTE DECOMPOSED PLANT MATERIAL PRESENT IN THIS SAMPLE.**

All soil pits feature gleying in the Cg horizon; gleying (and mottling) are indicative of water saturation and periodic anaerobic conditions due to fluctuating water tables in the subsoil. Coupled with strongly acidic soil conditions that are characteristic of peat soils, this would result in some reduced nutrient availability – with potassium and phosphorous being limited macronutrients alongside limited mobilization of high valence micronutrients (e.g. Cu, Ca, etc.) from the organic matter under anaerobic and acidic conditions. Mottling starts as shallow as 30 cm in Pit 1 and as deep as 80 cm in Pit 3 – mottling would not be present in the organic horizon (peat, Op or Oh).

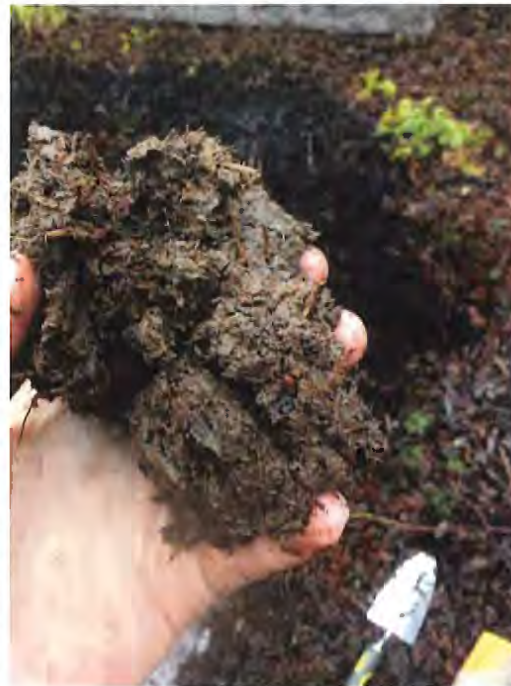
**PHOTO 8: MESIC PEAT FROM SOIL PIT 3. THIS IS THE ONLY PIT WITH A MESIC PEAT BELOW A HUMIC PEAT.**

The thickness of the peat horizon (in my soil pits) ranged from 35 cm to 80 cm however, the geotechnical test pits excavated by Geopacific during drier summer 2019 conditions (which enabled deeper excavations into wet areas of peat that I could not excavate during my assessment in January) yielded peat depths between 0.6 m and 1.8 m (maximum). A review of Geopacific's test pit locations in their report shows that none of our pits overlap exactly therefore, peat depths are highly variable over very short distances on the property.

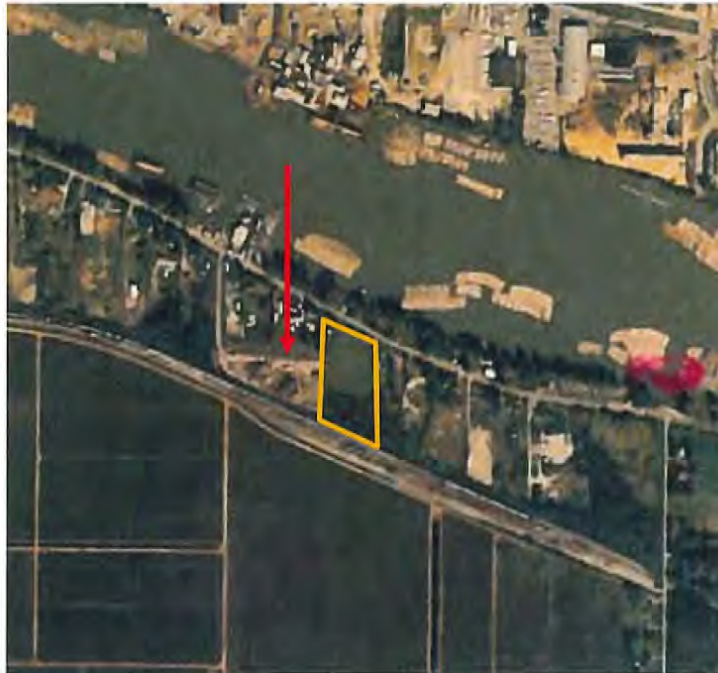
**PHOTO 9: AIRPHOTO FROM 1997 SHOWING ACTIVE SOIL FILLING TO THE WEST (RED ARROW). THIS MATERIAL WAS PLACED SEVERAL METRES HIGH AND IS NOW OVERGROWN WITH BLACKBERRY. MR. SAHOTA'S PROPERTIES (BOTH THE SITE AND 17260 RIVER ROAD) ARE OUTLINED IN ORANGE.**

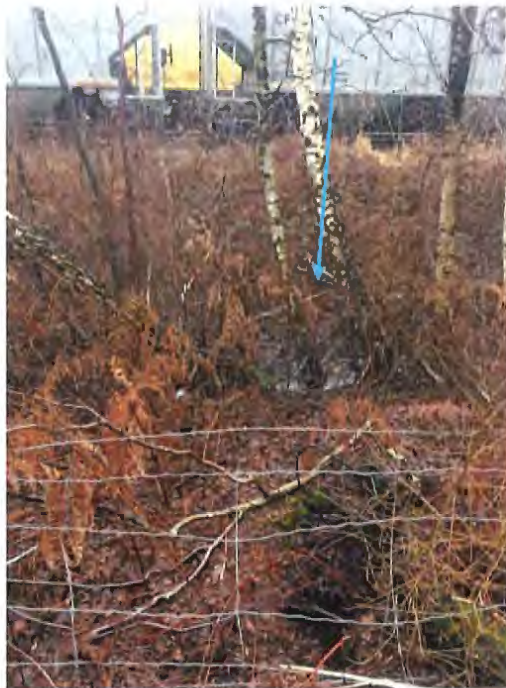
**PHOTO 10: DITCH SITUATED BETWEEN THE CN RAILWAY AND THE PROPERTY, WHICH IS THE FENCE IN THE FOREGROUND. THE WATER LEVELS ARE INDICATED BY A BLUE ARROW.**

As described in Section 2.6, there is a ditch situated at the south property line and on the north side of the railway grade. Water levels were below the crest of the ditch at the edge of the property near the fence but the ditch was not completely full. The elevations of this ditch relative to the property is unknown as the land survey does not extend into private railway property. The ditch collects drainage from the property as well as the railway right of way. My initial observation is that water levels in the ditch are not significantly lower than that of the property, perhaps on the order of less than 0.5 m. Confirming ditch elevations would require taking topographic points (land surveyor), however, it is noted that this ditch appears to be on CN railway property, as it is situated outside the property fence.

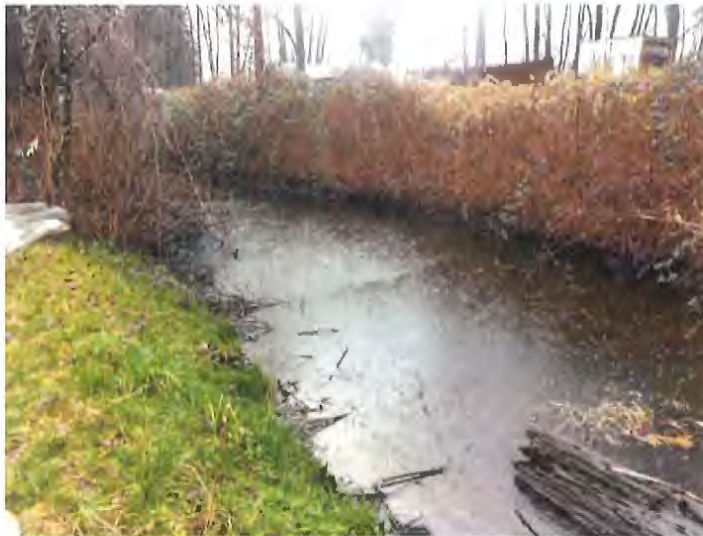
**PHOTO 11: DITCH LOCATED AT 17260 RIVER ROAD - NOTE WATER LEVELS ARE QUITE HIGH. THIS PHOTO WAS TAKEN JANUARY 7, 2020**

There is a ditch along the northern property line of 17260 River Road. The water levels in this ditch were observed to be quite high. Connecting perforated pipes to this ditch from the Property would require piping the water between 40 (from northeast corner to River Road ditch) and 180 m (southeast corner to River Road ditch).

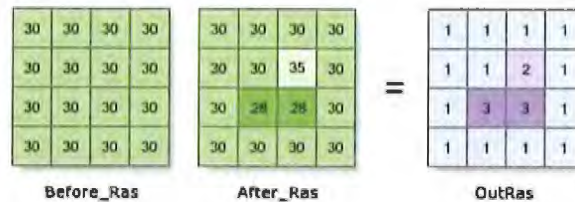
## Illustration

OutRas = CutFill(Before\_Ras, After\_Ras)

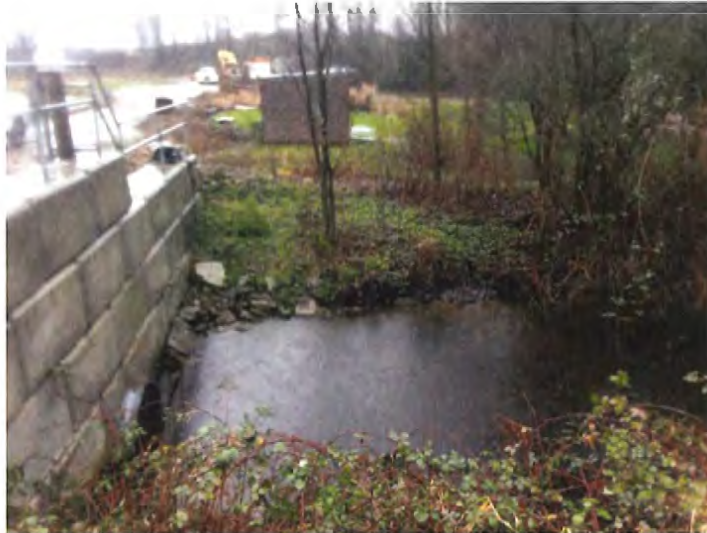
**PHOTO 12: LOOKING DUE SOUTH ACROSS THE ENTRANCE OF 17260 RIVER ROAD. THE SOIL PLACEMENT AREA IS LOCATED IN THE TOP LEFT CORNER OF THE PHOTO. THIS CROSSING WAS UPGRADED IN 2019 - THE OLD CROSSING WAS SITUATED TO THE RIGHT OF THIS PHOTO.**

There is a ditch situated on the south side of River Road (therefore, along the northern property line of the 17260 River Road property). This ditch is treated as a watercourse and riparian management area (RMA) by the City of Richmond. There is a 15 m riparian area regulation (RAR) setback established by the CoR. **As the 17260 River Road lot will not be developed, the setback will not be infringed by the proposed soil placement.** The crossing over this ditch has been upgraded by Mr. Sahota, as seen in the photo below.

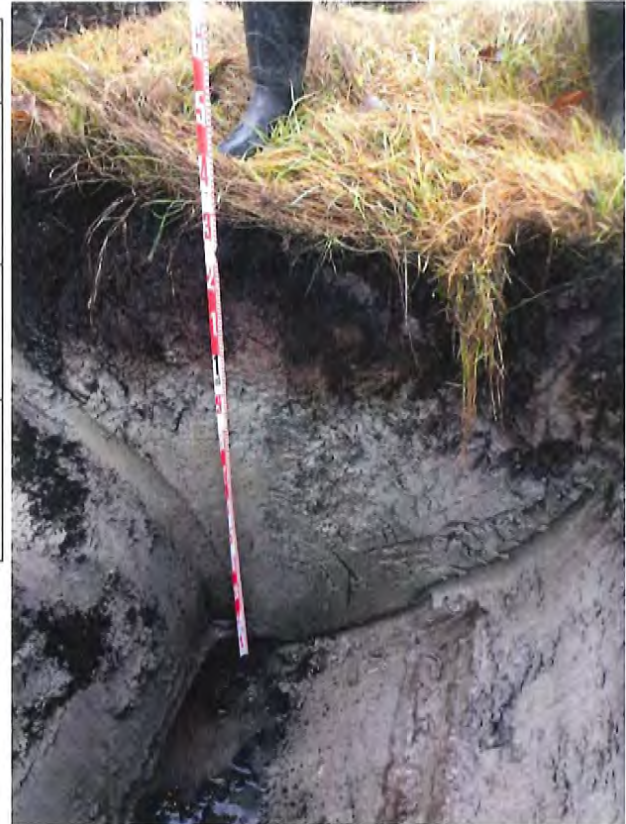
Horizon	Depth (cm)	Description
Op	0 - 35	Dark, reddish brown to black, humic (von Post class 7), plentiful fine roots. Cultivated (p) in the past. Wavy, uneven contact with Cg1 horizon (as seen in photo)
Cg1	35 - 70	Light blue-grey, silt loam, firm, moist, no roots, no coarse fragments. Common, medium prominent orange mottles.
Cg2	70 - 130+	Light blue-grey, silty clay loam, firm, no roots, no coarse fragments. Many, prominent, medium orange mottles. Increased mottling with depth.

- Located in the centre-north property boundary.
- Water encountered at bottom and sides of pit (seeping in quickly) - 1.3 m deep.
- Soil classification: Rego Gleysol

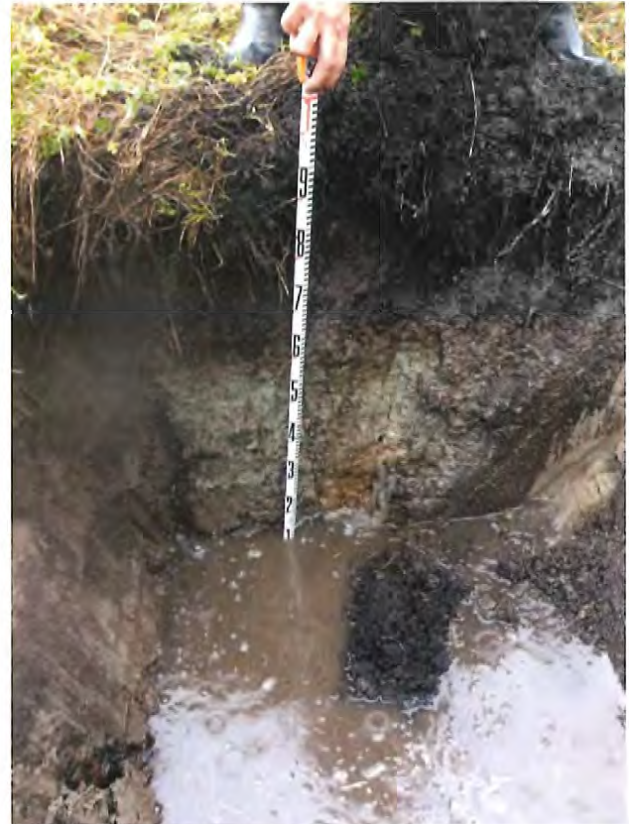
Horizon	Depth (cm)	Description
Op	0 - 50	Dark brown to black, humic (von Post class 7), plentiful fine roots. Cultivated (p) in the past. Uneven boundary with Cg 1 horizon.
Cg	50 - 110+	Grey to blue grey, silt loam to silty clay loam (variable), very firm, moist, no roots, no coarse fragments. Common to many, medium prominent orange to yellow mottling with depth. Did not encounter Cg2 horizon due to water table/seepage.

- Located in the northeast corner of the Property.
- Pit excavated to 1.1 m before hitting water table. Water seeped from bottom and sides quickly (see photo above). Groundwater piping evident from sides of pit. Completely filled in less than 5 minutes.
- Soil classification: Rego Gleysol

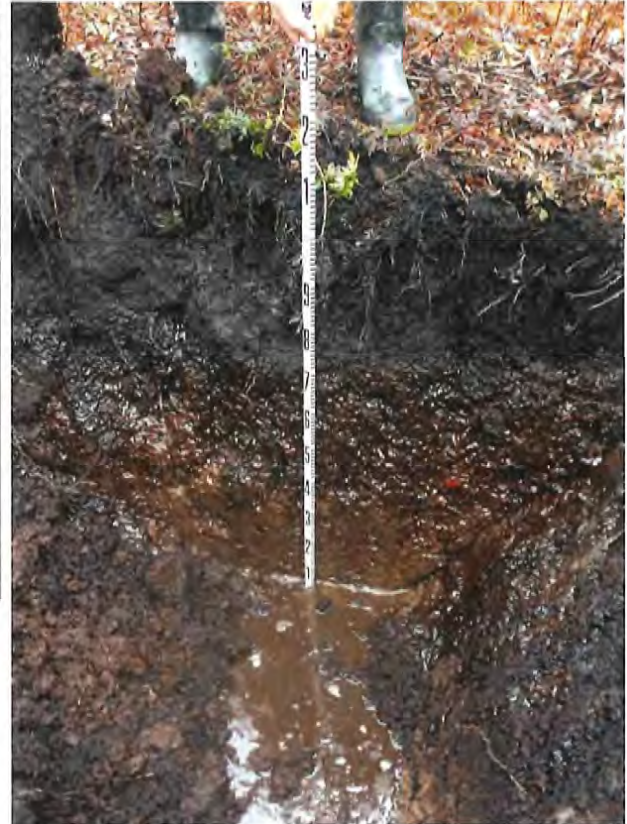
Horizon	Depth (cm)	Description
Oh1	0 - 50	Black to reddish black, humic (von Post class 7-8), plentiful fine to large roots. Very wet. Uncultivated area that has recently been cleared.
Oh2	50 - 80	Dark brown to reddish brown (lower), mesic, (von Post class 5-6), plentiful fine to large roots. Very wet. This is distinctly lighter than the upper organic horizon and less decomposed.
Cg	80 - 120+	Light grey, silty clay loam, firm, no roots, no coarse fragments. Many, prominent, medium orange mottles, contains decomposed plant remains.

- Located in southeast corner of the property near the fence line. Originally upland forest bog – has been recently cleared. This area does not appear in historical imagery to have ever been cultivated for agriculture. Organic horizons are deeper than in Pits 1 and 2 here.
- Pit excavated to 1.2 m before encountering water table. Pit filled with water in less than 10 minutes.
- Soil classification: Rego Gleysol

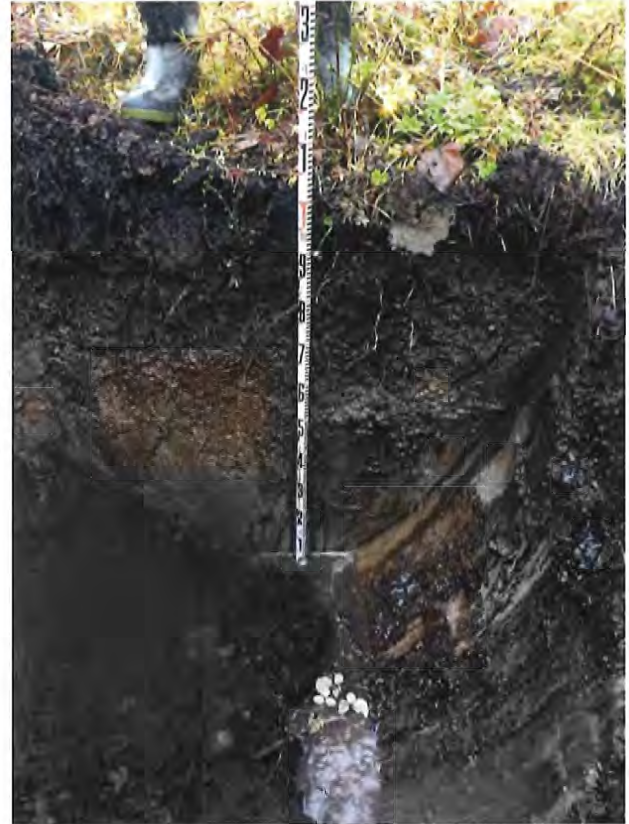
Horizon	Depth (cm)	Description
Oh	0 - 40	Dark brown to black, humic (von Post class 7 to 8), plentiful fine roots. Does not appear to have been cultivated – formerly an upland forest bog area. Very wet.
Cg	40 - 110+	Grey, silt loam, firm, no roots, no coarse fragments. Many, prominent, medium orange mottles. Decomposed plant material (woody plant, sedges etc). Wet.

- Located in the southwest corner of the property – this area was forested until 2019. Surrounding land is wet – ponded water over 0.3 m deep throughout.
- Excavated an area without ponded water but encountered water table at 1.1 m deep. Filled with water during assessment but did not completely fill.
- Soil classification: Rego Gleysol

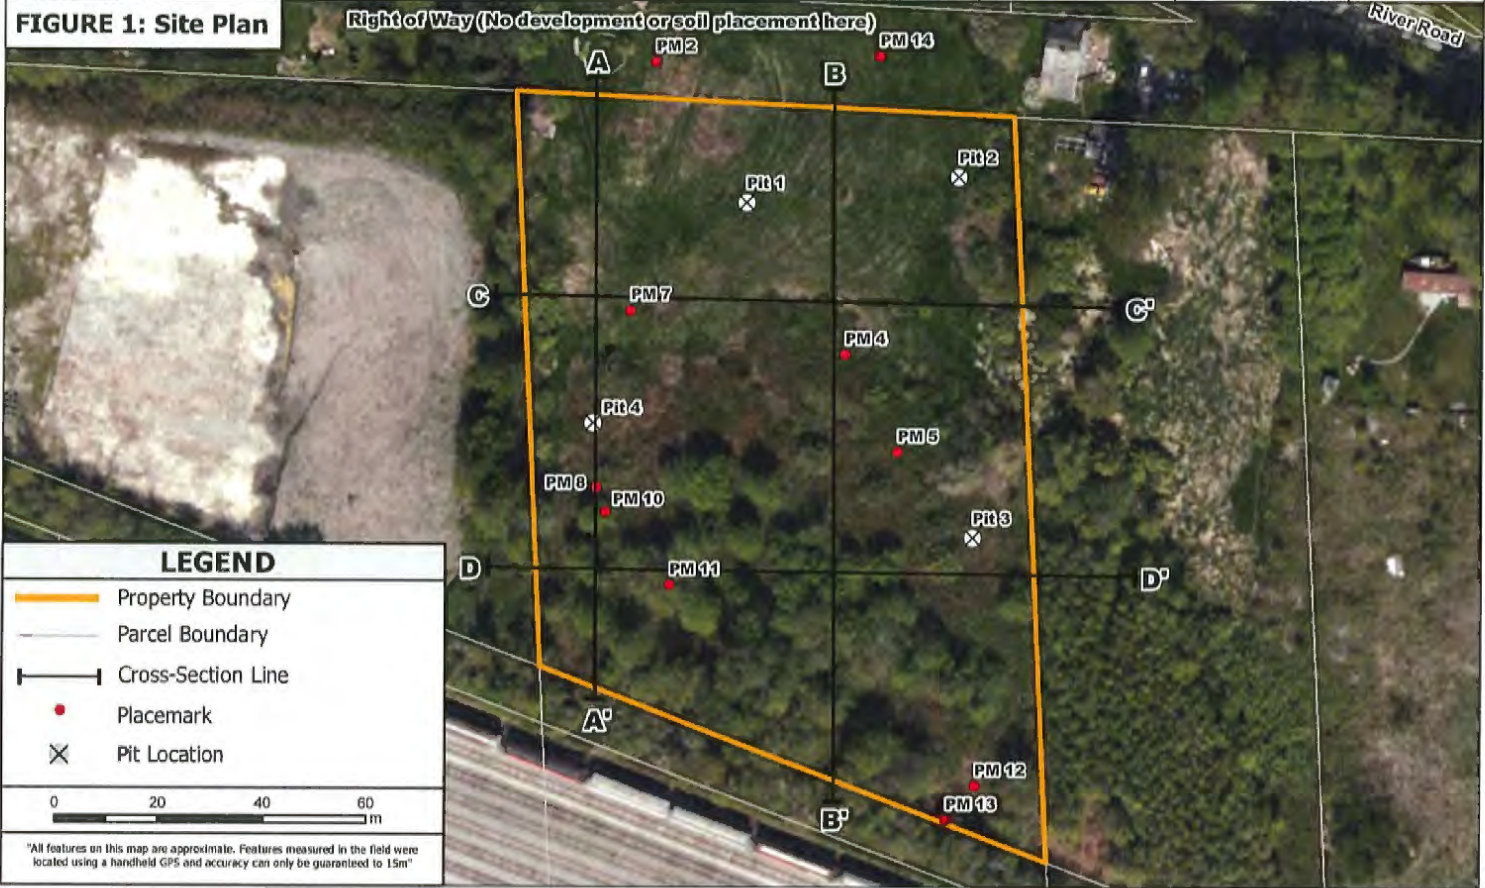
**PROJECT:**  
Soil Deposit Assessment : PID 005 - 480 - 663

<b>ASSESSED BY:</b> Jessica Stewart, P.Geo, P.Ag.	<b>FIELD VISIT:</b> January 7, 2020	<b>LOCATION:</b> Richmond, BC	<b>MAP SCALE:</b> 1:1,400	<b>MAPPING DATE:</b> July 7, 2020	<b>DRAWN BY:</b> Jessi Yellowlees
