# City of Richmond

## Report to Committee

**To:** General Purposes Committee **Date:** October 31, 2017  
**From:** Serena Lusk **File:** 06-2345-20-MINO1/Vol  
 Interim Director, Parks and Recreation 01  
**Re:** **Minoru Place Activity Centre Reuse Options**

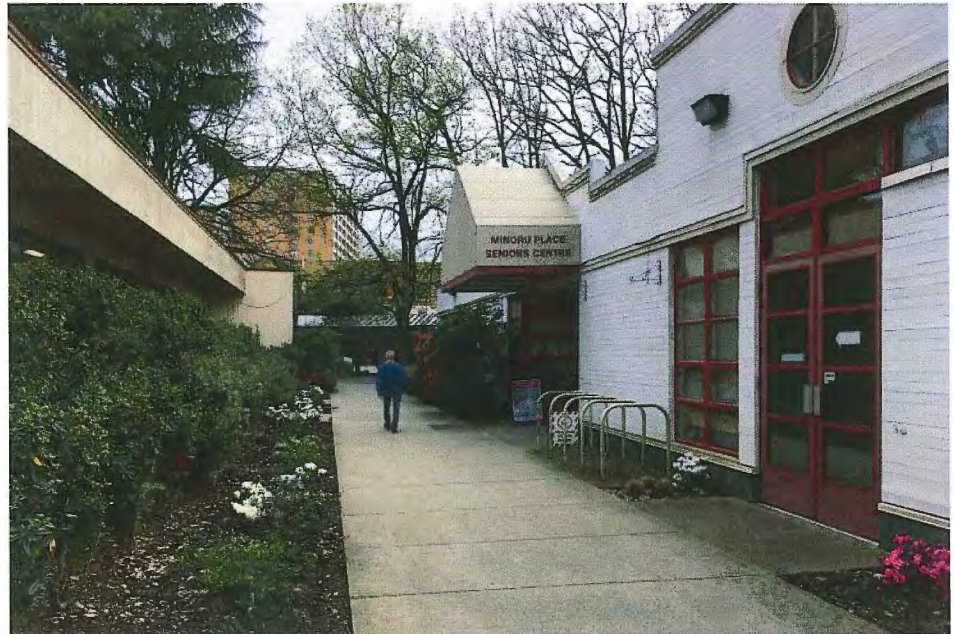
View of west walkway indicating need to update and highlight the building entry.

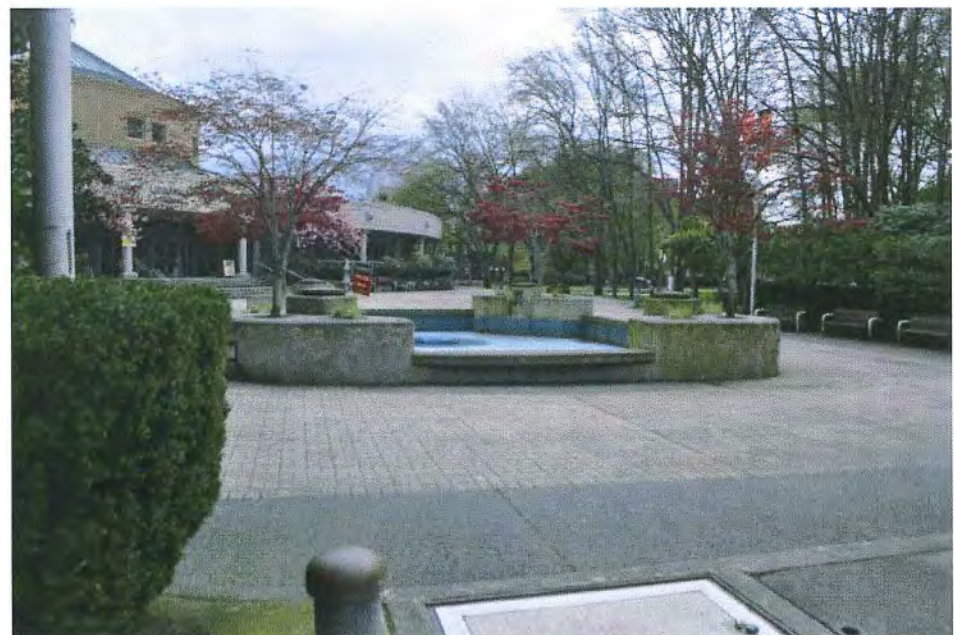
View of plaza showing open space limited by the central fountain.

The current arrival point into the plaza from the west visually and physically blocks the plaza. We would recommend removal of the central fountain to provide a more flexible and functional plaza space as well as some of the shrubs and bushes around that obscure views to the Minoru Place Activity Centre and entry point into the plaza from the south west corner.

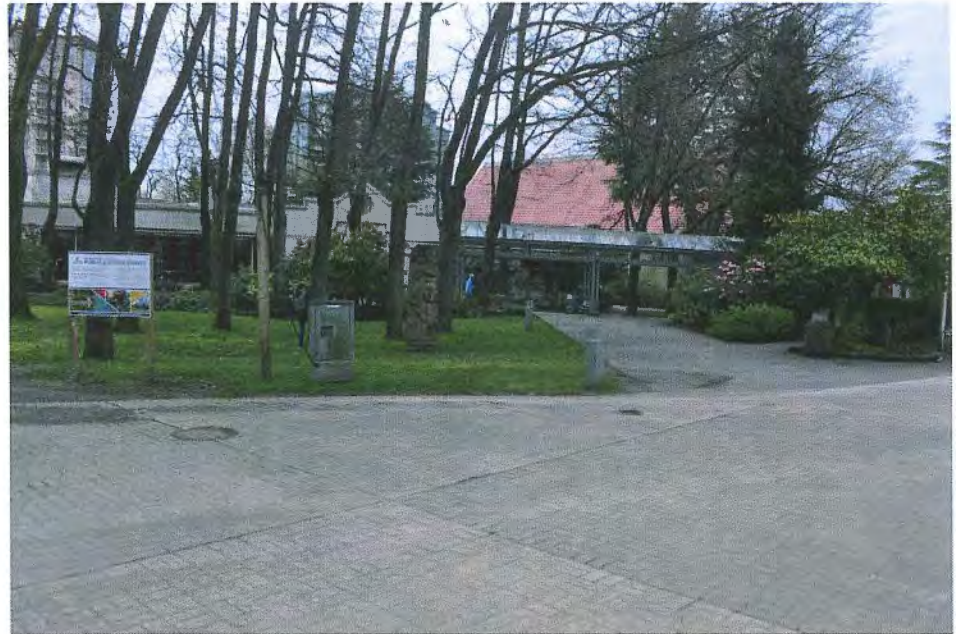
View from plaza to MPAC showing lack of visibility to building entry and indirect pathway.

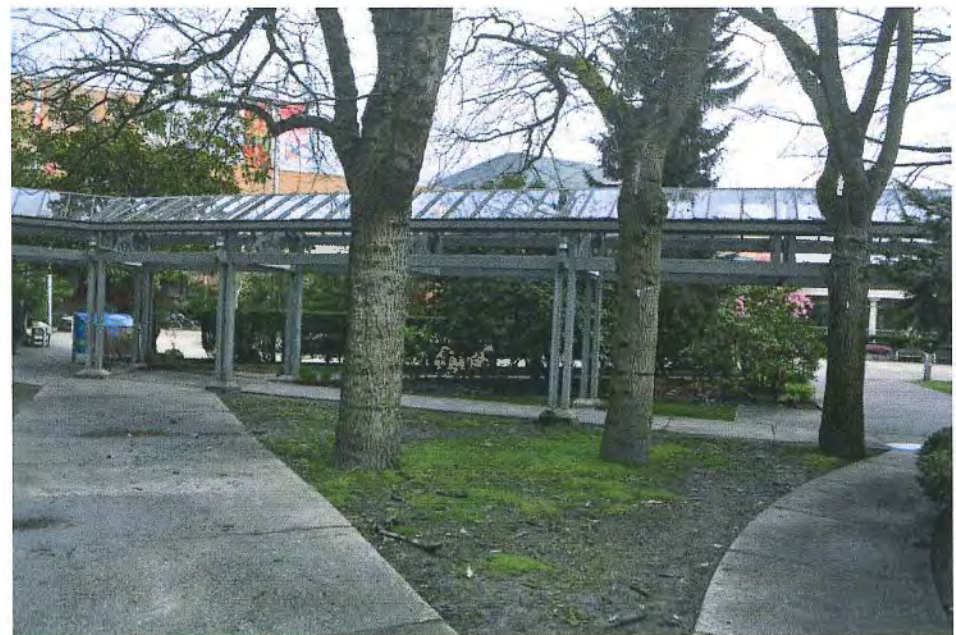
View from west side of MPAC showing visibility obscured by bushes and covered walkway.

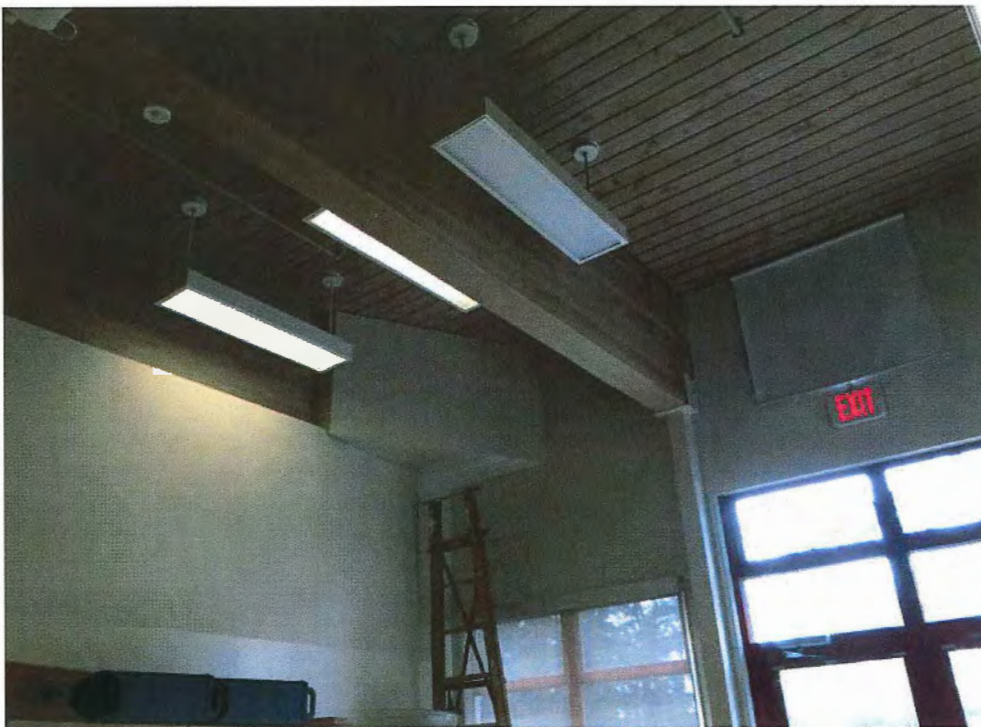
Picture 2 - Glulam Beams Clearspan Activity Room

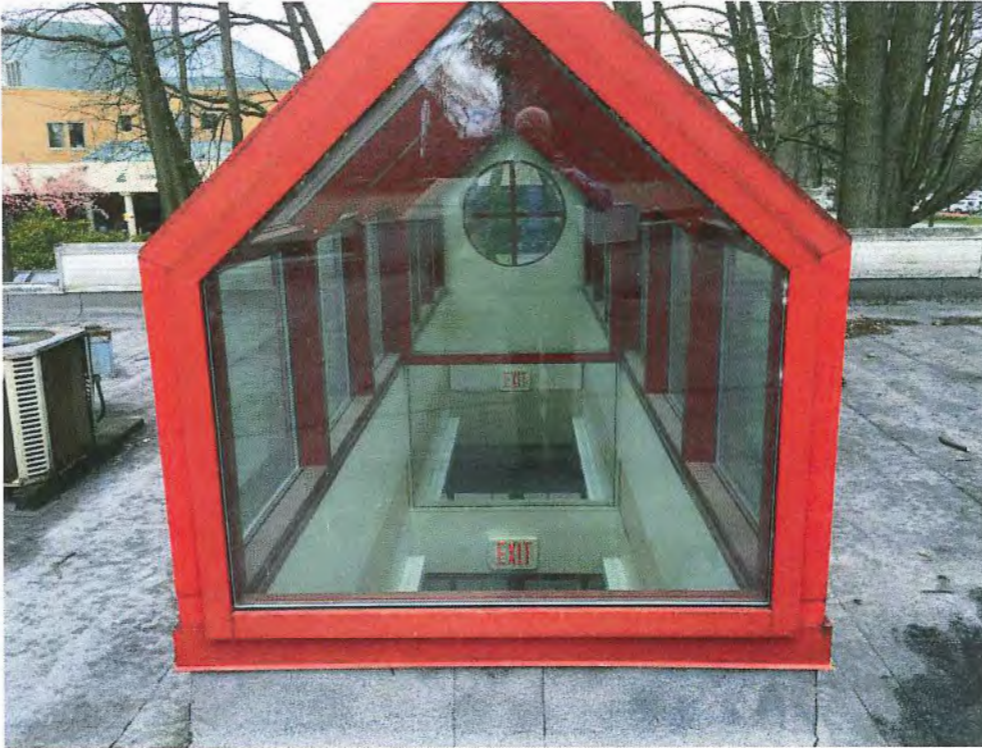
Picture 4 - Aluminum Framed Skylights

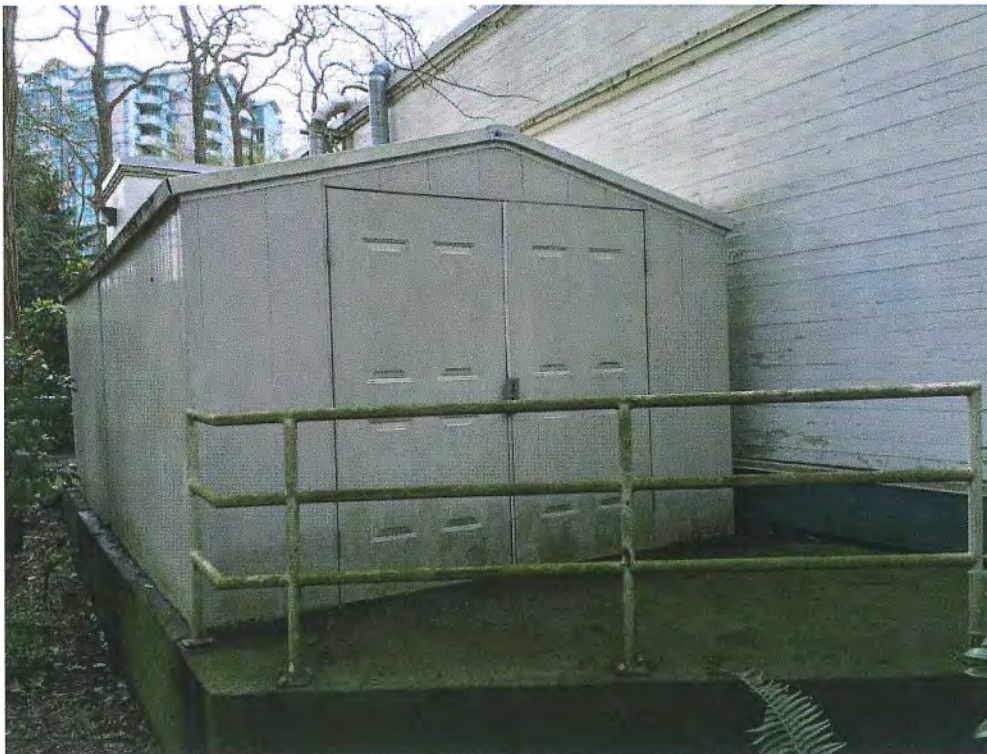
*Picture 6 - Storage building added at south elevation*

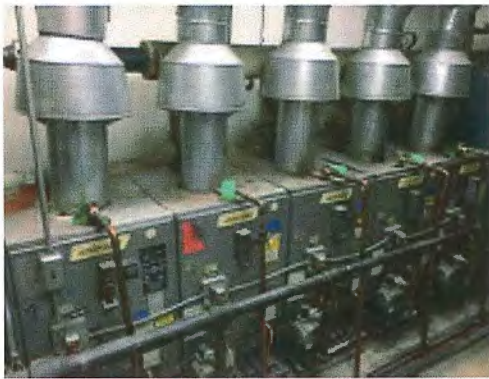
Figure 1 – Existing Boilers

The current mechanical systems consist of a Hydro Therm boiler model with five modules which serves air handling unit coils, reheat coils, perimeter baseboard radiation and the domestic hot water tank. Each modules capacity is 300,000 BTUH input for a total capacity of 1,500,000 BTUH or 1,500 MBH. The building is currently ventilated by two indoor heating only air handling units zoned roughly east and west. There are two split air condition unit serving the office with remote condensing unit located on the roof.

The mechanical and electrical systems for the building are mostly original and are in need of replacement, if it was decided to extend the life of the building beyond 5 - 10 additional years. This would include the AHU, roof top units, boilers, hot water tank, lighting, DDC, fire alarm system, low voltage system, and PA system. Though some of the mechanical unit replacement could be phased, it would be sensible to replace most of the electrical items during a major renovation of the building.

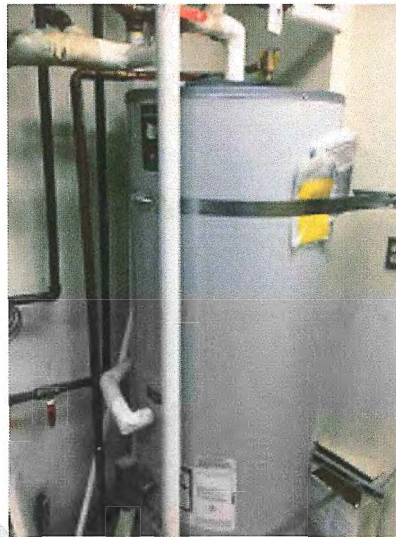
Figure 5 – Existing indirect DHW heater/tank

The incoming combined fire/cold water main is currently a 150Ø pipe terminating in the water entry room at the north of the building. The water entry room contains the fire station and the domestic water station c/w water meter and PRV assemblies. A 65Ø cold water main feeds the 60 US Gallon indirect hot water tank with an immersion heater capacity of 250 BTUH input located in the Boiler Room. There are 25Ø domestic hot water (DHW) and 12Ø domestic hot water recirculation (DHW) pipes from the Boiler Room which distributes to various fixtures through the ceiling of the main floor.

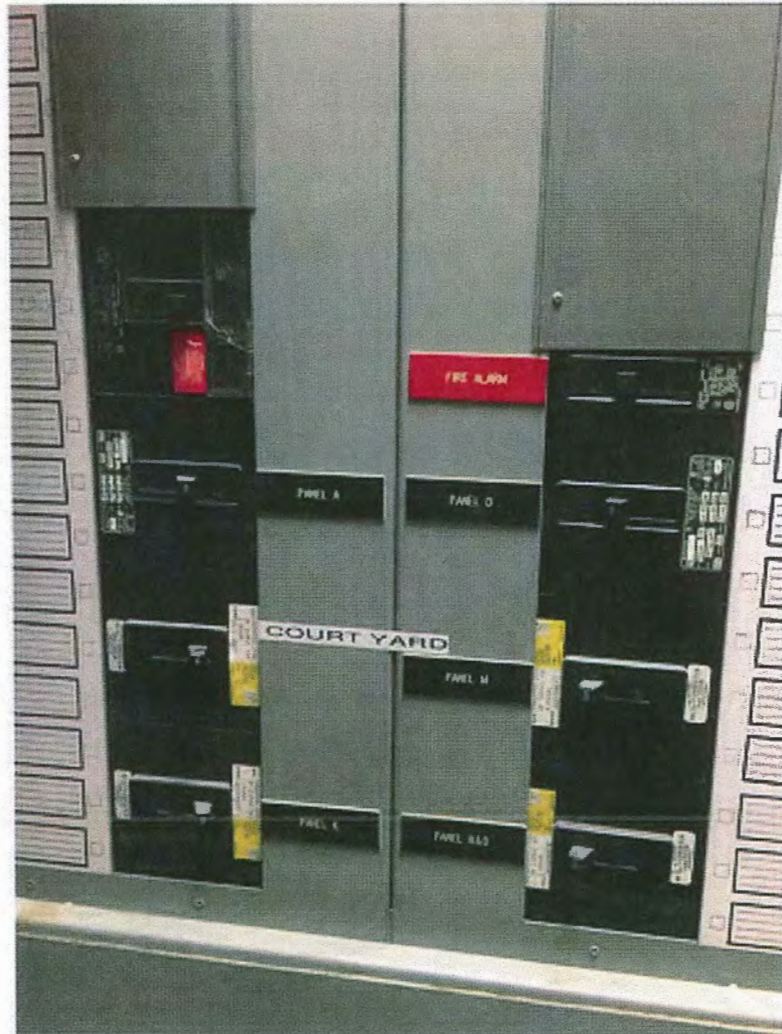
Figure 3 – Service panels

- 2.1. The building has a 3-phase, 4-wire, 800A service (120/208V) terminating on a main switchboard located in the main electrical room. The main switchboard and the service panel are shown in Figure 2 and Figure 3, respectively.
- 2.2. It's not foreseen that an upgrade to the electrical service will be required, since the

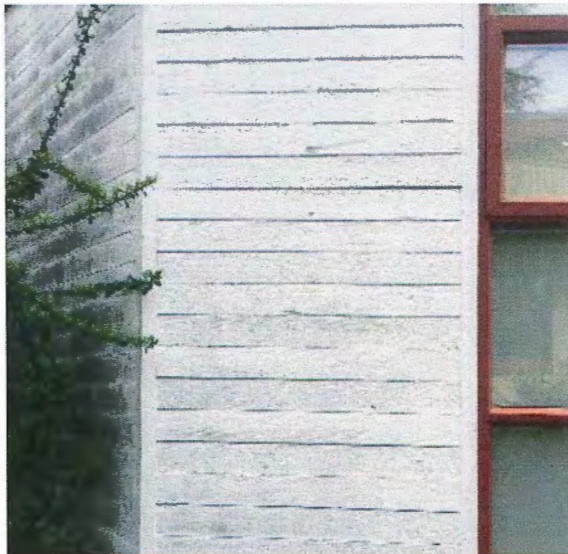
The exterior walls are primarily clad in painted horizontal cedar siding (Figure 8). The wall assembly, from exterior to interior is indicated on Architectural Drawing A8 (Figure 9) and through visual observation to be:

Figure 8 – Painted horizontal cedar siding

The wall assembly design, from a rain resistance point of view, is known as a “concealed barrier”. In this design, the building paper behind the cladding is considered to be the primary moisture barrier as some incidental moisture is expected to leak past the siding. However, the majority of the water is meant to be deflected by the exterior surface of the siding and the design does not incorporate an intentional drainage path to the exterior.

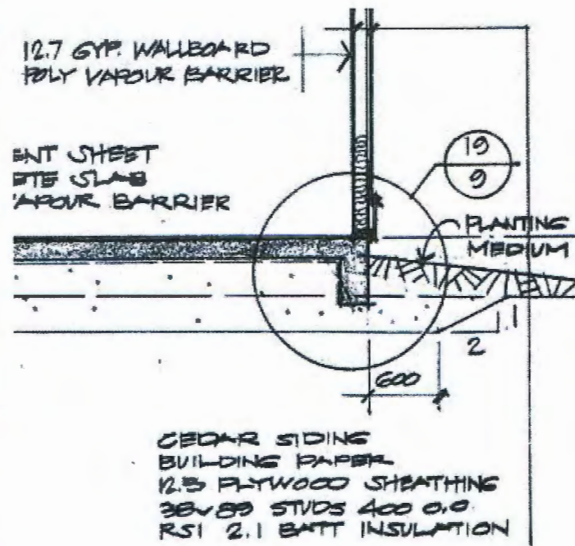
Figure 9 – Exterior wall assembly with horizontal cedar siding (from Howard Yano Architects).

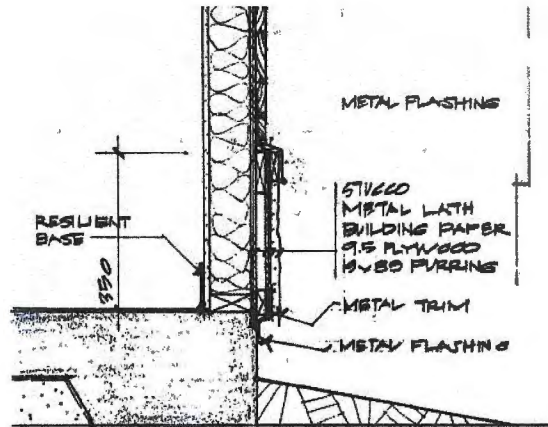
1. The wood framed exterior walls bear on the concrete slab on grade. This is shown on the architectural drawings and was verified on site (Figure 10 and Figure 11). The architectural drawings indicate an elevation difference between the finished grade and top of slab on grade; however, at many locations the finished grade is near the top of the slab. The current building code indicates foundation walls shall be not less than 150mm above the finished grade. We observed that water ingress was occurring at the base of wall at multiple locations (Figure 12).

Figure 11 – Typical base of wall (from Howard Yano Architects).

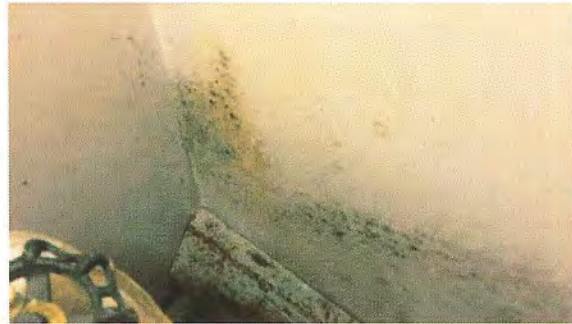
Figure 14 – Signs of water ingress in the sprinkler room, below the glass canopy to wall interface on the north-east elevation.

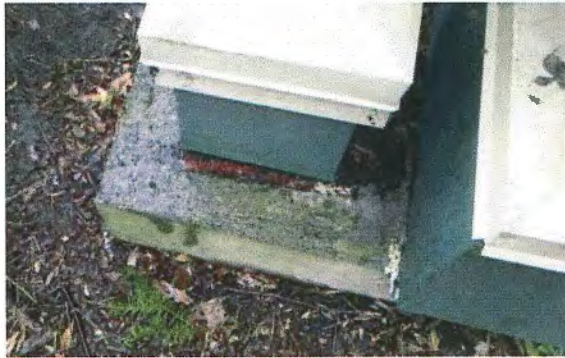
- The metal base plate at exterior columns appears to be only shop painted. This is less durable than galvanization.

Figure 15 – Typical base of exterior column.

- At some locations, such as the exterior columns, the top of the slab on grade is exposed and there is no waterproofing membrane at the wall upturns (Figure 15 and Figure 16).
- The paint finish on the horizontal cedar siding and metal flashing is delaminating and damaged in many areas.

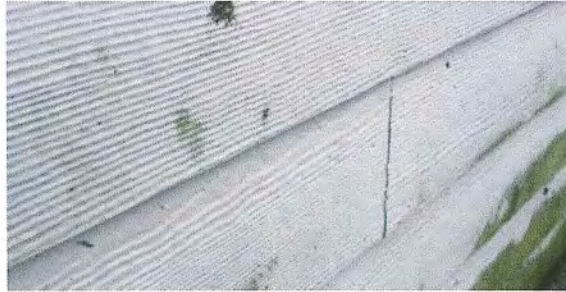
7. The joints at the cementitious horizontal siding are sealed, at some of the locations the sealant has failed.

Figure 24 – Failed sealant at joint in the cementitious horizontal siding.

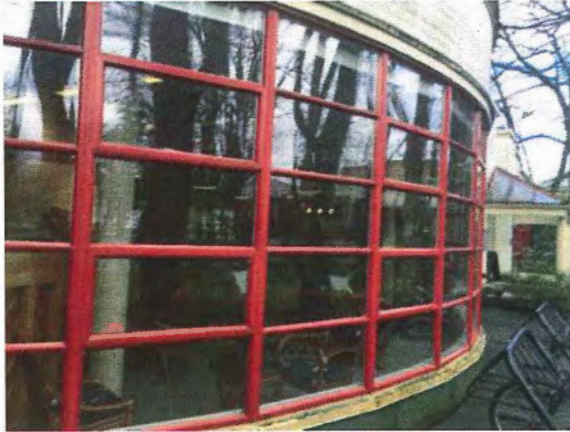
- The windows at Minoru Place appear to be the original aluminum framed, double glazed windows. There are two types of windows: aluminum-framed windows with rolled-in glazing stops, and aluminum-framed storefront windows.

Figure 29 – Aluminum-framed windows with rolled-in glazing stops.

4	Replace the windows with new windows of improved rain, air, and thermal resistance. These will likely be thermally broken aluminum or fibreglass framed windows with low-e coated, argon filled, IGUs. At all locations, the replacement of windows/doors is to include improved detailing (e.g. new sealants, and rain screen design with sub-sill waterproofing membrane).
---	--

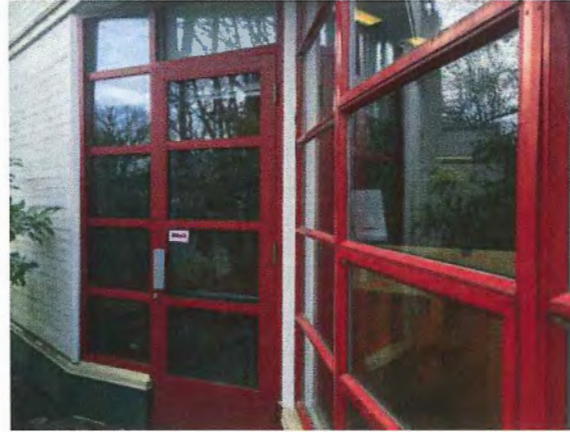
Figure 30 – Aluminum-framed storefront window.

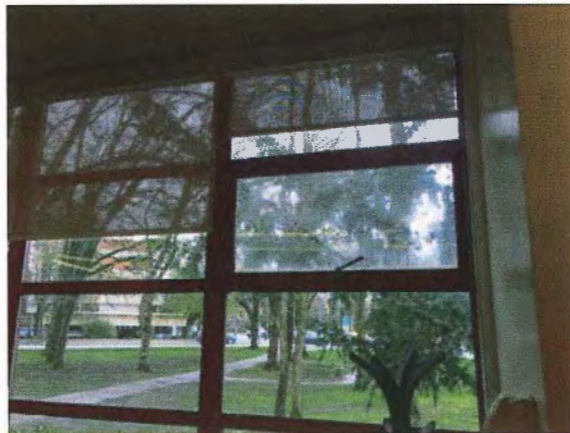
2. The operable vents are a casement style. Many of the operable vents were difficult to open, close, and/or lock, and require adjustments. Some windows were missing or had broken handles or hardware.

Figure 31 – Casement opening vent.

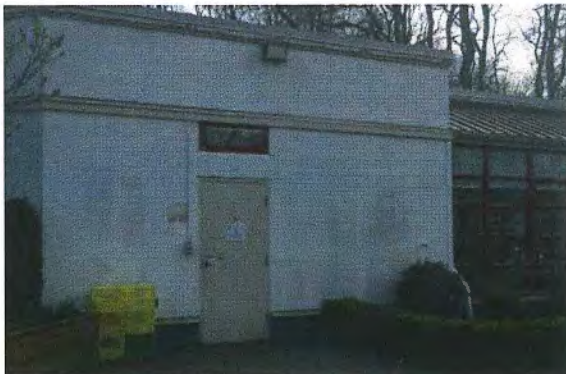
4. Many of the doors do not have overhang (i.e. completely exposed) and these doors have low water penetration resistance.

Figure 42 – Exposed pressed steel door.

5	Replace the glazed doors with new doors of improved rain, air, and thermal resistance. These will likely be thermally broken aluminum framed with low-e coated, argon filled, IGUs. Also replace the pressed steel and wood doors with new pressed steel doors to allow for improved detailing. For pressed steel doors not under cover, canopies or large metal head flashings can be considered. At all locations, the replacement of doors is to include improved detailing (e.g. new sealants and rain screen design with sub-sill waterproofing membrane).
---	---

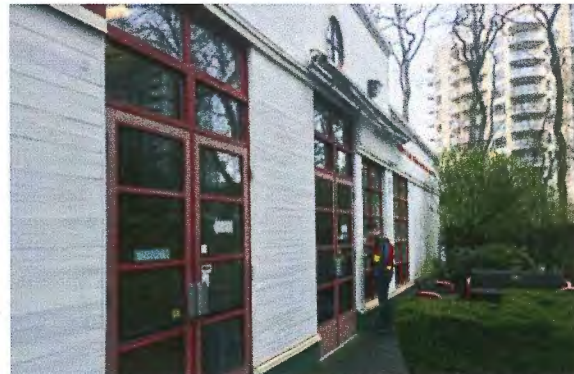
Figure 43 – Exposed doors at the storefront system.

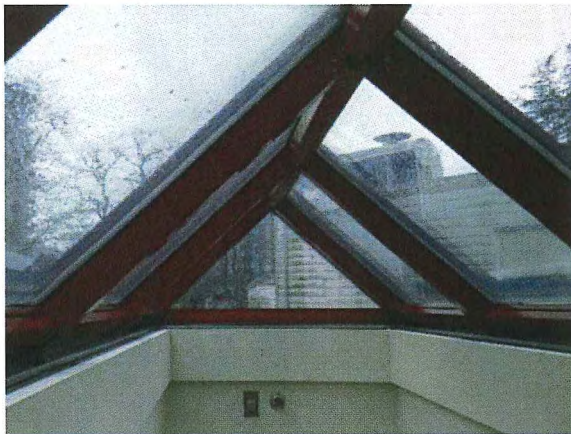
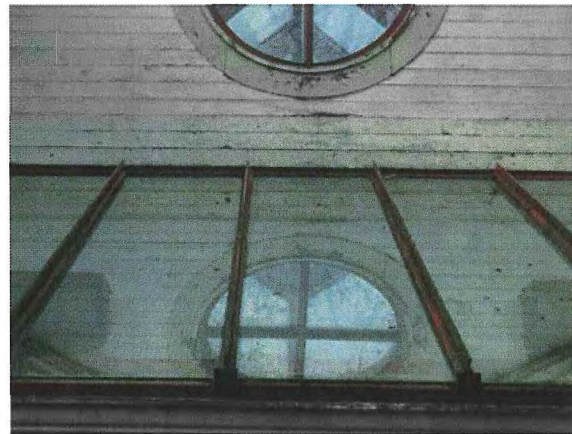
1. The skylights (i.e. located over occupied space) at Minoru Place are pressure-plate aluminum glass skylights (Figure 48). Glass canopies (i.e. located over exterior space) are T-bar aluminum glass canopies (Figure 49).

Figure 48 – Pressure-plate aluminum glass skylight. Figure 49 – T-bar aluminum-framed glass canopy.

6	Perform skylight water penetration testing to better confirm the performance of the skylights and the necessary repairs. Alternatively, consider replacing the skylight assemblies.
7	In conjunction with the wall rehabilitation, remove and replace glass canopies with a new assembly with improved performance and detailing.

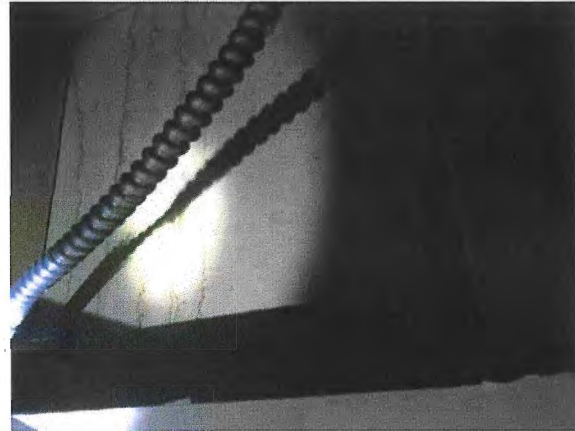
3. There is moisture staining adjacent to and below the skylight at the multipurpose room at north-east side of the building.

Figure 52 – Signs of water ingress at skylight.

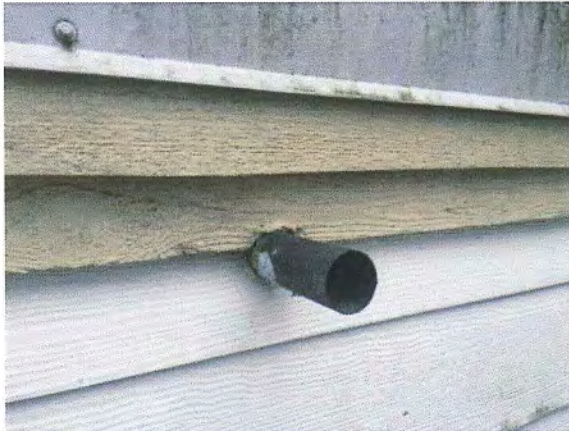
At most locations, there is no sealant around wall penetrations, such as scupper drain and hose bib.

Figure 54 – Wall penetration (typical).

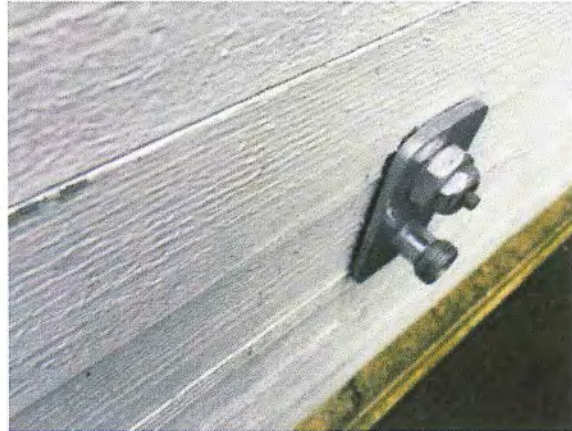
Figure 55 – Wall penetration (typical).

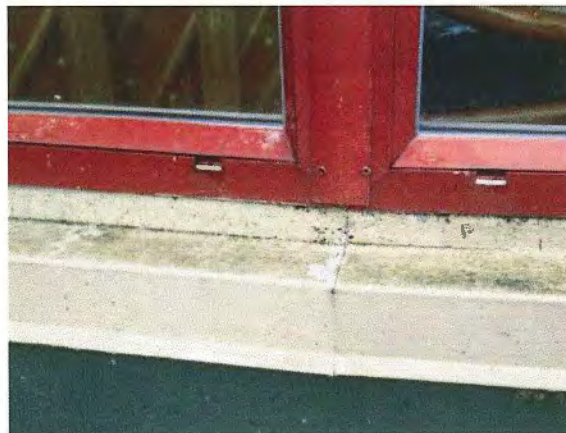
1. Metal flashings seams at Minoru Place were not adequately detailed or sealed. Rather than having s-lock seams, the metal flashing is only overlapped.

Figure 56 – Metal flashing seam unsealed and only overlapped.

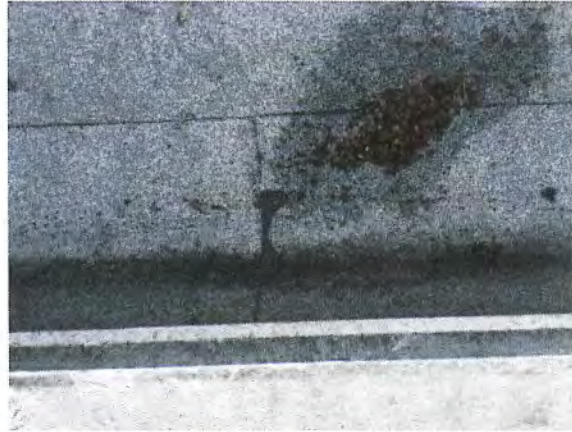
2. We could not confirm the age of the roofs. It appears that the roof is not all the same age, and there are possible two dates of installation. Based on our review, it is likely the remaining service of the roofs is between 5 and 10 years. We recommend the roofing should be reviewed again within the next 5 years.
3. We observed fish mouths and excessive bleed out in the torch-applied roofing membrane. At some locations, the roofing membrane is not well adhered, has failed seams, being cut/damaged by the metal flashing, or has exposed edges (Figure 63 to Figure 69).

Figure 64 – Roofing membrane bleed out.

10	Review and correct deficiencies in the 2-ply SBS membrane.
11	Adequately secure all metal flashings.
12	Remove and replace failed sealant.
13	Improve detailing at roof penetrations, ensuring all incorporate two lines of defence.
14	Ensure all equipment and fans are well secured to the roof, replace all corroding fasteners, and seal all penetrations.
15	Replace roof hatch hardware and provide a new gasket.
16	As part of regular maintenance, remove debris and ensure the drains are cleaned, ponding water is removed/minimized, and the drainage is not restricted.
17	During the wall and door rehabilitation, improve the transition detailing to the roofs.
18	During our review, we did not have access to the metal roofs. However, based on our experience, we recommend that the sloped metal roofing be replaced at the same time as the exterior wall rehabilitation, with improved detailing.

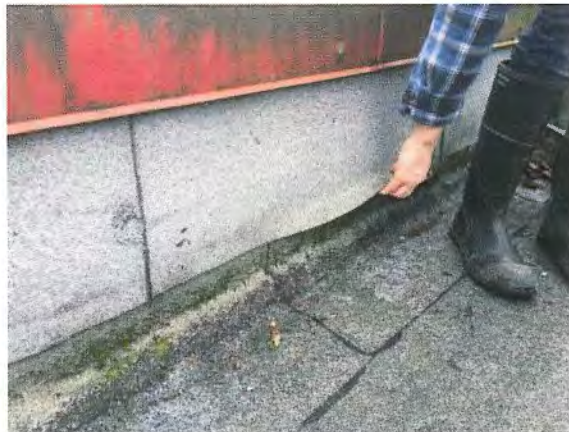
Figure 65 – Roofing membrane not well adhered.

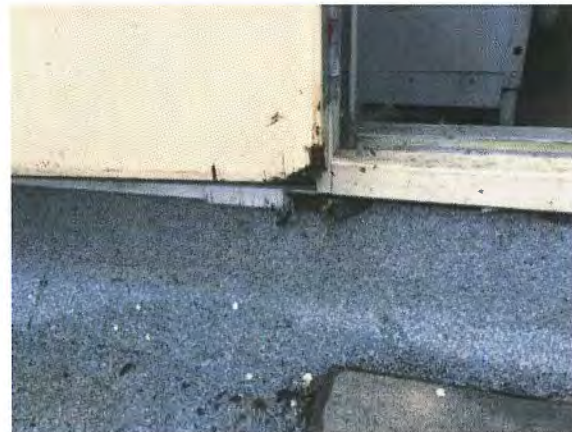
Figure 68 – The roofing membrane not extending into door rough opening and has exposed edge.

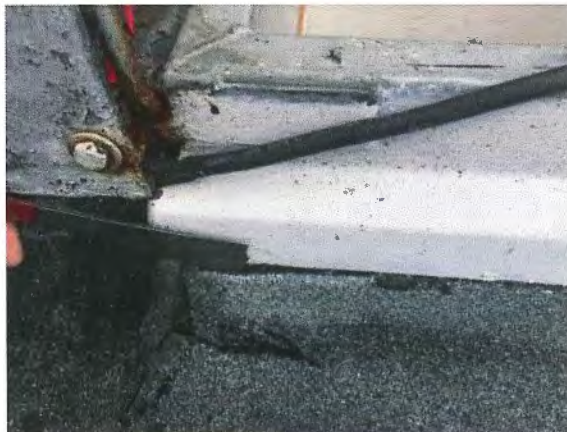
Figure 69 – Exposed edge of roofing membrane.

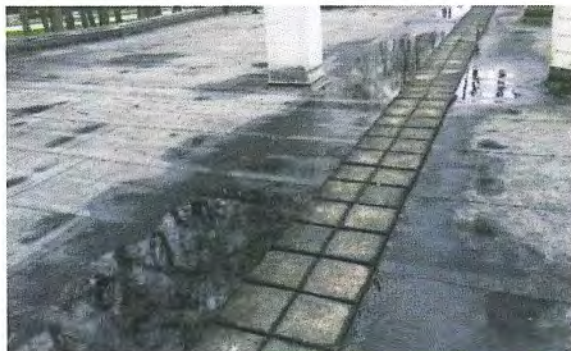
4. Ponding water at various locations on the roof, including at scupper drains.

Figure 70 – Ponding water within the field of roof where pavers are obstructing drainage.

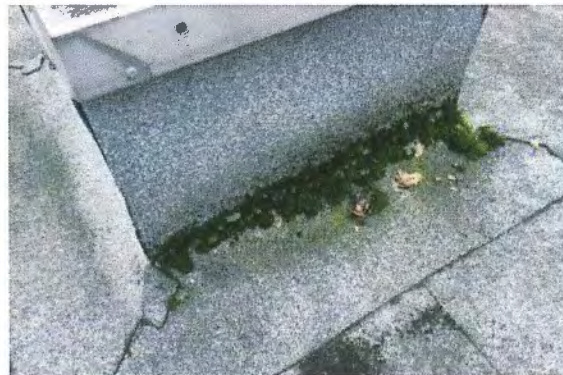
5. We observed debris and/or moss growth. At some locations, the debris and/or moss growth is restricting drainage.

Figure 73 – Moss growth on the roofing membrane (typical).

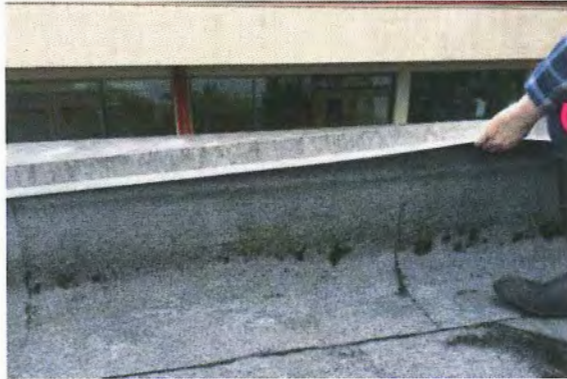
6. At some locations, the metal flashing on the parapet is not well-secured and the attachment of roof parapet metal flashing is questionable.

Figure 74 – Roof parapet metal flashing not well-secured.

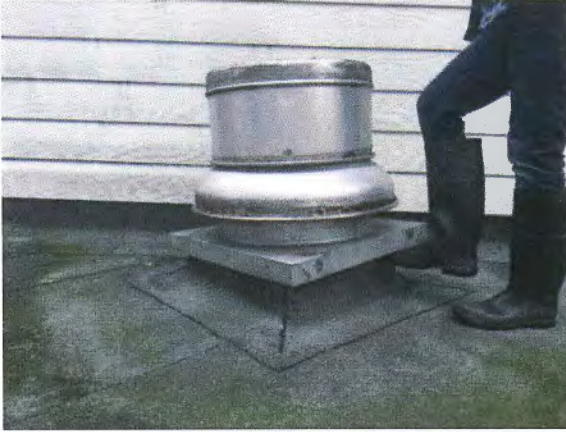
9. At some locations, the extraction fans are not well secured, and/or have unsealed fasteners.

Figure 77 – Extraction fan not well secured

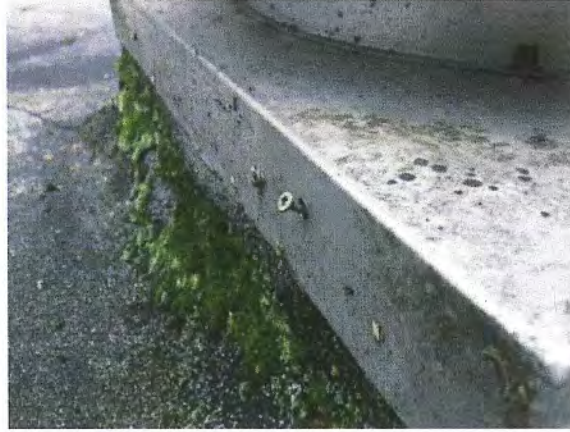
Figure 78 – Unsealed fasteners at extraction fan.
