File: RZ 06-330060

Re: **Application by Watson and Barnard, BC Land Surveyors for Rezoning at 12751 Rice Mill Road from Agricultural District (AG1) to Light Industrial District (I2)**

PROPOSED REZONING

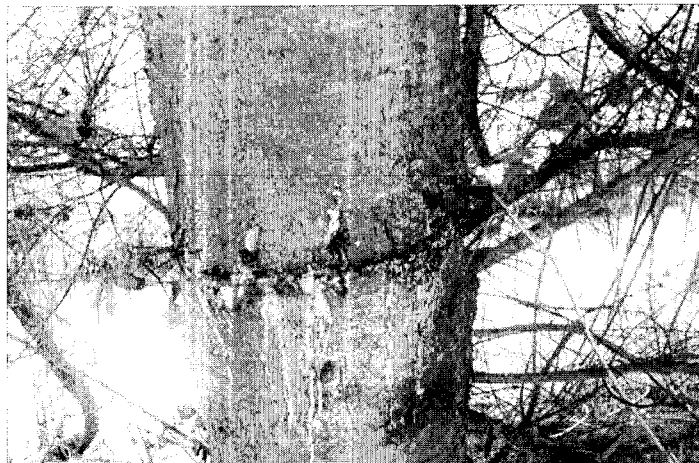
Photograph 1:

Example of girdling by staking equipment (Tree #160).

Douglas-fir trees represent the bulk of trees in moderate condition observed onsite. Almost all of these trees show signs of minor to significant girdling caused by staking equipment that was not removed after the trees were established (Photographs 1 and 2). In addition, a large percentage (approximately 55%) of the Douglas-fir trees are located under overhead transmission lines, and have been topped to accommodate this infrastructure (Photograph 3). The conditions of the site's Douglas-fir trees are noted as moderate, and appear stable under current circumstances. These trees should be monitored over time however, as their health will continue to decline. Risks associated with the Douglas-fir trees (e.g., potential for failure) will increase and must be mitigated on an ongoing basis considering the proposed land use.

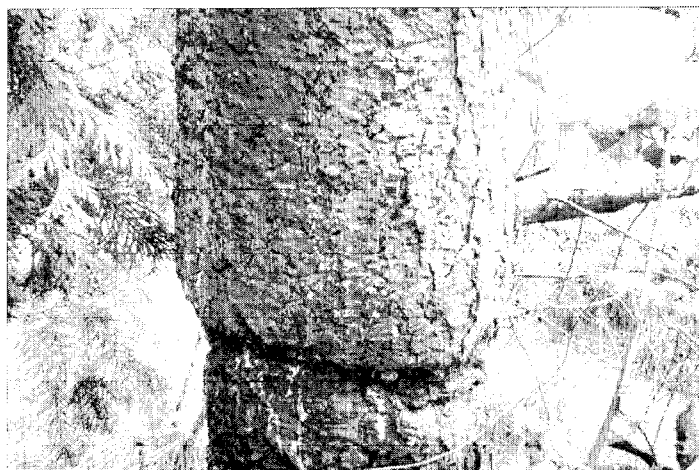
Photograph 2:

Additional example of girdling by staking equipment (Tree #185).

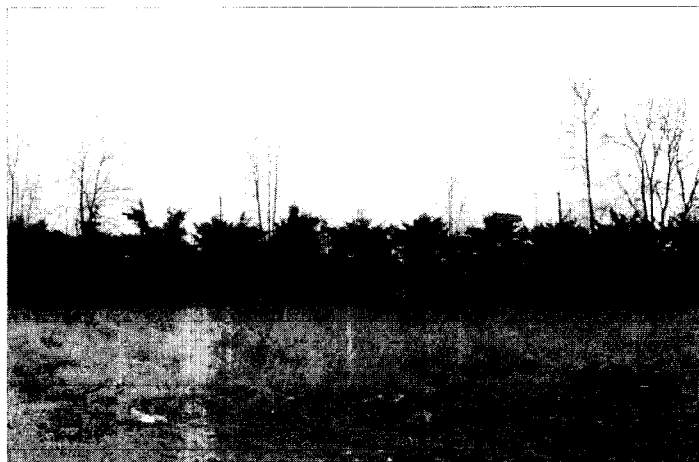
Photograph 3:

Topped Douglas-fir trees under transmission lines, looking southeast.

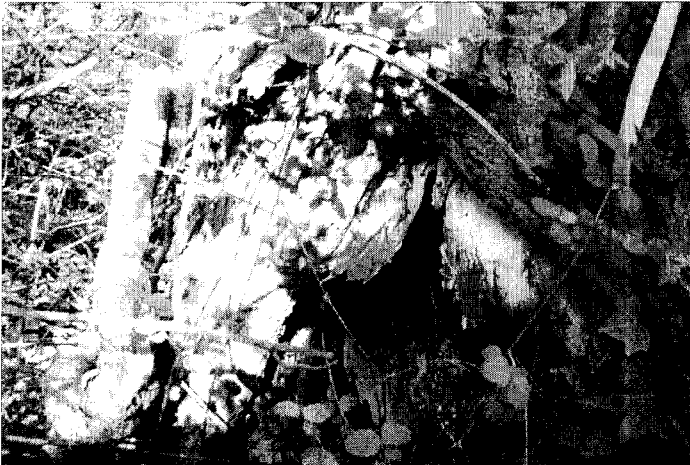
Photograph 4:

Wound and subsequent decay at base of Tree #129.

Two mature black cottonwood trees (Tree #129 and #130) located along the northern limit of the property are in poor condition (significant defects and/or in decline). These two trees appear to have been historically joined by a third middle stem. The failure of the middle stem has compromised the base of Trees #129 and #130 and rendered both remaining stems vulnerable to significant decay (Photographs 4 and 5). Under current conditions, these trees do not pose a significant risk due to a lack of significant targets (e.g., buildings, heavily used land); however, risks will increase with the proposed development plans as the presence of potential targets will be introduced. Options to mitigate these risks include:

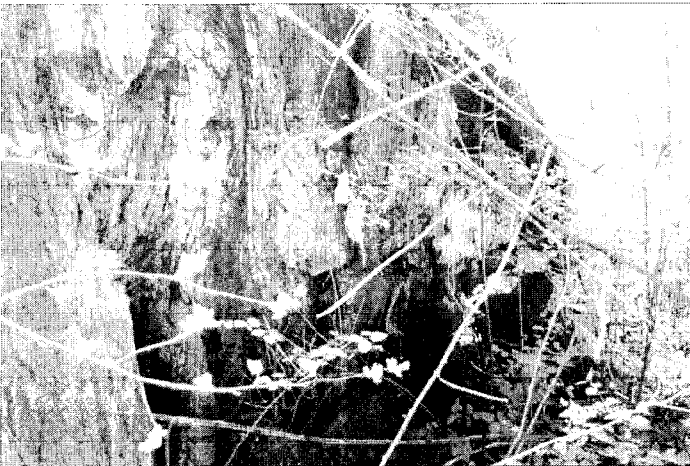
Photograph 5:

Wound and subsequent decay at base of Tree #130.
