RZ 06-330060

Re: Application by Watson and Barnard, BC Land Surveyors for Rezoning at
12751 Rice Mill Road from Agricultural District (AG1) to Light Industrial District
(I2)

ESA AND RAR SETBACK LOCATIONS AND AREAS

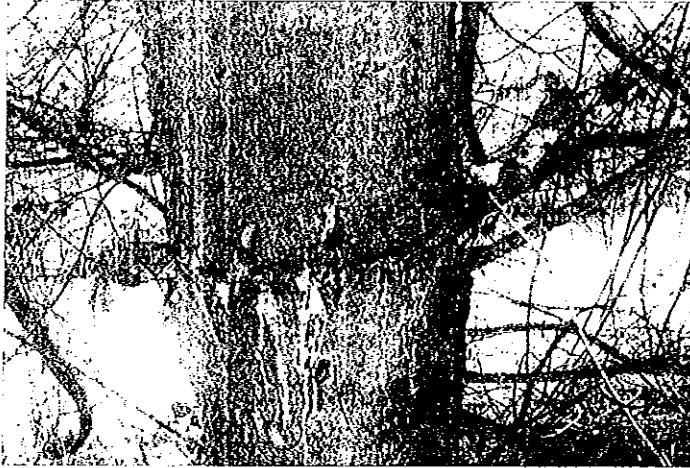
Photograph 1:

Example of girdling by staking equipment (Tree #160).

Douglas-fir trees represent the bulk of trees in moderate condition observed onsite. Almost all of these trees show signs of minor to significant girdling caused by staking equipment that was not removed after the trees were established (Photographs 1 and 2). In addition, a large percentage (approximately 55%) of the Douglas-fir trees are located under overhead transmission lines, and have been topped to accommodate this infrastructure (Photograph 3). The conditions of the site's Douglas-fir trees are noted as moderate, and appear stable under current circumstances. These trees should be monitored over time however, as their health will continue to decline. Risks associated with the Douglas-fir trees (e.g., potential for failure) will increase and must be mitigated on an ongoing basis considering the proposed land use.
