Re: **Application by David Lin for a Heritage Alteration Permit at 6471 Dyke Road (McKinney House)**

David Lin has applied to the City of Richmond for a Heritage Alteration Permit (HAP) to alter the heritage-designated house, known as the McKinney House, at 6471 Dyke Road (Attachment 1). An HAP issued by City Council is required for the proposed alterations consistent with the provincial *Local Government Act* and the City's *Heritage Procedures Bylaw No. 8400*, as the property is protected by Heritage Designation Bylaw No. 6130. The scope of the proposed alterations is to remove and replace the existing wood shingle and horizontal lap siding cladding on a like-for-like basis, as well as to repair, replace, and install new components of the wall assembly to address water ingress. Incidental repair of existing soffits may also be required, as needed, where the proposed new cladding meets up with it.

The McKinney House was constructed in 1911 and is an excellent example of Foursquare Edwardian-era architecture with Craftsman influences. The house became a protected heritage building in 1988 through Heritage Designation Bylaw No. 5186.

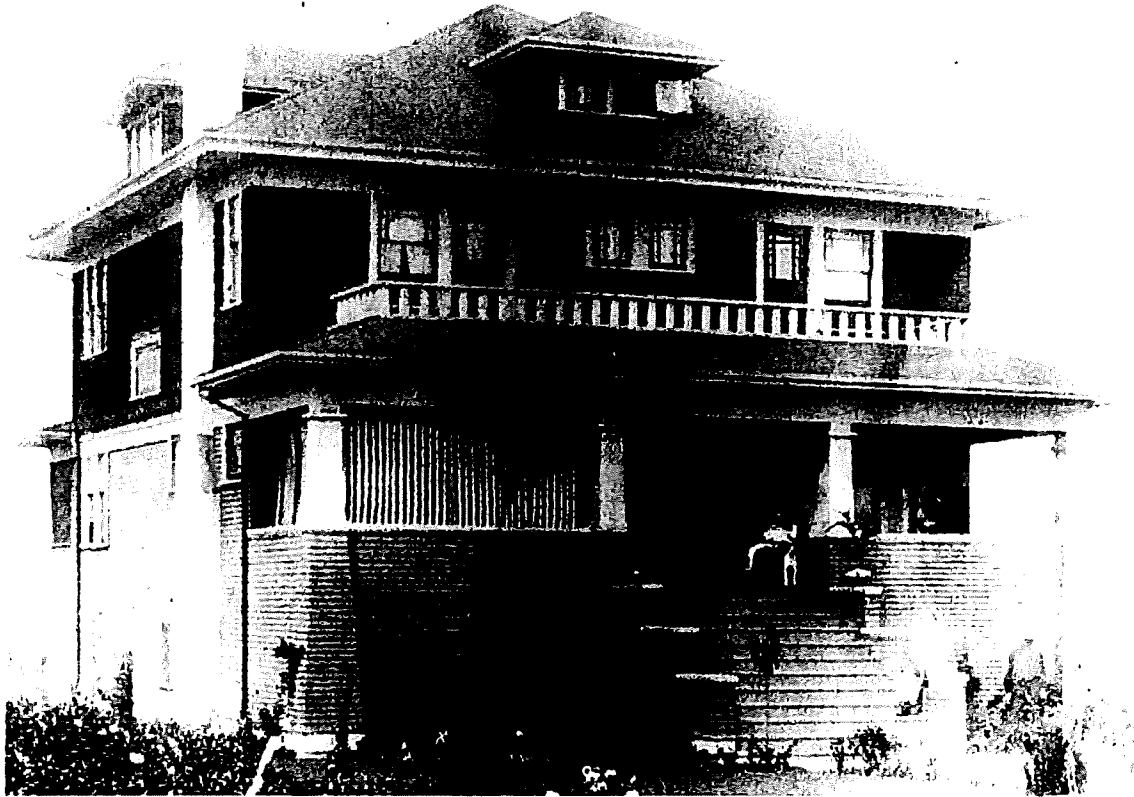
Ca. 1914 image of the McKinney House, shortly after its completion, City of Richmond Archives

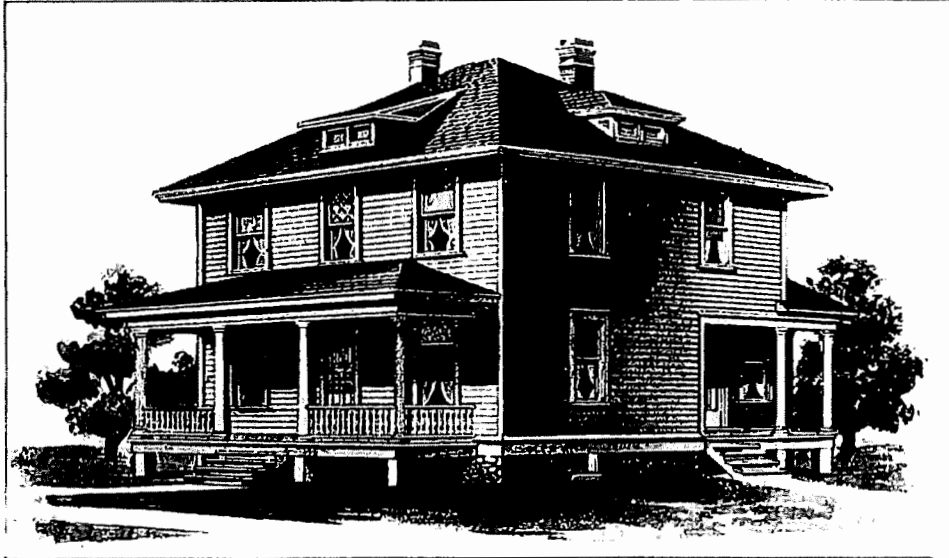
MODERN HOME No. 102

This house contains ten conveniently and economically arranged rooms as shown on the two floor plans.

Sears, Roebuck and Company Hamilton house plan, 1908

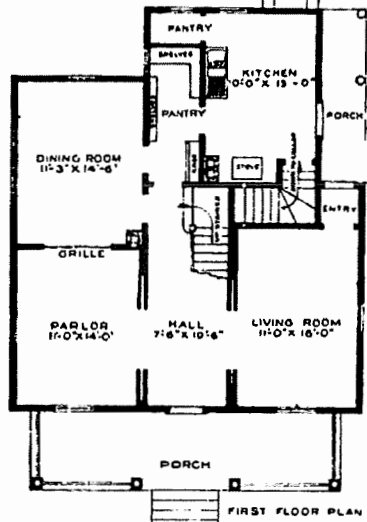
FIRST FLOOR PLAN

Bedroom.
Bedroom.
Bedroom.
Bathroom or Store-room.
Large Hall.
Length of building 36 feet, exclusive of porches; width, 32 feet, exclusive of porches.

This house is one of the most economical to build. Being practically square, every inch of space can be utilized to the very best advantage. It has proven to be a favorite in all parts of the country. It is the best house ever built in recent years under \$3,000.00. The material we specify is always the best. Send for the plans (blue prints), specifications and bill of materials which we will send you free on conditions as explained on Page 2.

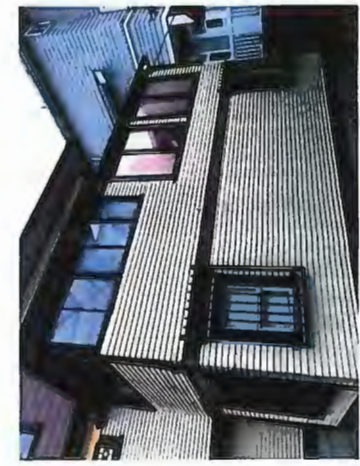
3 EXISTING NORTH ELEVATION

NORTH ELEVATION
