Report to Committee

Re: Application by David Lin for a Heritage Alteration Permit at 6471 Dyke Road (McKinney House)

STATEMENT OF SIGNIFICANCE

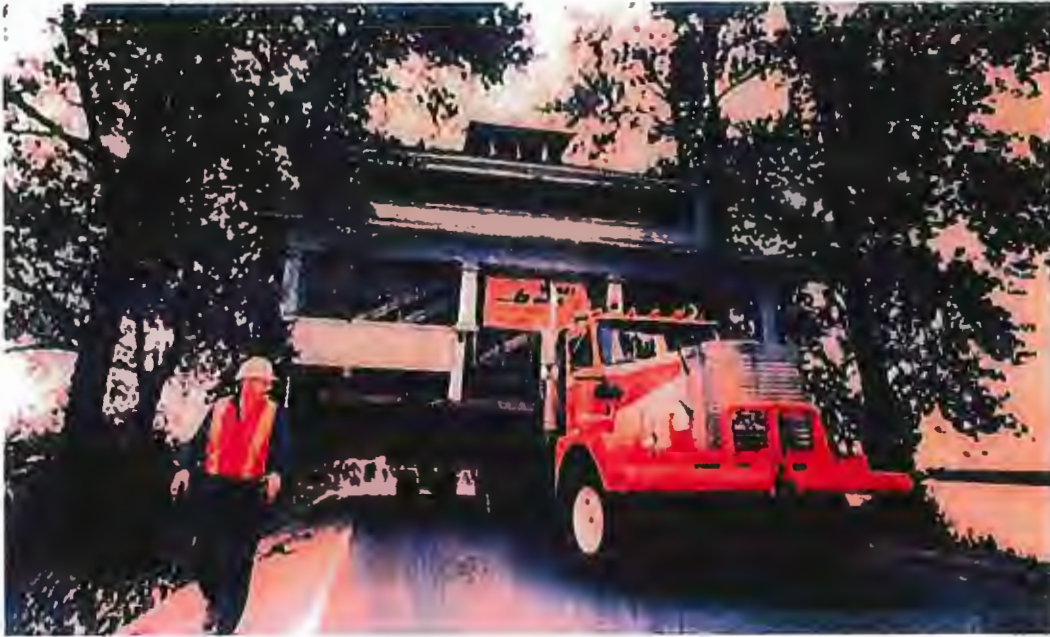
Moving of the McKinney House, August 1, 1993, *The Review*
