Report to Committee

Re:	Garden City Lands Update and Site Activation Plan		
From:	Todd Gross Director, Parks Services	File:	06-2345-20-GCIT1/Vol 01
То:	Parks, Recreation and Cultural Services Committee	Date:	October 31, 2019

and the second s	
Date:	November 4, 2019
To:	Alex Kurnicki, City of Richmond
From:	Hemmera
File:	989645-04
Re:	Garden City Lands – Rationale for Fill Material

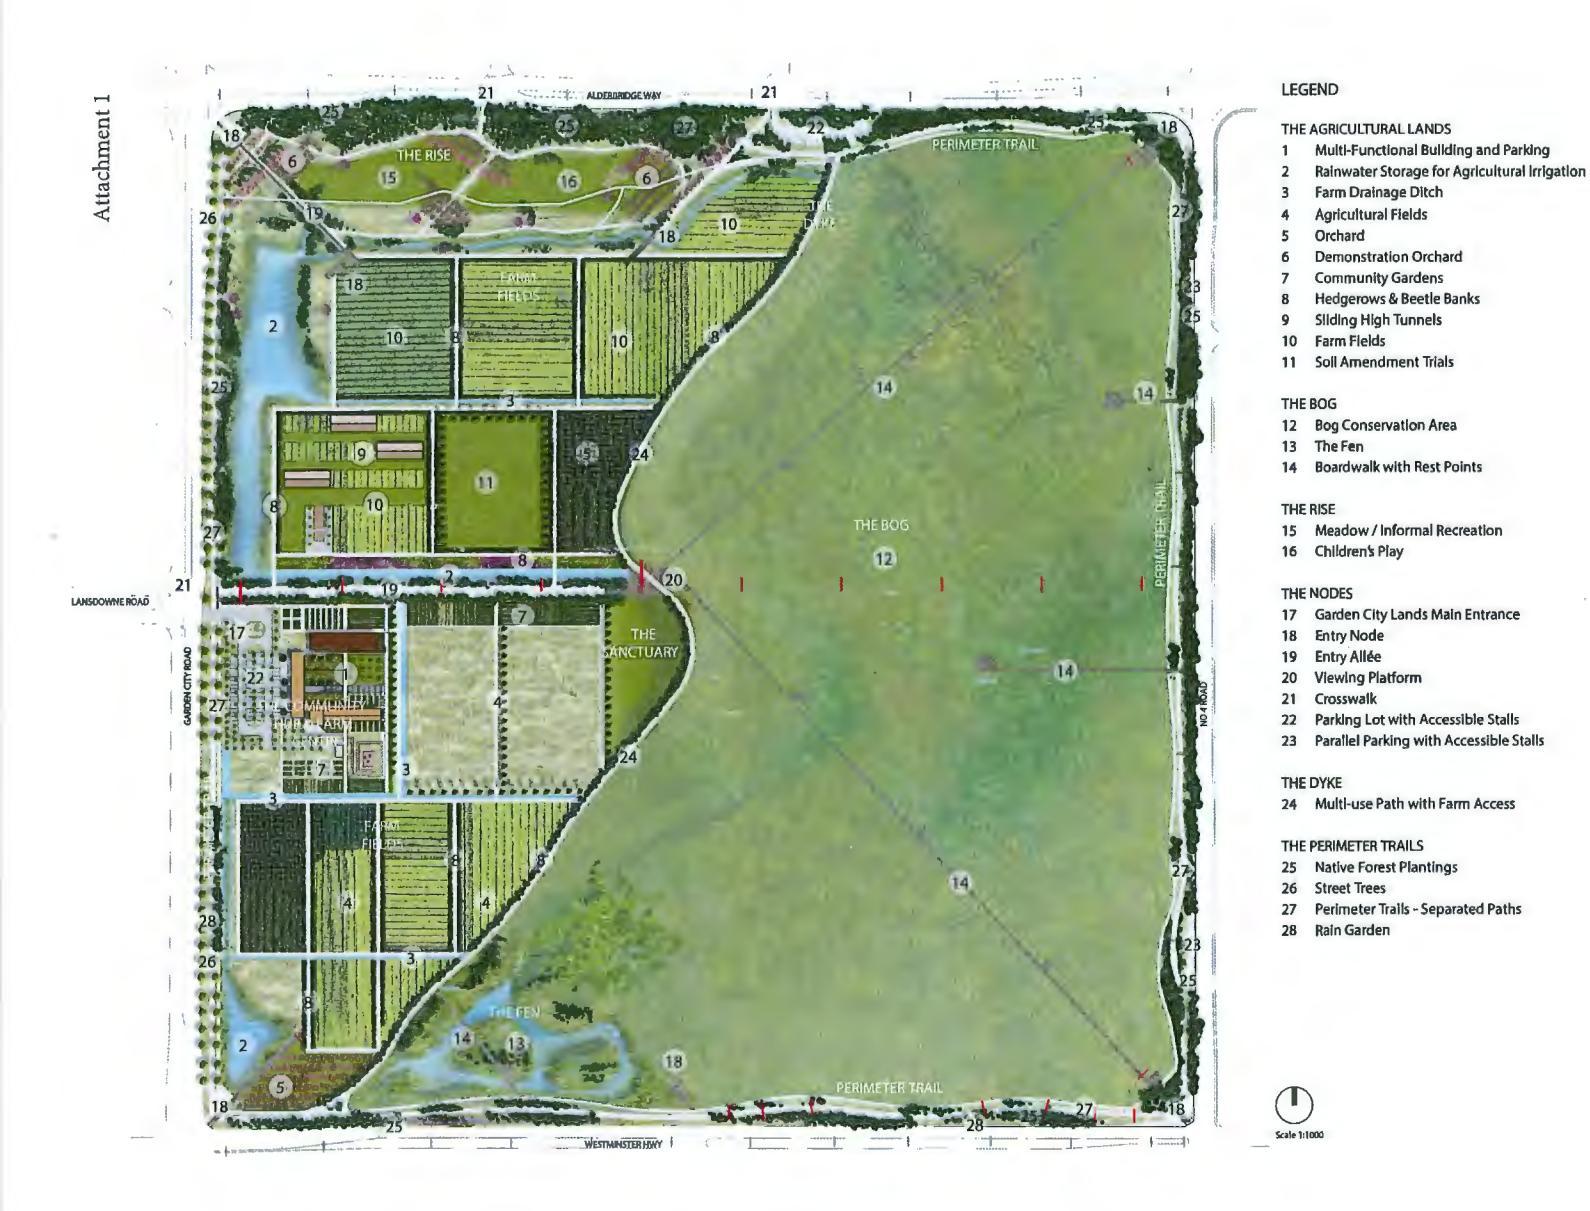
Att. 1: Garden City Lands Park Development Plan2: Memorandum: Rationale for Fill Material (Hemmera)

A Park Development Plan (the "Plan") (Attachment 1) was created based on the direction provided by the Legacy Landscape Plan. The Plan guides staff's implementation of the park program and vision of the Legacy Landscape Plan, including approximately 16 ha (40 acres) of agricultural fields on the western half of the site. Portions of the Plan implemented to date include the development of the 8 ha (20 acres) farm leased to Kwantlen Polytechnic University (KPU), the perimeter recreational trail, extensive plantings and the construction of a pond. In the southwest corner of the Lands, an 8 ha (20 acres) field is envisioned to become incubator farm plots, demonstration gardens and community gardens. The entire agricultural zone on the Lands will be managed according to organic farming best practices.
