To: Planning Committee
From: Jean Lamontagne
Director of Development
Re: Application by Malhi Construction Ltd for Rezoning at 8451 No. 1 Road from Single-Family Housing District, Subdivision Area E (R1/E) to Single-Family Housing District (R1-0.6)

To Planning - April 17, 2007
Date: March 27, 2007
RZ 07-359348
File: 12-8060-20-8223

TREE RETENTION REPORT:

Project: Two Lot Subdivision

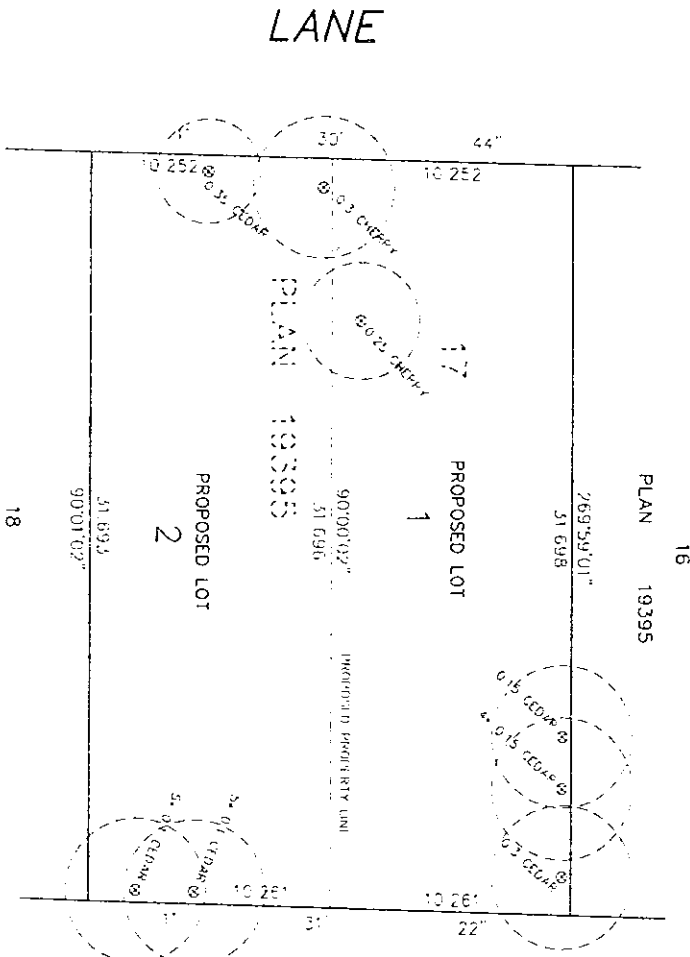
BRITISH COLUMBIA LAND SURVEYOR'S CERTIFICATE SHOWING EXISTING TREES ON LOT 17 SECTION 22 84N R7W NEW WESTMINSTER DISTRICT PLAN 19395.

Note: All trees to be removed

Note:
All dimensions are in meters.
This plan is NOT to be used for location of property lines.
Only trees with a diameter of at least 100mm are shown.
This plan does not show non-plan changes, hence in arrears.

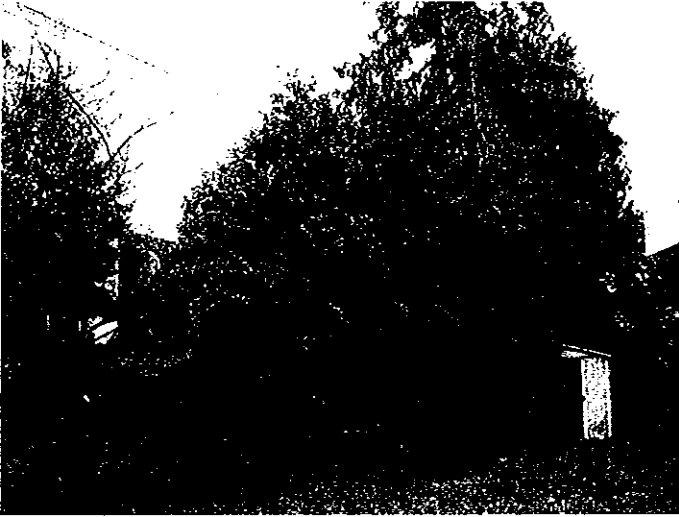
Tree #'s 028 and 029 forming a hedge along the southeast frontage of the subject property.

Treatment	Tree #	Dbh ¹	Species	Condition	Comments
Remove	028	multi	Western redcedar	Poor	This tree is part of a hedgerow with tree # 029, and is formed by 5 stems growing from the base, all less than 15 cm dbh each. The crown is wide spreading and merged with adjacent trees. The main leaders have been topped at a height of 4.5m high, and several small leaders have developed.
Remove	029	multi	Western redcedar	Poor	This tree is part of a hedgerow with tree # 028, and is formed by 9 stems growing from the base, all less than 15 cm dbh each. The crown is wide spreading and merged with adjacent trees. The main leaders have been topped at a height of 4.5m high, and several small leaders have developed.
Remove	030	25	Western redcedar	Very Poor	Part of a hedgerow with tree #'s 031 and 032. The trunk of this tree splits into two at a height of 2.5m and these stems have been topped at 4.5m high and multiple leaders have formed.

- Tree #'s 028 to 032 are to be removed due to the fill required in the front yard. While viable, these trees are rated in poor to very poor condition.

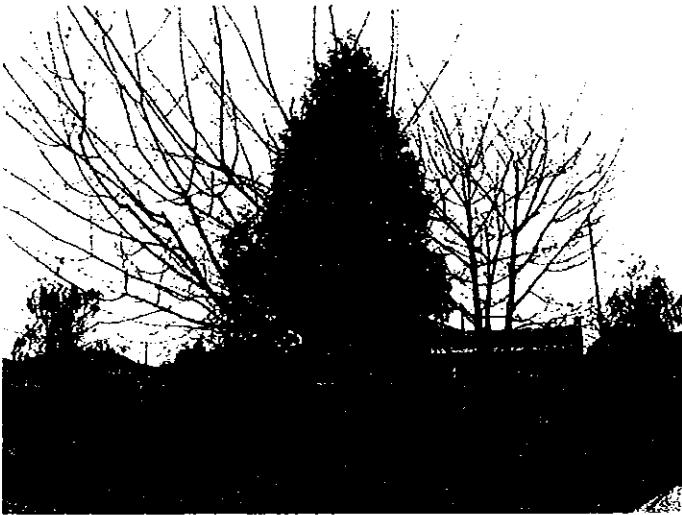
Rear yard trees #'s 033, 034 and 035.

- Tree #'s 033, 034 and 035 are not suitable for retention considering their poor to very poor condition ratings.
