Re:	Drainage Box Culvert Rehabilitation No. 2 Road from Steveston Highway to London Road		
From:	John Irving, P.Eng. MPA Director, Engineering	File:	10-6340-20- P.16201/Vol 01
То:	Public Works and Transportation Committee	Date:	February 1, 2017

That funding of \$3,700,000 from the Drainage Improvement Reserve be included as an amendment to the 5 Year Financial Plan (2017-2021) to complete rehabilitation of the drainage box culvert on No. 2 Road from Steveston Highway to London Road.

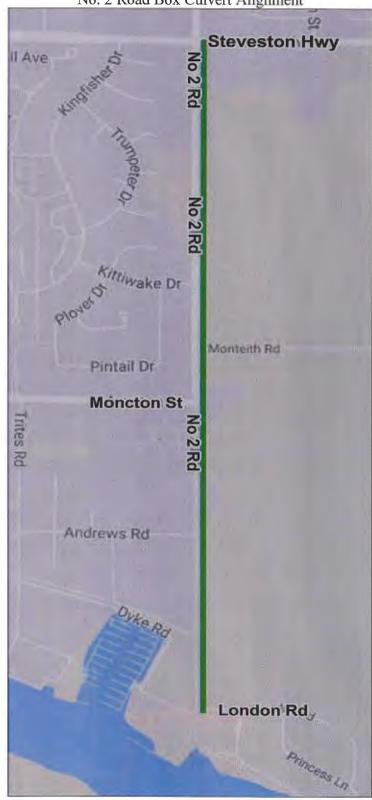
Attachment 1

No. 2 Road Box Culvert Alignment

The box culvert on No. 2 Road south of Steveston Highway is located in the eastern portion of the road corridor, mostly in the boulevard area east of the existing two lane roadway (Attachment 1). Assessment of approximately 1.7 kilometres of box culvert between Steveston Highway and London Road has revealed joint separation and/or infiltration in 257 locations, as well as significant settlement in one section of the culvert. In order to ensure the long term stability of the proposed new pathway and roadworks, rehabilitation work on this box culvert is required. This consists of replacing the settled section, repairing the compromised joints, and filling potential voids outside of the box culvert. The estimated cost to complete these works is \$3,700,000.
