*To Council - Sept 10, 2007*  
*To Planning - Sep 6, 2007*  
Date: August 15, 2007  
RZ 07-375571  
*File: 12-8060-20-8292*

**To:** Planning Committee  
**From:** Wayne Craig  
Acting Director of Development  
**Re:** **Application by Hari and Gurinder Gill for Rezoning at 7520/7540 Langton Road from Single-Family Housing District, Subdivision Area E (R1/E) to Single-Family Housing District, Subdivision Area B (R1/B)**

**Re: 7520 & 7540 Langton Road, Richmond - ARBORIST'S REPORT**

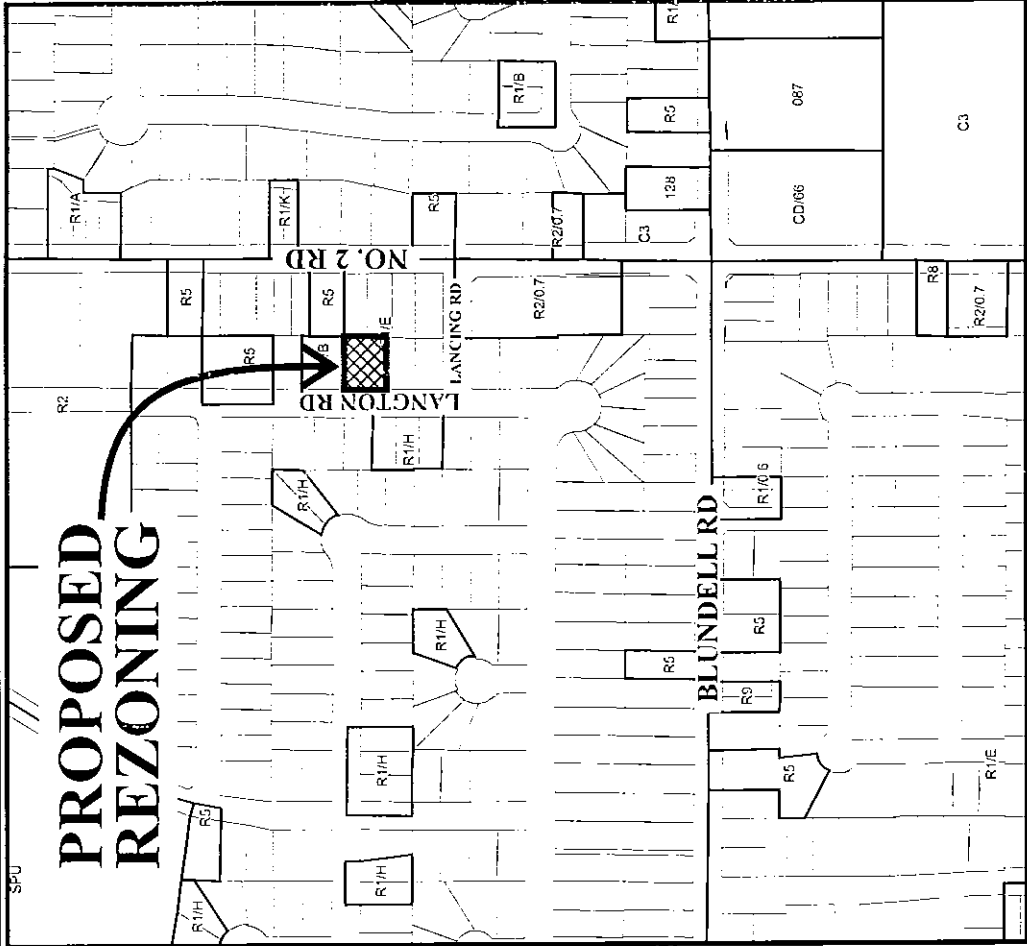
RZ 07-375571

LANGTON RD				
71	7551	7531	7511	7491
20.12	16.64	20.12	20.12	20.12
5	7560	20.12	7480	29.79
	36.58	20.12	29.78	24.95
		16.47	16.47	12.4

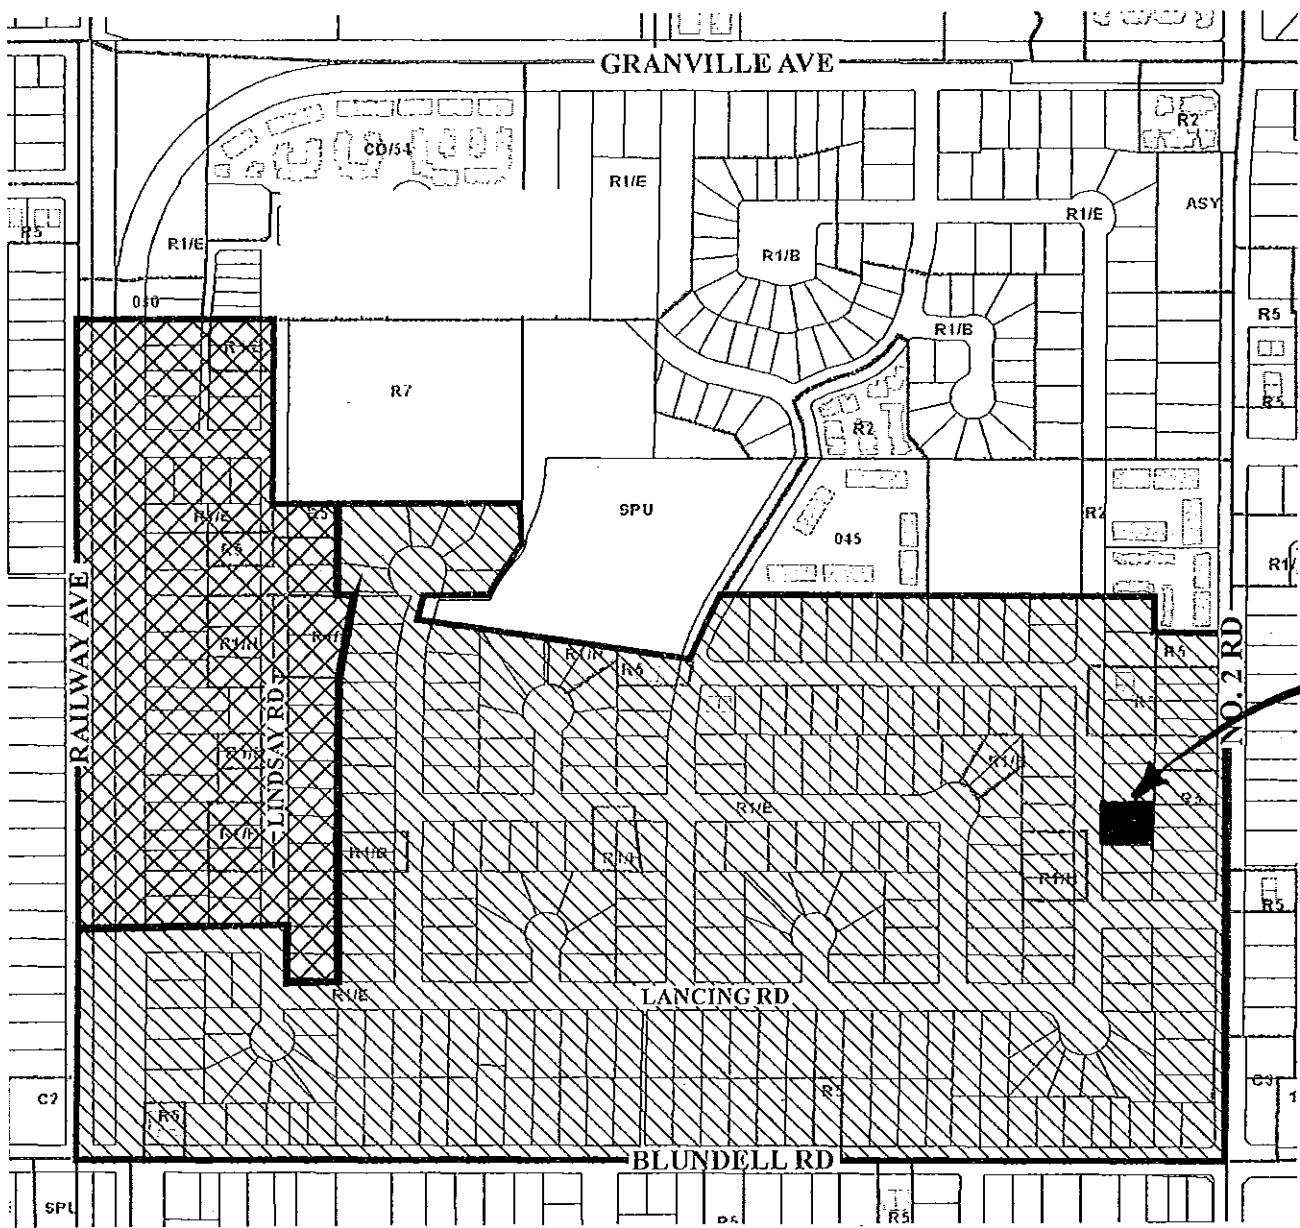
**POLICY 5463**  
**SECTION 13, 4-7**

SUBJECT PROPERTY

Subdivision permitted as per R1/H with the exception that R1/B applies to existing duplexes and R1/E applies to lots facing No. 2 Road and Blundell Road that do not have a lane or internal road access.

Subdivision permitted as per R1/B with the exception that R1/E applies to lots facing Railway Avenue that do not have a lane or internal road access.

The following policy establishes lot sizes for properties within the area generally bounded by **Railway Avenue, Blundell Road and No. 2 Road**, in a portion of Section 13-4-7 as shown on the attached map:

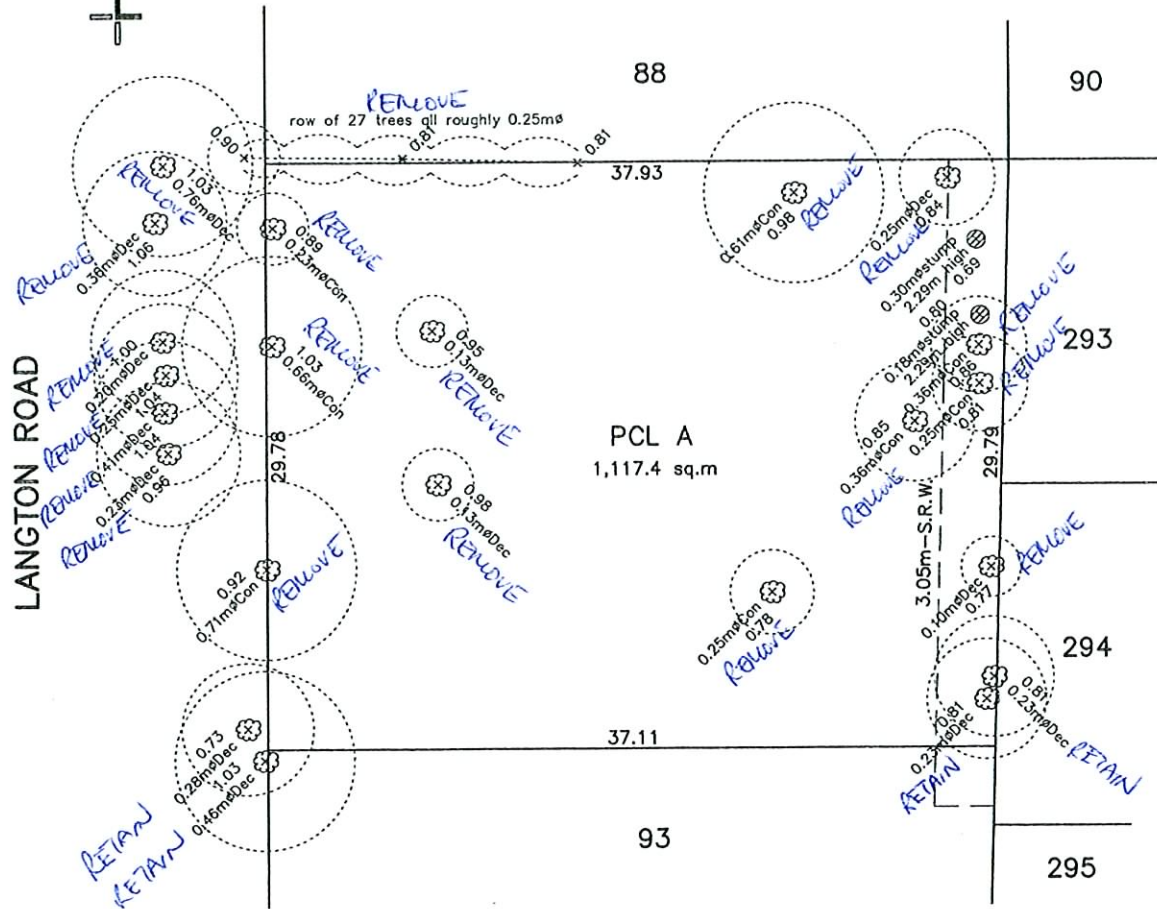
TREE SURVEY PLAN OF PARCEL "A" (EXP. PLAN 27247)  
 LOTS 92 AND 93, SECTION 13, BLOCK 4 NORTH, RANGE 7 WEST  
 NEW WESTMINSTER DISTRICT, PLAN 23547

- Lot dimensions are derived from field survey.
- All trees have been plotted as required by Richmond Tree Protection Bylaw
- Elevations are based on the Geodetic Datum of Richmond

Staff Comments	<p><u>Background</u></p> <ul style="list-style-type: none"><li>• A Development Application Data Sheet providing details about the development proposal is attached. (<b>Attachment 3</b>).</li></ul> <p><u>Trees &amp; Landscaping</u></p> <ul style="list-style-type: none"><li>• A Tree Survey submitted by the applicant indicates the location of 22 trees and a row of hedges (<b>Attachment 4</b>):<ul style="list-style-type: none"><li>• 2 non-bylaw-sized tree are located in the front yard of the subject property;</li><li>• 11 bylaw-sized trees are located on the subject property;</li><li>• 8 bylaw-sized tree are located on the City boulevard in front of the subject site; and</li><li>• a row of hedges is located between the subject property and the property to the north (7480 Langton Road).</li></ul></li><li>• An Arborist Report (<b>Attachment 5</b>) is submitted in support of the application. The Report recommends removal of a row of Cedar hedge and all of the bylaw-sized trees noted on site except the two (2) Birch trees at the southeast corner.</li><li>• Tree Preservation Group staff have reviewed the Arborist Report and concurred with the recommendations for tree removal on the basis of tree condition and conflict with proposed development plans.</li><li>• Based on the 2:1 tree replacement ratio goal stated in the OCP and the size requirements for replacement tree in the Tree Protection Bylaw No. 8057, 18 replacement trees with the following minimum calliper sizes are required:<ul style="list-style-type: none"><li>• 6 trees of 11 cm;</li><li>• 2 trees of 8 cm; and</li><li>• 10 trees of 6 cm.</li></ul></li><li>• Due to the configurations of the future lots and building footprints, it is expected that only eight (8) trees (6 trees at 11 cm calliper and 2 trees at 8 cm calliper) can be planted in the two (2) future lots. The applicant has agreed to provide a voluntary contribution of \$5,000 to the City's Tree Compensation Fund in-lieu of planting the remaining 10 replacement trees.</li><li>• To ensure that the 8 replacement trees are planted and maintained, the applicant is required to submit a Landscaping Security to the City in the amount of \$4,000 prior to final adoption of the rezoning bylaw.</li></ul>

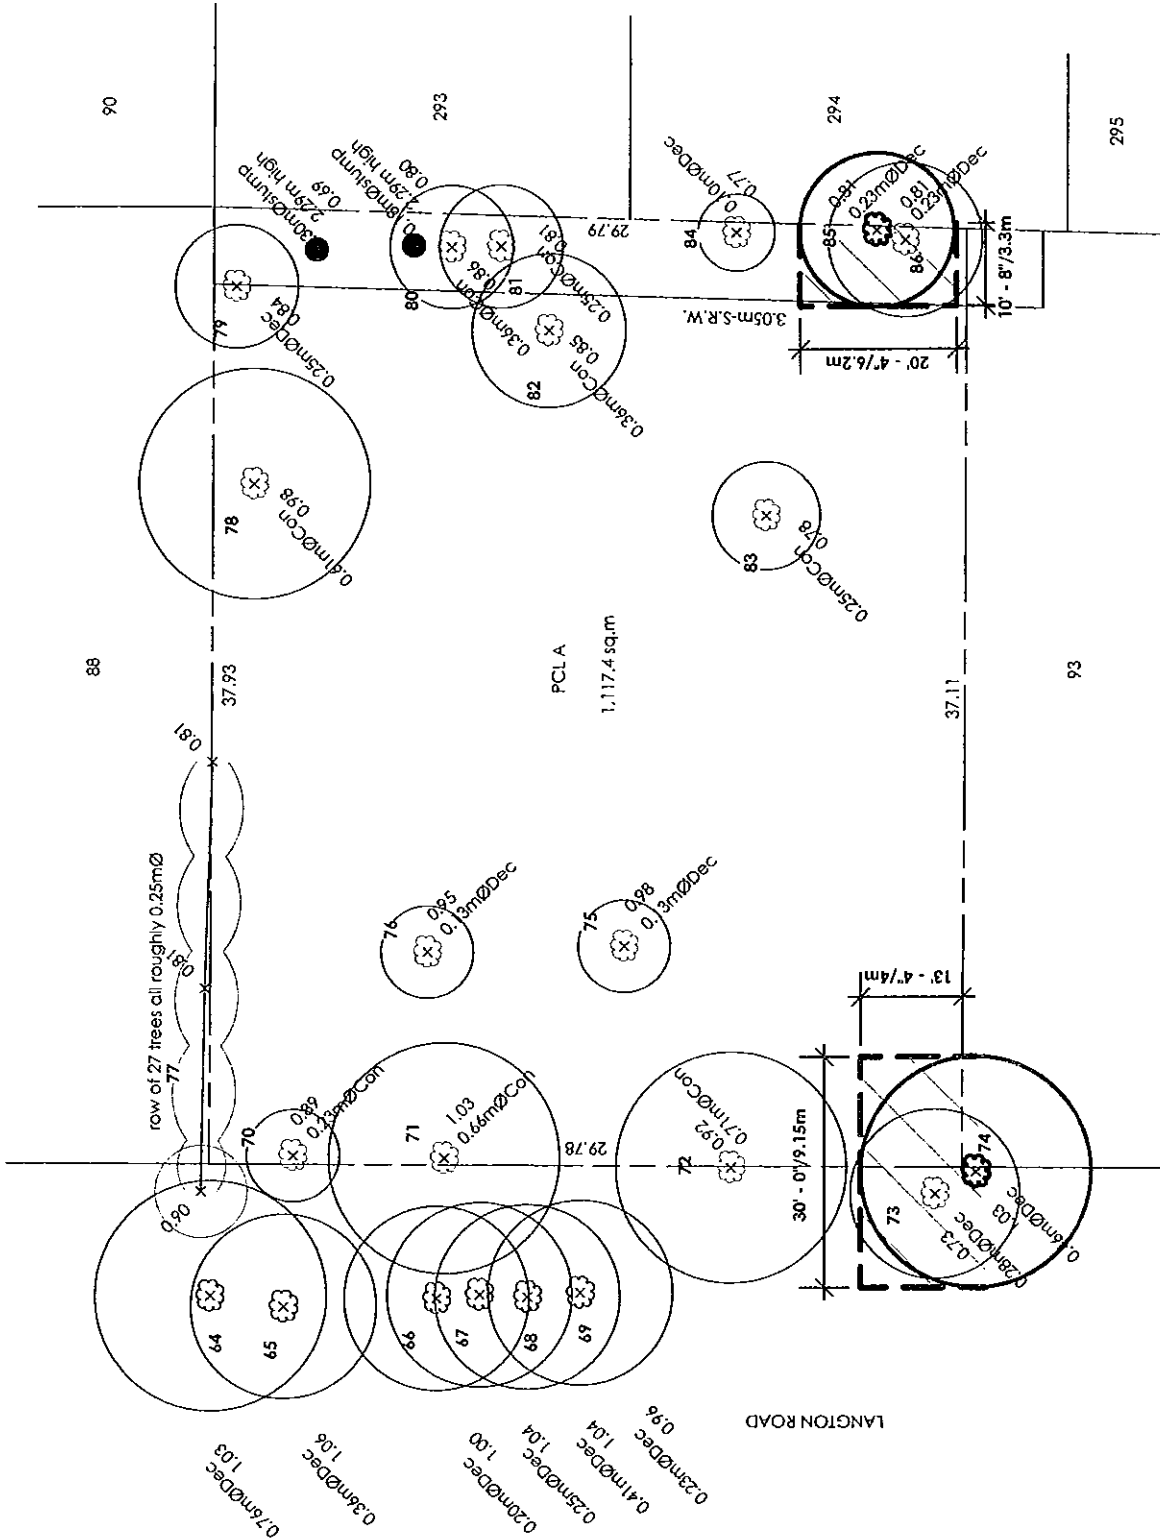
**ARBORIST REPORT**

TREE NUMBERS REFER TO TAGS ON TREES.

TREE PROTECTION AREA: DIMENSION TREE PROTECTION BARRIERS AS SHOWN (TO DRIPLINE) BARRIERS TO BE AT LEAST 1.2M HIGH AND UNSTRUCTURED OF ORANGE SNOW FENCING SECURELY FASTENED TO WOOD OR METAL STAKES, OR PLYWOOD FASTENED TO WOODEN STAKES, OR OTHER BARRIER SATISFACTORY TO MUNICIPAL STAFF. INSTALL SIGNAGE AS PER CITY OF RICHMOND REQUIREMENTS.

NO MATERIALS STORAGE OF ANY KIND, VEHICLE TRAFFIC OR PARKING WITHIN PROTECTION AREA.

With regard to the above proposed development site, I am pleased to provide this Arborist's Report on 22 trees and one hedge ("row of 27 trees"), as noted on the attached annotated Survey. The proposed project intention is to demolish the existing duplex building and create two separate residences. A site assessment was conducted Friday 20 July 2007. This Report documents the condition of the trees as below and makes general comments about future activities on this site relative to the existing trees. I do not have other project information, such as servicing or Site Plan, for the project. Common sense would indicate that the lot coverage will increase over the current amount. As well, the owner proposes to locate the two new driveways towards the joint property line. A number of trees in the front yard (some partially or wholly owned by the City of Richmond), most rated Poor or Fair, will be impacted by site planning. The number of replacement trees will depend on the Site Plan, and viable growing space remaining; there is certainly space on the boulevard for well chosen species.
