Re: **Non-Farm Use Fill Application by Sunshine Cranberry Farm Ltd No. BC735293
for Property Located at 12871 Steveston Highway.**

Staff Report

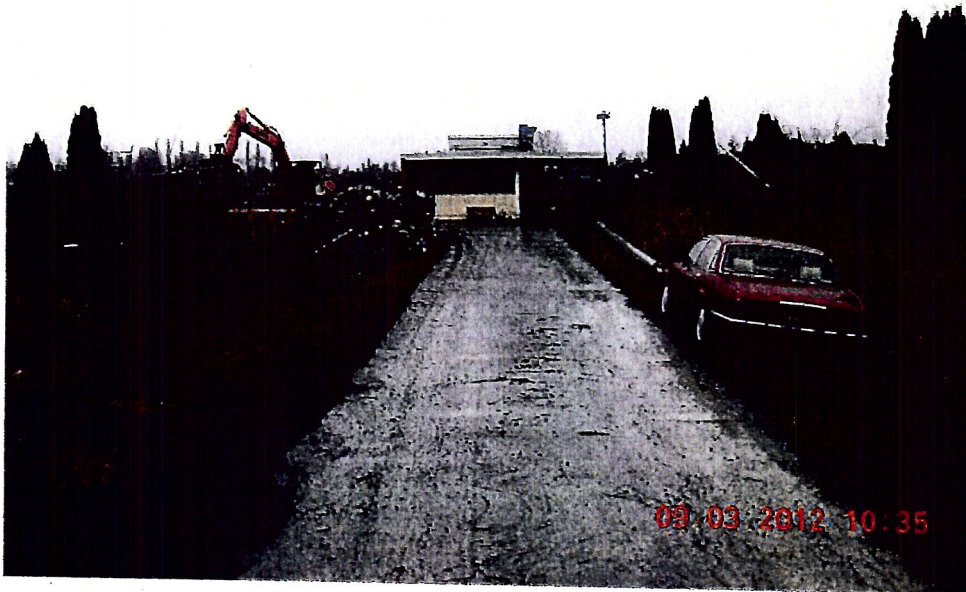
Photograph 1 Site entrance with cell phone tower steel stacked on the left.

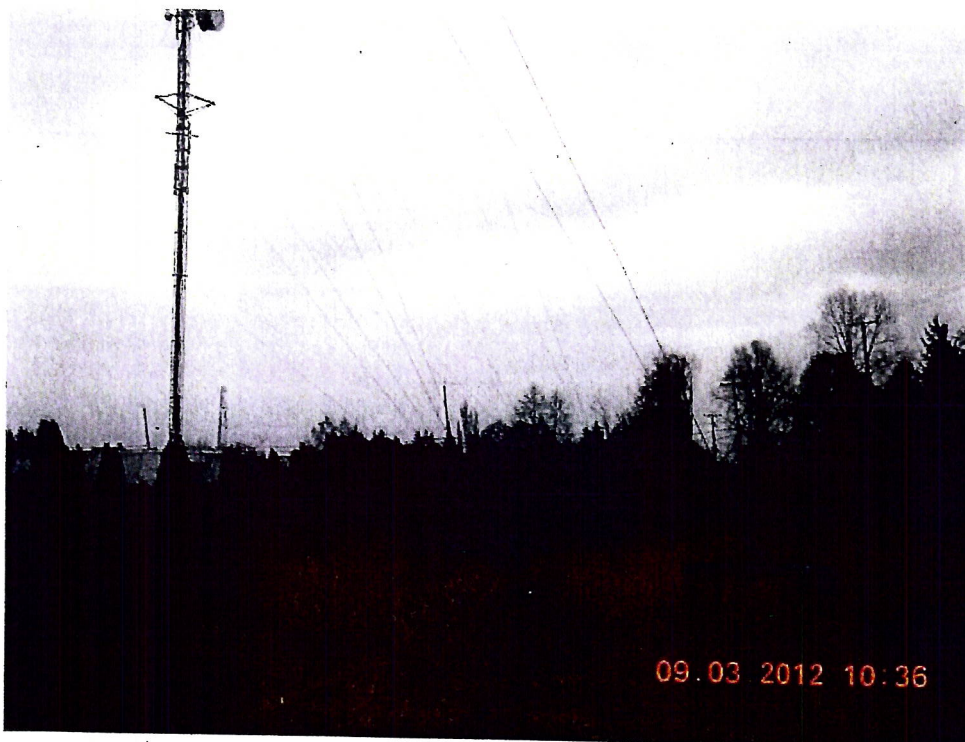
Photograph 2 Existing cell phone tower with concrete anchor blocks.

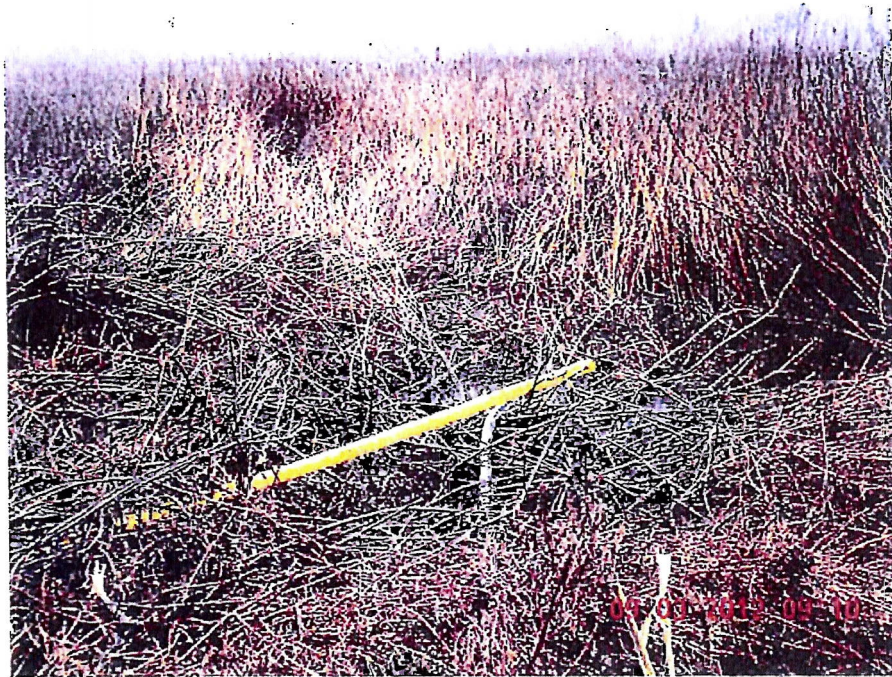
Photograph 3 A patch of hardhack around an anchor block and stay cable.

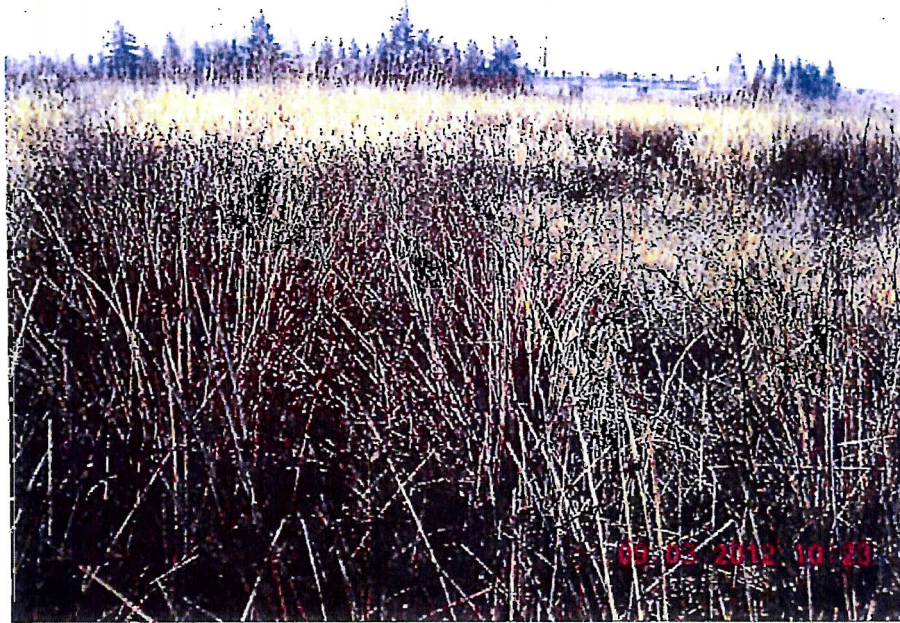
Photograph 4 Sedges and reed canarygrass.

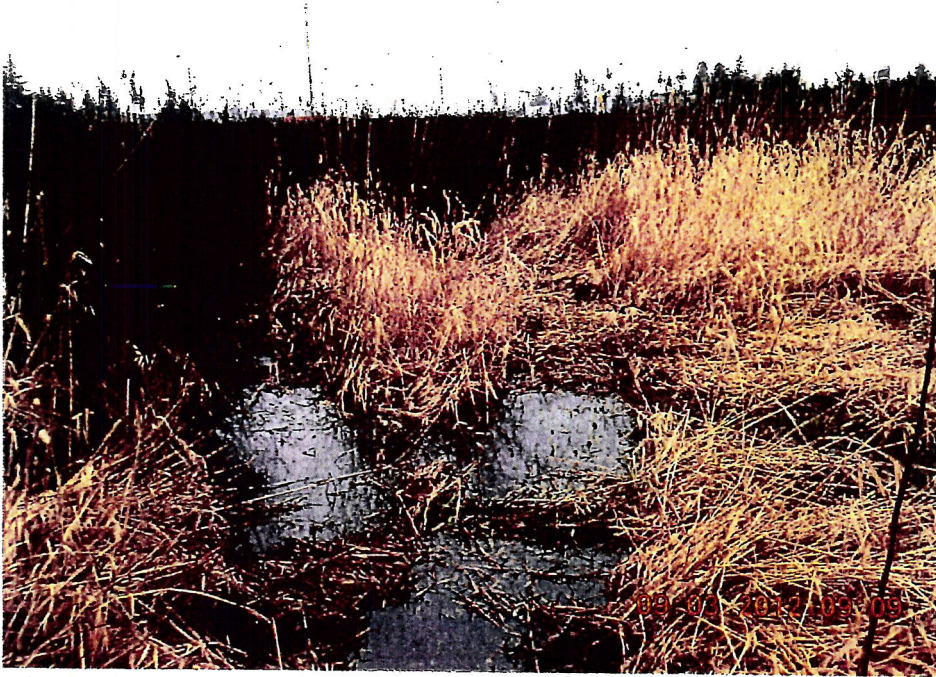
Observations of the Site were made in February, March and April 2012. During all three months, standing water was observed on the southwest section of the land and during February also in other areas of the Site. During February and March, the drainage ditches surrounding the Site were at capacity, not allowing drainage of the adjacent lands into the ditches. It was reported by the Mr. Bhullar, that the ditches around the Site have been at capacity during December and January as well. Ground truthing of soils and agricultural capability maps was carried out in March 2012 and the pictures contained within this report are representative of conditions at the Site on March 9, 2012.

Photograph 5 Standing water noted on the southwest portion of the Site.

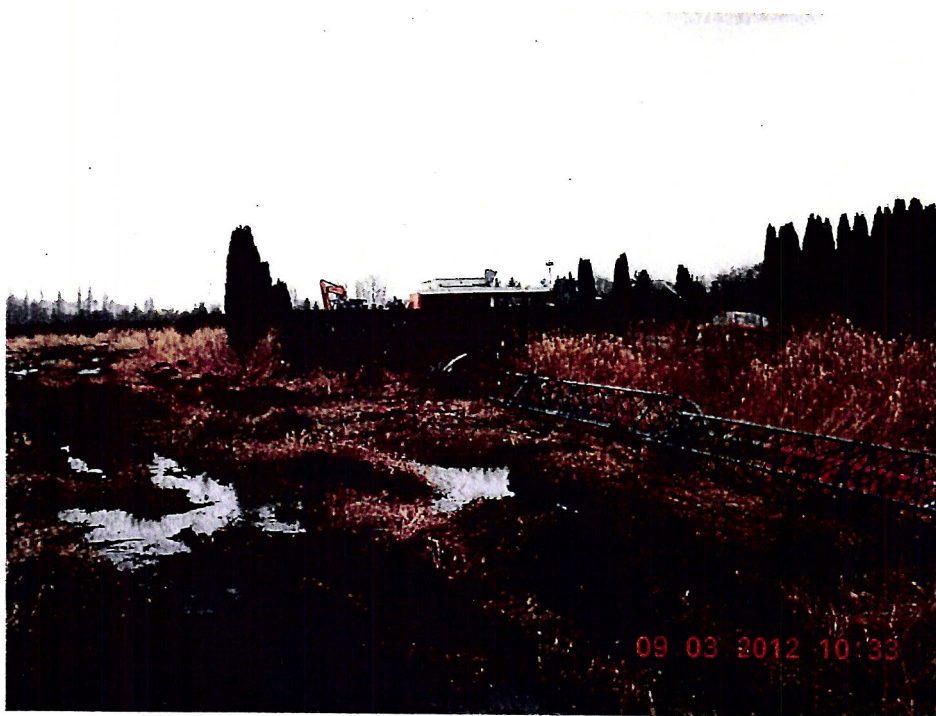
Photograph 6 Standing water on the southwest portion of the Site.

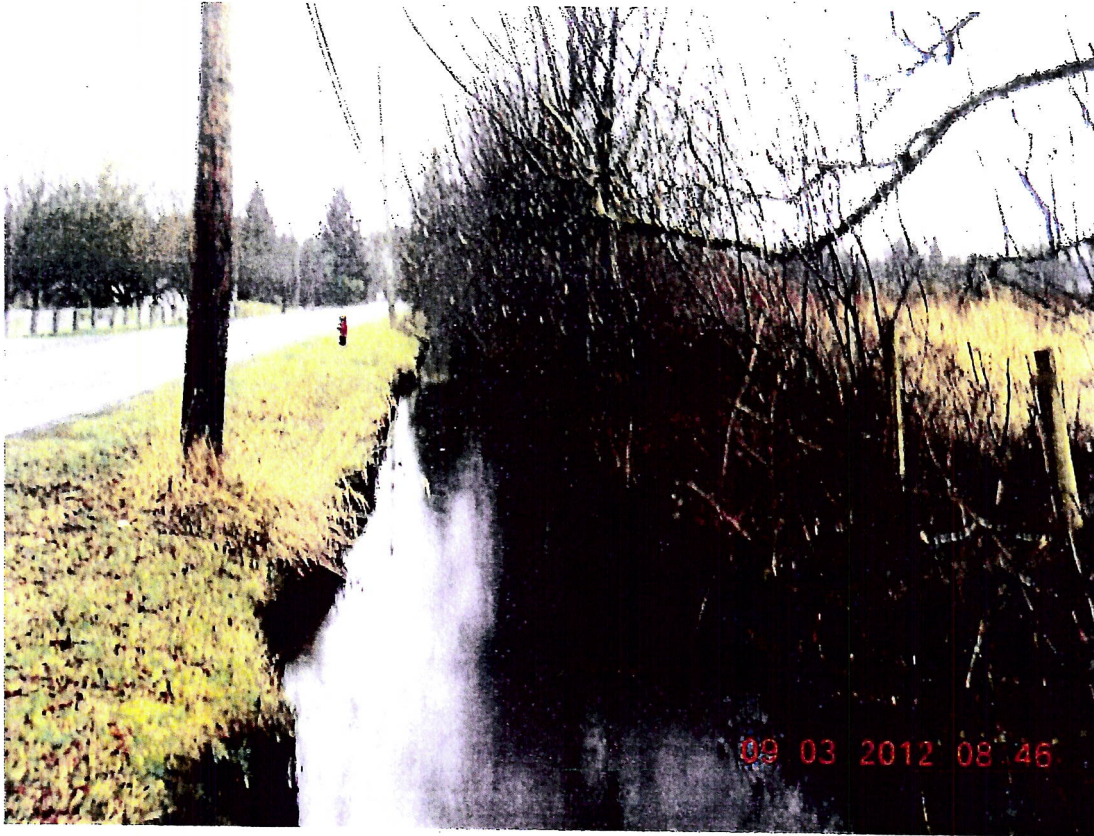
- The drainage ditch running parallel to the east property boundary had a steady southern flow and was approximately 2.5 m wide and 0.5 m deep (Photograph 9). This ditch separated the property from Sidaway Road.

Photograph 9 Eastern Drainage Ditch parallel to Sidaway Road.

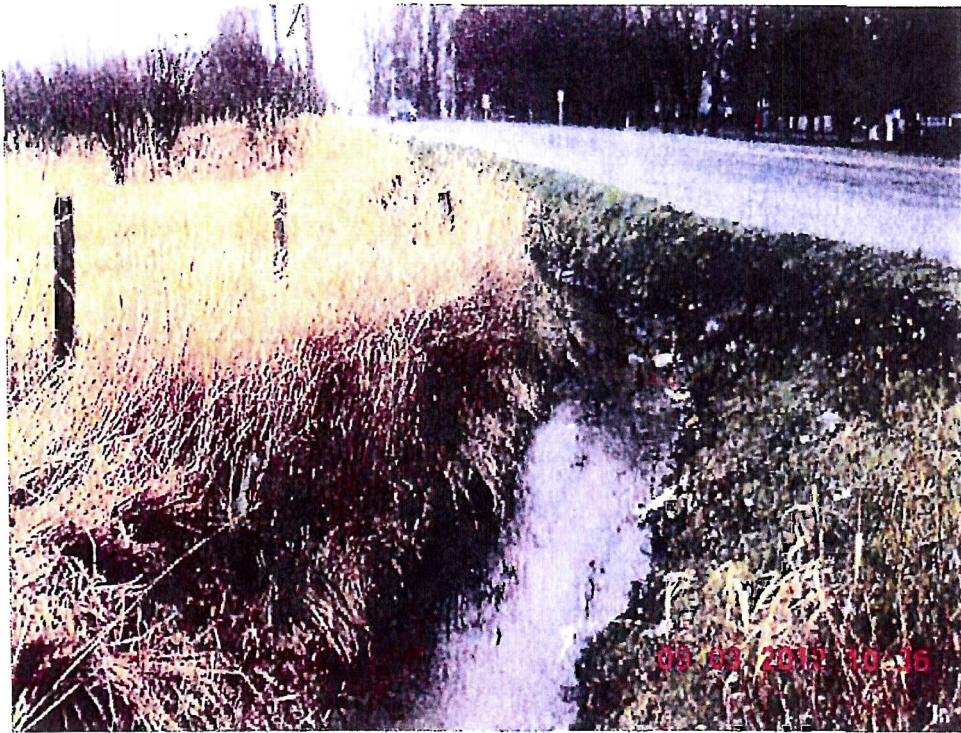
- The drainage ditch running parallel to the west property boundary, adjacent to Highway 99, was approximately 2 m wide and 0.5 m deep. Water was present in this ditch and appeared stagnant in places. The general flow direction was southward.
- The drainage ditch running parallel to the south property boundary was connected to the western ditch. This ditch was approximately 1.5 m wide and 0.5 m deep, with an easterly flow direction (Photograph 10).

Photograph 10 Southern Drainage Ditch Parallel to Steveston Highway.

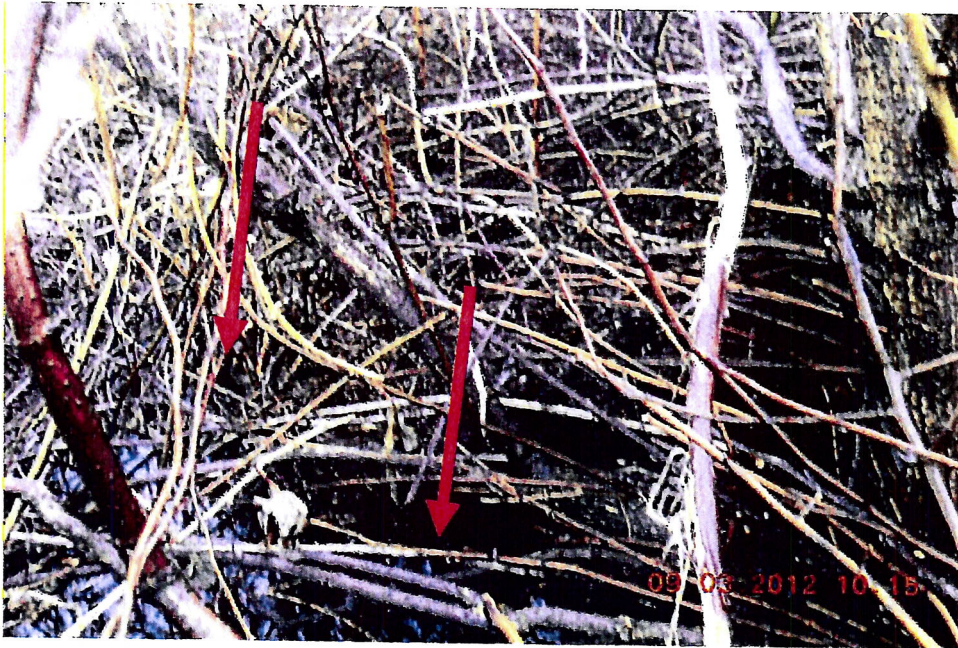
- Drainage on the north property boundary consisted of an ill-defined, heavily vegetated, shallow swale approximately 1 m wide (Photograph 11). Water in the ditch was stagnant with no observable flow direction. This drainage ditch is not shown on the City of Richmond map site and is considered a private ditch that has been established by either the previous owner or the adjacent property owner.

Photograph 11 Heavily Vegetated Northern Drainage Swale.
