**City of Richmond**  
Planning and Development Department

**Report to Committee**

**Re:** **Application by Simon Development Ltd. for Rezoning at 7791 and 7931 No. 4 Road from Single-Family Housing District, Subdivision Area F (R1/F) to Townhouse District (R2 – 0.6)**

RZ 05-313124

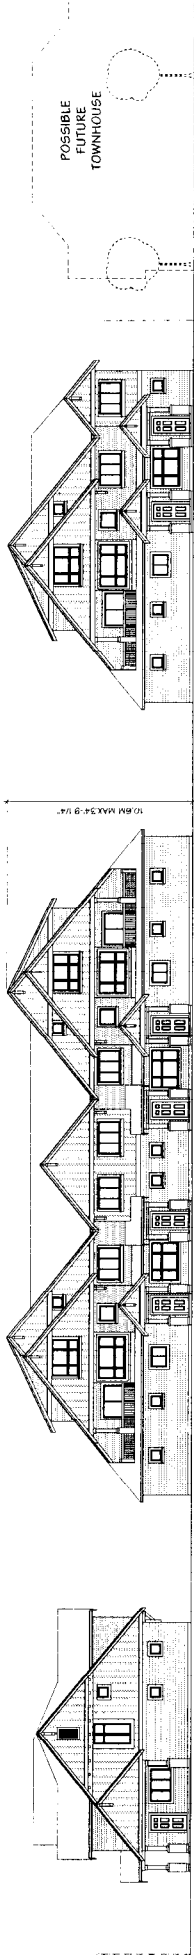
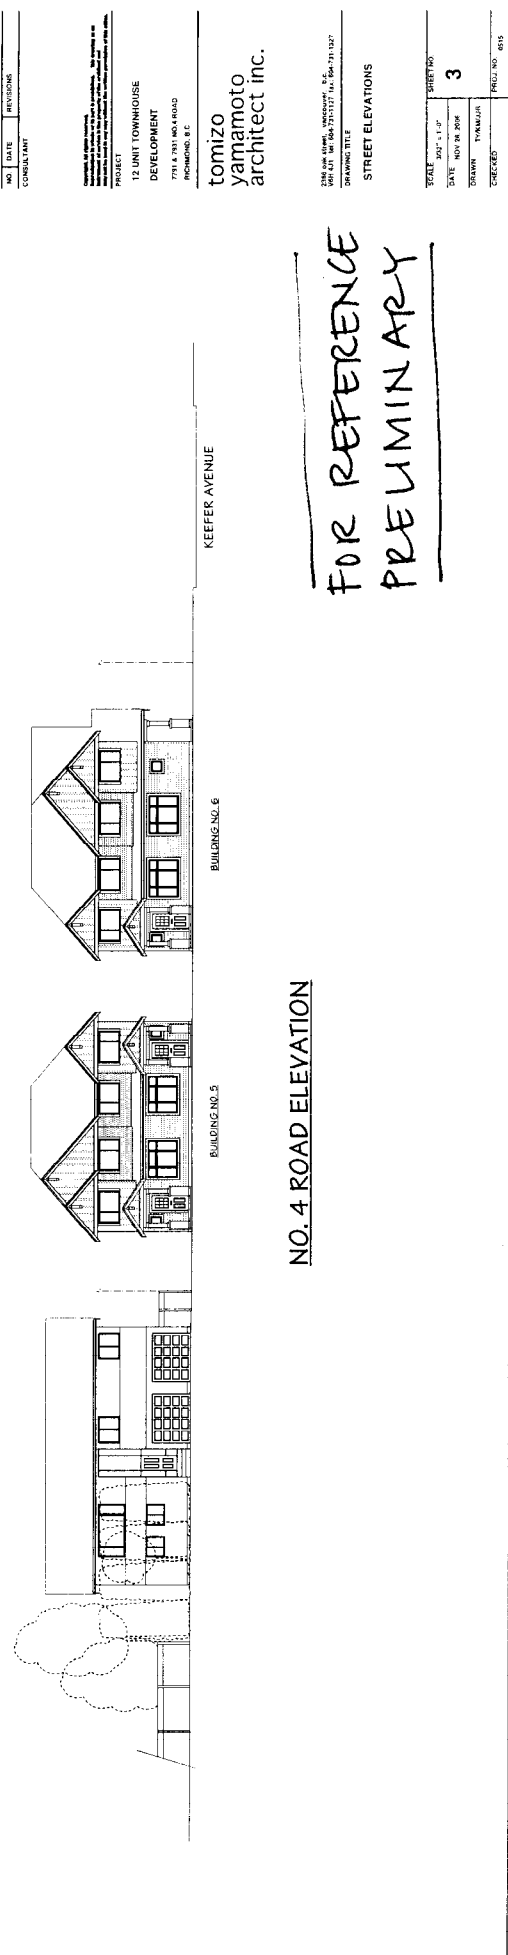
KEEFER AVENUE ELEVATION

BUILDING NO. 1

BUILDING NO. 2

BUILDING NO. 4

BUILDING NO. 5

BUILDING NO. 6

DATE: 10/10/2023  
DRAWING TITLE: STREET ELEVATIONS

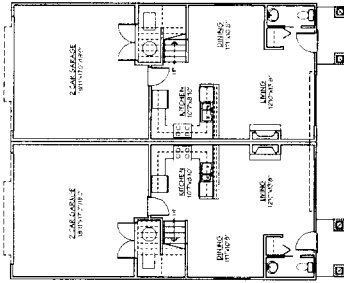
GROUND FLOOR PLAN  
SCALE: 1/8" = 1'-0"

BUILDING NO. 4

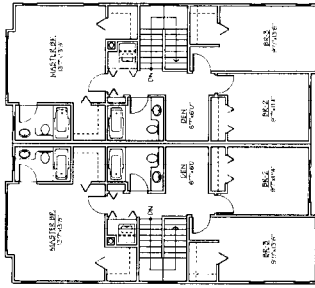
SECOND FLOOR PLAN  
SCALE: 1/8" = 1'-0"

BUILDING NO. 4

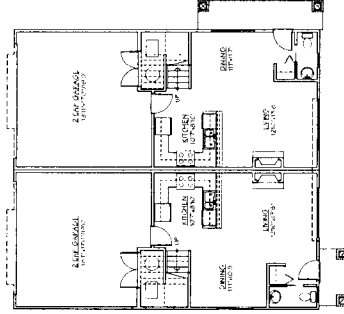
GROUND FLOOR PLAN  
SCALE: 1/8" = 1'-0"

BUILDING NO. 5

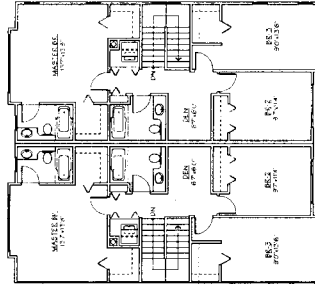
SECOND FLOOR PLAN  
SCALE: 1/8" = 1'-0"

BUILDING NO. 5

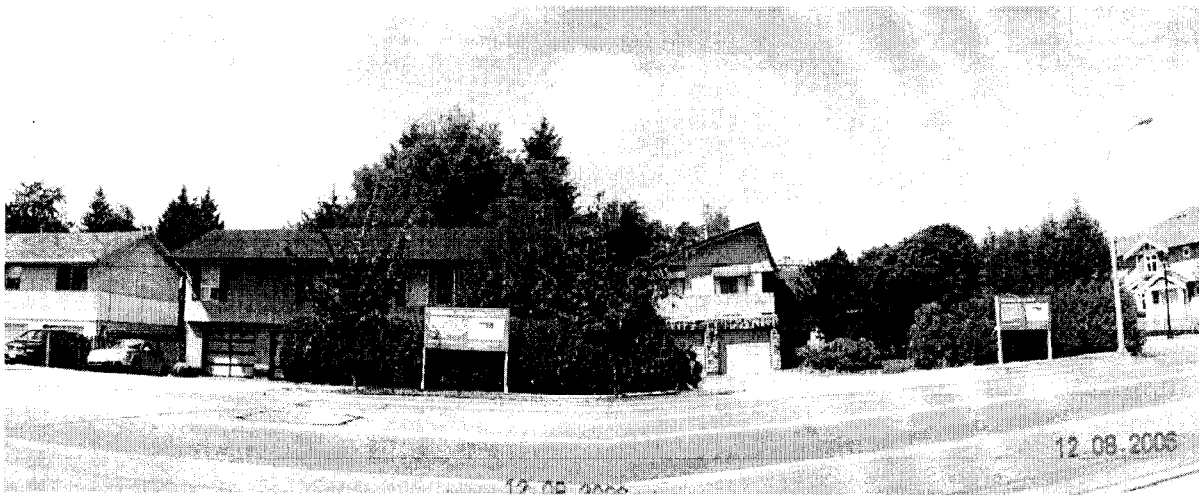
Photograph 1 shows a panorama view of the two building lots along No. 4 Road proposed for a 12 townhome subdivision.

There are two existing residential dwellings at 7791 and 7931 No. 4 Road. The existing homes are scheduled for demolition to enable the proposed development. The ground is relatively flat and there are no significant environmental features (including rapture nests) to report. The yards are landscaped with varying mixes of trees and shrubs around the existing homes. The over all health condition of the trees and shrubs on the building lots is moderate – good. However, there is a small stand of native Lodgepole pine and Birch trees at the rear (West side) of the proposed development property at 7791 No. 4 Road; these tree are in relatively poor condition and are not considered for preservation. It is to be noted that the native Birch trees at the rear of 7791 No. 4 Road were not numerically field-identified, however their locations are shown on the Appendix 1 Site Map.

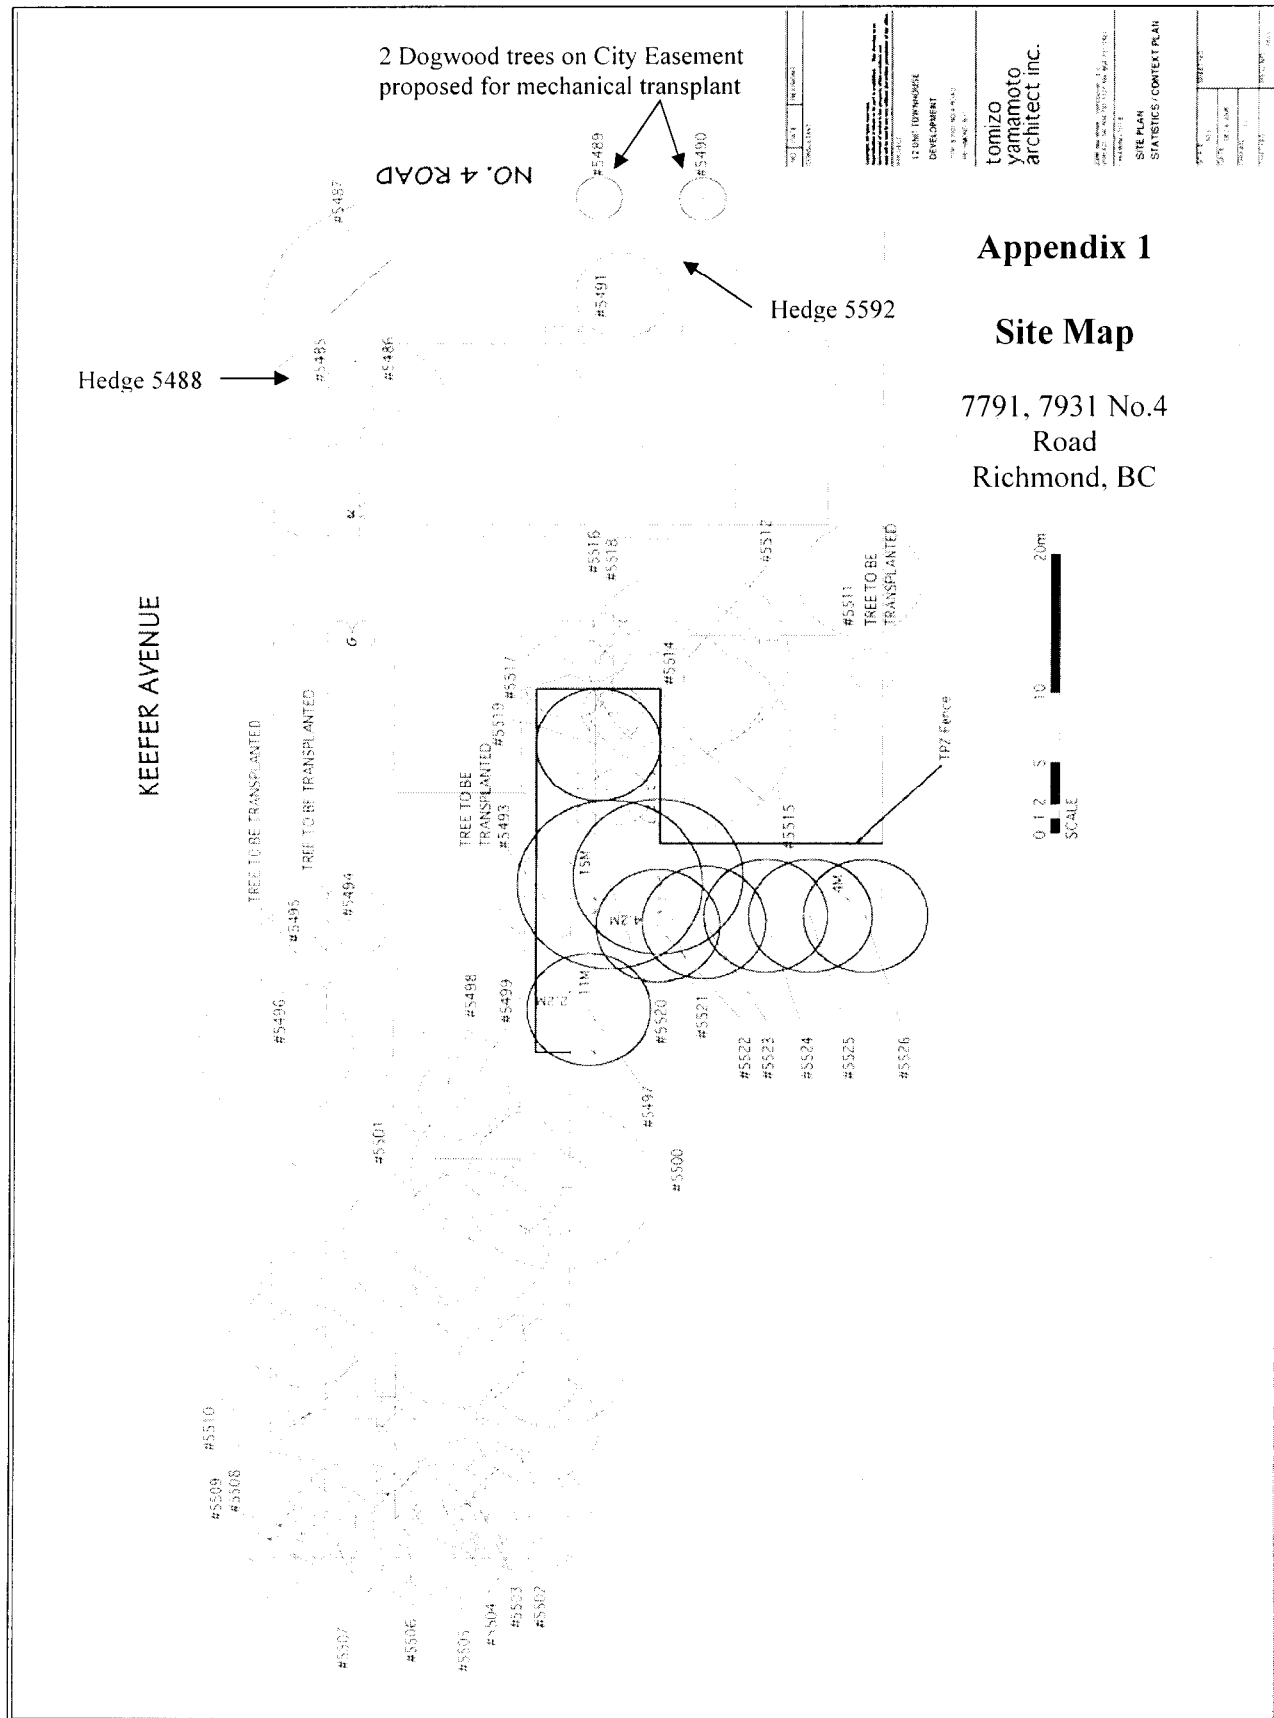
- Appendix 1 Site Map shows the locations of the trees and hedgerows, proposed building envelopes, interior roadway system and landscape areas
- Appendix 2A and 2B Tree Survey / Evaluation report documents the *on-site* and *off-site* trees / hedgerows respectfully. The Tree Survey / Evaluation report lists: tree number, species, diameter-breast-height (DBH) size, condition rating, observations and tree preservation recommendations. There are several undersized (< 20 cm DBH) trees documented in this report
- Appendix 3 provides:
  - A tree preservation strategy that summarizes *on-site* trees proposed for retention, removal, transplant
  - Calculation and number of replacement trees required in accordance to City of Richmond Tree Protection Bylaw No. 8057, Schedule A
- Appendix 4 provides tree preservation recommendations
- Appendix 5 contains mechanical tree transplant specifications

There are 3 specimen on-site trees > 20 cm DBH (# 5519, 5520 and 5521) at 7931 No. 4 Road building lot that are in good condition. The subdivision and proposed building layout configuration has been altered to permit the on-site retention of these trees.

Off-site Trees # 5522 – 5526: It is proposed that the TPZ fence is to be placed 3.0 meters East of the property line fence (on the development side) and run the entire length of the rear fence line bordering 9731 Blundell Road, immediately adjacent to the subject trees. It is proposed that a layer of landscape fabric be placed inside the TPZ fence; thereafter a 4" inch layer of "standard bark mulch" be placed in the TPZ over the landscape fabric. The purpose of the landscape fabric and the addition of bark mulch will help conserve soil moisture and help prevent soil compaction in the root zone of the neighbouring off-site preservation trees. The concrete pre-load blocks are to be placed next to the TPZ fences. As construction progresses and the rear patio areas behind the building are installed/developed, the TPZ fence can be dismantled and moved. The bark mulch can also be easily lifted-off the landscape fabric and removed to enable rear patio / landscape installation. The bark mulch may be salvaged and used in the finished landscape during the landscape installation phase of development. Mechanical soil-cuts into the parent soils in the TPZ are to be avoided.
